Board briefing – DAM SAFETY QUARTERLY REPORT

Quarterly Featured Damsite – Wilsey Dam

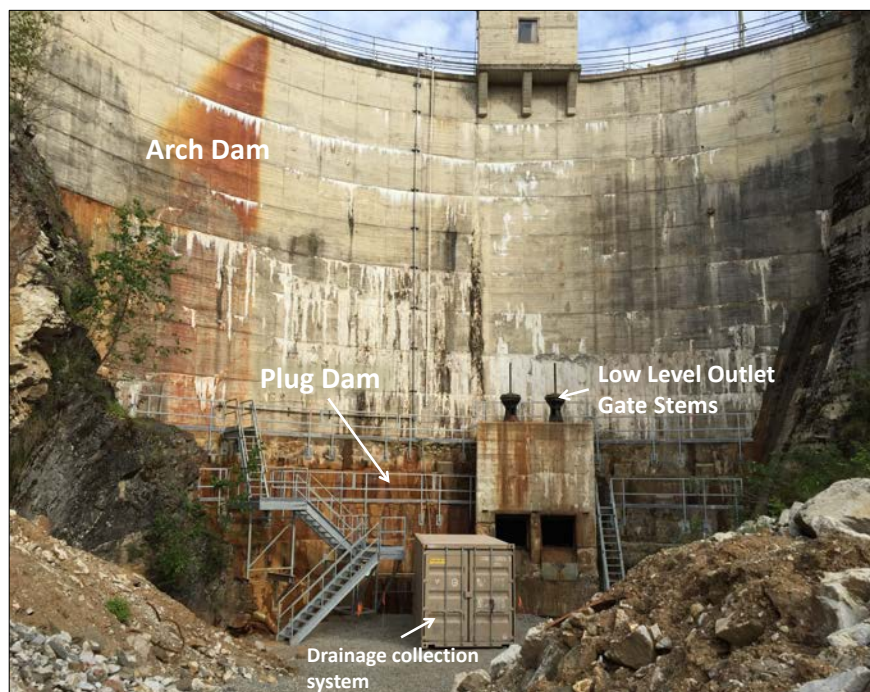
Wilsey Dam view from the downstream following F2016 work

A project was carried out in F2016 to provide monitoring of foundation drainage system, re-establish monitoring capability in the left abutment and improve access to the toe of the arch dam and the top of the plug dam.

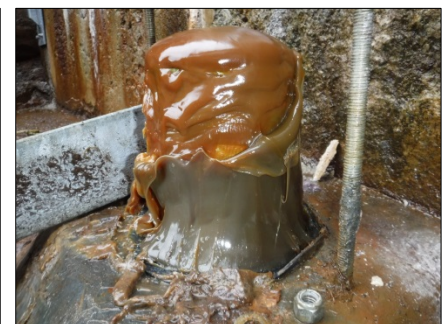
Post-tensioned anchor head

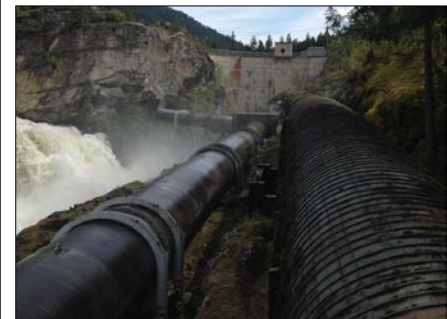
Steel and woodstave penstocks

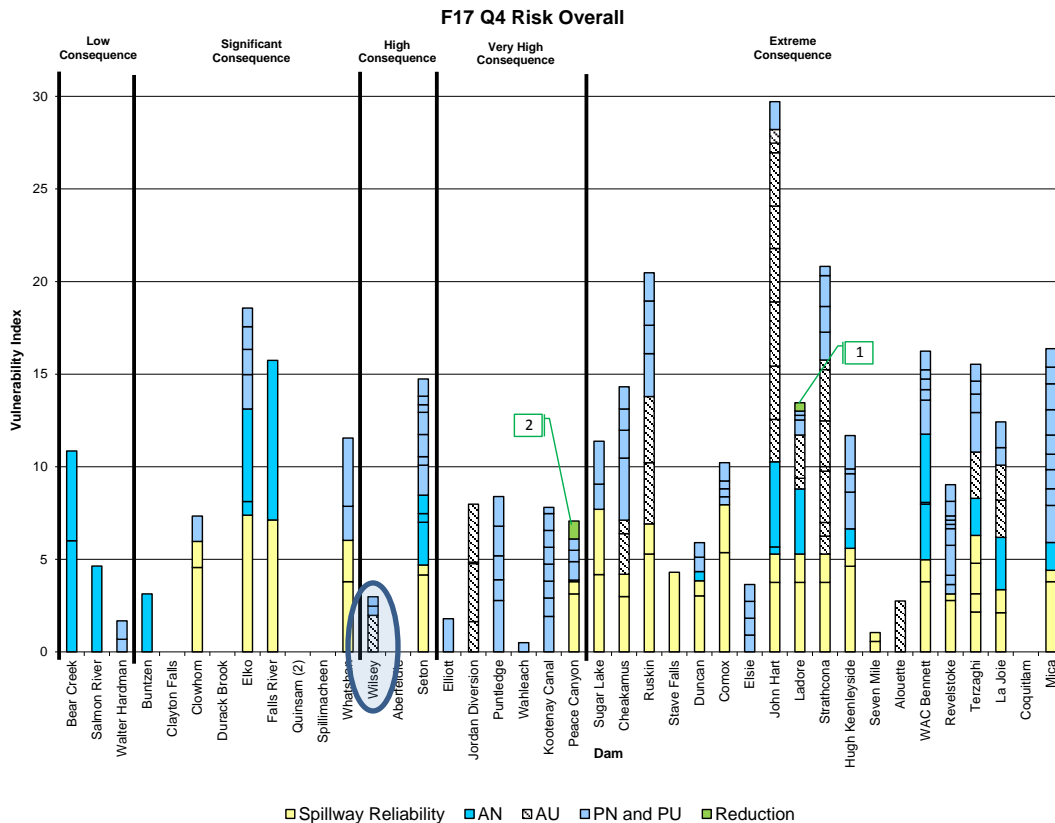
Figure 1 - Dam Safety: Overall Risk Profile

The Dam Safety Program has been carried out consistent with its stated objectives throughout the reporting period. The overall Dam Safety risk profile is shown in Figure 1. There has been an overall decrease in the risk profile this quarter due to completion of a stability model for Peace Canyon Dam and completion of the Ladore Dam stability assessment under seismic loading.

- Ladore Dam** – The database was updated to reflect the previously completed stability assessment for seismic loading which determined the dam to be stable for the Maximum Design Earthquake.
- Peace Canyon Dam** – The stability of the dam is sensitive to uplift pressures in the foundation. A model has been developed to allow for rapid assessments of dam stability for changing uplift pressures. The model can be used to determine the requirement for foundation drain maintenance or rehabilitation.
