Board briefing – DAM SAFETY QUARTERLY REPORT

Quarterly Featured Damsite – Whatshan Dam

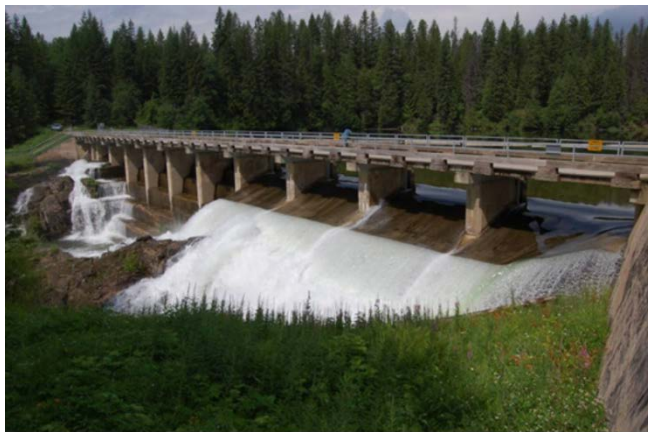
Whatshan Dam – Spillway in operation

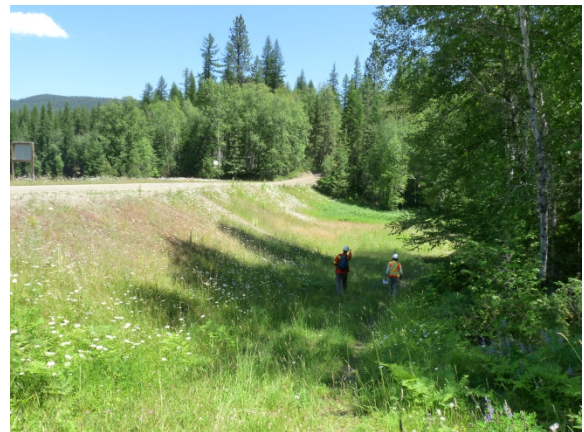
Downstream face of the Saddle Dam
