6.0: Quarterly Dam Safety Report

Executive summary

The purpose of this report is to update the Operations, Planning, Information & Technology Committee of the Board of Directors on key dam risk management activities during the period from October 1 to December 31, 2023 (F2024 Q3) and to provide reasonable assurance that the safety of dams operated by BC Hydro continues to be managed to the established guidelines and criteria of the Dam Safety Program. To keep the Committee as fully abreast of the Dam Safety Program as possible, some notable developments that took place after December 31, 2023, but before the completion of this report have also been included.

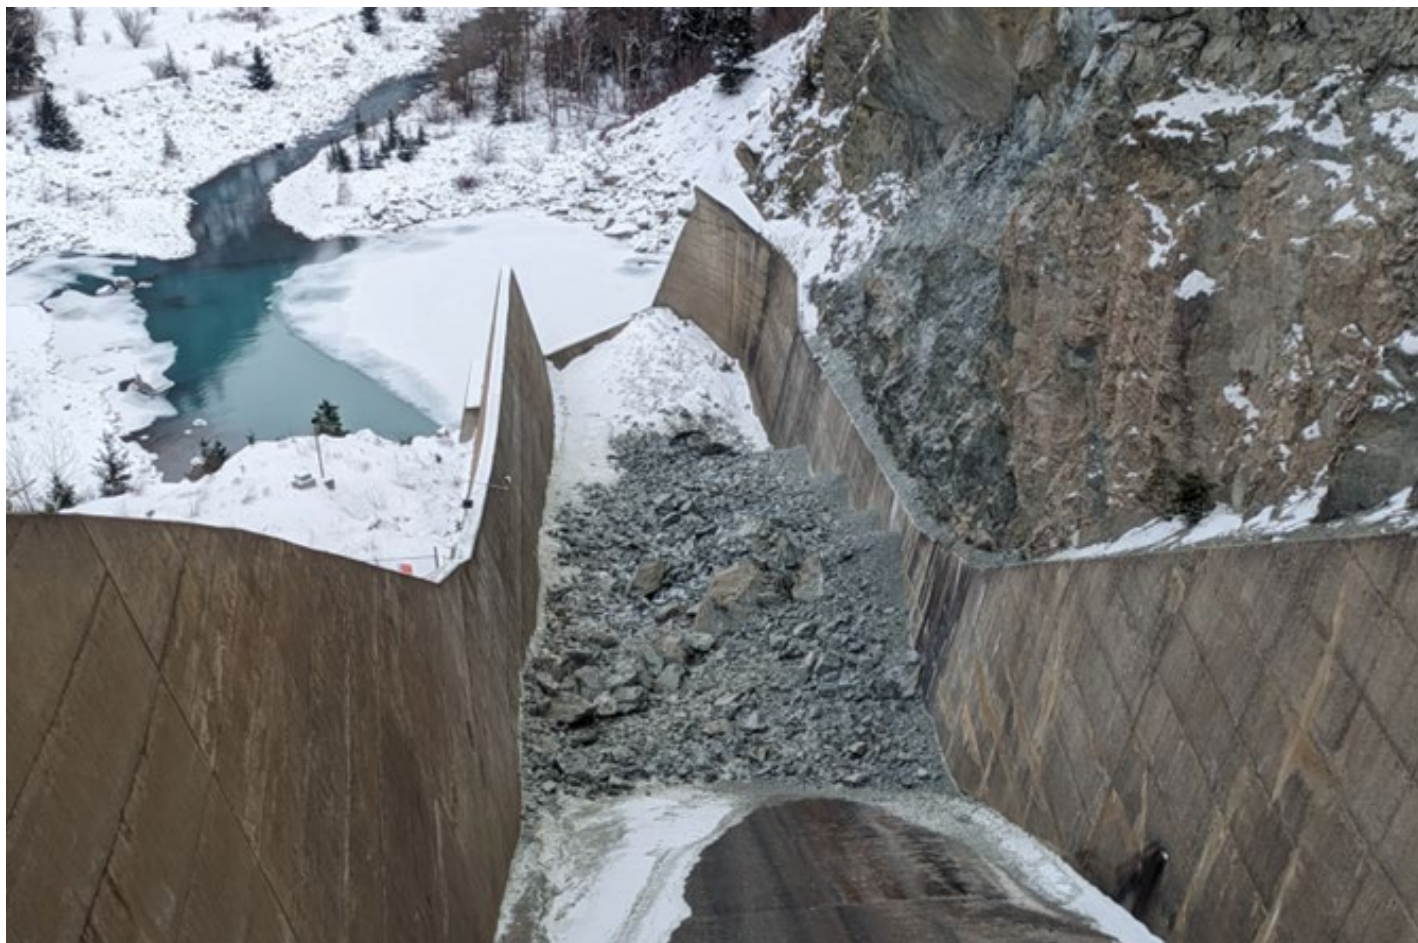
Figure 4 Rockfall in the spillway at Terzaghi Dam.

At some time between January 11 and January 15, 2024, during an extreme cold spell in southwestern British Columbia, several hundred cubic metres of rock fell from the steep slope adjacent to the spillway at Terzaghi Dam, blocking the spillway. See Figure 4, below.

There are no immediate impacts to operations. At the time of the incident, Carpenter Reservoir was at an elevation of approximately 638 metres and falling, well below the spillway’s gate sill elevation of 641.63 metres. The elevation of Carpenter Reservoir does not typically reach the gate sill elevation until July and current operating projections indicate that will be delayed this year if it is reached at all. Figures from Stochastic Event Flood Modelling indicate that, with the remaining discharge capacity of the dam’s low level outlet and at least one-half of the Bridge River generating units operating, we can safely route floods having return periods in excess of ten thousand years.

These results notwithstanding, the spillway is a safety-critical feature of the dam. An Interim Dam Safety Risk Management Plan is in preparation and an Issue is being entered into the Dam Safety Issues Database with a Vulnerability Index of 7.5, which is far and away the highest in the system. (Please note that this issue is not included in the end of Q3 results reported in the “Vulnerability Index Update”, above.)

To address this issue, plans are being developed to safely remove the rock from the spillway chute when weather at Terzaghi is more amenable for safe working conditions and the rock face is less prone to rockfall; likely this summer. An active project to design and construct stabilization and catchment works on this rock slope is currently moving into Definition Phase. Given that project team’s familiarity with the slope, they have been directed to take the lead in planning and implementing that work. An update on this work’s progress will be provided in next quarter’s report.

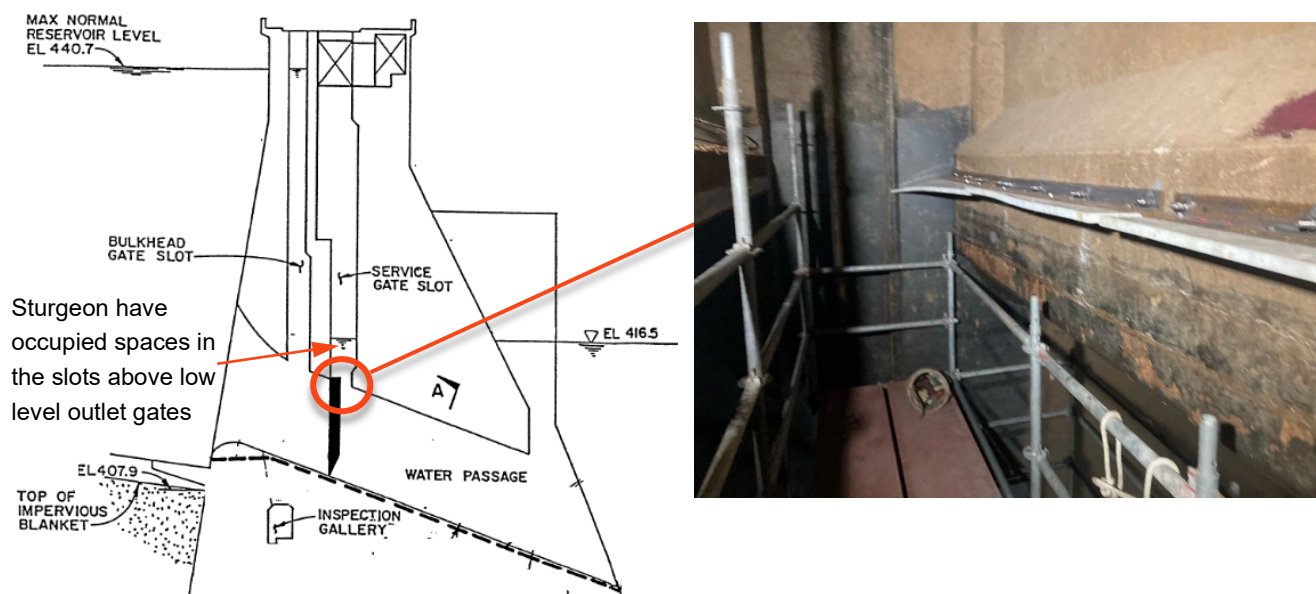
Figure 5 Prototype sturgeon exclusion plates installed in low level outlet gate slot at Hugh Keenleyside Dam.

As reported previously, white sturgeon have been observed entering the dam's low level outlet ports and swimming up the operating gate slots to access the tops of the gates during the summer months. To avoid injury or mortality to these fish, which is an Endangered Species under the Federal Species at Risk Act, BC Hydro is continuing to monitor for the presence of white sturgeon before any operation or testing of the gates. An engineering solution to prevent sturgeon from entering the gate slots has now been developed. In F2024 Q3, the first prototype was installed on one gate (Figure 5) to evaluate the effectiveness of the design and to ensure that it doesn't interfere with gate operation. The installation – basically a 1-inch thick rubber plate fastened to the downstream wall of the gate slot – performed well from a gate operating perspective. Material for the installation on the remaining low level gates is being received on site, with the next installation planned for January. The effectiveness of the solution at preventing sturgeon from entering the gate slots cannot be assessed until the summer months when the sturgeon are typically present in greater numbers.

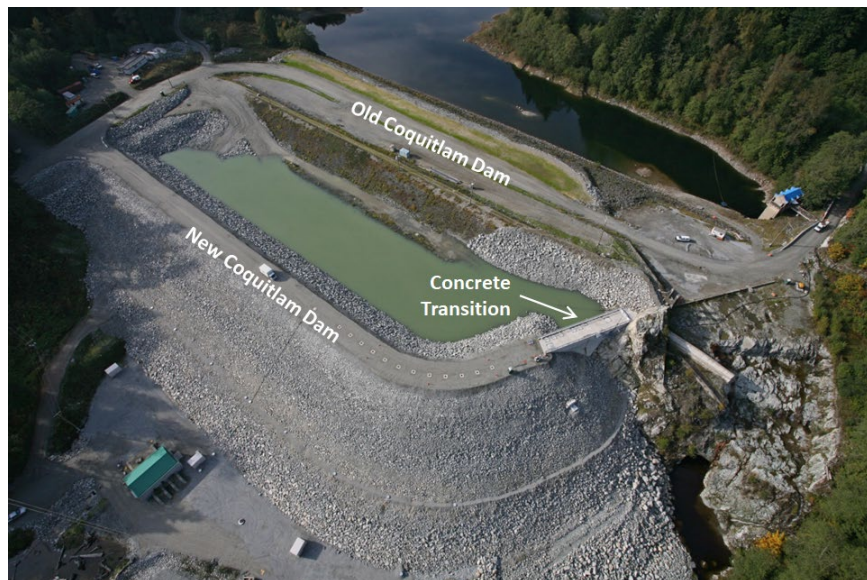
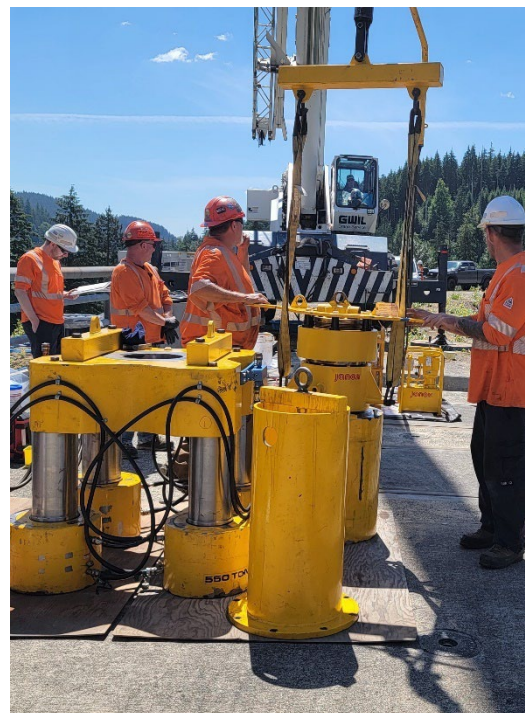
Figure 6 Above: Coquitlam Dam and the concrete transition structure. Right: Setting up the equipment to pull-test the concrete transition's three post-tensioned anchors.

One particularly notable maintenance project that was completed in Q3 was load confirmation testing of the three post-tensioned, 61-strand steel anchors in the concrete transition structure at Coquitlam Dam. Ranging in length from 29 to 43 metres, these anchors were installed during construction to provide additional stability to the concrete transition under seismic loading. After installation, they were each tensioned to 9540 kilonewtons (over 2 million pounds) and “locked off” to hold that tension in the anchors. In the event of an extreme, design-level earthquake, this tensioning will allow the anchors to resist the seismic loads without allowing excessive sliding or lift-off of the transition from its rock foundation. Given their importance to the seismic performance of the dam, these anchors must be periodically tested to ensure that they remain tensioned to their design level. See Figure 6 on the following page.

The anchors are slightly inclined from the vertical to provide additional stability on the sloping bedrock foundation. To ease the threading of a large jack to the inclined anchor heads, and importantly to avoid damaging the threads, an articulating harness was designed and fabricated, and added to the anchor testing apparatus. The contractor-designed and supplied modification was very successful, and all three anchors were verified to remain within their design envelop. Testing was overseen and directed by Generation Stations Civil Engineering and supported by Stations Field Operations.

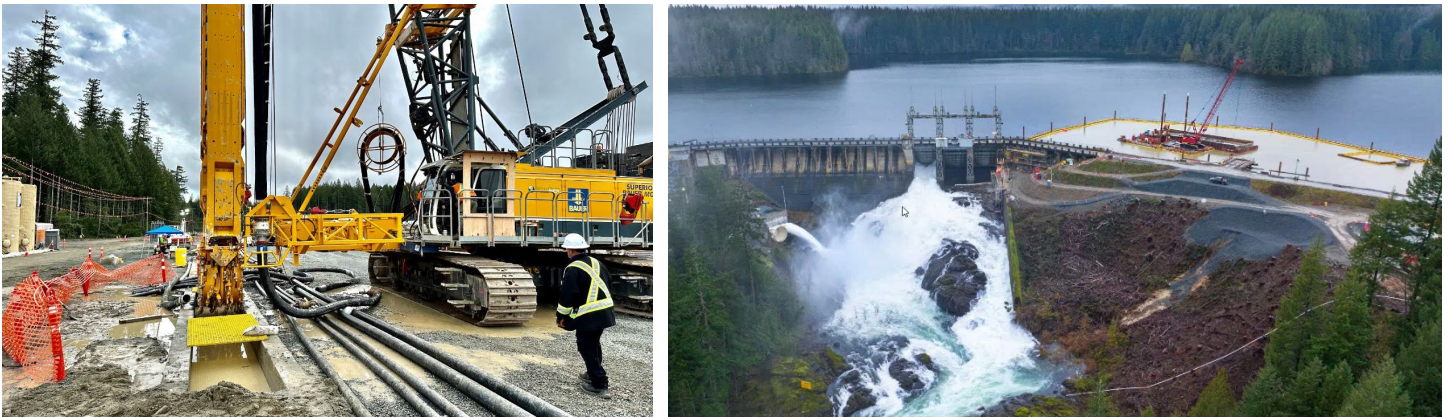
Figure 8 Construction on the John Hart Dam Seismic Upgrade Project. Left: Construction of a panel of the plastic concrete cut-off wall, showing the specialized excavating equipment in use (November 2023). Right: Looking upstream toward the North Earthfill Dam work site (January 2024).

- On the North Earthfill Dam, the double-walled silt curtain was fully installed, in-water excavation of the upstream riprap was completed, and dredging of loose materials that will enable the placement of the compacted upstream berm progressed.

- On the Concrete Main Dam, work to raise the spillway's left training wall and to upgrade the dam roadway structures between the spillway and the North Earthfill Dam commenced.

- On the Middle Earthfill Dam, construction of the new plastic concrete cut-off wall progressed. The wall is built by excavating a vertical-walled trench, as deep as 37 metres, between concrete guide walls on the crest of the dam. To prevent the trench from collapsing, it is excavated in panels and clay bentonite is used to fill the gap. A pipe is lowered to the bottom of the trench and the plastic concrete is pumped in, pushing the bentonite upward and out. Construction continues in this way, panel-by-panel. By the end of January, the wall was approximately 50 percent constructed and is scheduled to be completed in the spring of 2024.

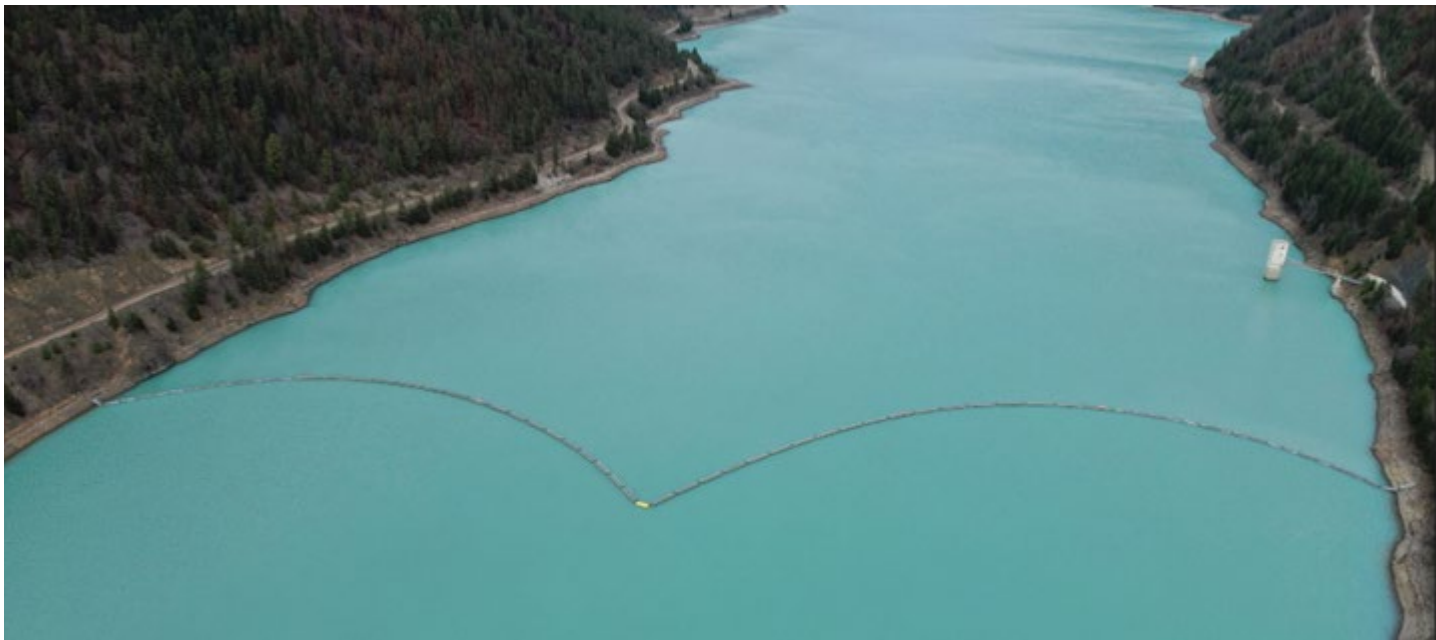
Figure 10 The new reservoir boom on Carpenter Lake. The intake structures for Bridge River 2 (at front) and Bridge River 1 (at back) are visible on the right side of the reservoir. Terzaghi Dam is just beyond the top of the photograph.

In F2024 Q3, the debris boom at Terzaghi was replaced with a new style steel boom. This boom replacement was particularly timely for two reasons: the existing log boom was identified as being in very poor condition and the 2023 wildfires around Carpenter Lake are expected to cause a larger than normal debris load in 2024. The new debris boom will be an essential part of the debris management strategy.

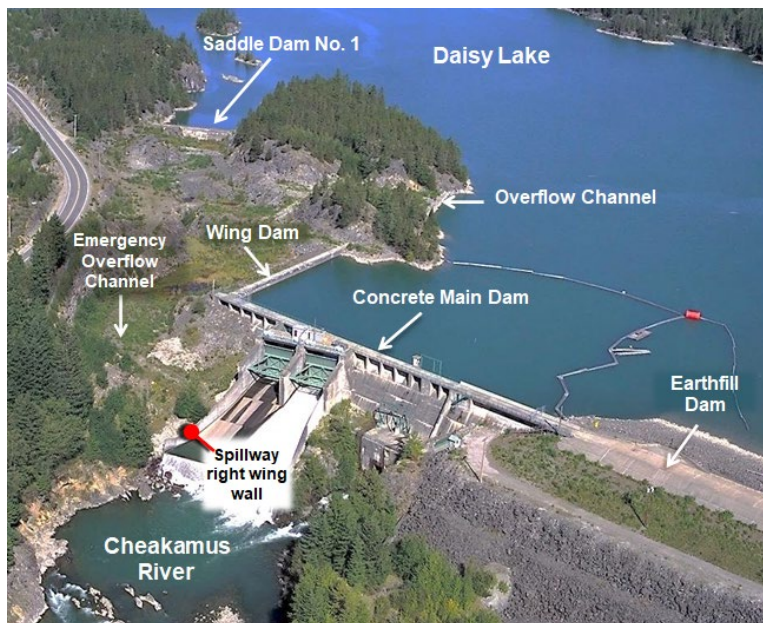
Figure 11 Aerial View of the Cheakamus Dam and Daisy Lake, identifying elements investigated in the Cheakamus Dam Hydraulic Assessment.

- No overtopping of the earthfill dam is expected for any of the updated Safety Evaluation Flood scenarios.
- Saddle Dam No. 1, the wing dam and the concrete main dam (see Figure 11 at right) all meet sliding and overturning criteria under the Safety Evaluation Flood scenarios with no loss of containment expected.
- Riprap at the base of the wing dam, the concrete main dam, and the Highway 99 embankment could be washed away as water flows through the emergency overflow channel during extreme floods.
- The spillway's right wing wall would be vulnerable to failure during extreme flooding. While it is unlikely that the wing wall's failure would retrogress to the dam and cause loss of containment, the modelling was not able to rule out that possibility.

The Investigation's final report will recommend closing three Potential Deficiencies and two Non-Conformances in the Dam Safety Issues Database and to update three other Non-Conformance issues.
