### Board briefing – DAM SAFETY QUARTERLY REPORT

### Quarterly Featured Dam Site

# Comox Dam

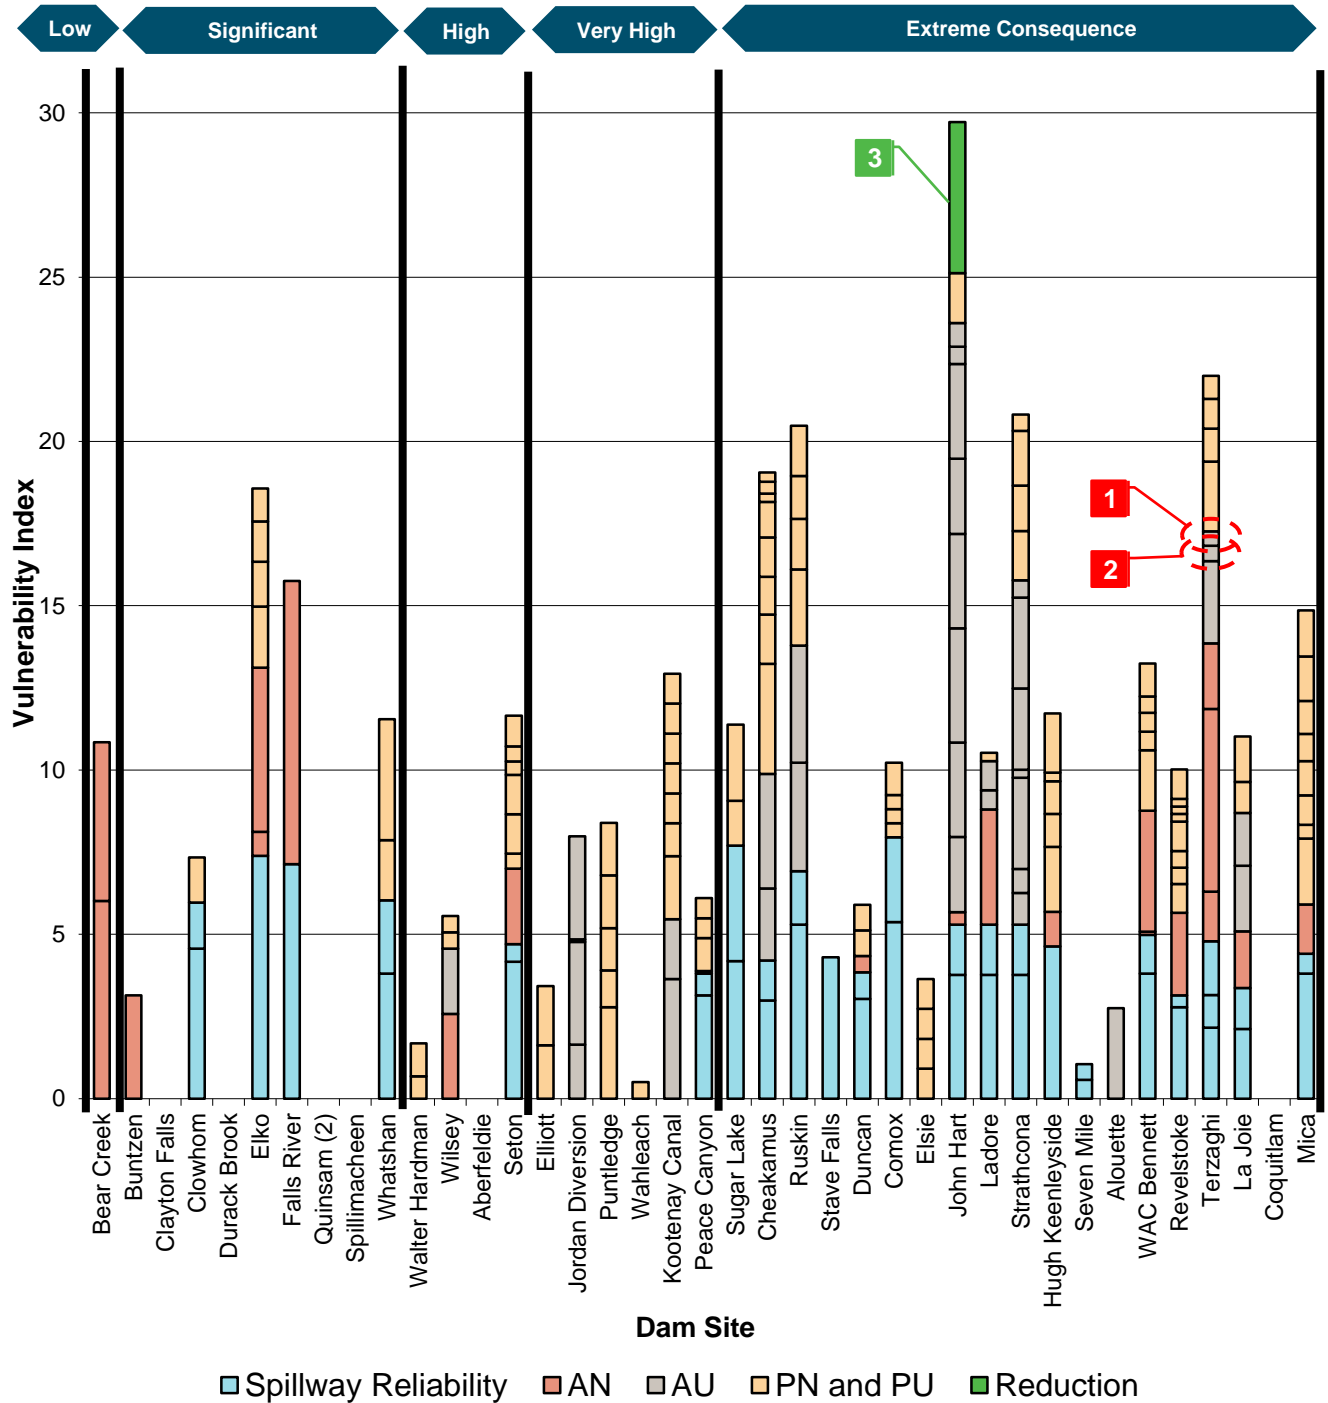
**Figure 1** Dam Safety overall risk profile at the end of F2019 Q3, as represented by the Vulnerability Index. Notable changes are identified.

Notable changes in Vulnerability Index in F2019 Q3 are described below and identified on Figure 1.

- 1**    A Vulnerability Index **addition** of 0.47 (AU deficiency) at Terzaghi Dam due to capacity to pass only approximately 80% of the updated Probable Maximum Flood, but with an estimated probability of overtopping the dam of less than  $1.7 \times 10^{-6}$ .
- 2**    A Vulnerability Index **addition** of 0.43 (AU deficiency) at Terzaghi Dam due to the possibility of the spillway chute walls being overtopped when passing extreme floods. The spillway was originally designed to have a capacity of about 1,275 cubic metres per second but the current Probable Maximum Flood requires discharge through the spillway greater than this.
- 3**    A Vulnerability Index **reduction** of 4.6 at John Hart Dam due to the permanent dewatering of the wood stave penstocks, eliminating the risk related to the penstocks failing under seismic loading.

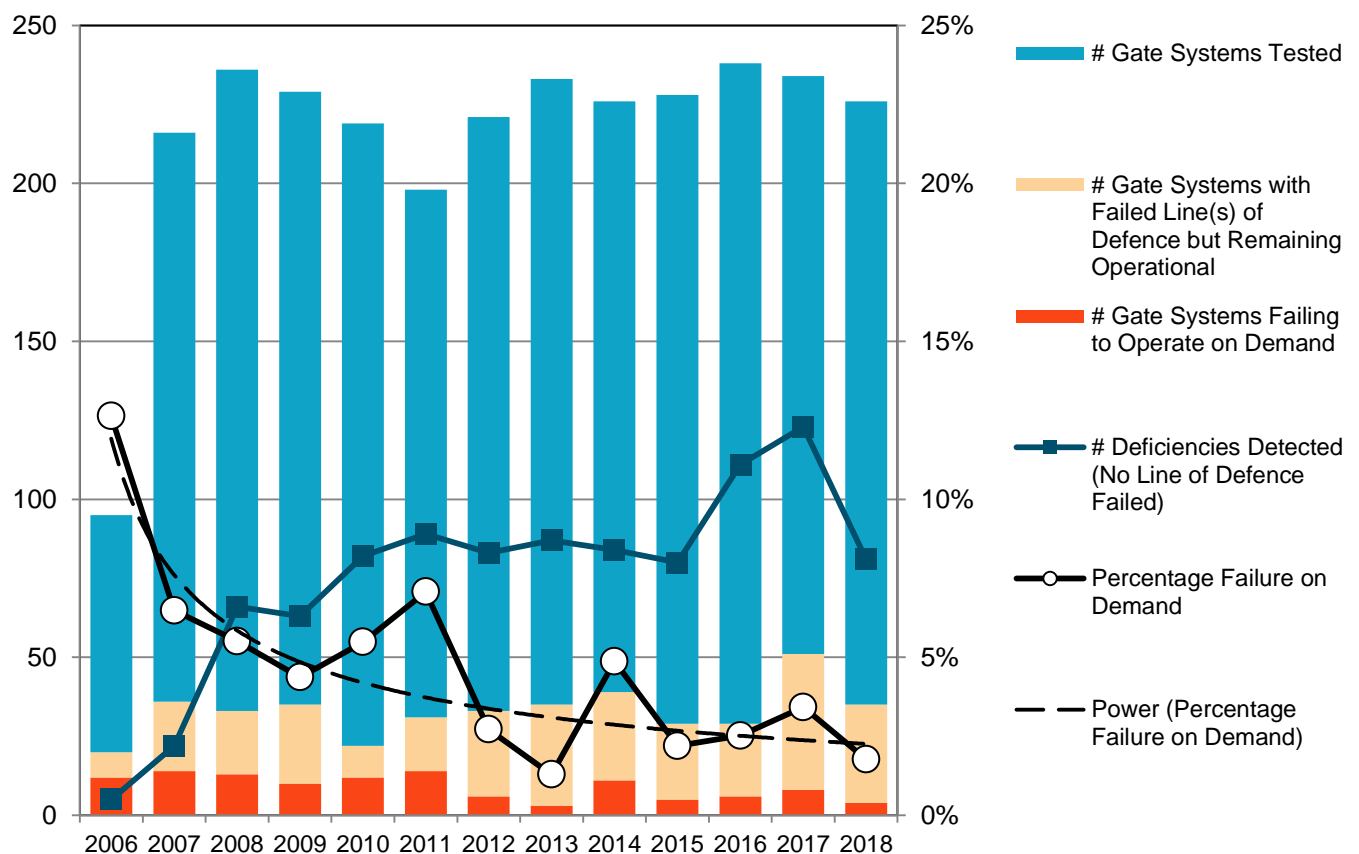
**Figure 3** Deficiencies detected and rates of failure to operate on demand during flood discharge gate testing.

Since 2006, when improved reliability of flood discharge (spillway) gates was identified as a priority in and the Dam Safety Program was adjusted to provide better stewardship of our spillway gates systems through regular maintenance and testing and capital upgrades, there has been a notable improvement in the rates of failure to operate on demand during scheduled tests. As illustrated in Figure 3, rates of failure have decreased by nearly a full order of magnitude.

Figure 3 additionally shows that the number of deficiencies identified each year through testing is not diminishing. It is not yet clear that the detection of deficiencies has settled into a reasonably steady state that would be commensurate with a well-established maintenance program. Dam Safety is presently evaluating maintenance records and developing metrics to assess the status and adequacy of maintenance of flood discharge gate systems. These metrics will be included in and become a regular part of future reports.
