Board briefing – DAM SAFETY QUARTERLY REPORT**Executive Summary**

The purpose of this report is to update the Capital Projects Committee of the Board of Directors on key dam risk management activities during the period from January 1 to March 31, 2021 and to provide reasonable assurance that the safety of dams operated by BC Hydro continues to be managed to the established guidelines and criteria of the Dam Safety Program. To keep the Committee as fully abreast of the Dam Safety Program as possible, some notable developments that took place after March 31 but before the completion of this report have also been included. The key highlights from F2021 Q4 documented in this report are:

Board briefing – DAM SAFETY QUARTERLY REPORT

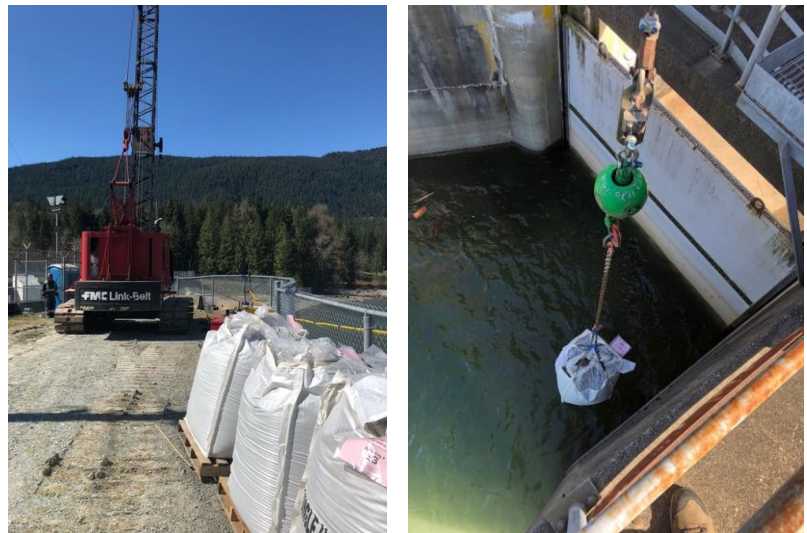
The Alouette Dam spillway is expected to be damaged by ground motions arising from a major earthquake – expected to occur on average once every 1000 to 2500 years – after which it would not be safe for use. Additionally, the tunnel that carries water from Alouette Lake to Stave Lake for generation at Stave Falls and Ruskin has structures that are not designed to resist earthquake loads. Until the tunnel is upgraded (see the Alouette – Headworks Tower and Surge Tower Seismic Upgrade Project under “Capital Projects” later in this report) the reservoir is being managed in a manner to extend the period of time before the spillway would pass flows following an earthquake.

Figure 1 Left: staging of crane and Superbags on the crest of Alouette Dam. Right: test placement of Superbag upstream of the sluice gate.

could be sealed by sandbags that have been stored at site in recent years. In this and a number of subsequent years, however, BC Hydro has agreed to support a study on the potential benefits of higher flows over the spillway to smolt outmigration. Outflows will average 10-11 m³/s with gate openings of about 800 mm, exceeding the capacity of conventional sandbags to seal off should an earthquake occur. In response, Dam Safety initiated a Dam Safety Investigation (see the F2021 Q2 report) and worked with Engineering, Generation System Operations and Environment to develop means of stopping the spillway flows in the unlikely event of a damaging earthquake under an Interim Dam Safety Risk Management Plan. Under this plan, a crane and very large, one cubic metre sandbags, commonly referred to as “Superbags”, have been staged on the dam crest (Figure 1) to provide a means of stopping the spillway flows if the gate cannot be closed. These measures will remain in place through the end of the smolt outmigration period on June 15, 2021.

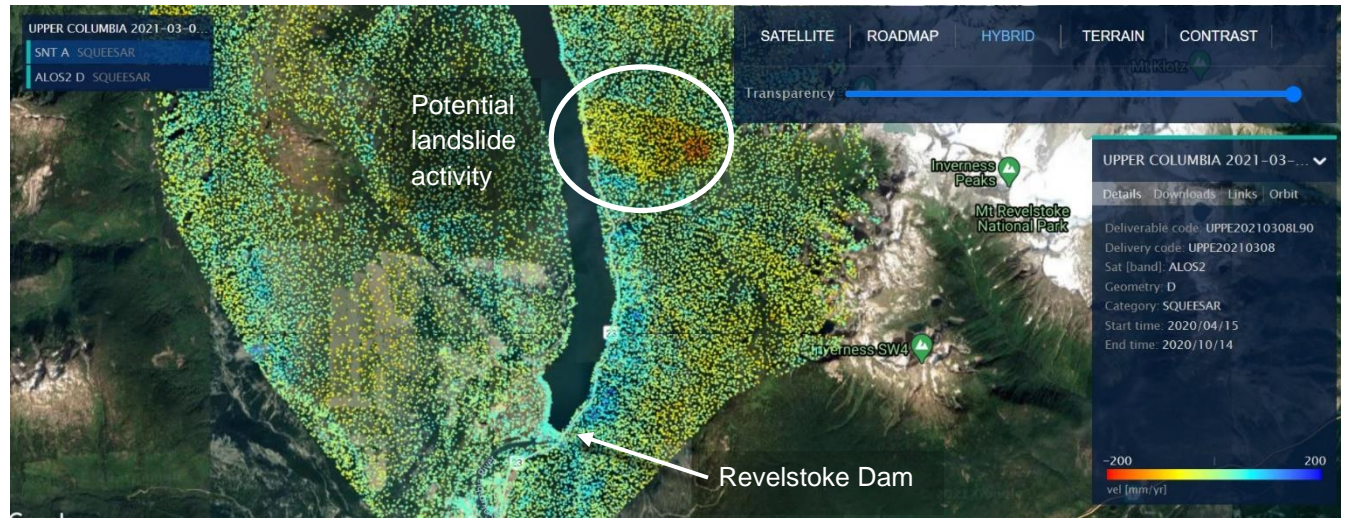
Figure 2 Imagery from the current InSAR landslide detection trial. The bright orange and yellow dots denote an area of measured slope displacement and potential landslide activity.

Preliminary results have been extremely promising. Figure 2, above, shows what may be an active landslide located approximately 10 km north of Revelstoke Dam. The general outline of the slide, the slide magnitude and landslide displacement rates can all be approximately quantified with this technology. This area has not previously been identified for landslide movements. Follow up work in early F2022 will include aerial inspection and ground based mapping of this site to confirm landslide activity.

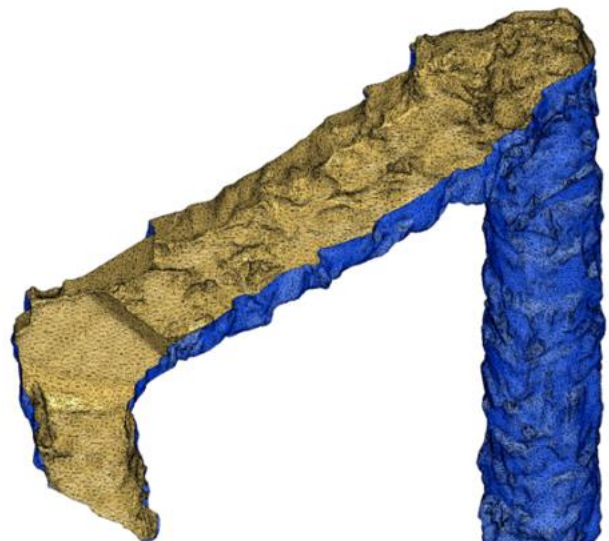
The survey was conducted in August of 2020 with the tunnel fully watered. ASI provided a full report with supporting video, photographic and point cloud data for the full inspection, and cross section profiles at specified locations for further analysis. See Figure 3 for a sample rendering of the survey data.

Figure 3 Mesh of sonar data from the Wahleach tunnel vertical shaft repeatable survey. The top of the shaft and the upstream connector segment of the tunnel are shown.
