### Board briefing – DAM SAFETY QUARTERLY REPORT

#### Quarterly Featured Damsite – SEVEN MILE DAM

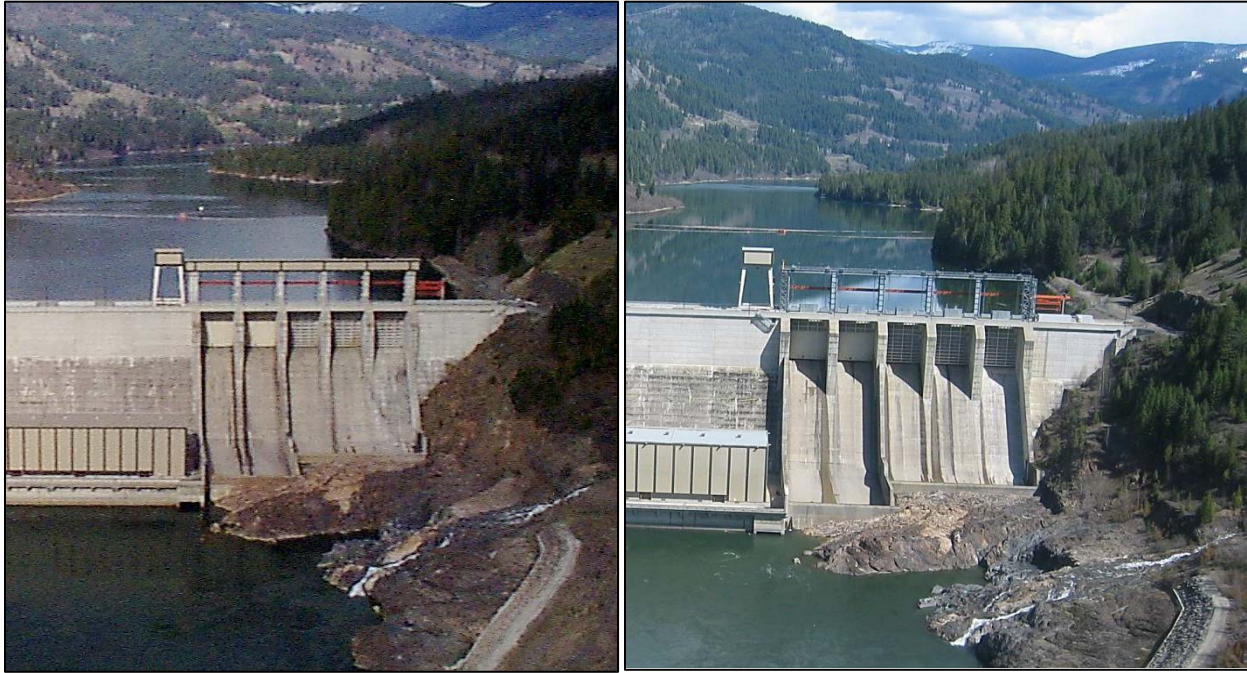
Concrete gate towers and hoist house structure (left) were replaced with steel towers and five hoist housings at deck level in 2005 (right)

Between 2000 and 2005, the Seven Mile Dam underwent strengthening and rehabilitation to meet modern design and safety expectations. This involved improvements to dam stability, the spillway and other systems. Modifications to the spillway included replacement of the concrete gate towers and hoist house structure with steel towers and five hoist housings. In effect, the site was upgraded to a reliability level similar to that now being achieved under the current Spillway Upgrade Program. The current spillway hoist facilities are likely the most reliable in the BC Hydro system, in terms of operation following a major earthquake.

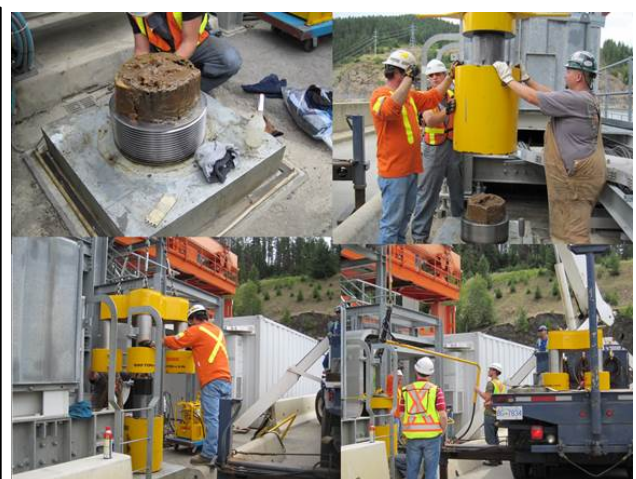
Anchor Testing

Dam stability was considerably improved with the installation of 57 post-tensioned, large capacity foundation anchors, carried out in 2 phases between 2002 and 2003. The anchors are post-tensioned 92 strand, fully corrosion protected, load testable and restressable. The anchors are oriented vertically and located near the upstream face of the gravity dam in four spillway blocks, four power intake blocks and seven gravity blocks. The two abutment blocks did not require anchoring. At the time of installation, the anchors had the largest capacity of any such anchors in the world. All 57 anchors were retested between 2003 and 2011 to determine if they were maintaining load capacity. All anchors achieved at least 2% above design loads.
