Board briefing – DAM SAFETY QUARTERLY REPORT

Quarterly Featured Damsite – Seton Dam

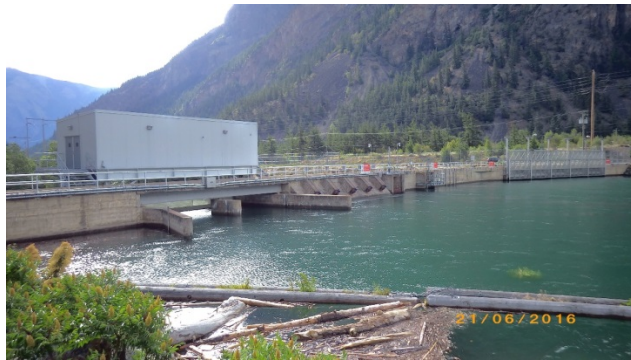
View of Seton Dam from the earthfill dyke

Current vulnerabilities at the Seton Dam mainly relate to the need to do an updated assessment of the dam components for the latest seismic hazard. This assessment has been prioritized and is expected to start within the next couple of years.

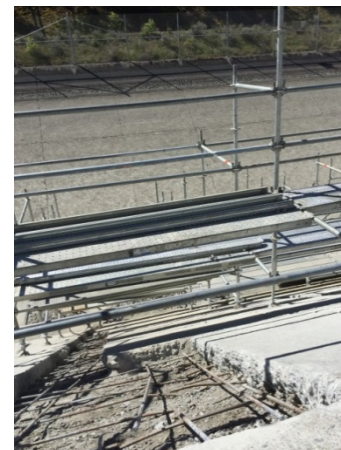
The canal embankments are almost 5 metres wide at the crest on the south side and 3 metres wide on the north side. The canal embankments are designed to be free draining and rely on the concrete lining to control seepage. Routine maintenance is required to fix cracks and spalls in the concrete canal lining in order to safely retain the water in the canal. This requires that the canal be dewatered every five to six years, and was most recently completed in April – May 2017.

2017 Canal lining repairs

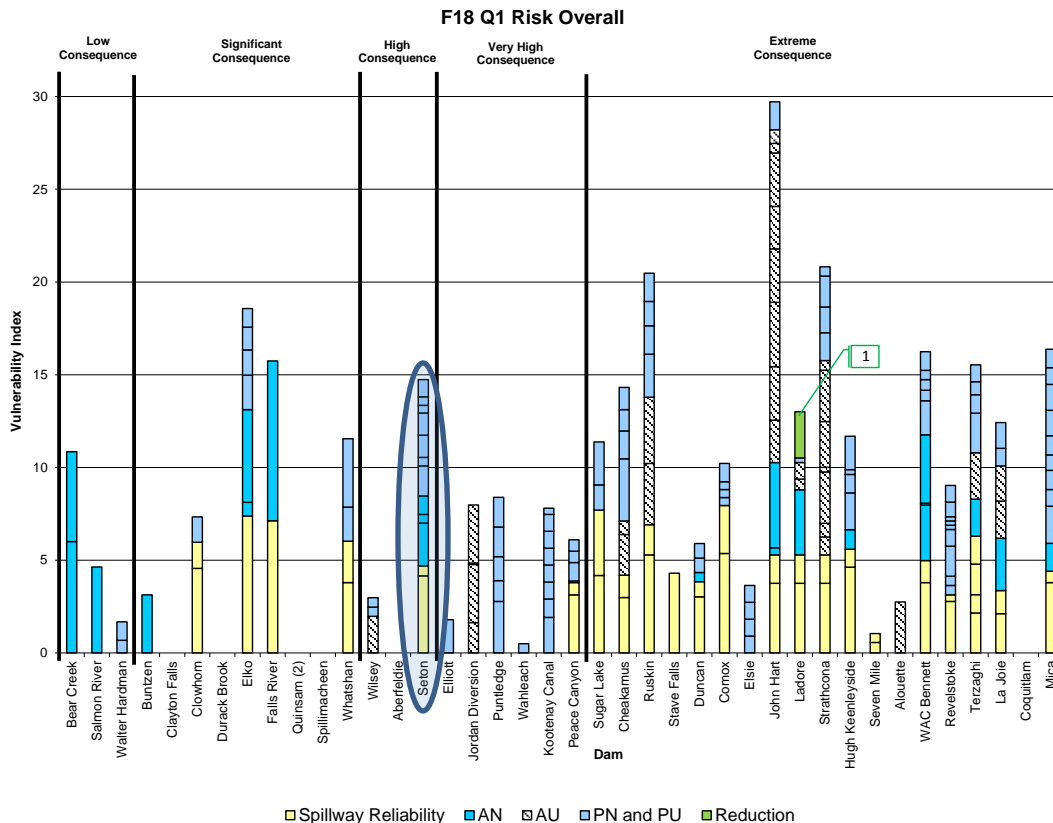
Figure 1 - Dam Safety: Overall Risk Profile

- Ladore Dam** – The database was updated to reflect the previously completed stability assessment for seismic loading which determined the dam to be stable for the Maximum Design Earthquake. Further reductions from those reported last quarter were made in Q1 as the issues related to the static stability of the dam, the seismic withstand of the surge tower and the ability to access to the gate controls post-earthquake were closed.
