Board briefing – DAM SAFETY QUARTERLY REPORT

Quarterly Featured Damsite – Aberfeldie Dam

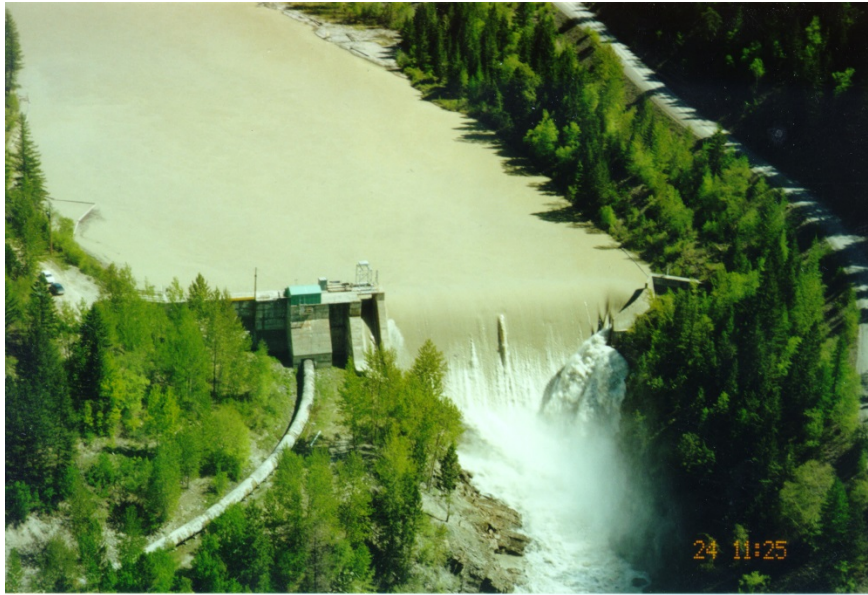
Aberfeldie Dam during the 1999 freshet

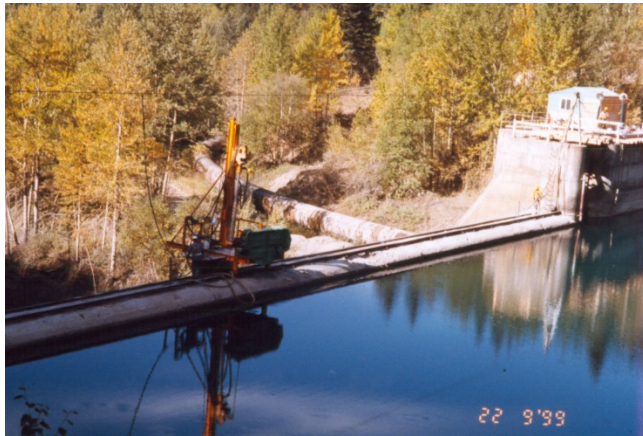
Drilling holes for the post-tensioned anchors

In late 1999, the dam was anchored with 29 fully grouted post-tensioned cable strand anchors to increase the stability of the dam under seismic and flood loading.

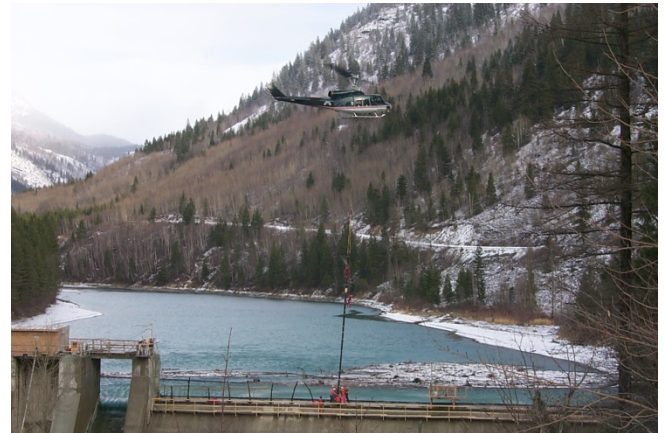
Installation of a post-tensioned anchor in the spillway

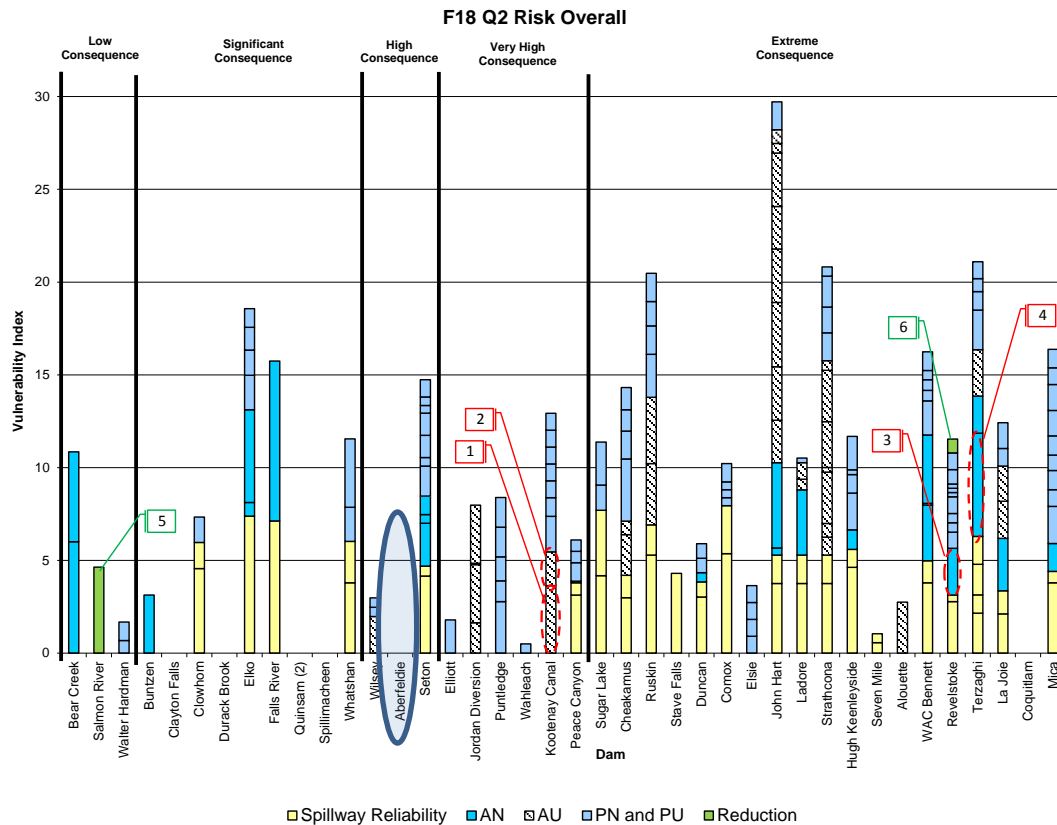
Figure 1 - Dam Safety: Overall Risk Profile

- Kootenay Canal Dam** – Updated analyses indicate the headworks centre pier is not stable for the design earthquake.
- Kootenay Canal Dam** – Updated analyses indicate the South gravity blocks are not stable for the design earthquake.
- Revelstoke Dam** – Movement of the Marble Shear Block has caused cracking of the spillwaychute concrete.
- Terzaghi Dam** – The design of the Terzaghi spillway does not meet modern design practices and could be susceptible to failure under normal load spills.
- Salmon River Diversion Dam** – The dam was decommissioned in Q2.
- Revelstoke Dam** – An error was corrected in a calculation of the vulnerability index for failure of the 731A Nose.
