Board briefing – DAM SAFETY QUARTERLY REPORT

Quarterly Featured Damsite – Falls River Dam

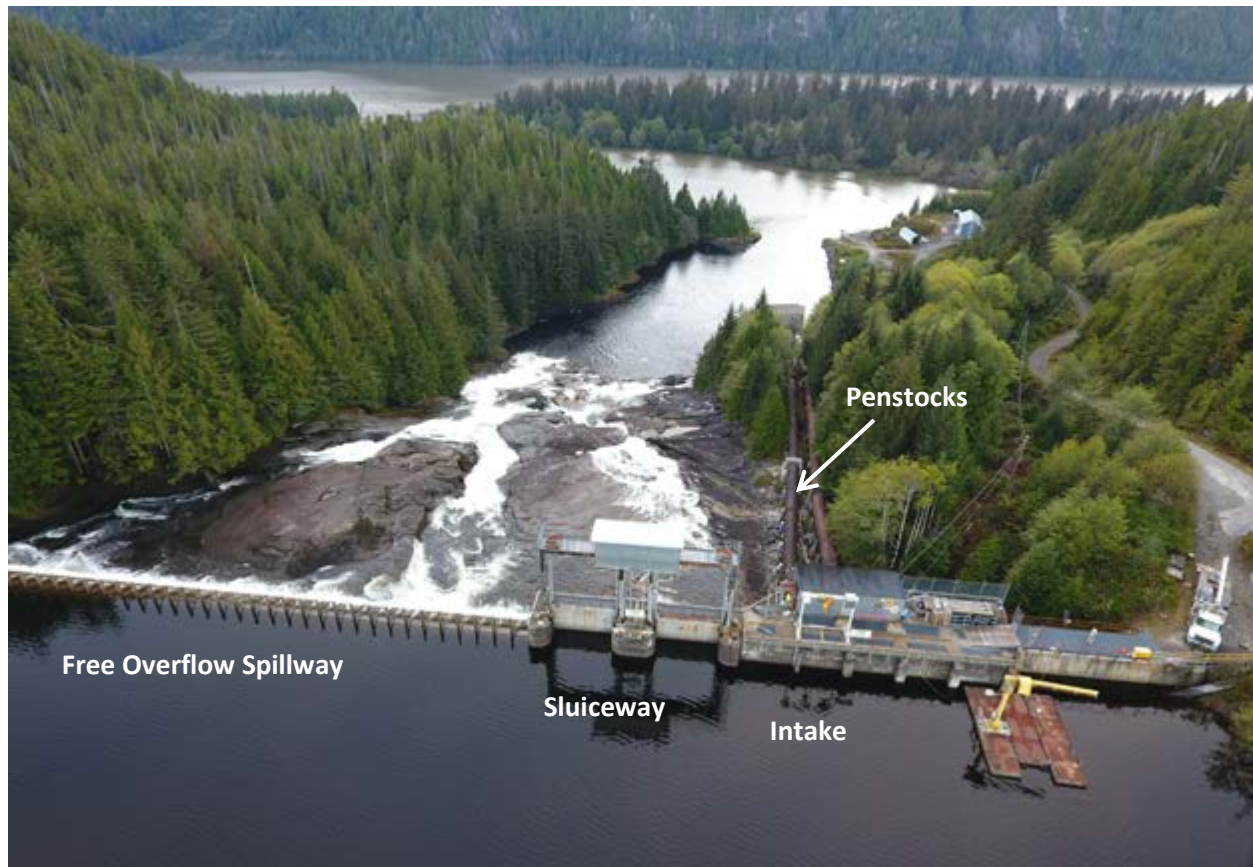
Falls River Dam looking downstream

A “fitness-for-service assessment” of the two facility penstocks was conducted in F2015. Although several tested sections had measured wall thickness loss which resulted in calculated safety factors below those recommended in guidance documents, both penstocks were deemed fit for continued service for three years with certain provisions such as annual inspections, repairs to the worst area and a complete internal inspection of the penstocks. Repairs have been made to mitigate one of the identified areas with the highest level of corrosion and deterioration, however these repairs are deemed unlikely to have restored the design factor of safety. An internal inspection was carried out in September 2016 as recommended. The inspection included non-destructive testing to measure the thickness of the steel penstock. This testing confirmed that the thickness is less than recommended in guidance documents and supports the recommendation that another fitness-for-service assessment be completed in 2018. While in operation, there is a risk that a transient event could rupture the penstock resulting in an uncontrolled release of the reservoir flooding the powerhouse and causing a significant environmental impact downstream. Since the site crew is typically only at site once a month and their time in the inundation area is minimized, the loss of life associated with failure of the penstocks is considered to be very low.

Penstock assessment frequency has been recommended to occur every 3 years so that any change in condition can be monitored to inform the risk mitigation strategy.

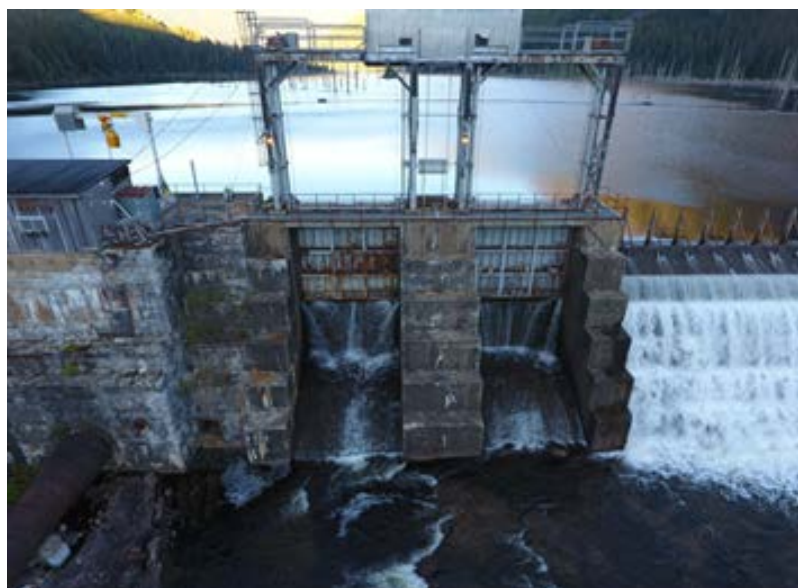
High inflows at Falls River are managed with the two spillway gates and the free overflow spillway. The vulnerability of the Falls River spillway gates has been given a very high rating in the Dam Safety Database due to their age, poor condition, and lack of reliability. There is also a vulnerability associated with these gates due to their potential inability to open when the reservoir level is above the crest of the free overflow spillway. For this reason, although the facility was designed to have flashboards installed along the free overflow spillway to store additional water in the reservoir, these are no longer used, so that a crew must be dispatched to site if the reservoir exceeds a certain elevation. The existing flood discharge gate system requires comprehensive review but this is not planned to be done prior to redevelopment as there is large capacity provided by the overflow spillway.

The gated sluiceway at Falls River.

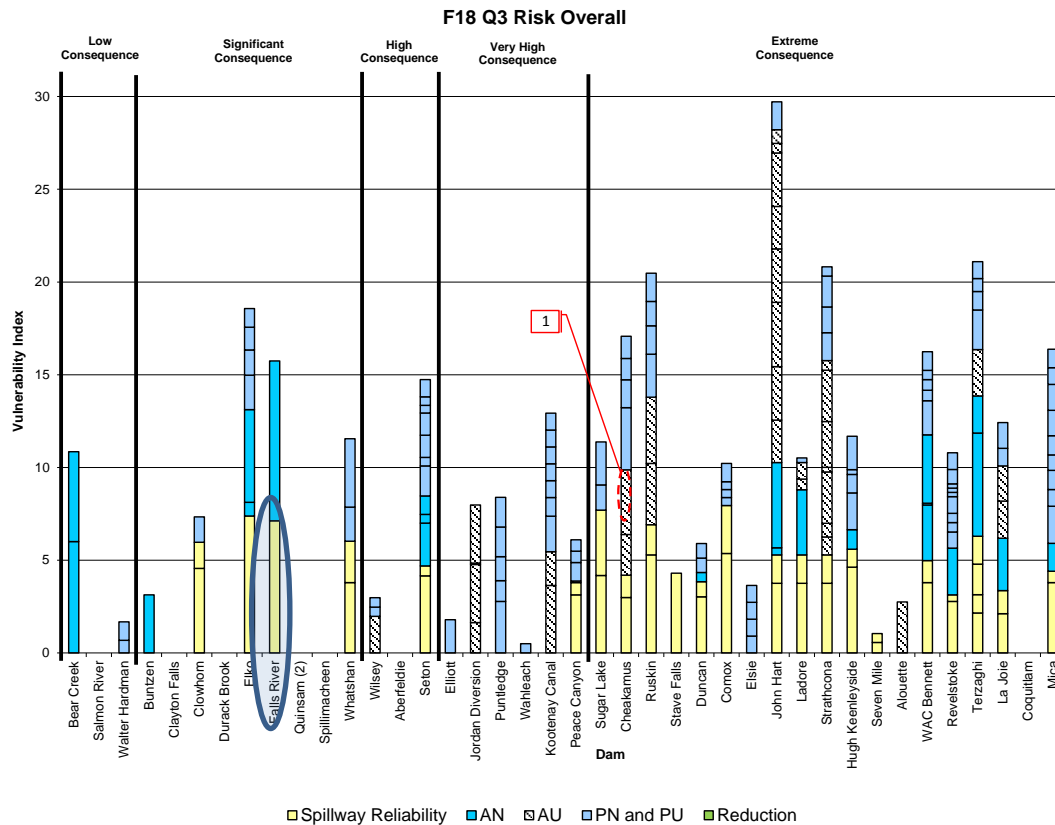
Figure 1 - Dam Safety: Overall Risk Profile

Cheakamus Dam – correction of an error in calculated vulnerability of the spillway gate piers.
