Board briefing – DAM SAFETY QUARTERLY REPORT

Quarterly Featured Damsite – Duncan Dam Updated

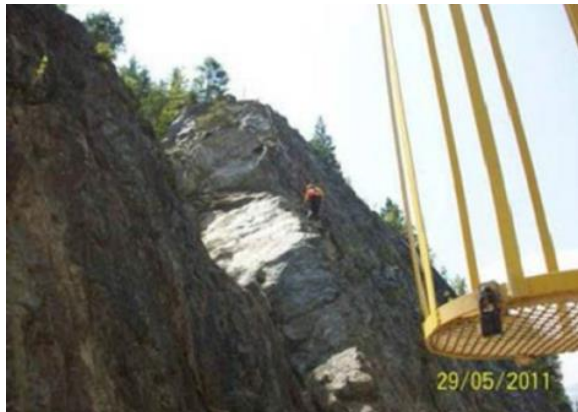
In 2011-2012, the dam's spillway gate systems were upgraded, beginning with the spillway rock stabilization project. The work involved removal of over steepened soil and rock, extensive scaling, rock and soil waste removal, rock bolting, rock mesh and application of steel fibre shotcrete. The early site works also included security fencing, excavation for the new UPS building foundation, and new concrete duct work to interconnect the existing Diesel Generator, the UPS Battery Backup and the distribution power system.

Rock Scaling Activities

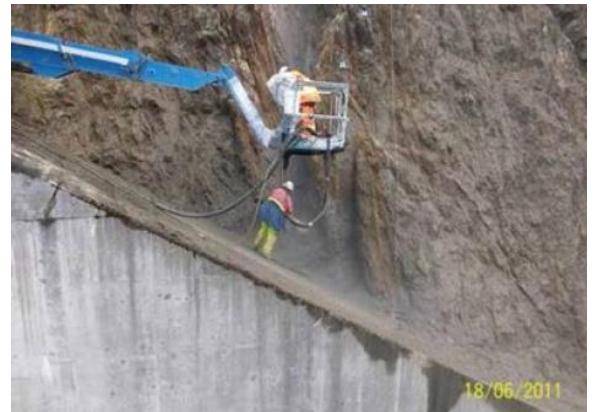
Shotcrete Application

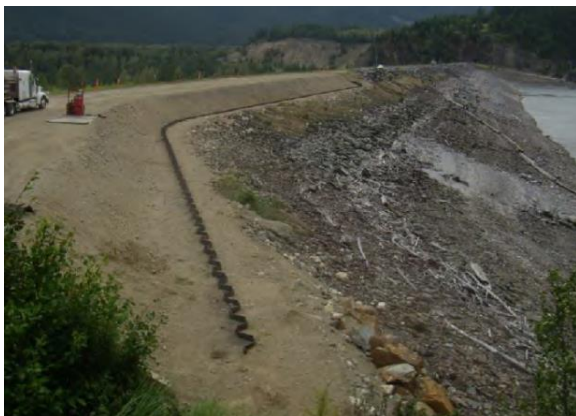
In the course of completing the Instrumentation Improvement Project, it was discovered that the portion of the dam core nearest to the left abutment was approximately 6-8 feet lower than the design elevation and the other portions of the core. This discovery raised concerns of the core not being high enough to safely route high inflows, such as occur during the spring freshet. A project was launched in 2015 to install a steel sheet pile cutoff wall along the crest of the core along the affected left end of the dam and thereby effectively raise the core of the dam to its design elevation. This cutoff wall installation work was completed in June 2016, prior to that year's freshet. The core upgrade was effectively tested with the prolonged and high inflows at Duncan Dam during the 2018 freshet.

Completed Sheet Pile Wall

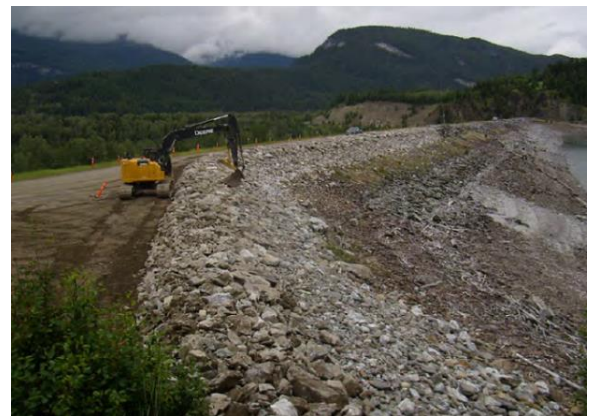
Completed Riprap Slope

The upstream face of the dam is protected with riprap which is in a varied condition; in some locations intact while in others it is missing or the rocks have degraded. The upper zone of riprap along the left-most part of the upstream face had been replaced recently in conjunction with the sheet pile core extension, so the riprap at that location is generally uniform and in good condition. A capital project in the 20 year outlook will address this issue.

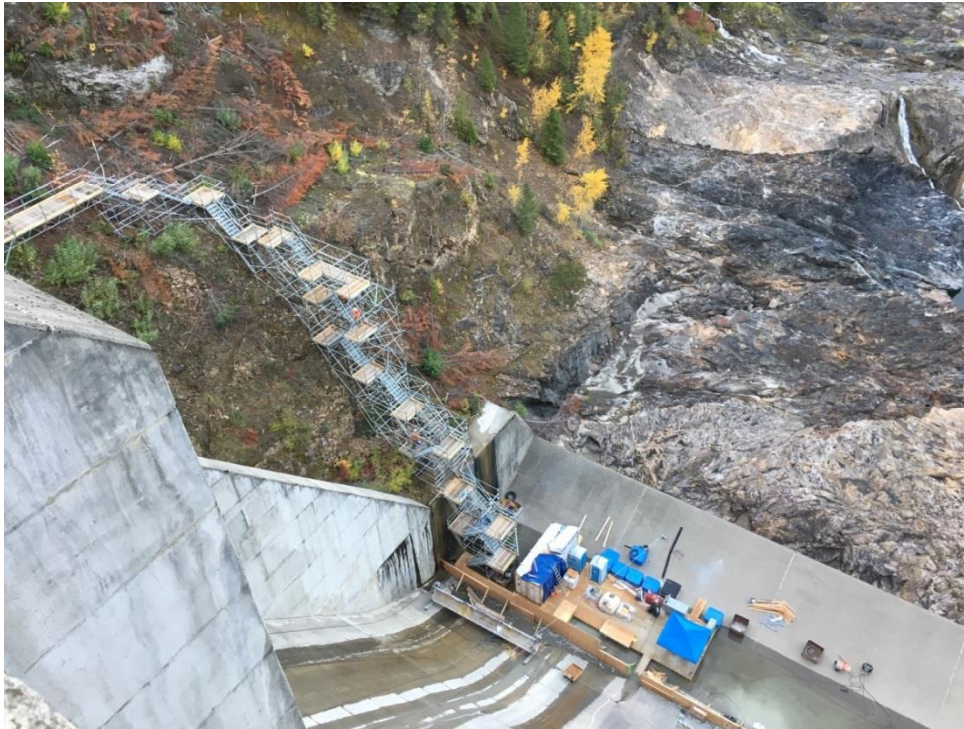
In Q2 the \$450K Seven Mile Dam Spillway Repair project started and is expected to be complete in October 2018. Access for this spillway repair project posed significant challenges, as shown in the photo below.
