Board briefing – DAM SAFETY QUARTERLY REPORT
Executive Summary

The purpose of this report is to update the Capital Projects Committee of the Board of Directors on key dam risk management activities during the period from April 1, 2019 to June 30, 2019, and to provide reasonable assurance that the safety of dams operated by BC Hydro continues to be managed to the established guidelines and criteria of the Dam Safety Program.

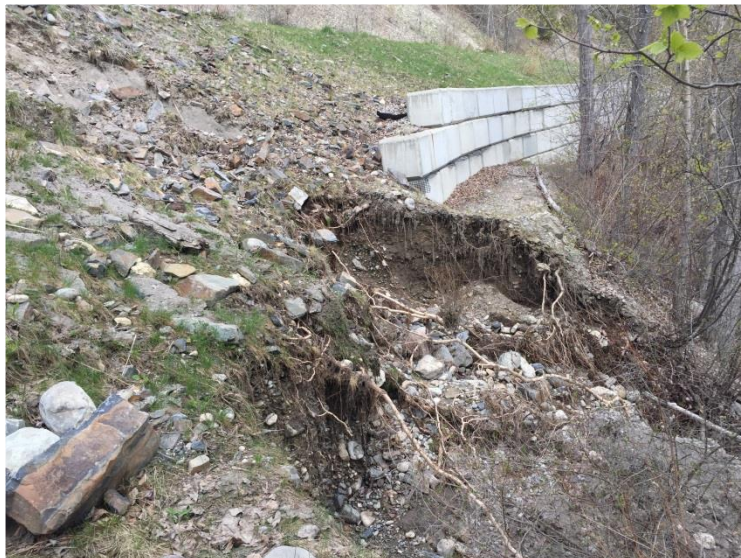
On the morning of April 30, a member of the public contacted BC Hydro to report water coming out of the bank near the road bridge over the Bull River. When the member of the public was contacted later to let them know the issue was being investigated, that person said that they thought that BC Hydro had turned something off because the water had disappeared suddenly. It was subsequently determined that this sudden reduction in flow was related to a coincidental closure of the intake gates at the dam and that the water coming out of the bank must therefore have come from the penstock. The penstock was left dewatered and, on inspection of the site, erosion of the slope above the road and adjacent to the buried penstock was observed (Figure 4). It was decided that the penstock would not be returned to service until the cause of the leakage had been investigated and repaired.

Figure 4 Erosion of the penstock slope above the road. The penstock is buried under the fill to the left of this photo.

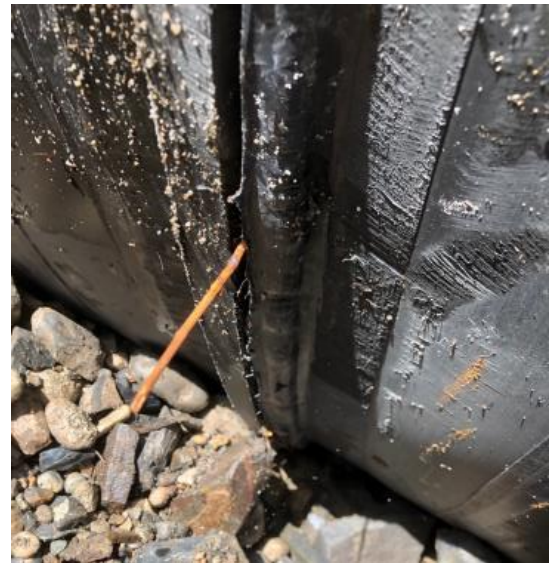
Figure 5 Weld failure at elbow joint observed after excavation.

On excavation of the fills around the pipe in the area of the leak, a split in one of the elbows was observed (Figure 5). The split measured 200 cm in length and was between 0.5 and 1 cm in width, extending upward from the bottom of the pipe. The factory welds on both the internal and external pipe walls were found to have failed due to poor adhesion of the weld, indicative of poor quality control during manufacturing.

A series of internal inspections have since been completed by BC Hydro Engineering. Two other splits and several other weld defects were found and since repaired.

Work is underway to return the penstock—and the Aberfeldie Generating Station—to service in October. Given that the failure of the welds is thought to be the result of poor quality control during manufacturing, there is potential for welds at other elbows to fail when the penstock is returned to service. A small capital project has been initiated by Dam Safety to install pressure taps in the annular

spaces between the inner and outer walls and standpipe piezometers in the fills at each elbow location to detect leakage. These instruments will be connected to Dam Safety's Automated Data Acquisition System (ADAS) for continuous monitoring. When returned to service, the penstock alignment will also be visually inspected on a frequent basis for signs of further leakage.

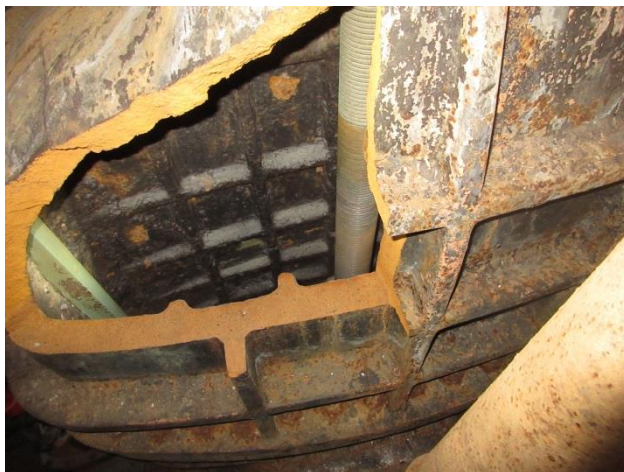
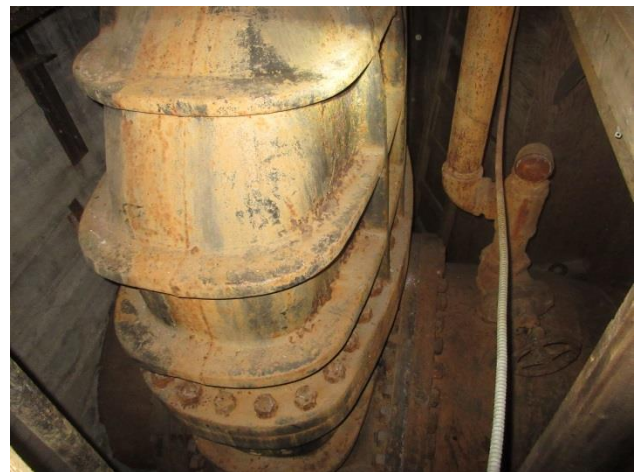
The failure of a penstock intake valve at Spillimacheen and the resulting Dam Safety Incident were reported in the previous quarter. In Q1, site cleanup and additional site assessments were performed. It has been confirmed that the valve failed when water inside the valve's bonnet froze. See Figure 6, below. Engineering's site inspection memo documenting this is to be issued prior to the end of August.

Figure 6 Damaged (left) and intact (right) penstock intake valve bonnets.

As the damage to the valve is irreparable, the valve is scheduled to be removed prior to the coming winter and replaced with a blocking flange.

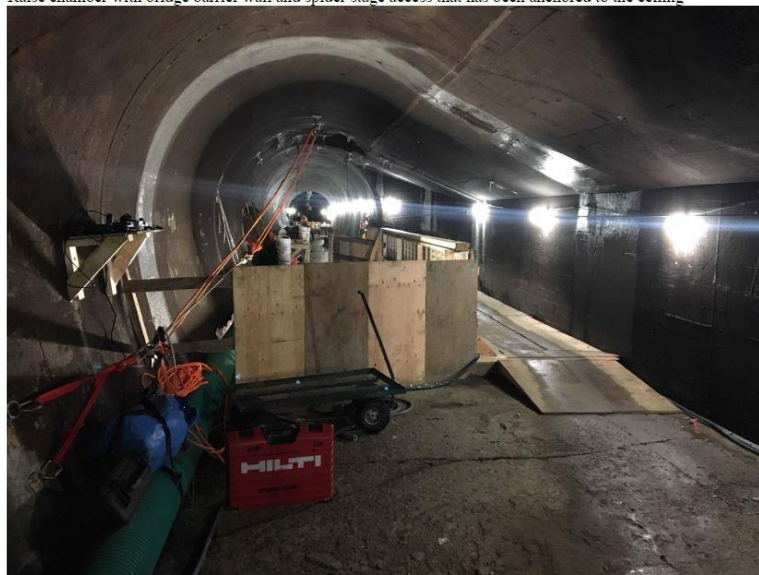
Raise chamber with bridge barrier wall and spider stage access that has been anchored to the ceiling

Figure 7 Whatshan Generating Station tunnel repairs and rock trap clean out set up (April 2019).
