**BC HYDRO**  
**WAC BENNETT DAM**  
**EXPERT ENGINEERING PANEL**  
**APPENDICES - VOLUME 2**

*August 2012*

*Report No. N3405*

## **WAC Bennett Dam Expert Engineering Panel on Seepage Flow Control Characteristics**

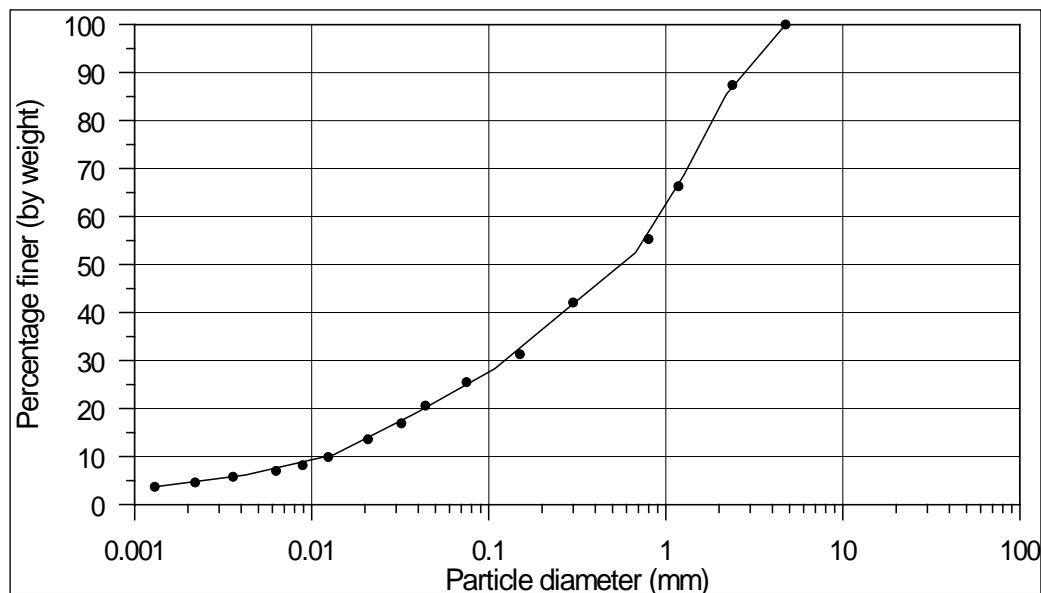
The tests were carried out on a single particle size distribution which is shown in Figure E1.

The soil plots in the coarsest 20% of the gradations from construction records.

**Figure E1. Particle size distribution plot for core sample tested by University Laval and Thurber Engineering in 2003**

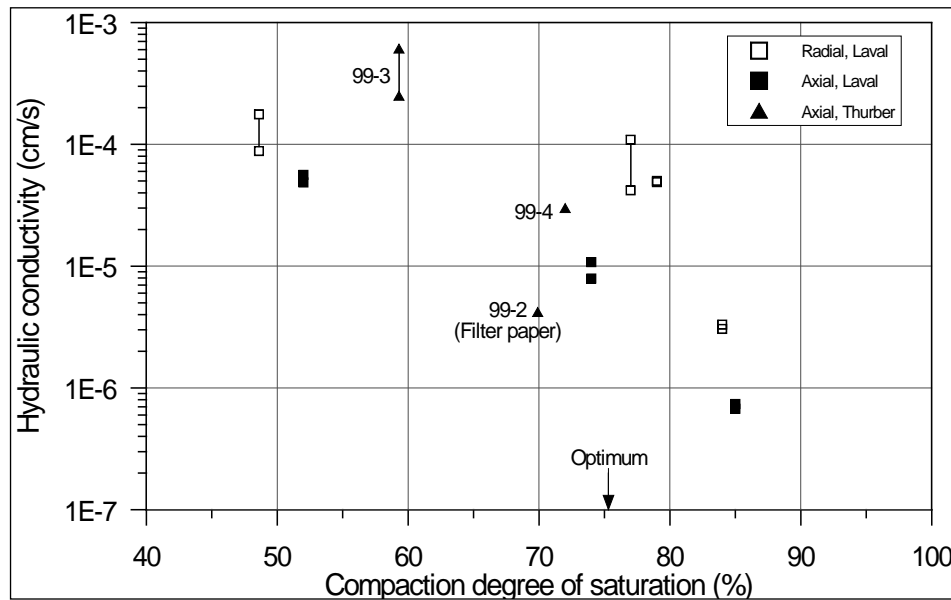
**Figure E2. Saturated permeability (hydraulic conductivity) as a function of degree of saturation of the soil at compaction for soil tested by Laval University and Thurber Engineering in 2003.**

Figure E2 shows the results of the tests. The report indicates that one Thurber test was affected by clogging of filter paper and should be disregarded. It points out the marked reduction in permeability of samples compacted wet of standard compaction optimum moisture content. They note that this has been observed in tests on similar glacial till soils reported in Watabe et.al. (2000). The significant change in permeability relates to the structure of the soil.

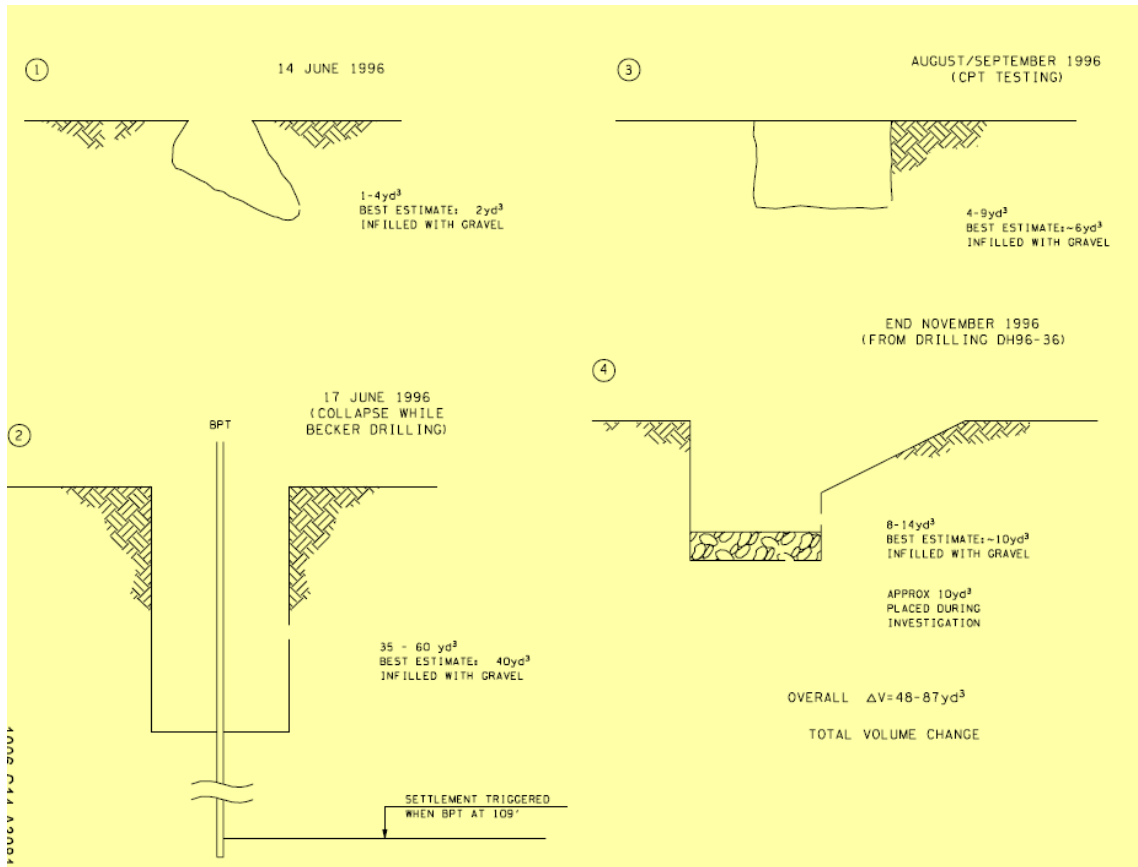
Figure H1. Evolution of Sinkhole No 1 (Figure 2-2, MEP 400)

Figure H1 shows the evolution of the sinkhole during investigations. At Stage 2 the sinkhole was 21 ft deep and 8 to 10ft diameter.

The sinkhole was filled but further settlements totalling 6 to 8 ft occurred during CPT and drilling. Hence the total settlement was 33 to 36ft, and volume 48 to 87 cu.yd, best estimate 58 cu.yd.

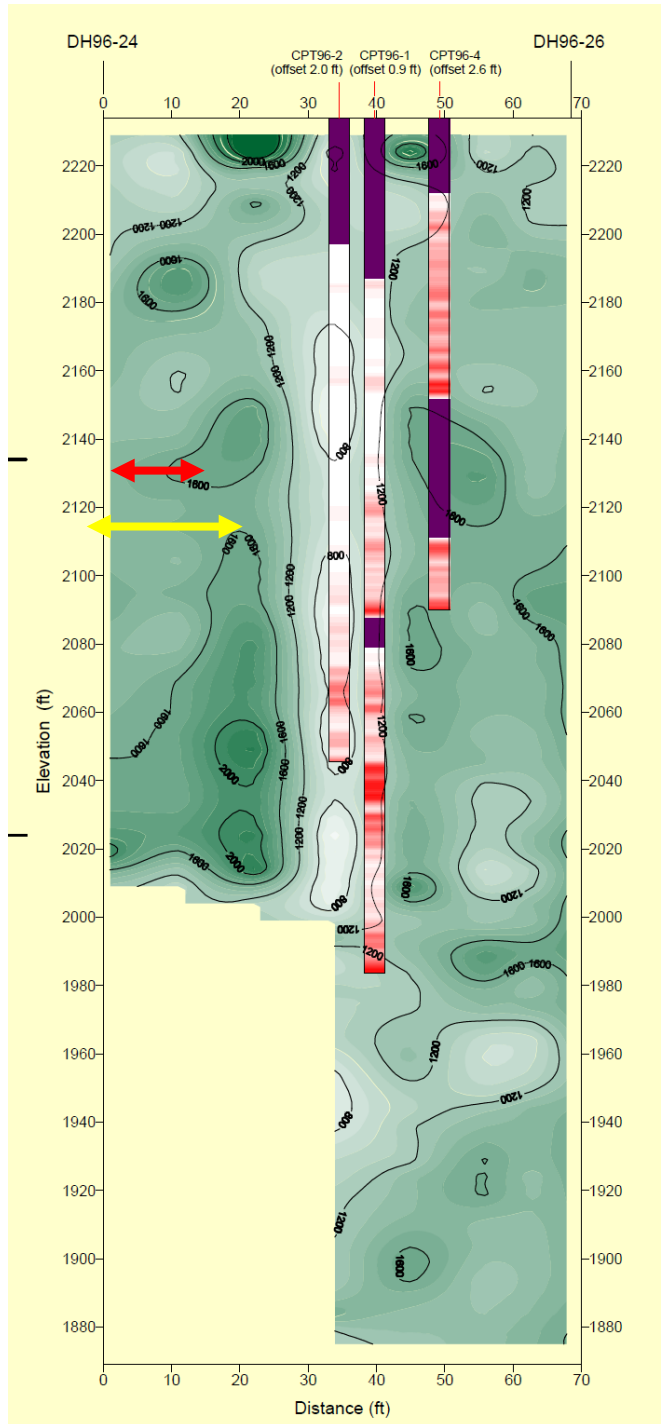
**Figure H2. Sinkhole No 1 Seismic Tomography and Cone Penetration Test Data from Figure 2-6, Report MEP 400. Red arrowed dimension is approx. sinkhole diameter. The yellow arrowed dimension is approx. area of lower velocity.**

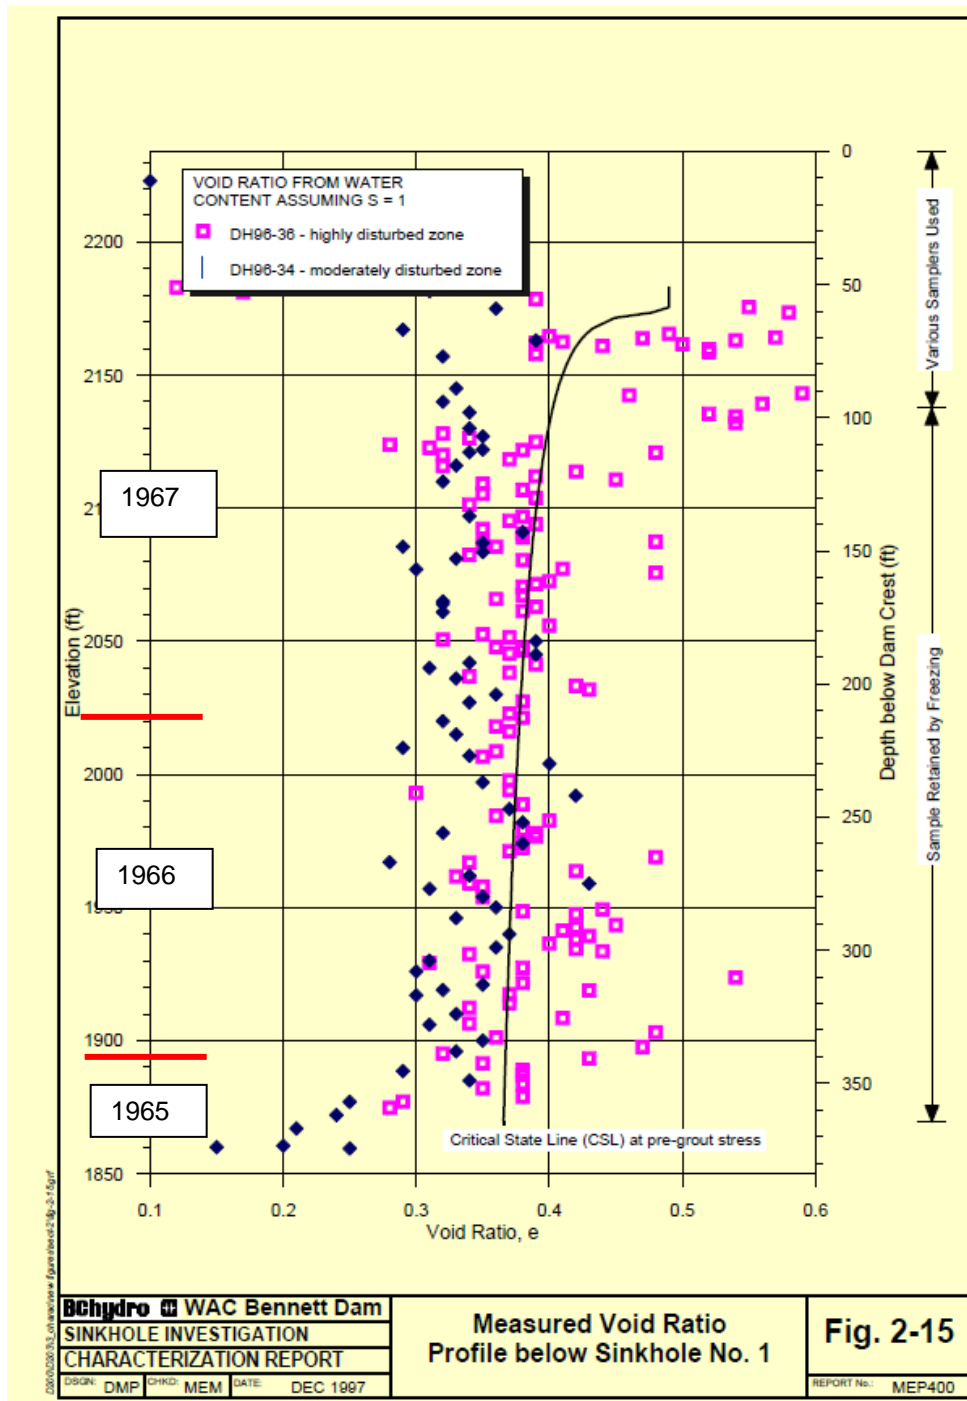
Figure H6. Measured void ratios below sinkhole No 1 at Benchmark No 1.

Figure H6 shows the void ratio measured from samples in drill holes through the sinkhole at Benchmark No 1 and in the surrounding soil described as disturbed in report MEP 400.

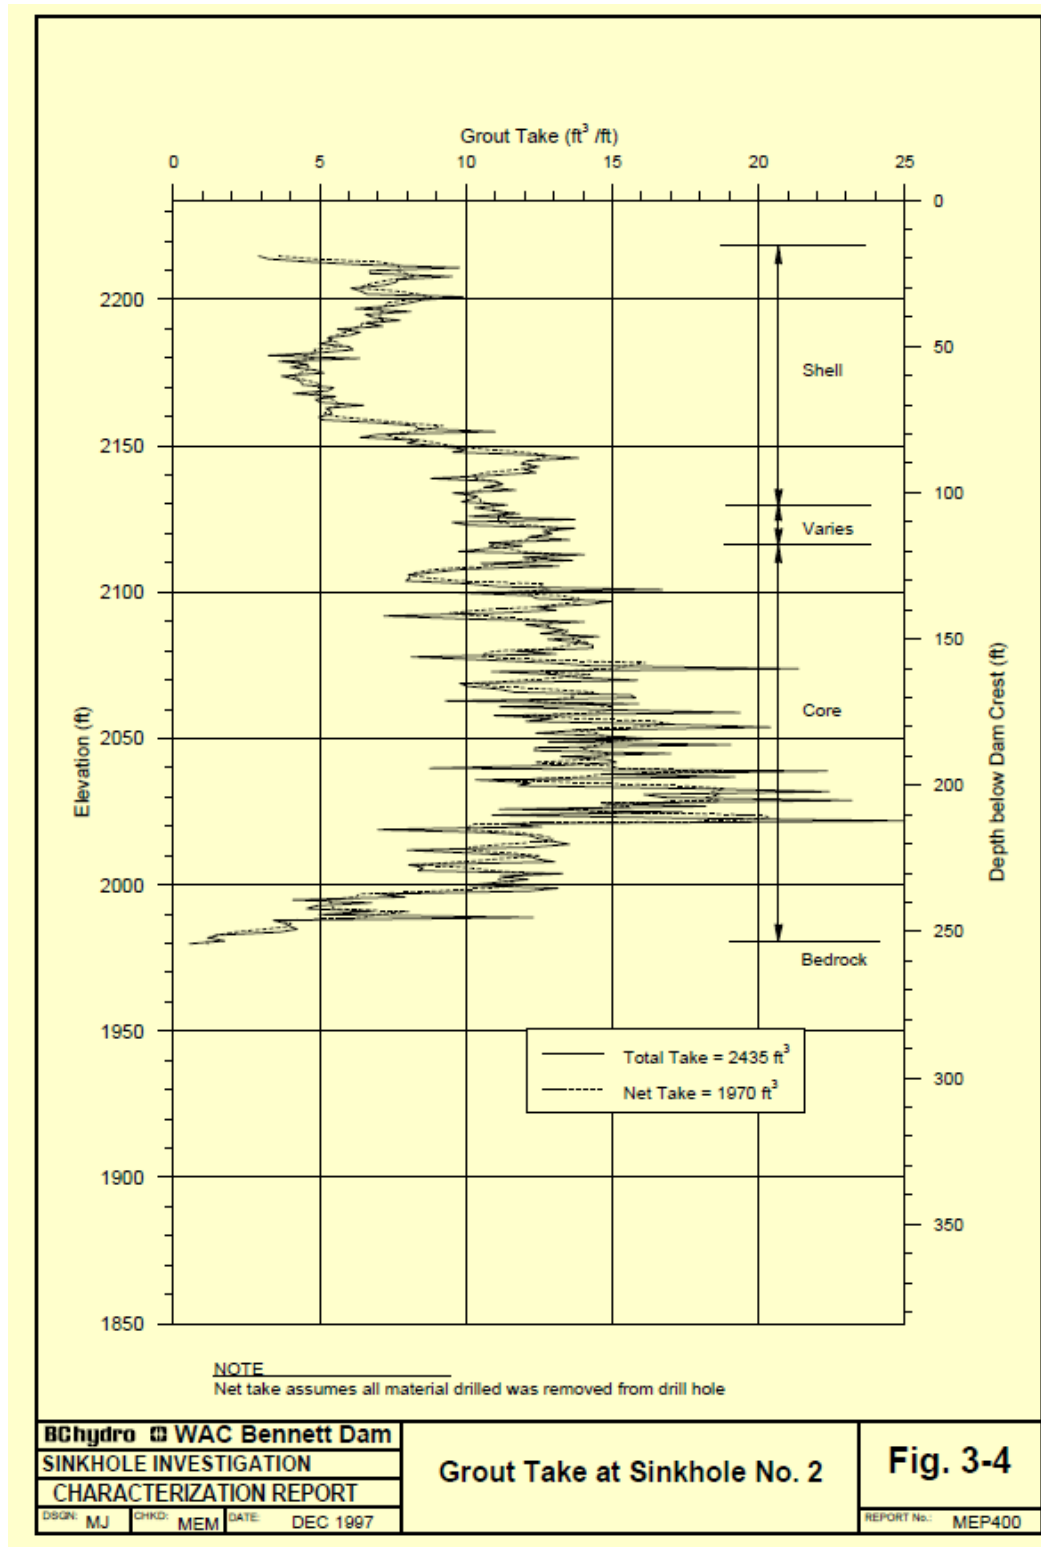
Figure H12. Compaction Grout Takes around Benchmark No 2.

- The grout takes are lower in the upper 75ft. This may be due to the significantly lower grout pressures used and to this part being in Shell, not Core material
- Grout takes below this are similar to Sinkhole No 1 despite the CPT data indicating sinkhole No 1 was lower density than sinkhole No 2 (Figure H12). From this it seems that the grout take is significantly controlled by the strata around the 10 ft diameter sinkhole rather than those in the sinkhole.

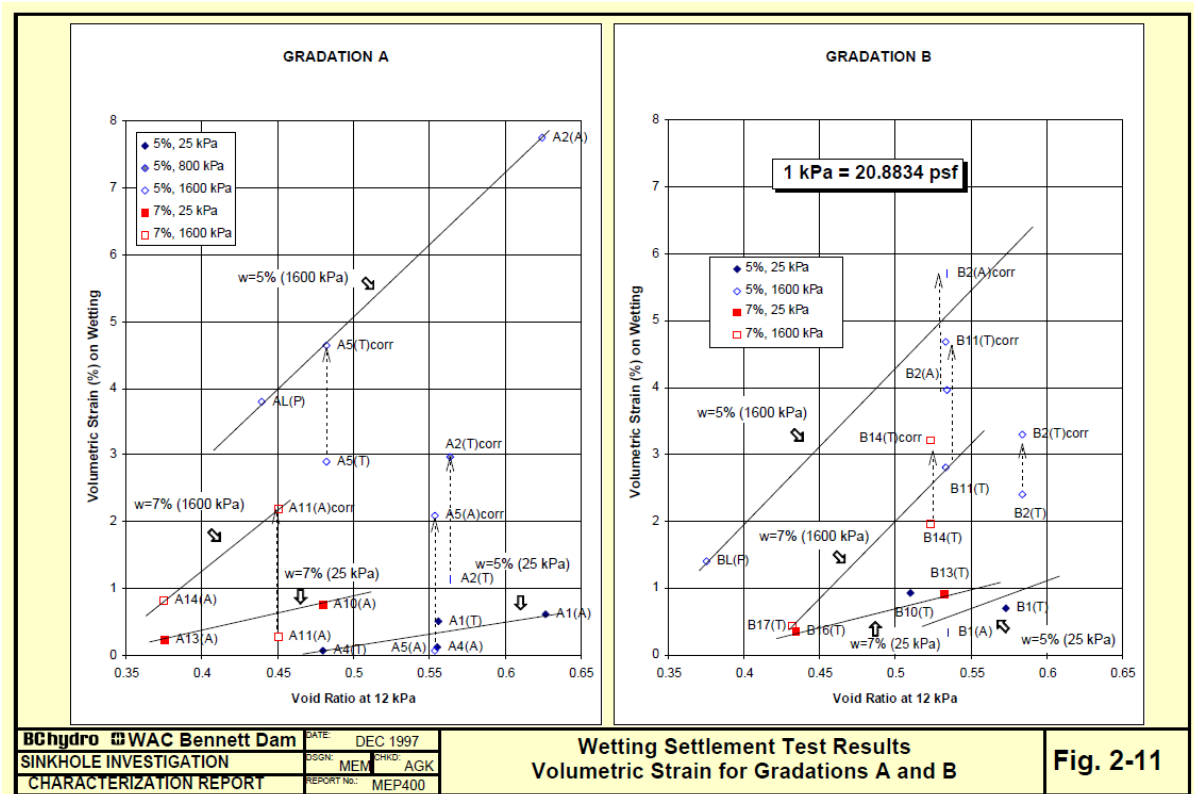
Figure H13. Volumetric strains on wetting from laboratory tests

- A volumetric strain of between 0.1% and 0.5% would be expected for soils wetted at 25kPa consolidation pressure, and initial compaction between 88% and 98%.
- Volumetric strains of between 1% and 3% would be expected for samples wetted at a consolidation pressure of 1600 kPa and initial compaction between 92% and 94%.
- Volumetric strains of up to 5% are possible for samples wetted at 1600 kPa consolidation pressure and 84% compaction, at 5% moisture content.
- Volumetric strains of up to 8% are only possible for samples wetted at 1600 kPa consolidation pressure and 80% compaction, at 5% moisture content.
