# APPENDIX A

## BEFORE AND AFTER PICTURES

## IRELAND CREEK SIDETCHANNEL SALMON HABITAT RESTORATION PROJECT

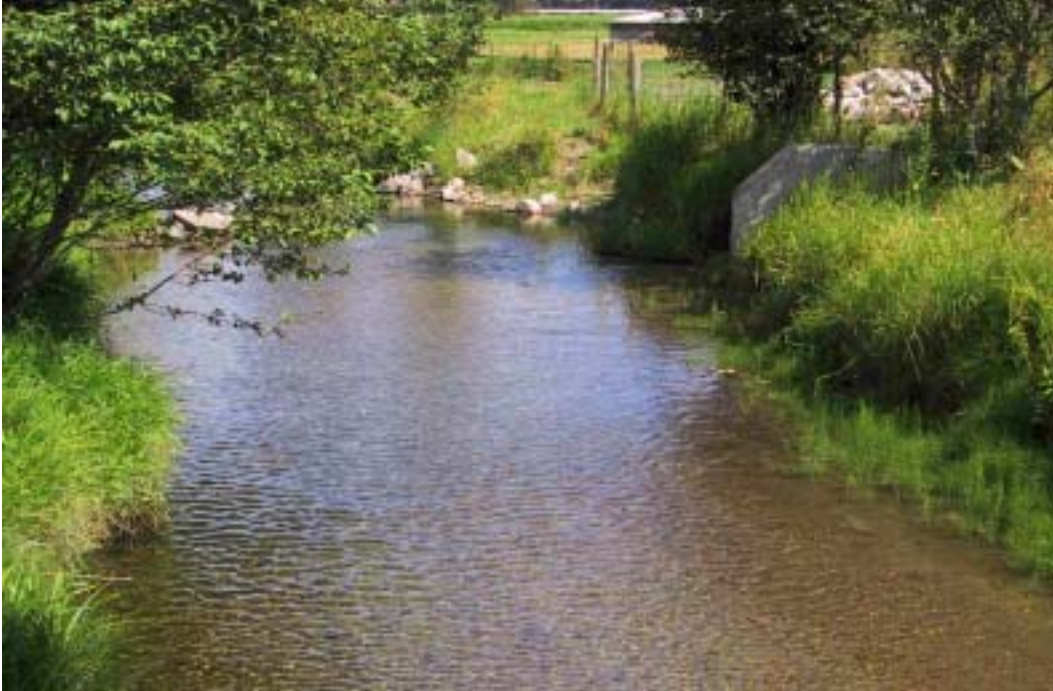
Figure 1a: Downstream view of Ireland Creek above the intake structure June 2001. The thalweg is on the left side of the stream. Sand and clumps of grass obstruct flow into the intake at low water. PP1

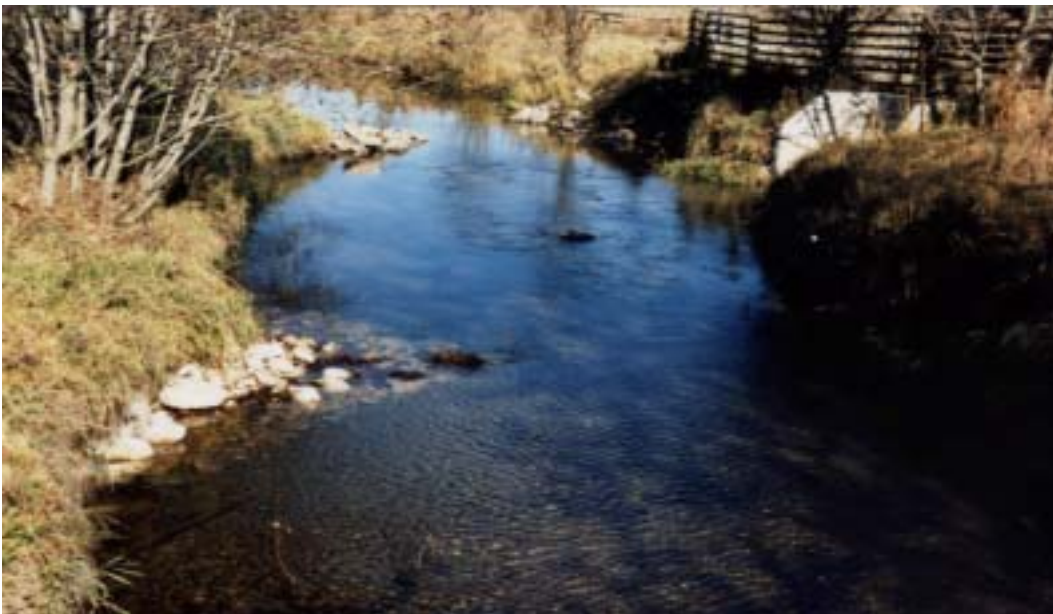
Figure 1b: A low-profile bend-away weir was built upstream of the intake to deflect the thalweg towards the intake. The sand and grass have been swept away. Sept 2002

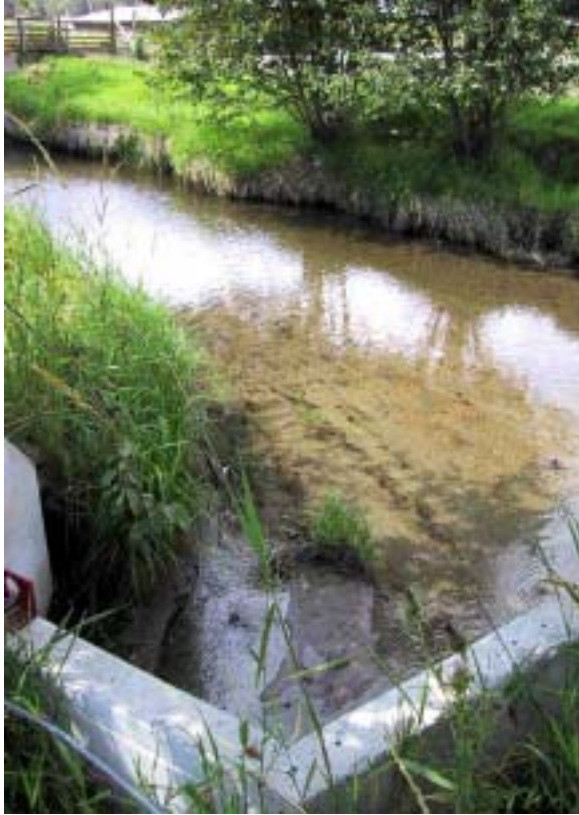
Figure 2a: Sediment is partially obstructing flow into the intake. The intake was installed outside the work window so was set back into the bank, separated from the creek by a thin berm. This berm was not completely washed away during freshet. Sediment subsequently collected around what remained of the bank. June 01

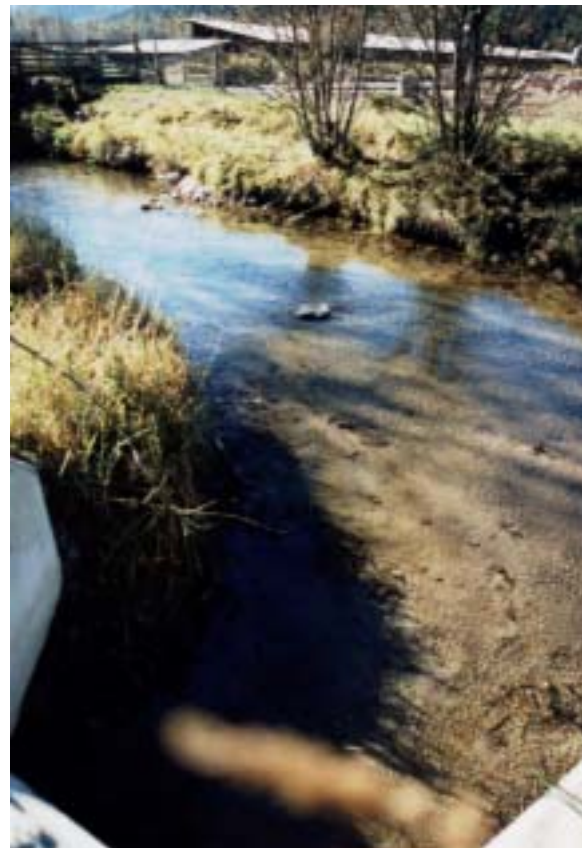
Figure 2b: The bend-away has been built, moving the thalweg toward the center of the creek. This has washed the collected sediment away from the intake. Sept 02

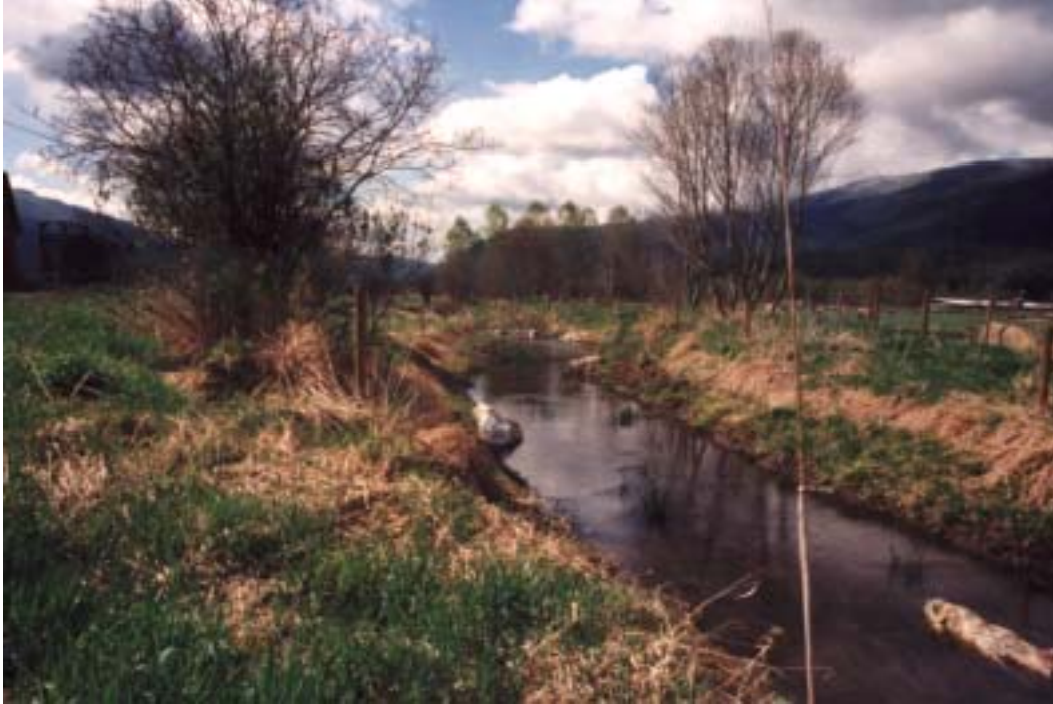
Figure 3a: 3+00 looking south in May 2003 before complexing

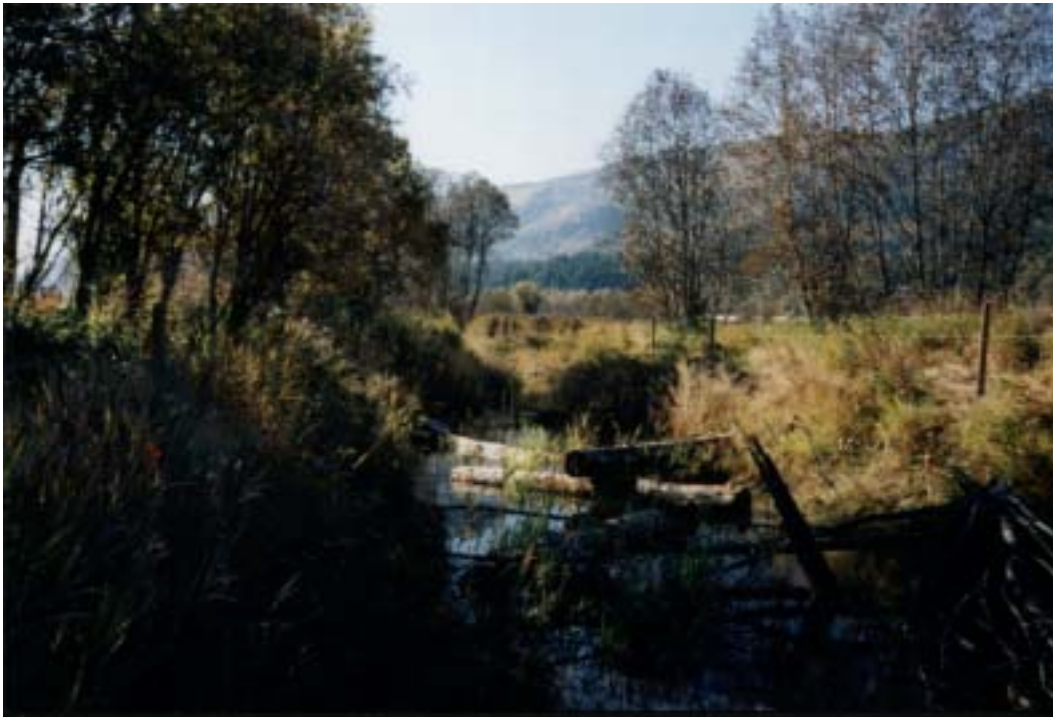
Figure 3b: 3+00 in August 2003 after wood has been added.

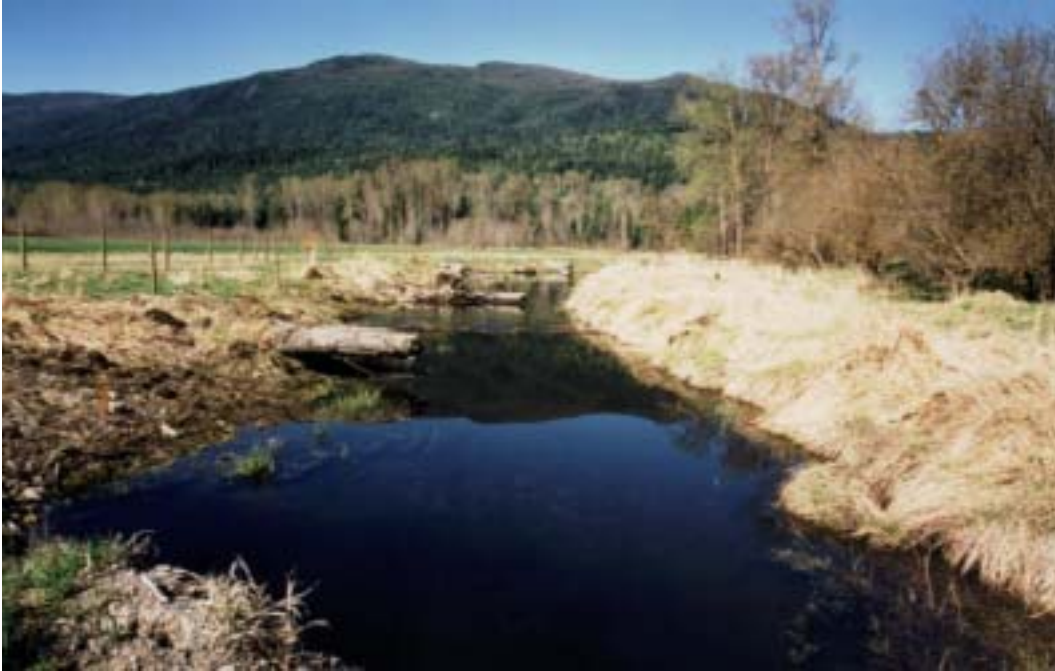
Figure 14a: 11+50 looking west before complexing. Wood had been buried into the bank during construction so that additional wood could be anchored to it.

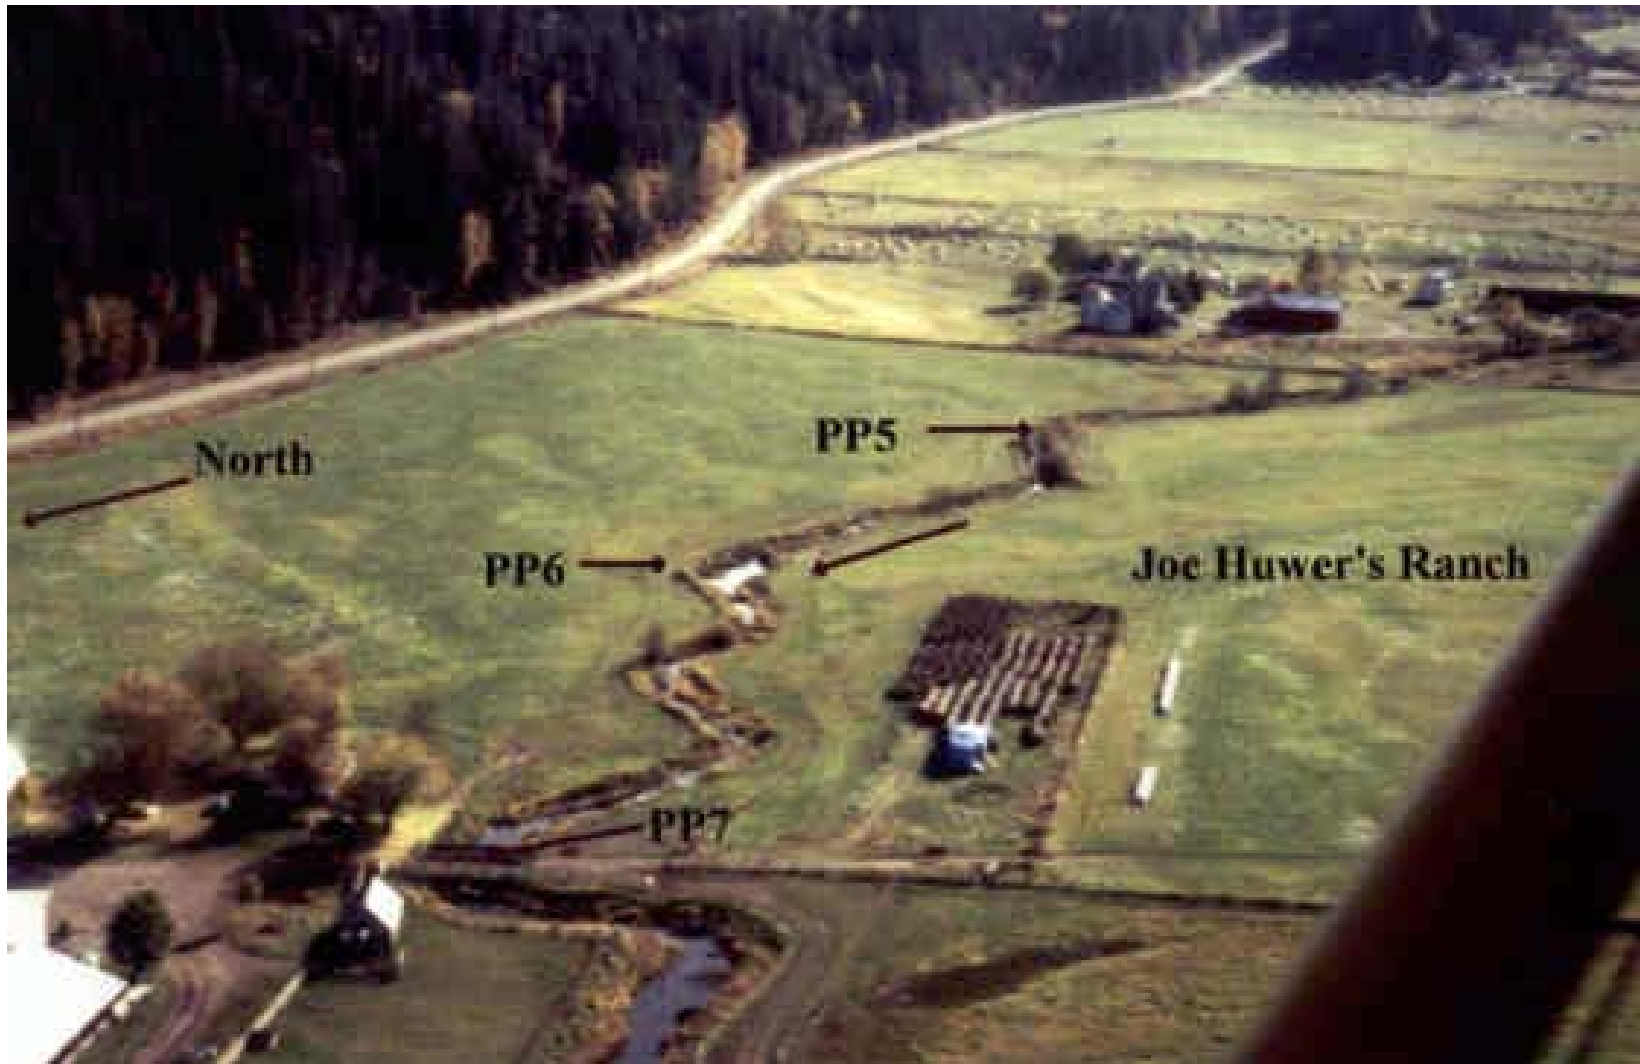
Air photo 3: There was less vegetation on Joe Huwer's property because the cows had access to the creek. The side channel is affected by high water in the Shuswap up to PP5 on most years.

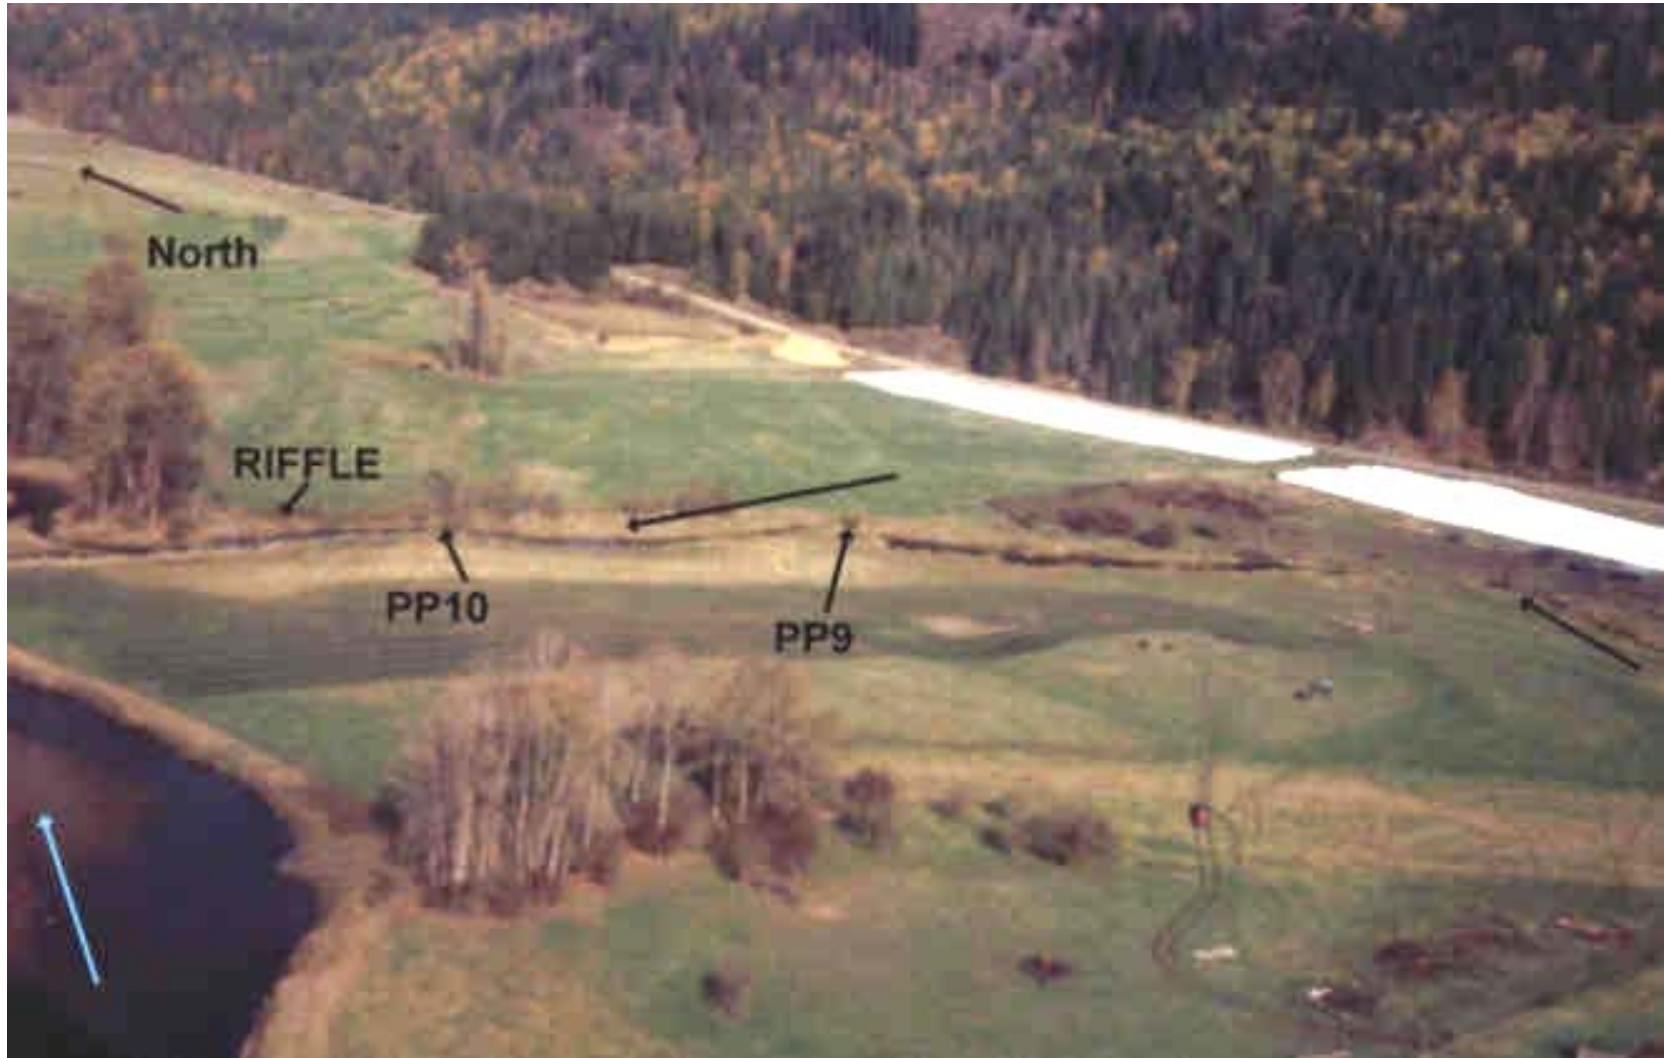
Air photo 5: This lower section of the channel is affected by water backing up when the Shuswap River is high. The riparian vegetation is inundated.
