# APPENDIX B

## BEFORE AND AFTER PICTURES

## Shuswap River - 02 sh 36

## SALMON HABITAT RESTORATION PROJECT

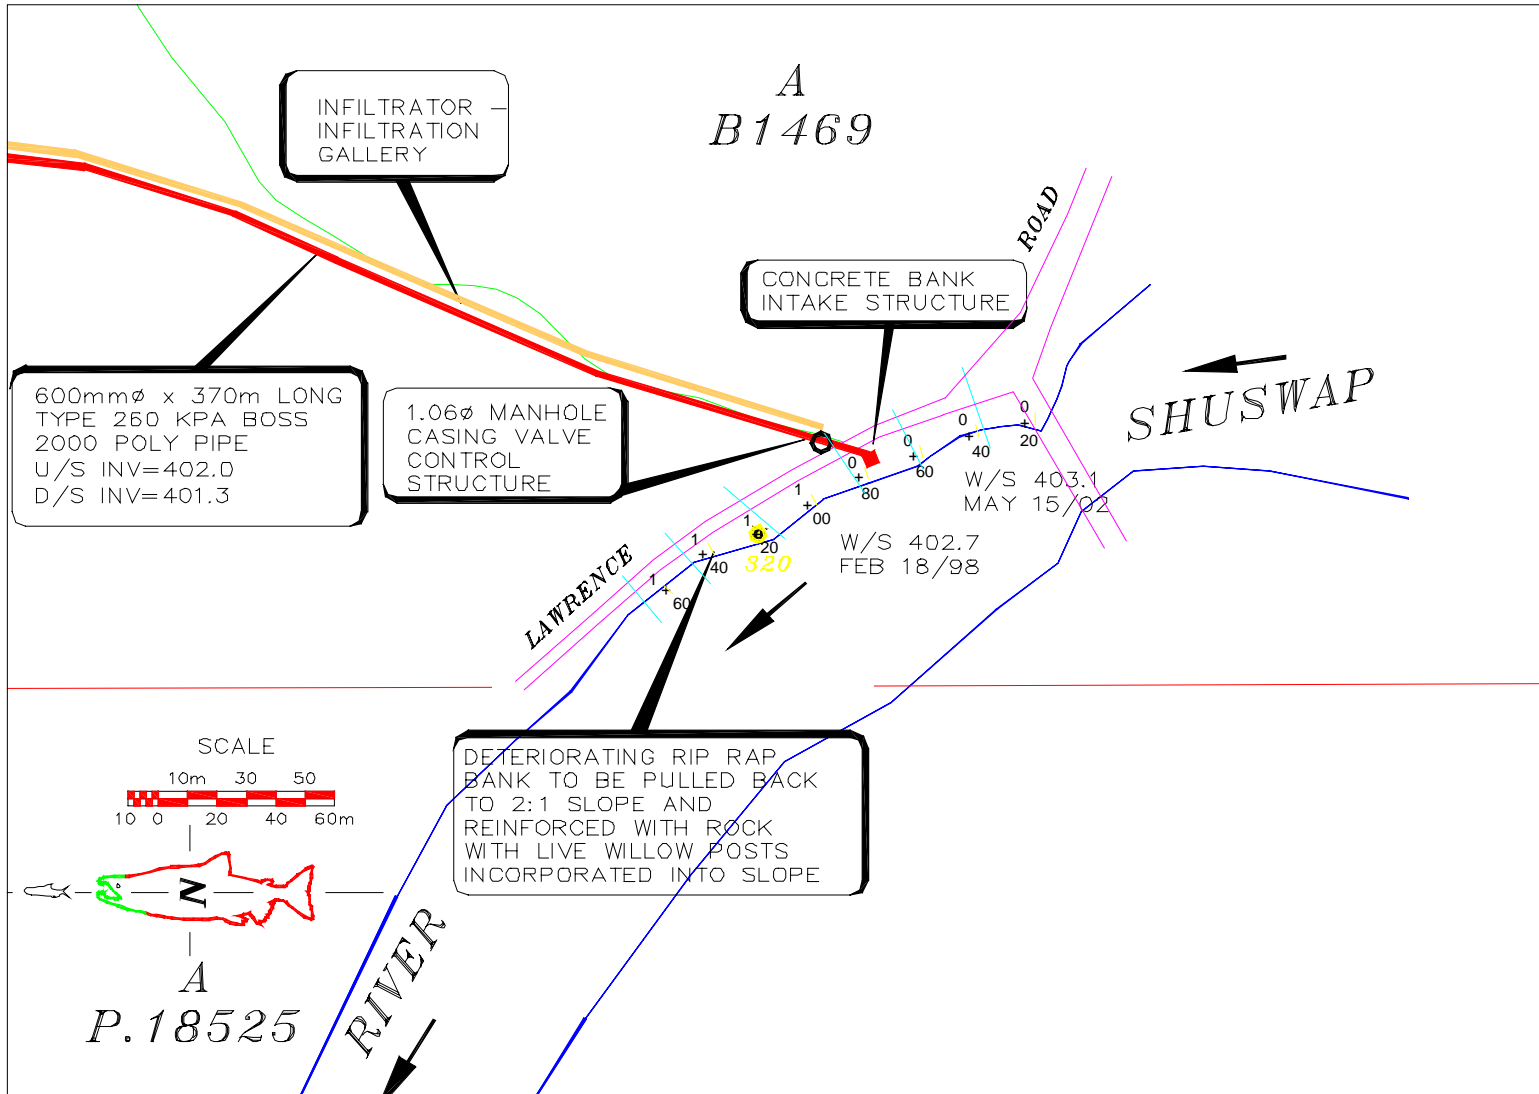
Profile of the intake pipe

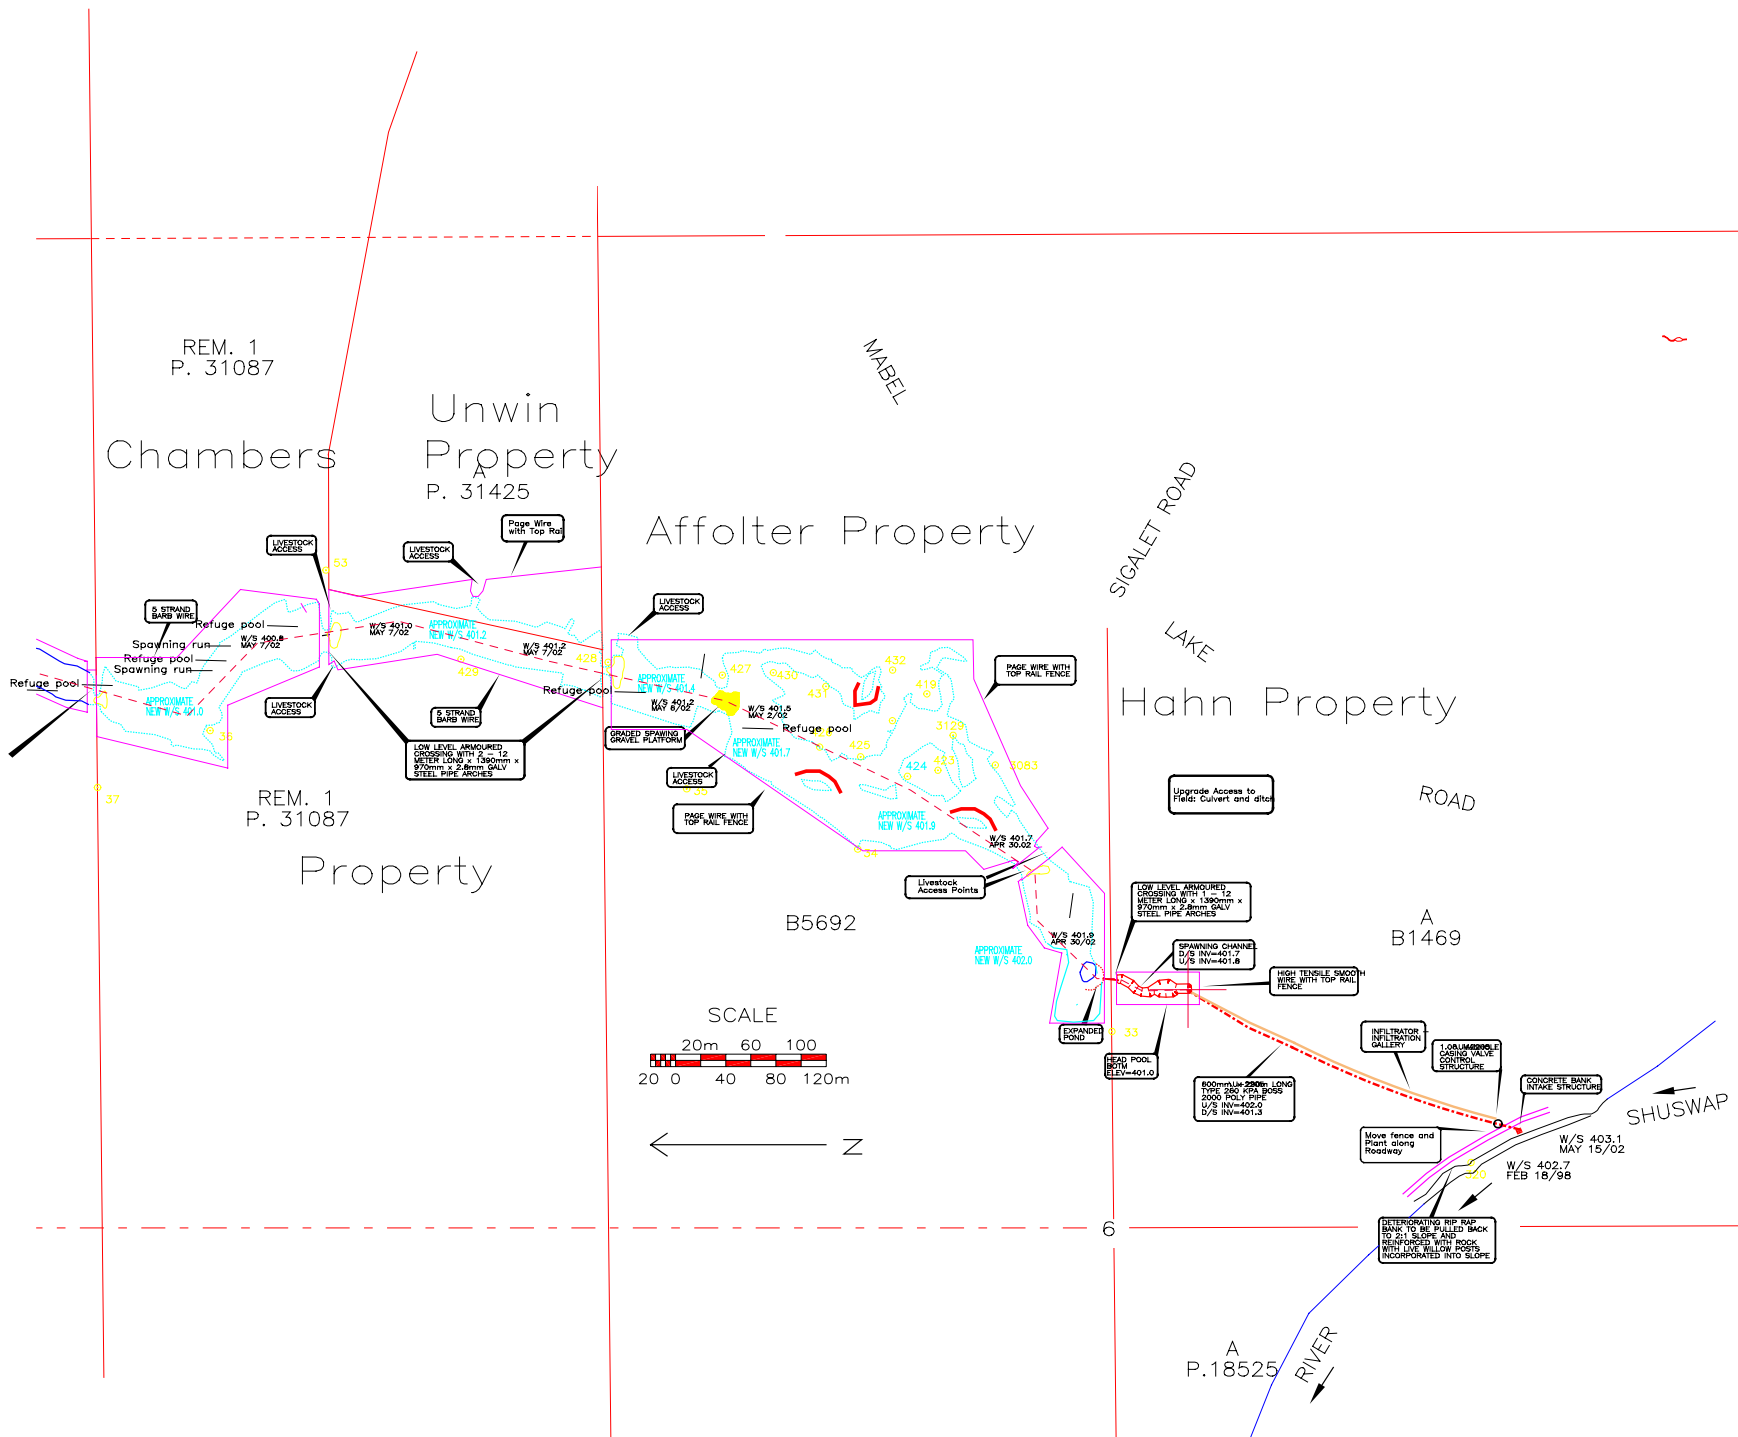
Plans for intake, control valve and the alterations done to Lawrence Road

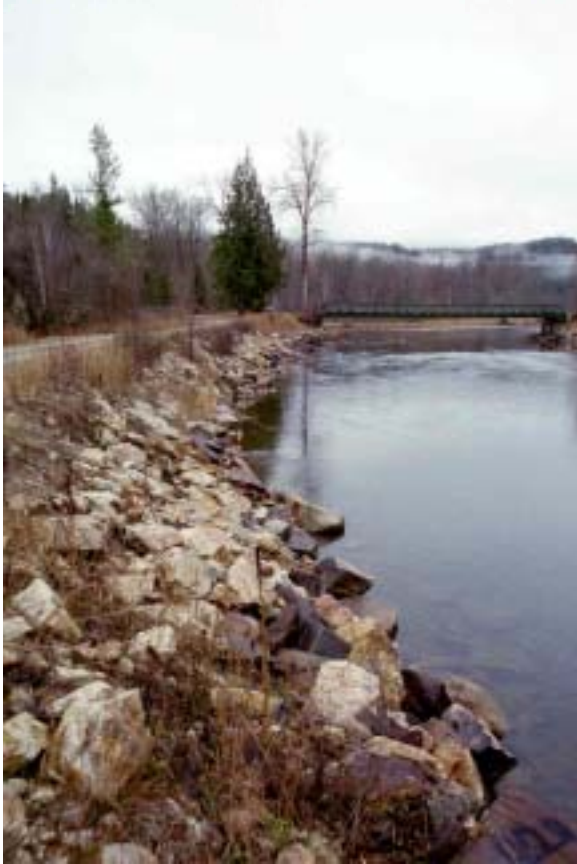
Before 1: An upstream view of the Shuswap River showing the riprap along Lawrence Road downstream of the Bailey bridge. The riprap was steep and self-launching where the intake was placed.

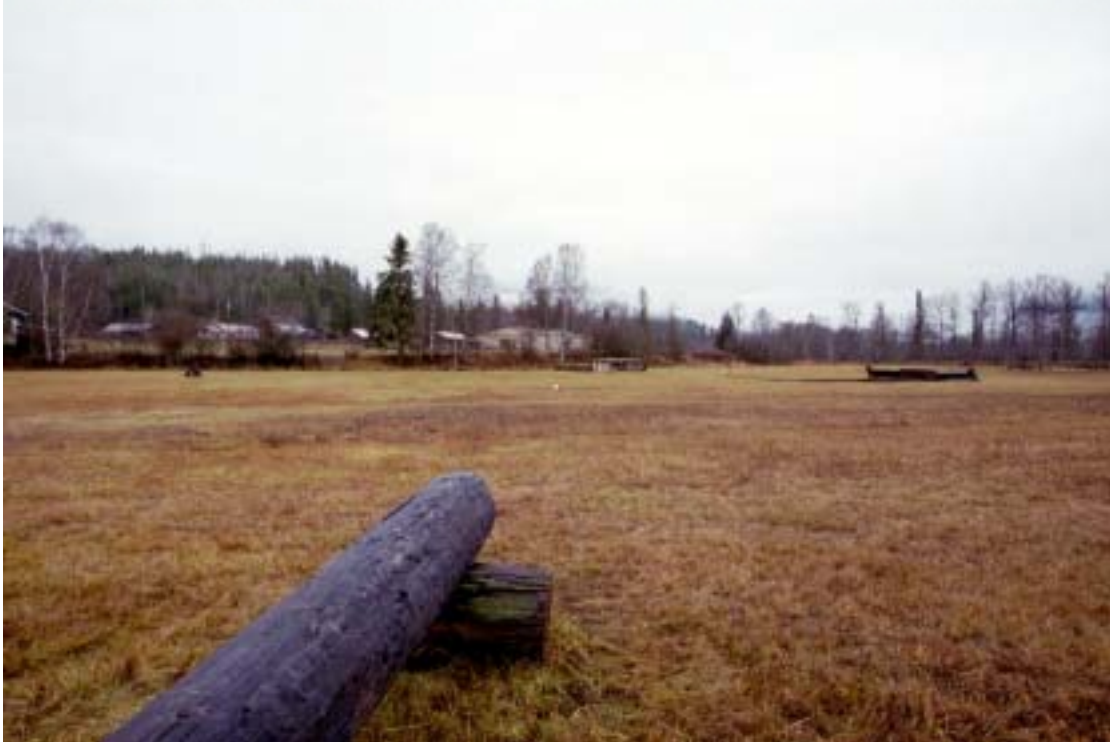
Before 2: The Hahn property looking south from the Affolter property line before the sediment pond was excavated in October 02.

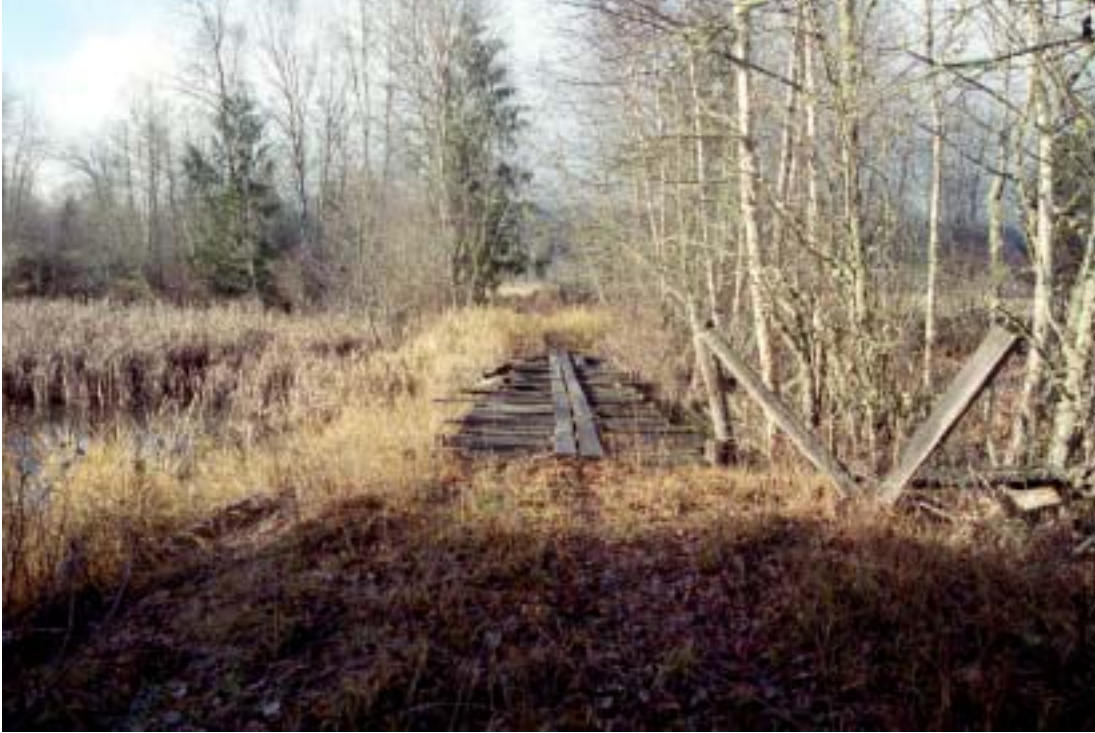
Before 7: Looking west along the Affolter-Chambers property line. The bridge was barely functional for foot traffic.

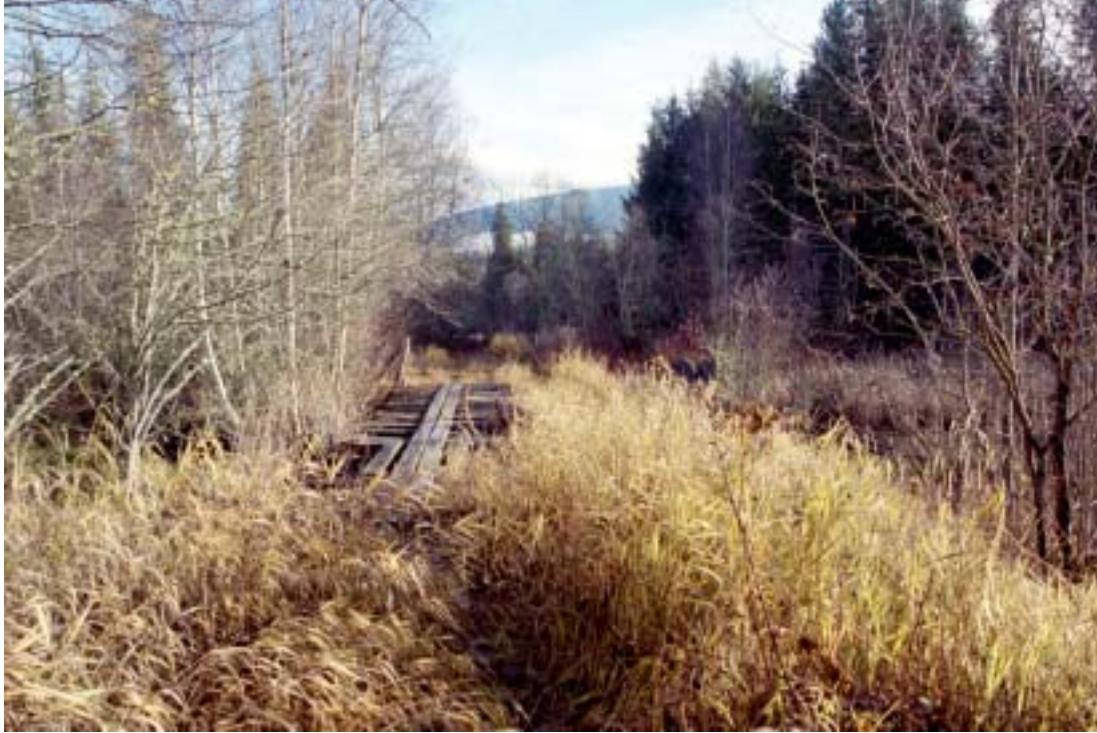
Before 8: Looking eastward across the old bridge.

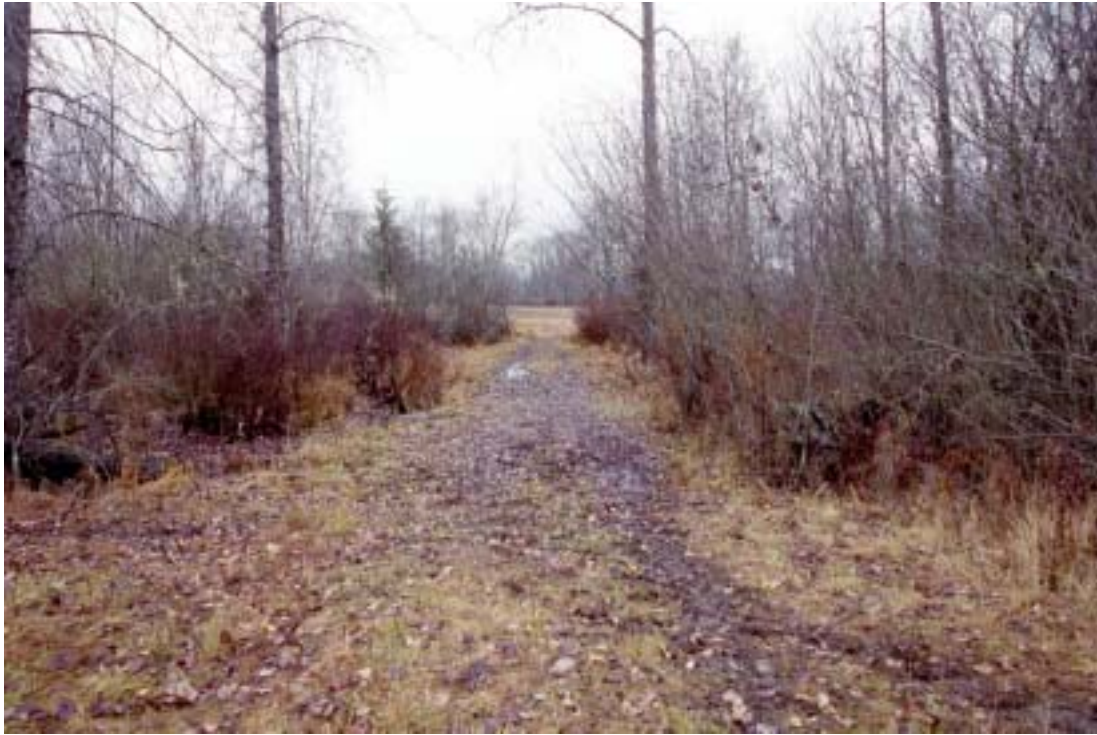
Before 9: Looking west across the southern most water access point on the Affolter property.

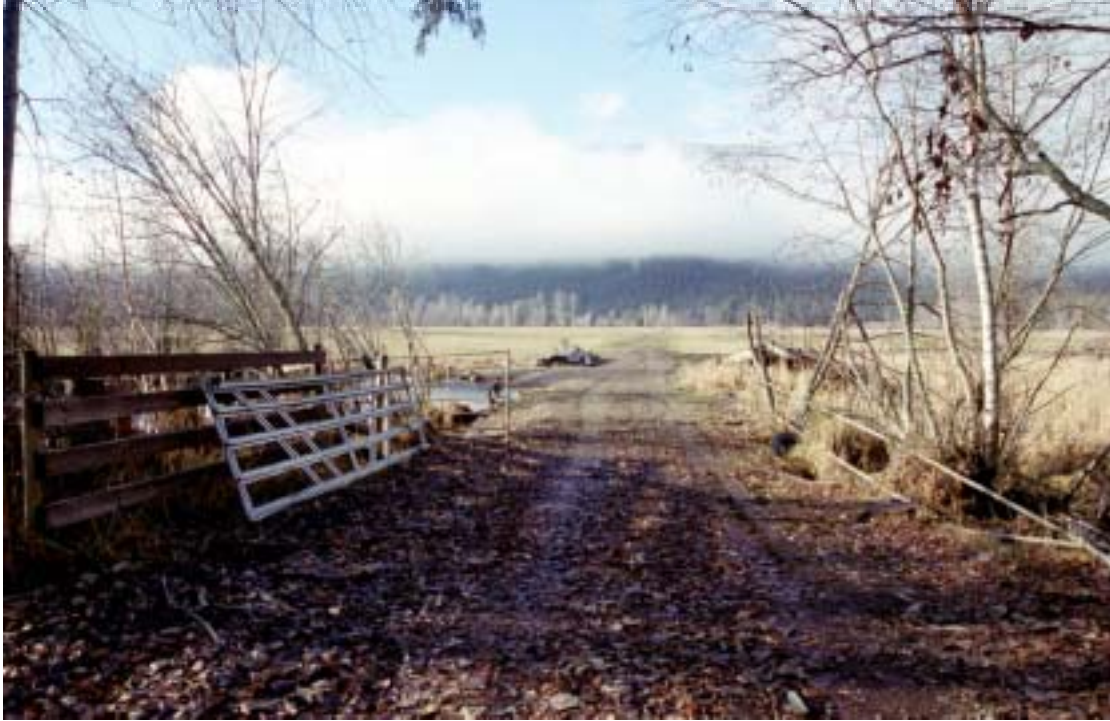
Before 10: The Chambers crossing looking westward. There were no functioning culverts before construction.

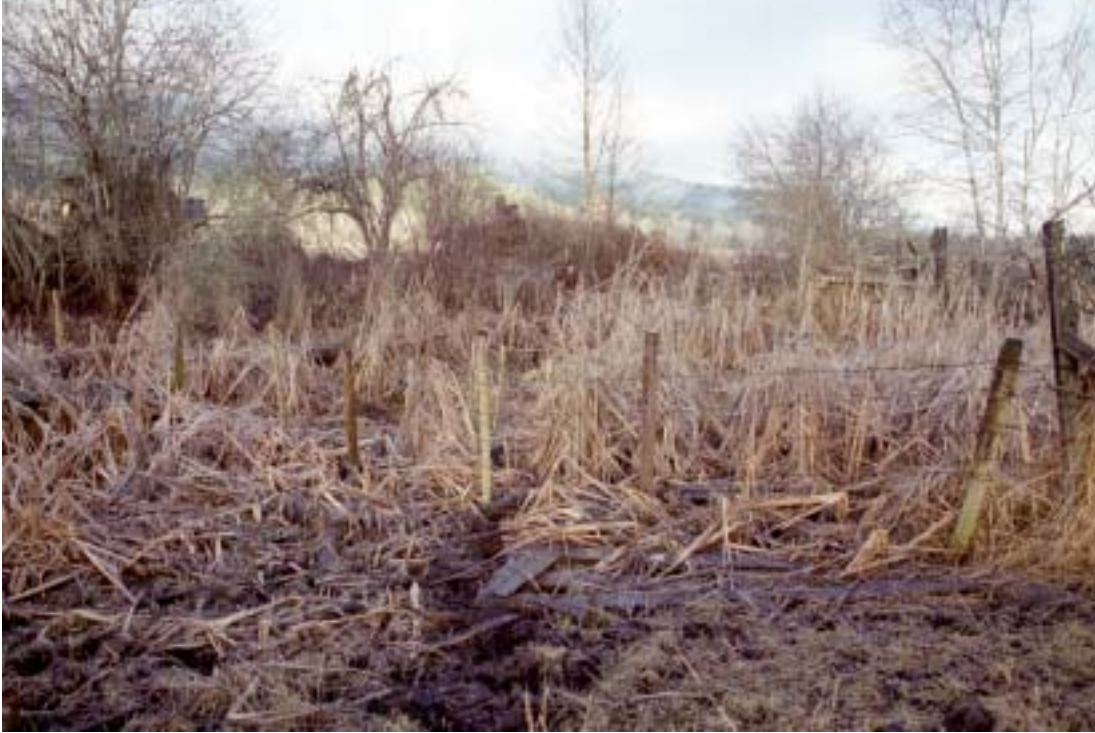
Before 14: This side channel on the Ltd property is dry in October before the water is diverted.

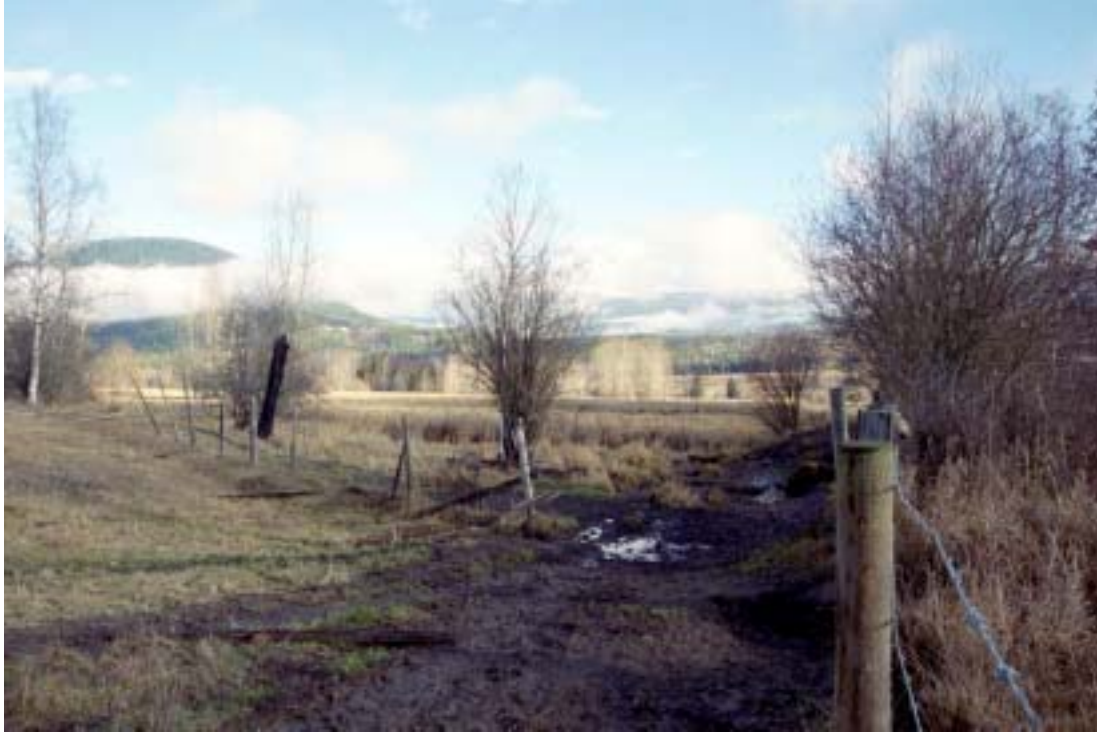
Before 15: The old culvert had washed out and the crossing had been trampled to the point that it was no longer usable. This is the southernmost crossing on the property owned by the 459218BC Ltd.

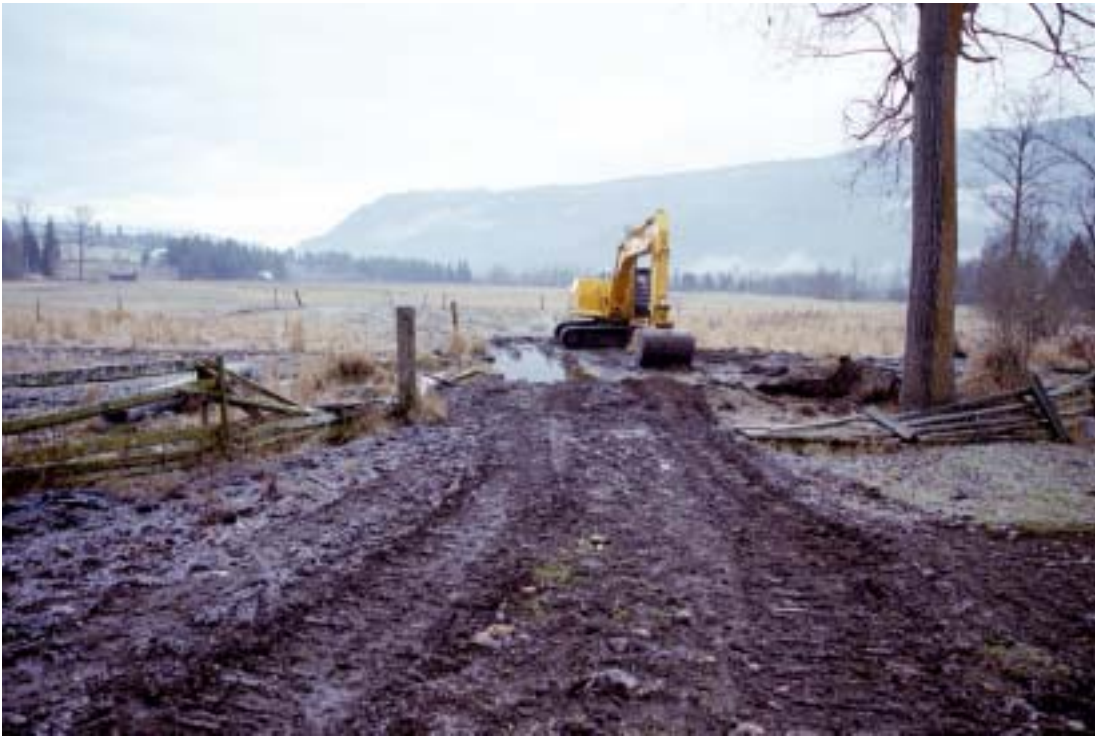
Before 16: The old culvert had been plugged from trampling by cattle making this crossing unusable most of the year.

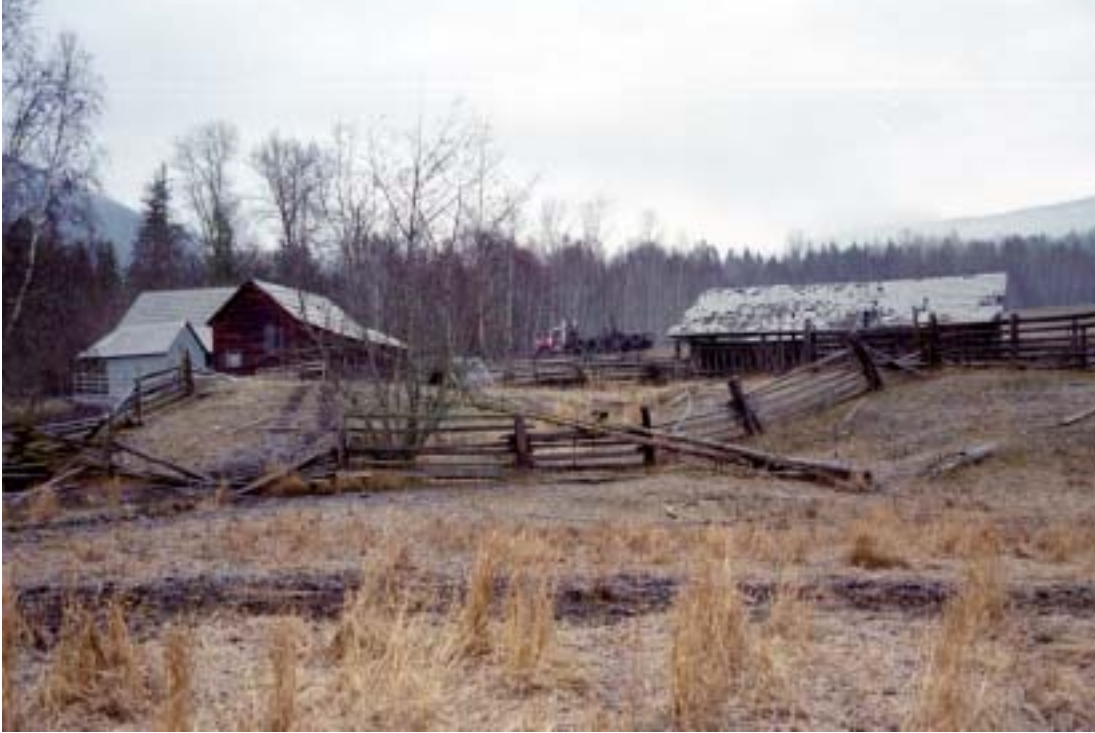
Before 17: A tributary to the Procter Channel flows through the farmyard of the 459218BC Ltd property.

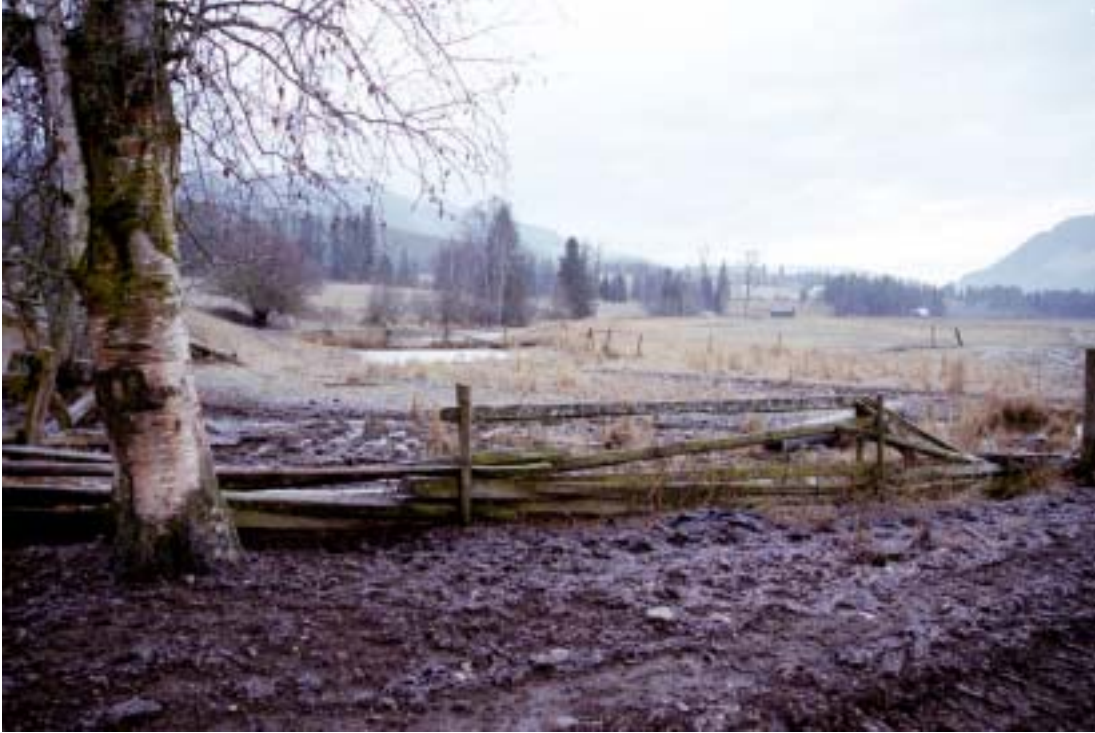
Before 18: Cattle had free access to the channel and tributary due to downed fences on the 459218BC Ltd property.

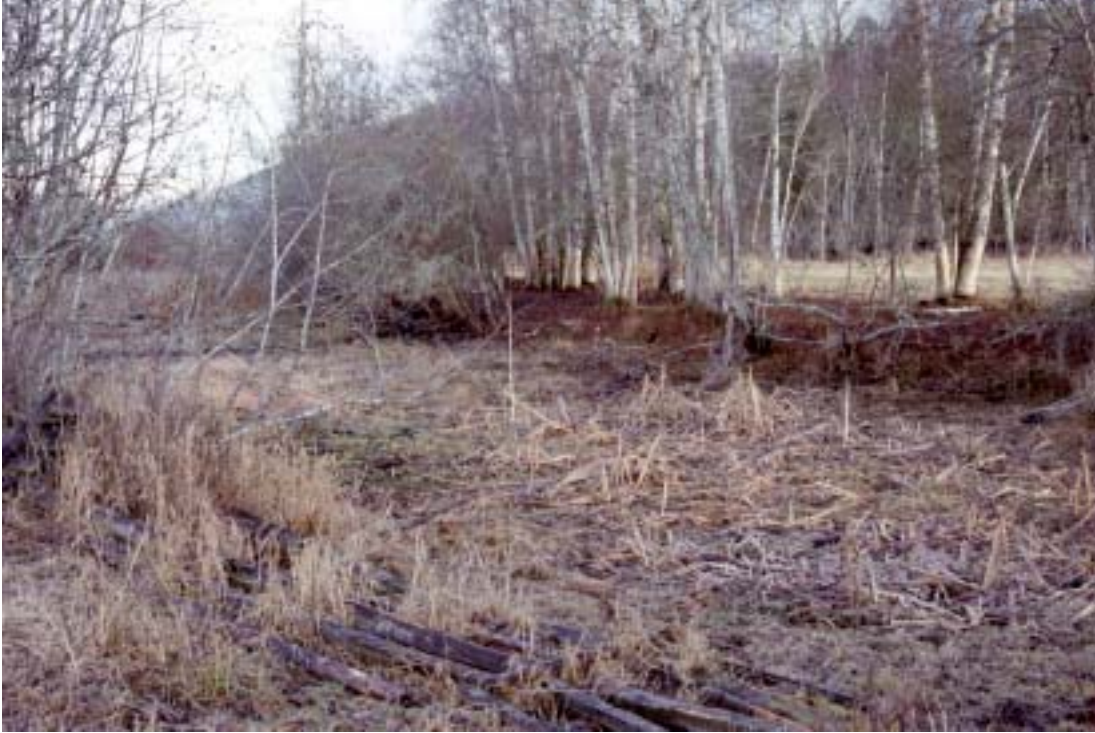
Before 19: This section of the channel was dry in October. The old rail fence that is lying on the ground in this photo was reused at the crossings on the 459218BC Ltd property.

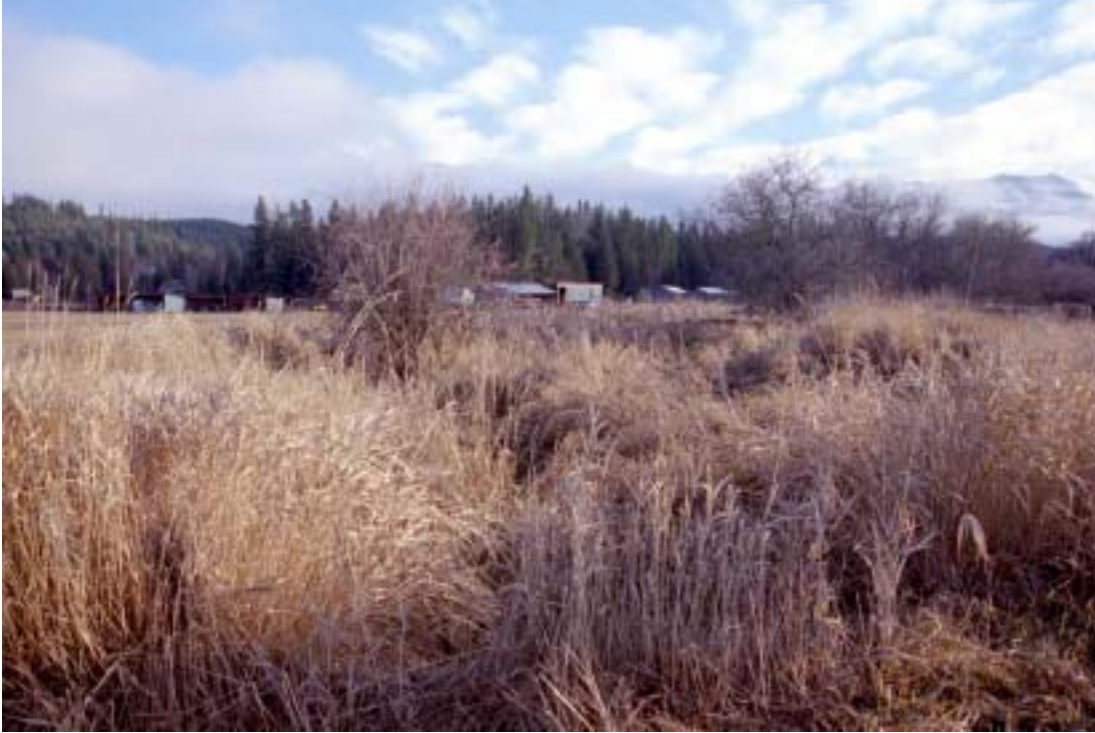
Before 20: A view from the old crossing facing upstream (south) on the Procter property. This section was dry except during freshet.

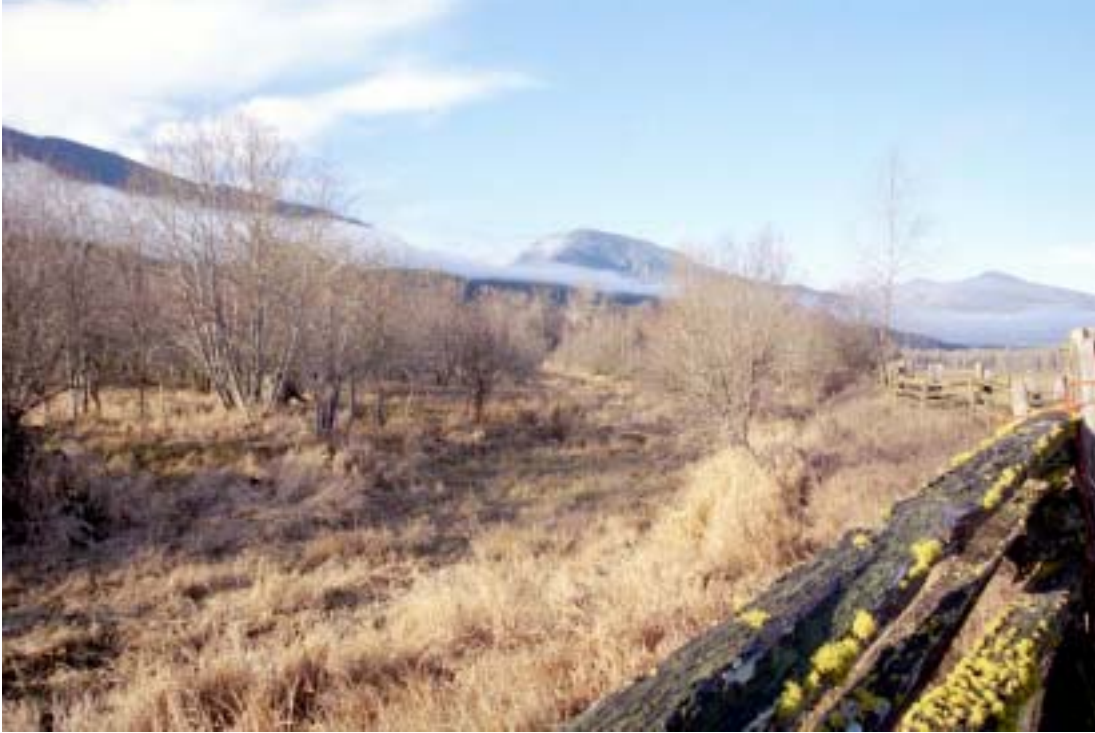
Before 22: From the crossing downstream was dry on the Procter property from July through May before the water was diverted.

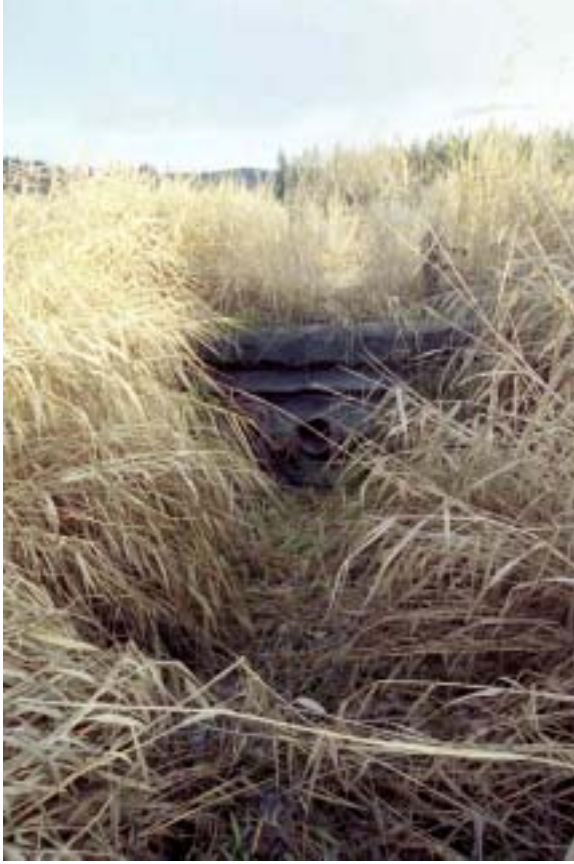
Before 25: The crossing on the Procter property had several 8 – 10” pipes for culverts.

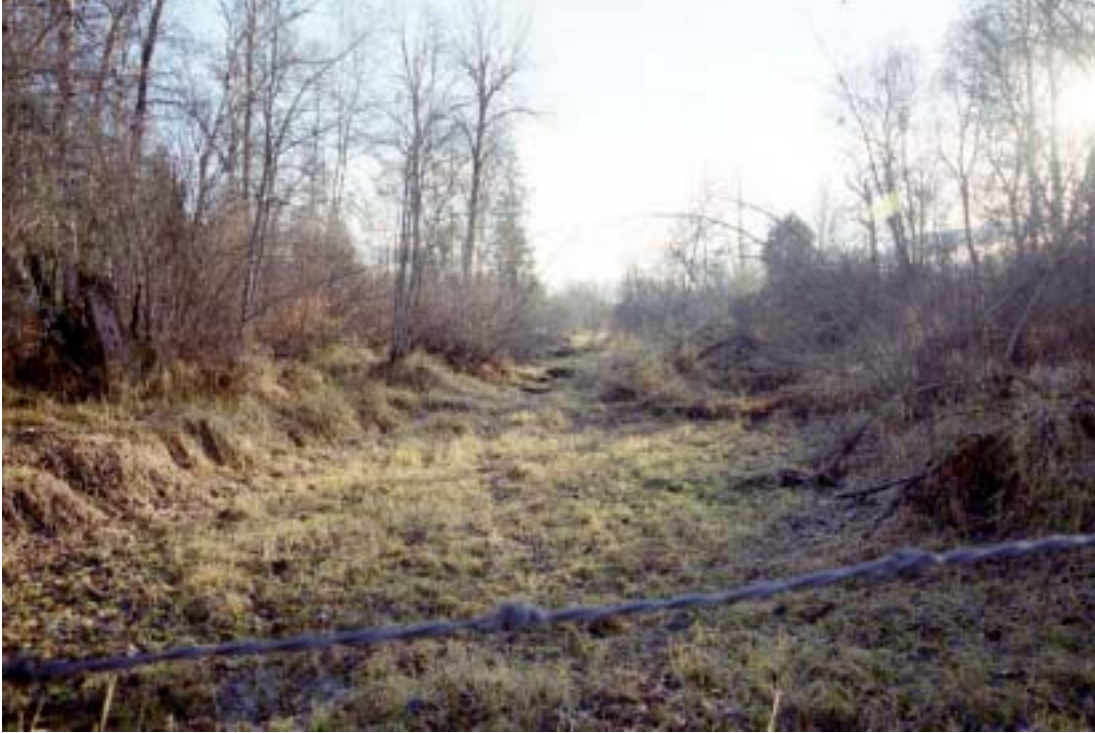
Before 26: An upstream view of the channel on the Procter property from the Huwer fence line. This area trapped fish when the high water dropped.

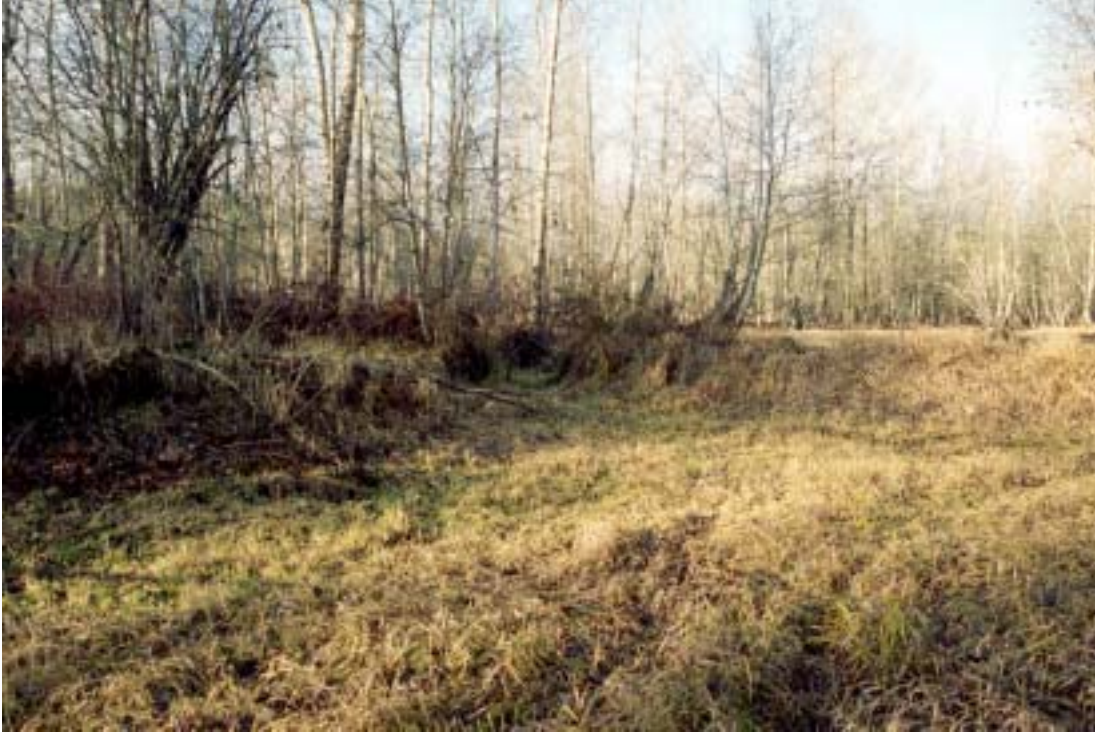
Before 28: The water had to make a 90<sup>0</sup> bend before entering the Shuswap.

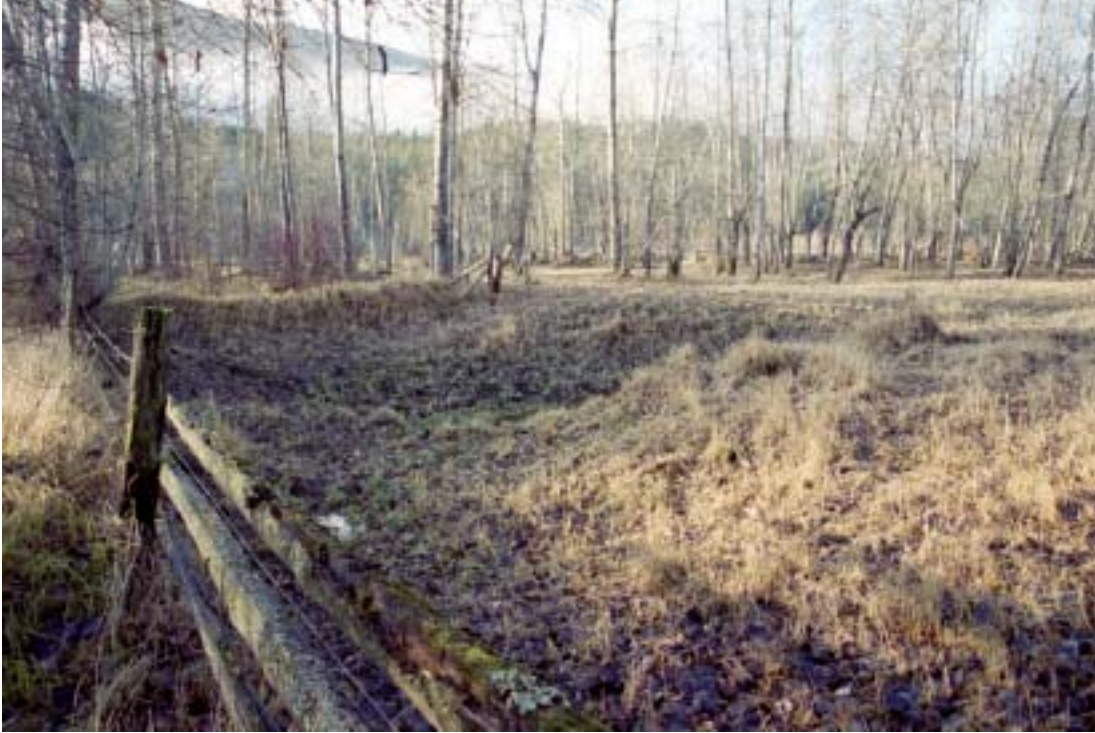
Before 20: The water would often break over the bank at the sharp corner and scour a hole that would trap fish.

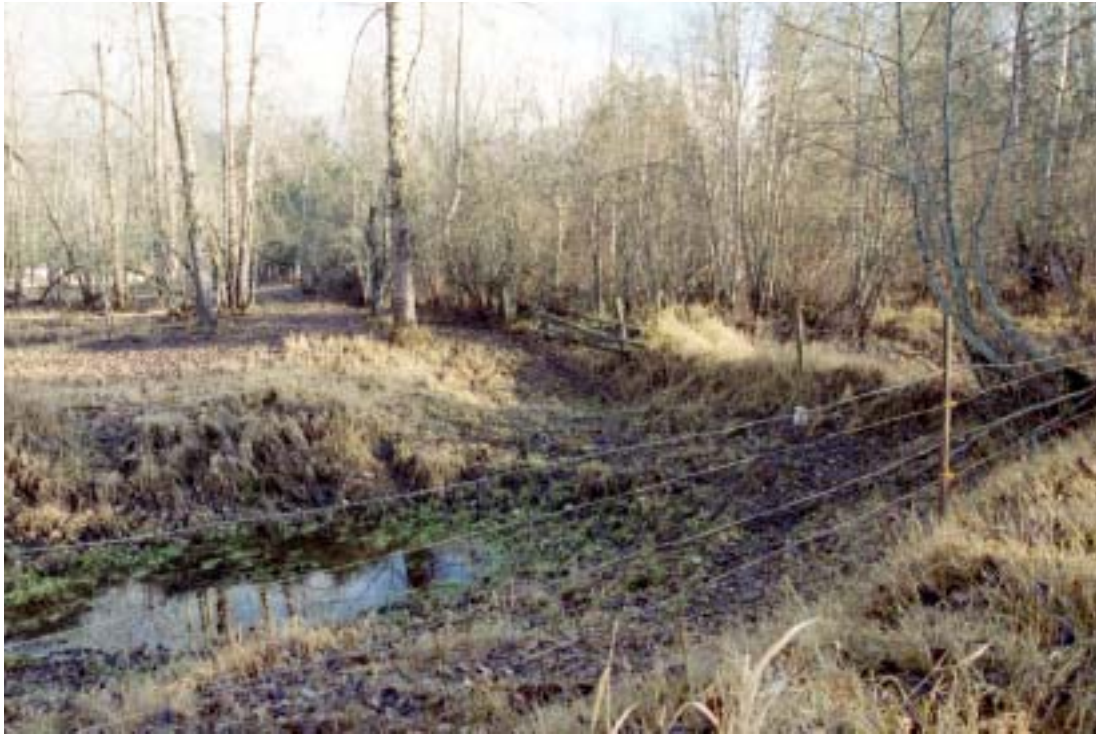
Before 30: A different view of the hole scoured on the backside of the 90<sup>0</sup> corner on the Huwer property.
