Executive summary

10: Dam Safety Quarterly Report

Dam Safety Program Dashboard

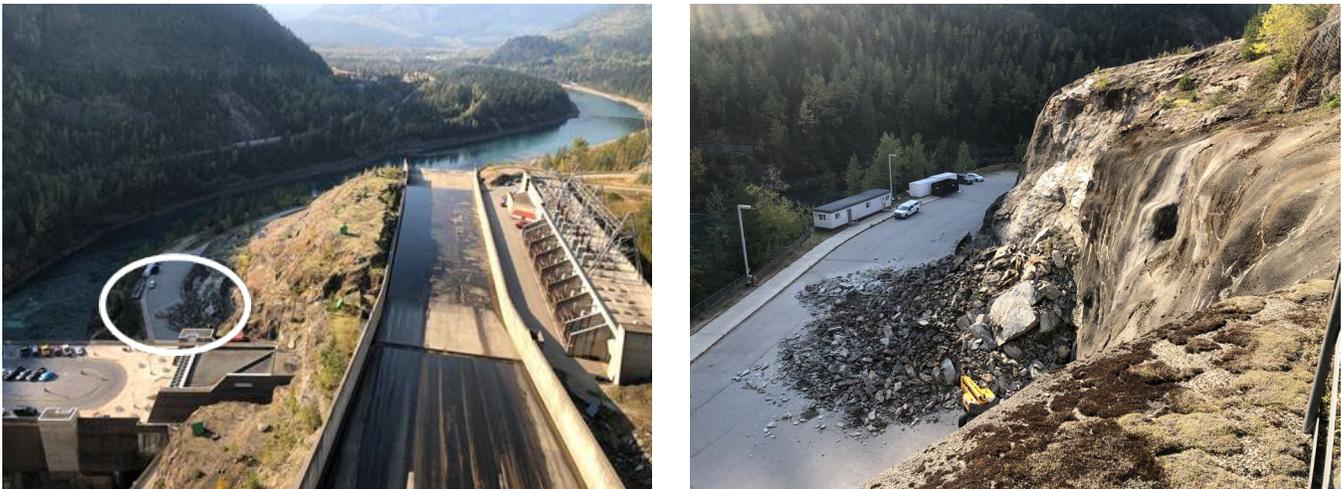
A rockfall occurred into the main parking lot at Revelstoke Generating Station at approximately 2:00 am on the morning of October 5, 2022. Comprising approximately 350 cubic metres of rock, the rockfall occurred on a feature known as the Marble Shear Block, over which the dam’s spillway is routed and below which is the principal access road to the generating station. Nobody was in the vicinity at the time and there were no injuries. The rockfall and potential instability of adjacent surfaces poses no threat to the dam, spillway or other critical infrastructure at the site, as instrumentation within the Marble Shear Block conclusively shows that there has been no global movement or instability of the Block. The access road to the generating station is partially blocked, however, and the road is closed. Access via the Visitor’s Centre and parking on the powerhouse roof remains open. See Figure 3, below, for photos showing the location and extent of the rockfall.

Figure 3 Rockfall on the Marble Shear Block at Revelstoke Dam and Generating Station. At left: the location of the rockfall as viewed from above the spillway. At right: view of the rockfall onto the access road and main parking lot of the generating station.

Dam Safety has established monitoring of the slope above the road through daily point cloud laser surveys, drone surveys, and inspections of the slopes above for signs of potential progressive failure. Engineering is presently completing designs for a temporary protective berm, composed of lock blocks and rock, to be constructed along the road centerline, that would contain a similar rockfall and allow one lane of the access road to be opened up for safe delivery of essential equipment and materials to the station. Construction will be sequenced such that construction crews will always be working behind the constructed protective works and not be directly exposed to the rockfall hazard. This work is being

funded under the Dam Safety Investigations budget while an emergent project is being initiated to design and implement permanent stabilization of the rock slope.

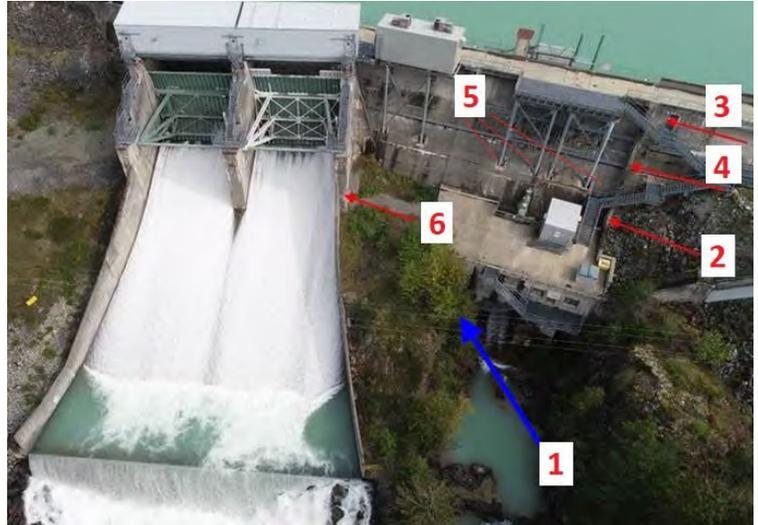
One maintenance project of interest took place at Cheakamus Dam. Various areas of the concrete dam are deteriorating due to alkali aggregate reactivity, as shown in Figure 4 at right. Repairs were made at two of the locations – areas 2 and 6 – and included trial applications of two products that are intended to mitigate the ongoing chemical reaction that is leading to the deterioration. These areas will be monitored for effectiveness of the treatment.

Figure 4 Drone photo showing areas of Cheakamus Dam where concrete is deteriorating due to alkali aggregate reactivity.

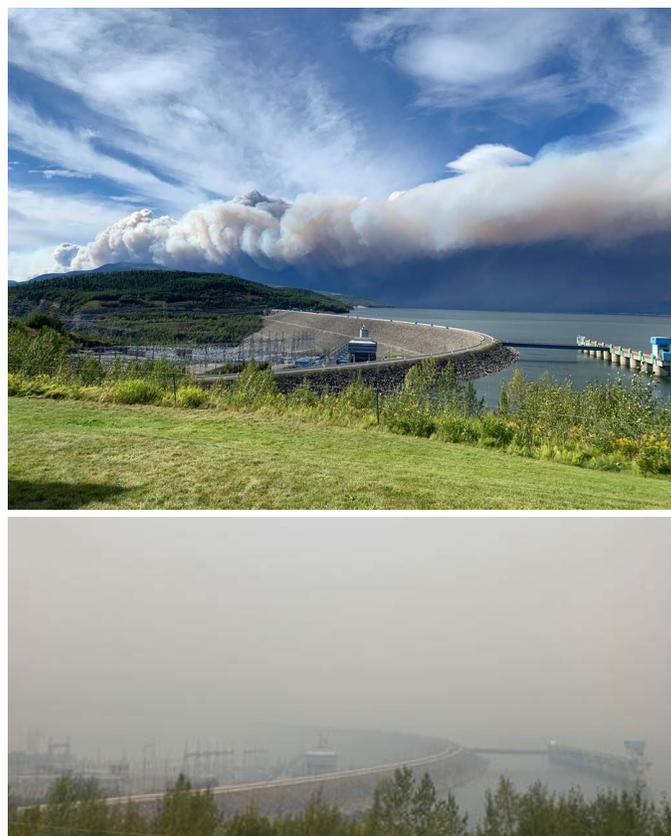
The wildfire did not pose a material hazard to the safety of either dam, but dam safety activities and considerations did impact BC Hydro’s response and contingency planning. Principally, WAC Bennett Dam’s spillway had been taken out of service for much-needed upgrades to the concrete surfaces within the WAC Bennett Dam – Spillway Concrete Upgrades Project. (See “Capital Projects” later in this report.) With large sections of the spillway’s concrete surface removed for this work, returning the spillway to service would have required eight days per the Interim Dam Safety Risk Management Plan. Williston Reservoir, however, was well below the Storage Reservation Curve elevation in place for management of flood risks at Site C and even further below the Maximum Normal Reservoir Elevation, so there were no tangible risks relating to overtopping of the dam and no dam safety priorities for returning the spillway to service. With the spillway out of

Figure 6 Smoke from the Battleship Mountain fire, as seen from WAC Bennett Dam: on September 8, 2022 (top) and September 9, 2022 (bottom).

There may be a medium-term impact from the wildfire to safe operation of the dam. The fire may have created conditions that could lead to an increased debris load in the reservoir during next year’s freshet. Surveillance of the reservoir next spring will target that potential.

Additionally, a lesson learned from this event is that the hazard from wildfires, in addition to more conventionally considered inflow forecasts, must be accounted for when planning and scheduling spillway outages and in developing the associated Interim Dam Safety Risk Management Plans.

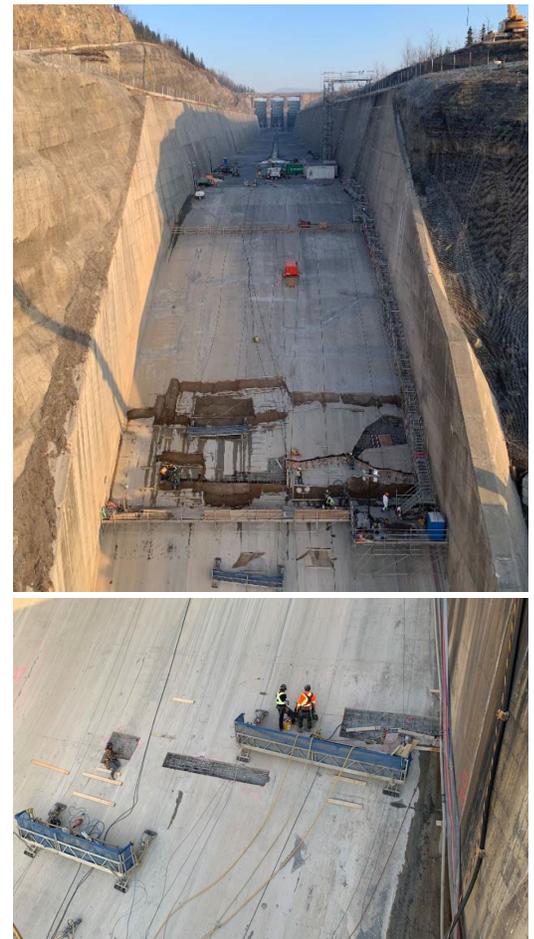
This project follows the Spillway Chute Upgrade Project, completed in 2016, which identified damage throughout the entire length of the spillway chute and remediated the highest priority areas located immediately upstream of the flip bucket. The specific sections of the spillway chute to be upgraded as part of this project are the next highest priority sections in the inclined chute, both above and below the previously resurfaced area, which have deteriorated more quickly than had been forecast.

Figure 7 Concrete removal and replacement work in the WAC Bennett spillway.

The project was forced to halt work and evacuate from site on September 3, 2022 as a result of the Battleship Mountain wildfire and the Evacuation Order for the District of Hudson's Hope. (See page 14 of this report.) The contractor was able to return to site and resume work on September 20, 2022. To take advantage of the continued mild weather at the site, and in recognition of the need to complete the work this season, the project added night shift work to recover from the schedule delays caused by the evacuation.

The concrete placement was completed at the end of October. Hoarding and curing of the concrete is expected to extend into mid-November.

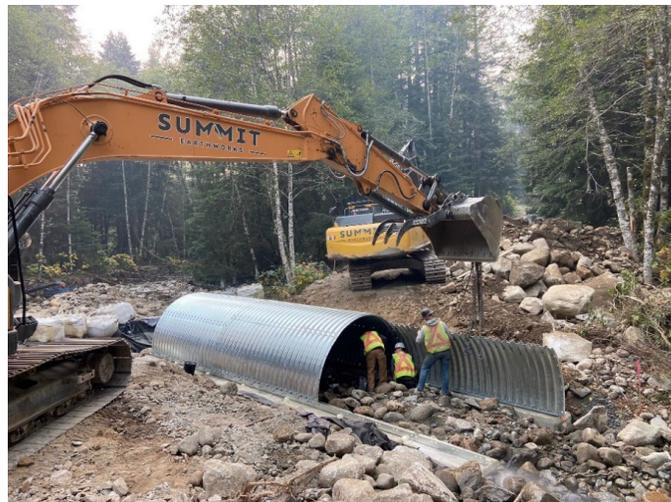
Access to Wahleach Dam and to the generating station's power intake on Jones Lake is by way of a steep and narrow, 8-kilometre-long logging road. That road is vulnerable to washouts during heavy rains, preventing access to the dam. The atmospheric river events in November 2021 washed out a section of the road and caused flows in the spillway discharge channel to jump the bank and form a confluence with Wahleach Creek upstream of where the spillway discharge channel merges with Wahleach Creek. Temporary road access was restored promptly following the atmospheric rivers.

Figure 8 Installation of a new culvert under the Wahleach Dam access road to prevent future washout.

Subsequently, an emergency project was initiated to install a culvert across the road and to restore the bank of the spillway discharge channel to prevent recurrence. That work was completed on October 25, 2022.
