DAM SAFETY QUARTERLY REPORT

QUARTERLY FEATURED DAMSITES – JORDAN RIVER SYSTEM DAMS

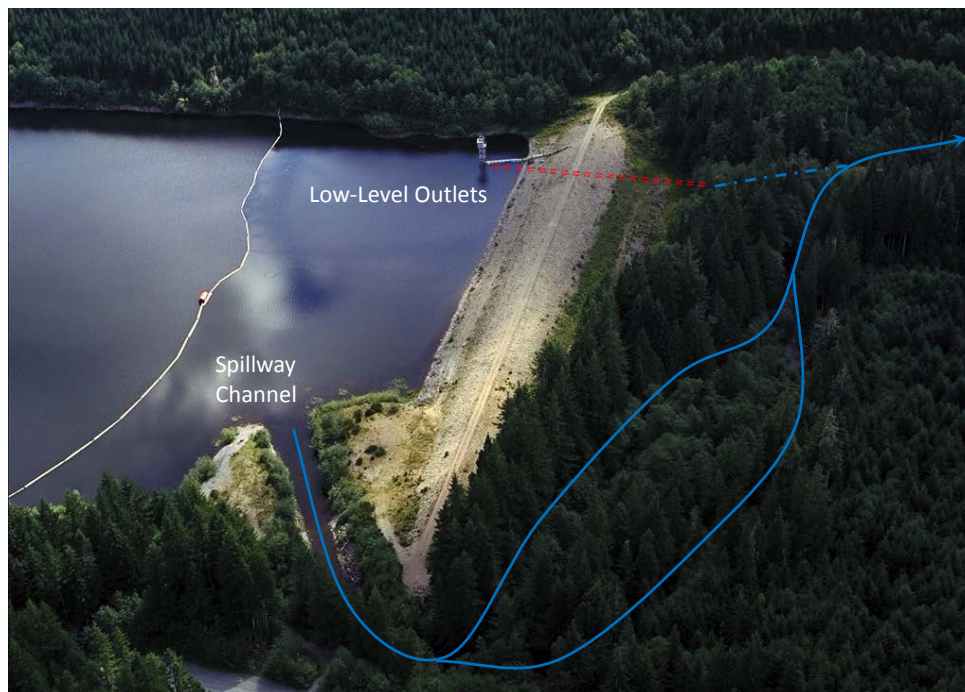
Figure 2: Bear Creek Dam

The Bear Creek Dam is a hydraulic fill structure built in 1911-12 and is currently classified as “Low” consequence. The dam was originally 17.5 metres high and 337 metres long.

The dam is founded on coarse cemented gravel (hardpan) underlain by sand and fine gravel. To form a positive cut-off, a 2.5 metre to 9.5 metre deep trench was excavated along the dam through the hardpan. Where bedrock was not reached, a row of interlocking sheetpiles was driven from the bottom of the trench to bedrock. The dam core consists of fine sands and silts which were sluiced into place over the foundation from the right abutment. The upstream and downstream shell materials vary from fine gravel, sand and clay near the core, to small boulders and coarse gravel near the outer slopes. The dam was raised in 1971 by 1.5 metres to provide additional freeboard for flood passage.

There are two 0.76 metre diameter low-level outlet pipes near the left abutment located through the base of the dam. The low-level outlets have not been operated since 2000.

The spillway consists of an approximately 110 metre long free overflow spillway channel excavated in rock at the right abutment. In 1971, the spillway capacity was increased by removing original spillway piers and stoplogs.

The seismic withstand of the dam has been estimated to be 0.065g which has a theoretical annual exceedance frequency of 1/37. As such, the spillway channel was lowered by 2.5 metres in 1993 to permanently reduce the reservoir volume to that which would be contained by the downstream reservoirs. This in turn reduced the consequence category of the dam, and no upgrades are in the capital plan. The site now essentially provides no active water storage, and a decision will need to be made in the future to either rehabilitate or fully decommission the structures.

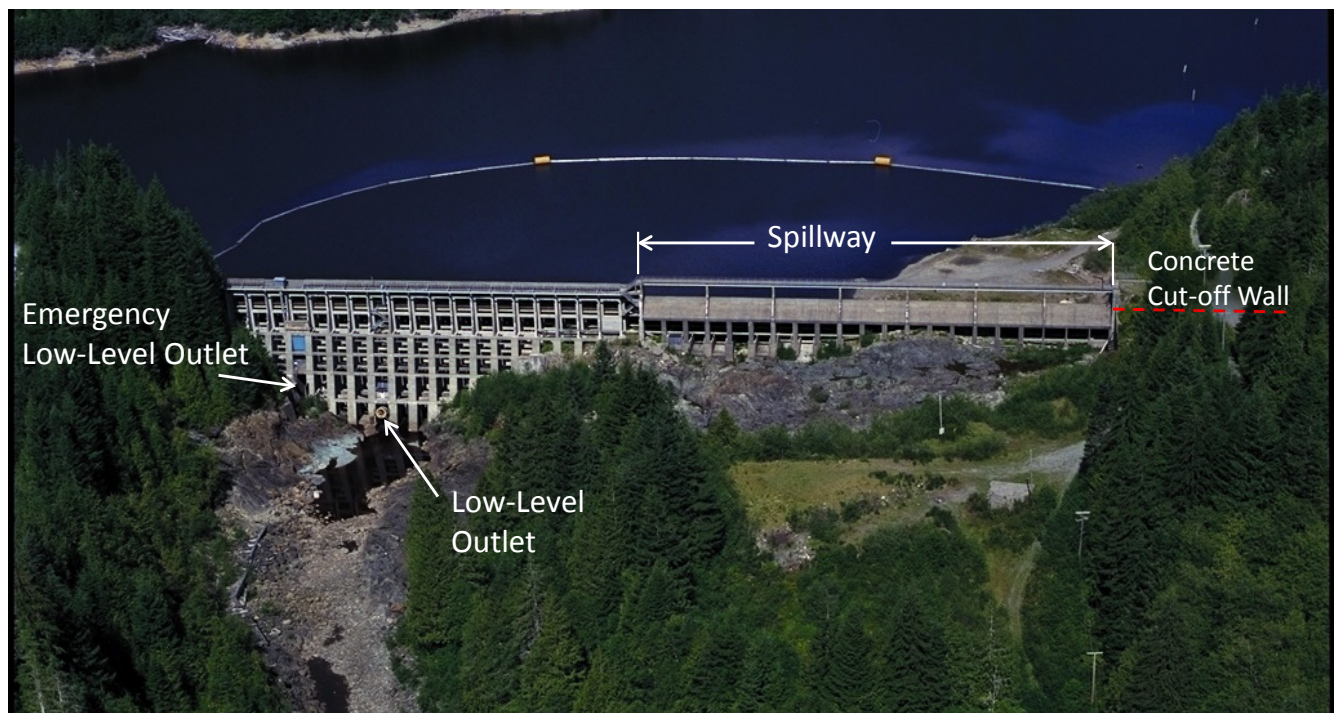
Figure 3: Jordan Diversion Dam

Jordan Diversion Dam, completed in 1913, is an Ambursen type concrete buttress dam, 40 metres high by 232 metres long, founded on bedrock. The dam is currently classified as “Very High” consequence. On the left abutment of the buttress dam is an embankment dam containing a central concrete cut-off wall. The spillway consists of a seven-bay free overflow section at the left end of the buttress dam.

The low-level outlet is the primary method of releasing water to the headpond at Elliott Dam. It consists of a 2.44 metre diameter steel pipe, controlled by a hollow-cone valve and a guard gate. A second emergency low-level outlet consists of a 1.1 metre wide by 1.7 metre high sluice, controlled by a hydraulic slide gate and a guard gate but this gate is not tested as there are concerns it may not close due to debris becoming jammed in the opening.

In 1990, the buttress dam and spillway section of Jordan Diversion Dam were rehabilitated to improve its seismic withstand for a 1/10000 AEF design load of 0.45g. However with the increase in seismic loading (the 1/10,000 AEF is now 1.475g), the dam no longer meets current guidelines. Refer to the New Issues section for a discussion regarding the ongoing public awareness work at Jordan River in regard to seismic withstand.

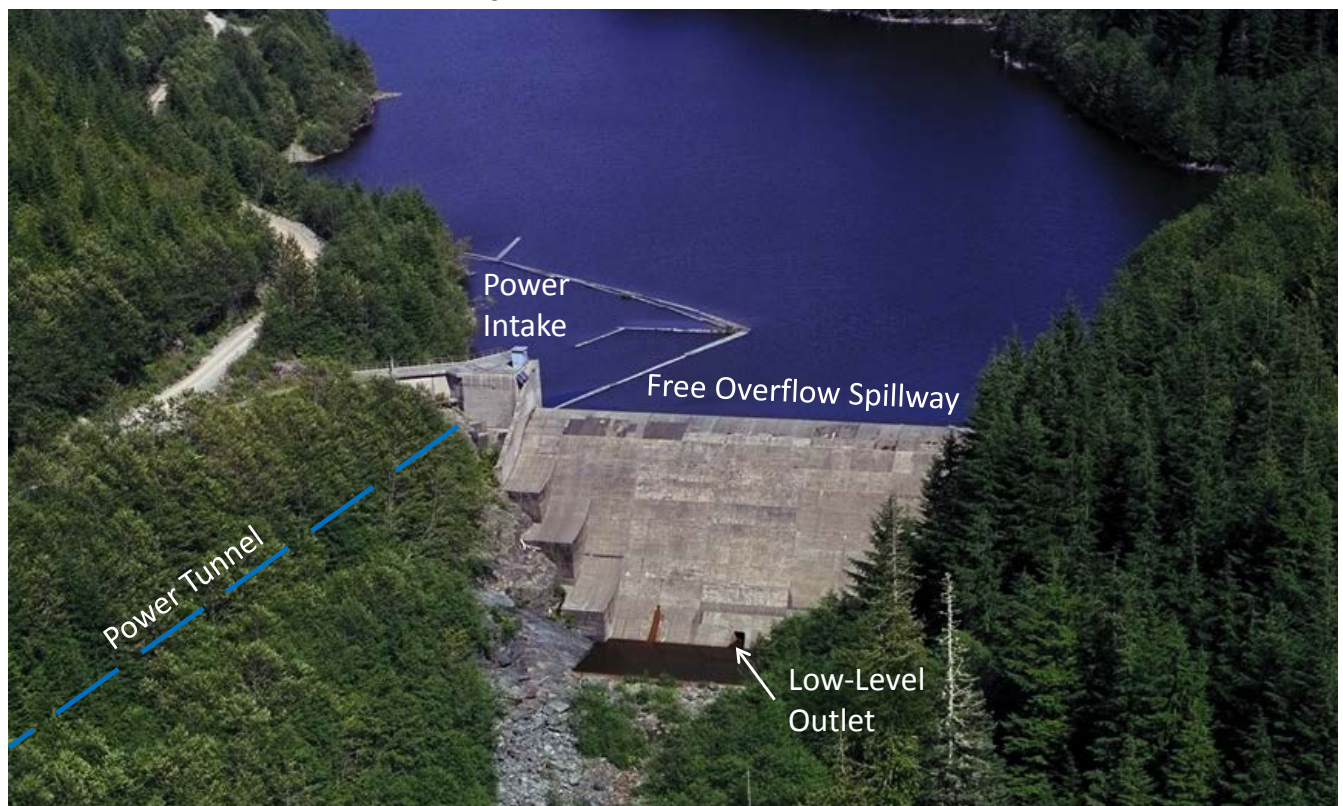
Figure 4: Elliott Dam

Elliott Dam is a 27 metre high, 115 metre long concrete gravity dam founded on bedrock. It consists of a non-overflow section on the right side where the power intake is located, a 73 metre long free overflow spillway and a non-overflow section on the left side. A low-level outlet is located at the base of the free overflow spillway.

No significant changes or major repairs have been made to the dam since construction other than the addition of a fish by-pass through the dam in 2005. The consequence classification of the dam increased from “Low” to “Very High” as a result of updated inundation mapping.

The seismic withstand has been estimated to be less than 0.4g, and as a “Very High” consequence dam, the dam does not meet current guidelines.

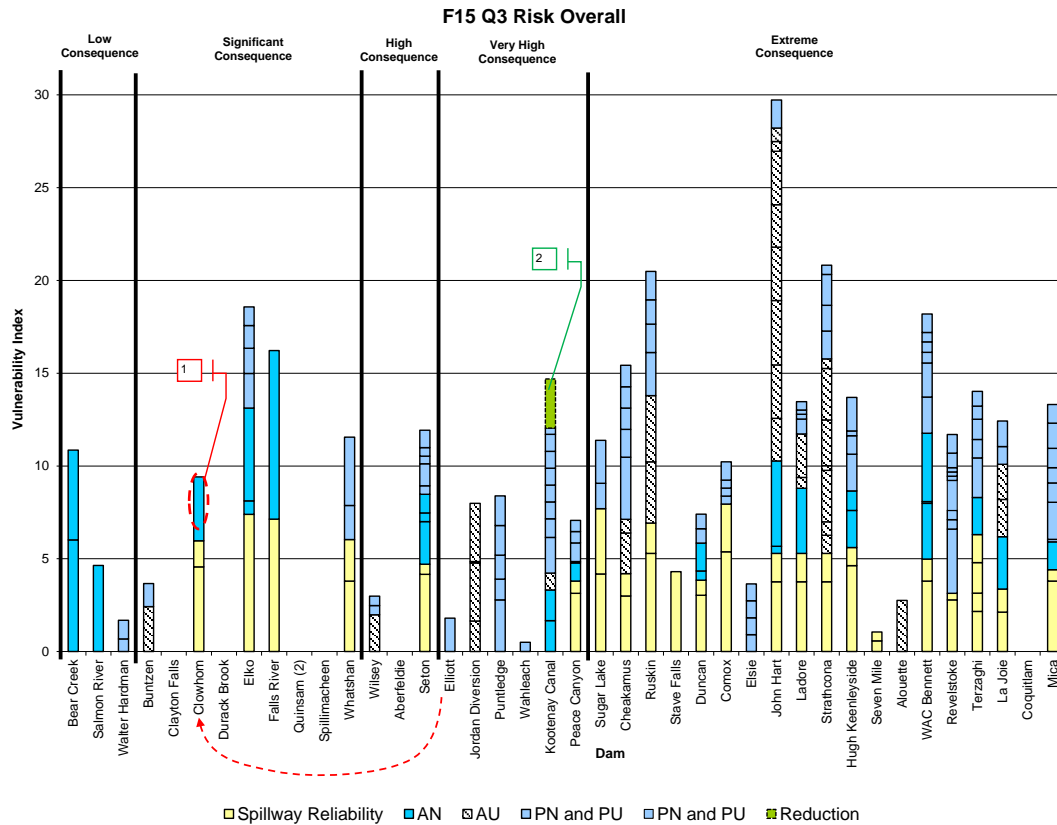
FIGURE 1 - DAM SAFETY: OVERALL RISK PROFILE

1. **Clowhom Dam** – Rating increased for seismic deficiency as reported last quarter. Consequence has since decreased, and this will be reflected next quarter.

3. **Kootenay Canal Dam** – the vulnerability associated with leakage through the canal liner has been decreased based on the installation of a Carpi membrane.
