2015–2016 Dam Safety Report

Dam Safety Program Report 2015 – 2016 (F2016)

Prepared by:

June 2016

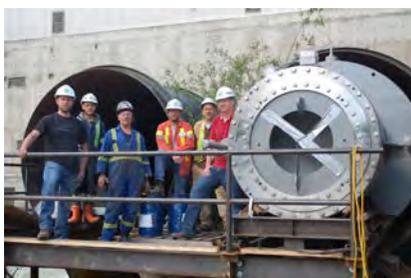
Pressure relief valve upgrade

Following the failure of the pressure relief valve discharge at the South Conduit in February 2012, a reliable alternative water passage was required via the North water passage.

- Replacement of the hollow cone valves in the North Conduit,
- Installation of a new low level outlet gate at the Intake Tower;
- Demolition of the damaged pressure relief valve conduit and construction of a new conduit,
- Upgrades to the pressure relief valve and section of the South Conduit,
- Design, fabrication and installation of new stoplogs, and
- Upgrades to the hollow cone valve heater systems.

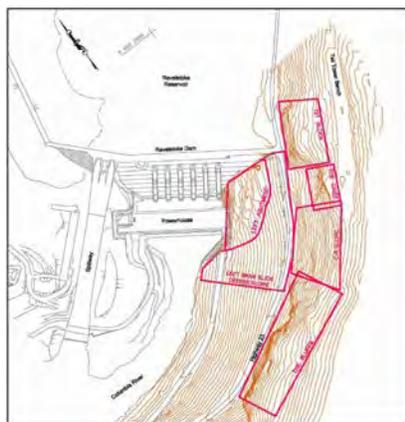
Revelstoke – Left Bank Slopes

The Revelstoke left bank rock slopes potentially pose a hazard to the Revelstoke Penstocks and Powerhouse, situated immediately below. In F2013, an investigation study was initiated to determine the risk the slopes posed to the facility and to determine if any upgrades were required.

There are seven slopes of interest on the Left Bank of Revelstoke Dam. The study recommended further stabilization work for one slope, which will be carried out under a future project. However, the investigation also concluded that for another two slopes, the geology was poorly understood, and there was insufficient instrumentation to make a definite stability assessment. The investigation recommended that instrumentation be installed and additional geological information be collected to provide a technical basis for whether or not stabilization is required for these slopes.

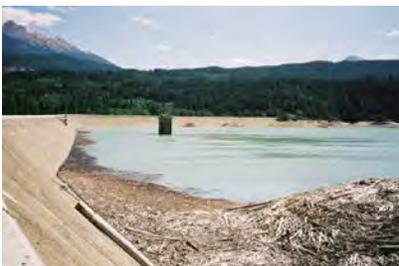
Upstream Shotcrete Face of La Joie Dam

The existing shotcrete facing of La Joie Dam installed in 1972 has deteriorated, resulting in increased leakage through the dam. Some of the leakage is currently managed through maintenance of the shotcrete panels accessible during low reservoir periods. A previous study to understand the performance of the dam has concluded that the dam requires significant upgrades to ensure safe performance following the design earthquake.

An update to the La Joie Operation, Maintenance and Surveillance Manual was issued in F2015 in the form of an Interim Dam Safety Risk Management Plan. Repairs to the upstream face of the dam will continue to be carried out as required (annually or bi-annually).

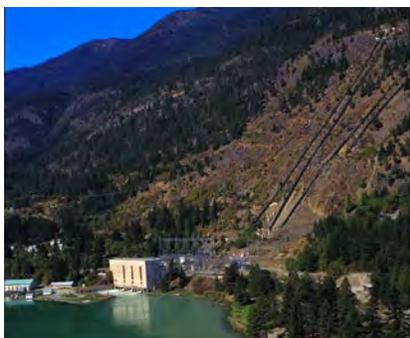
Bridge River 1 - Penstocks

Bridge River 1 has a history of geotechnical issues. The powerhouse is situated on soils subject to artesian uplift pressures. Extensive remedial measures were required early in the plant's life to arrest rotational movement between the powerhouse and the Bridge River 1 penstocks. The upper portions of the penstocks are founded on a more stable rock foundation on the side of Mission Mountain above the powerhouse.

This project is installing appropriate instrumentation to monitor for penstock leakage and differential movement between the penstocks and powerhouse; detect elevated powerhouse foundation pore pressures and provide appropriate relief of excess artesian pressures.

Installation and alarming of flowmeters on penstocks 2 and 3 were completed prior to F2016. In F2016, installation of flowmeters on penstocks 1 and 4 was completed; alarm levels were set to detect significant leaks; and procedures for manual closure of the valves were included in the site operating orders.

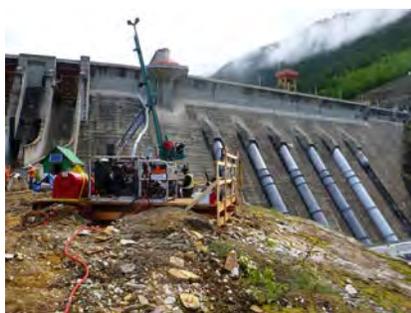
Drilling in the Marble Shear Block

Significant work was carried out in 1998/99 to reduce water levels but they have since increased. In 2012, a number of drains were cleaned by high pressure jetting and six existing drains were reamed. Ten new drains were also installed at the head of the Marble Shear Block Drainage Adit. The drainage trenches on top of the Marble Shear Block were cleared to reduce ponding. While these measures did impact water levels slightly, the average water level is still above the originally defined acceptable limit.

It was concluded that in order to assist in monitoring these thresholds, two additional in-place inclinometers should be installed within the Marble Shear Block and a detailed LiDAR surveying of the spillway chute should be completed. This work will be carried out in F2017.

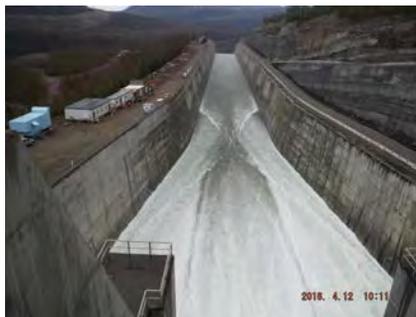
WAC Bennett Dam Spillway Chute- Ice Flushing

This project is carrying out repairs to the spillway chute concrete surface at the W.A.C. Bennett Dam. Safe access to the chute was achieved in August 2011 following completion of rock slope stabilization works which allowed for a complete chute inspection.

- installation of waterstops in the upstream construction and contraction joints,
- repairs of significant cracks by removal of the cracked concrete and replacement with new concrete, and
- minor patching of other cracks.
