Peace Project Water Use Plan

WILLISTON TRIAL TRIBUTARIES

Implementation Year 9

Final Report Year 9 (2019)

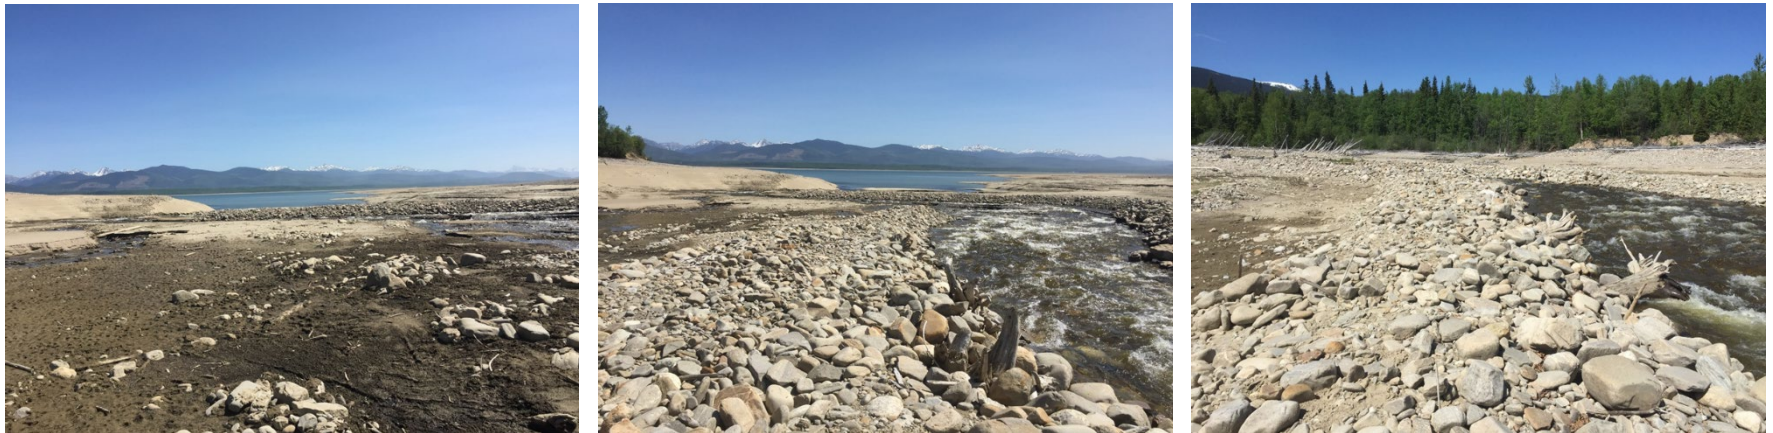
Structure	2019 Structural Integrity	Likely Deterioration Cause	2019 Ecological Function	Action Needed
Berm D: Low gravel-cobble berm	Berm structurally sound; we observed a small amount of cobble erosion and movement as well as fines accumulation on the berm crest	Driftwood, ice movement, rising and falling reservoir	Berm D maintained a single channel	Inspection in 2020 to see whether erosion progressed
Berm B: Low gravel-cobble berm; embedded LWD	Berm structurally sound; embedded LWD structures were present and stable	None observed	Berm B maintained a single channel; embedded LWD stabilized berm toe but created little scour, cover or shading because they were elevated above the creek	2020 inspection; detailed elevational survey
Berm C: Low gravel-cobble berm, embedded LWD; WDC	Berm structurally sound; embedded LWD structures present and stable; woody debris catchers were intact; a small amount of erosion and cobble movement on the crest of the downstream berm portion	Driftwood, ice movement, rising and falling reservoir	Berm C maintained a single channel; embedded LWD stabilized berm toe but created little scour, cover or shading because it was elevated above the creek; WDC intact and functional; small amount of driftwood inside WDC did not interfere with works yet	Inspection in 2020 to monitor erosion; possible manual removal of driftwood inside of WDC

Figure 6 From left to right, Berm D, Berm B and Berm C with embedded LWD (Ole Creek, May 29, 2019).

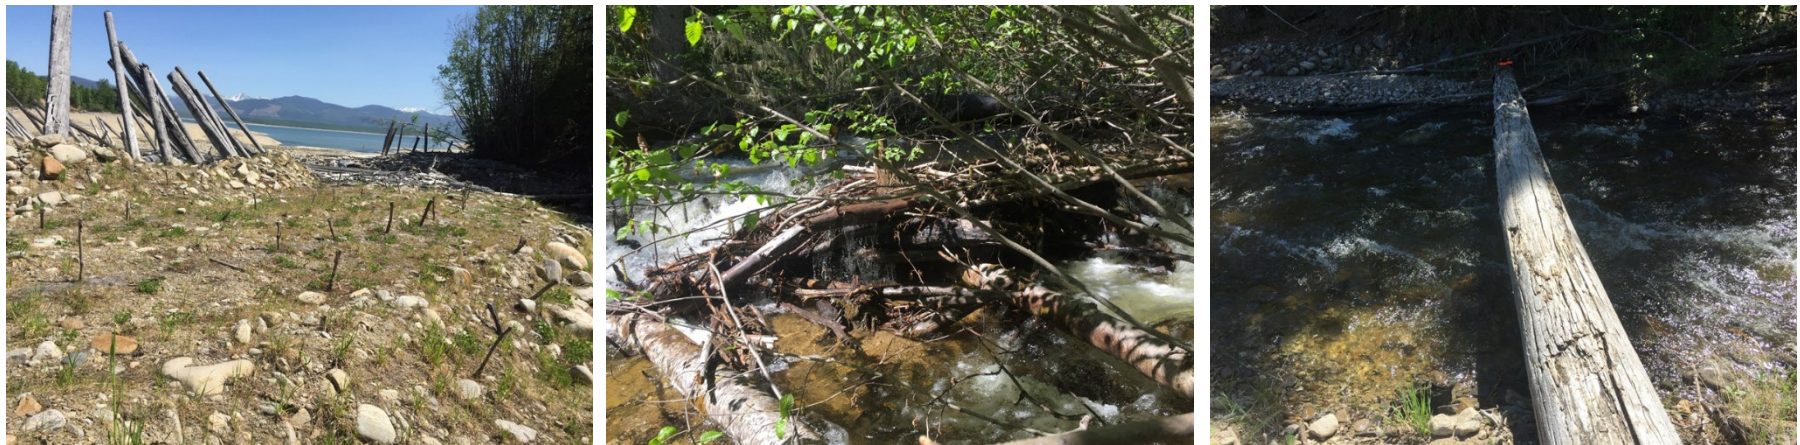
Structure	2019 Structural Integrity	Likely Deterioration Cause	2019 Ecological Function	Action Needed
Berm A: Low gravel-cobble berm; WDC; embedded LWD; planted willow stakes	Berm structurally sound; small amount of cobble erosion at base of upright WDC logs; small amount of driftwood inside of WDC; embedded LWD present and stable; all but a few willow plantings failed; natural vegetation (mainly grass) was starting to establish	Driftwood, ice movement, rising and falling reservoir	Berm A maintained a single channel; embedded LWD stabilized berm toe but created little scour, cover or shading because it was elevated above the creek; WDC intact and functional; small amount of driftwood inside WDC did not interfere with works yet	Inspection in 2020 to monitor erosion; possible manual removal of driftwood inside of WDC
Log Jam at Long.: 124°31'48.53"W; Lat.: 56°27'15.54"N;	The previously (2016, 2018) reported log jam was not present anymore on May 29, 2019.	N/A	N/A	Inspection in 2020 to assess log jam presence

Current velocities, water depths, discharge (14.6 m ³ /s) at 56°27'14.00"N; 124°31'43.73"W	Based on visual assessment, Ole Creek current velocities and water depths through the DDZ may have been suitable for fish migration on May 29, 2019 based on a minimum thalweg depth of 0.5 m and velocity breaks behind cobbles and boulders.	None observed	Facilitated fish migration	Inspection in 2020

Figure 7 From left to right: Berm A with WDC and natural revegetation; log jam; discharge measurement site (Ole Creek, May 29, 2019).

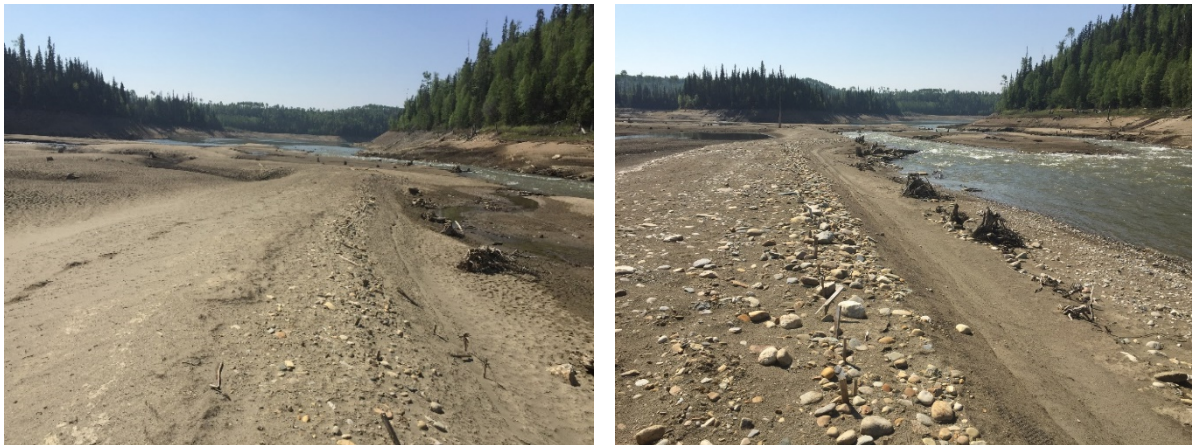
Structure	2019 Structural Integrity	Likely Deterioration Cause	2019 Ecological Function	Action Needed
Berm A: Large buried bulk bag berm with embedded LWD	Berm A appeared structurally sound but mild continuous erosion along all of the berm crest was observed (needs to be confirmed through a detailed elevational survey)	Driftwood, ice movement, rising and falling reservoir	Berm A was still functioning in maintaining a single channel	Detailed elevational survey below reservoir elevation of 663 m to check for berm crest erosion
Berm G: A buried bulk bag berm with embedded LWD	Berm structurally sound; embedded LWD structures present and stable; coir material used in soil wraps was in good condition and stable	Driftwood, ice movement, rising and falling reservoir	Berm D maintains a single channel; embedded LWD stabilized the berm toe	Inspection in 2020
Berm F: Non-vegetated geogrid soil wrap berm with embedded LWD	Berm structurally sound; embedded LWD structures present and stable; coir material used in soil wraps was in good condition and stable	Driftwood, ice movement, rising and falling reservoir	Berm F maintains a single channel; embedded LWD stabilized the berm toe and used to create scour (2016) but scouring function was lost.	2020 inspection; detailed elevational survey (to monitor potential accumulations of fines or erosion on berm crest)

Figure 9 From left to right: Berm A; Berm F and Berm G (in background) with embedded LWD (Six Mile Creek, May 28, 2019).

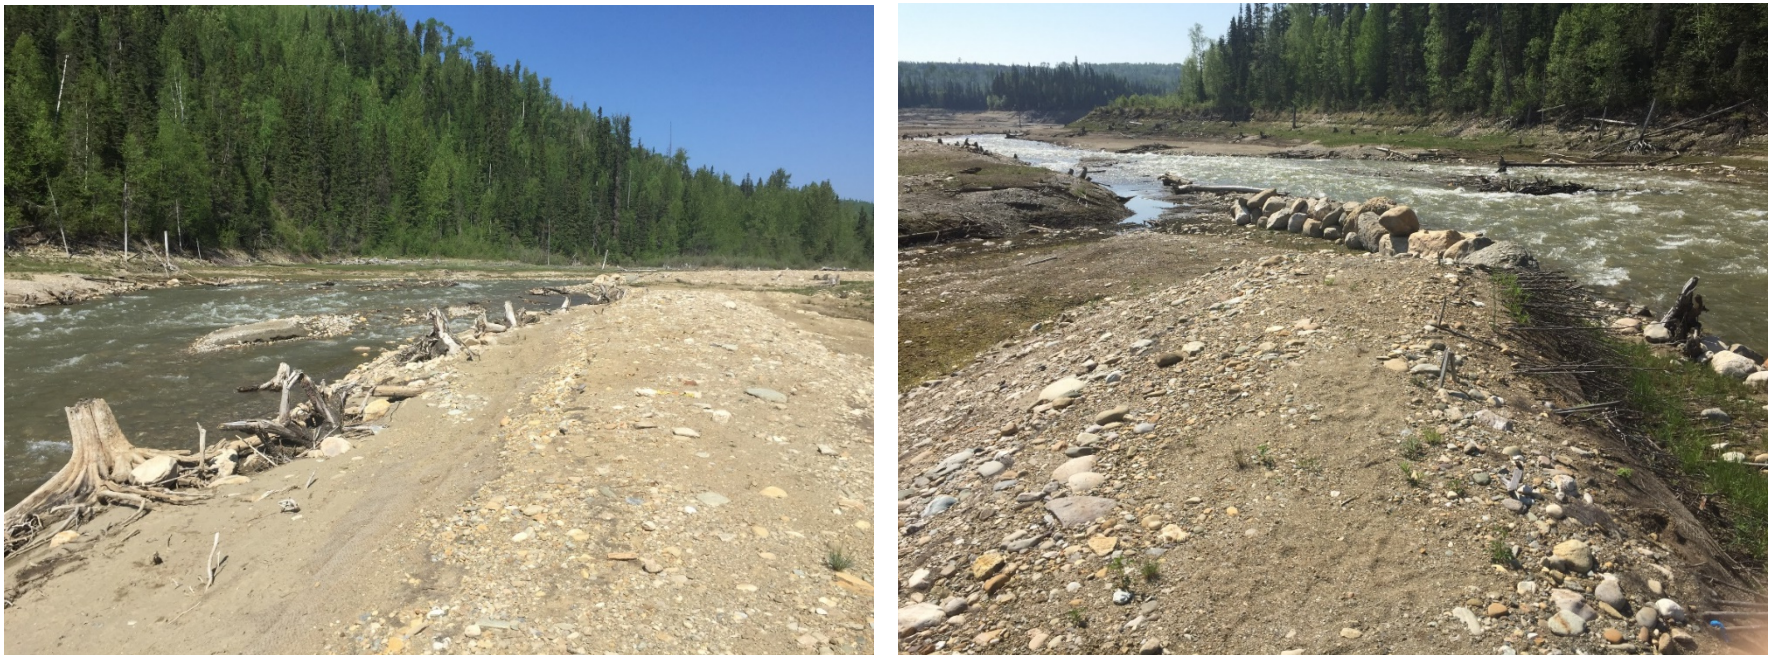
Structure	2019 Structural Integrity	Likely Deterioration Cause	2019 Ecological Function	Action Needed
Berm B: Non-vegetated geogrid soil wrap berm with embedded LWD	Berm structurally sound; embedded LWD structures present and stable; coir material was in good condition and stable	Driftwood, ice movement, rising and falling reservoir	Berm D maintained a single channel; embedded LWD stabilized the berm toe	Inspection in 2020
Berm C: vegetated geogrid soil wrap berm with embedded LWD, willow stake plantings and rock spur	Berm structurally sound; embedded LWD structures present and stable; willow live stakes withered away but grass cover appears healthy; rock spur was structurally sound; coir material in good condition and stable; tie-in to beaver pond was stable	Driftwood, ice movement, rising and falling reservoir	Berm C and the rock spur maintained a single channel; embedded LWD stabilized the berm toe; no larger plants for shading established	2019 inspection, possible re-planting of willow stakes in 2020

Figure 10 From left to right: Berm B with embedded LWD; Berm C with embedded stakes and rock spur; (Six Mile Creek, May 28, 2019).

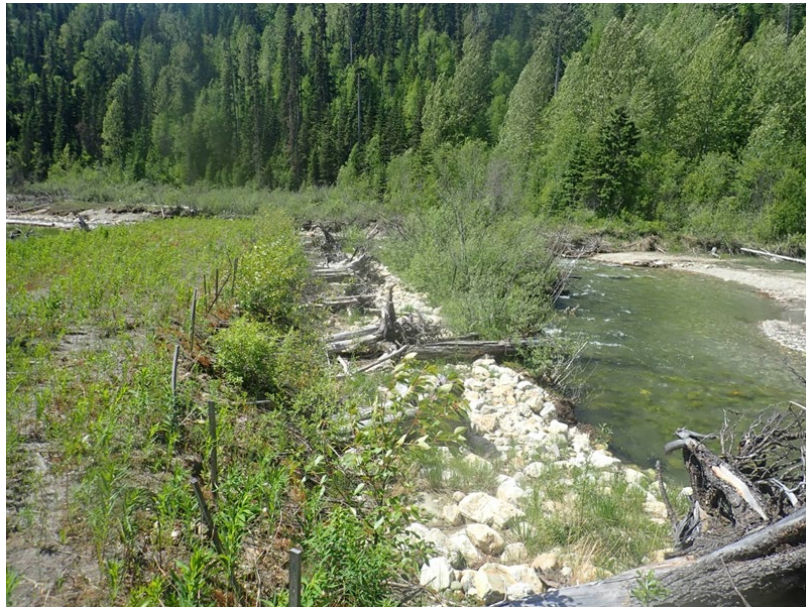
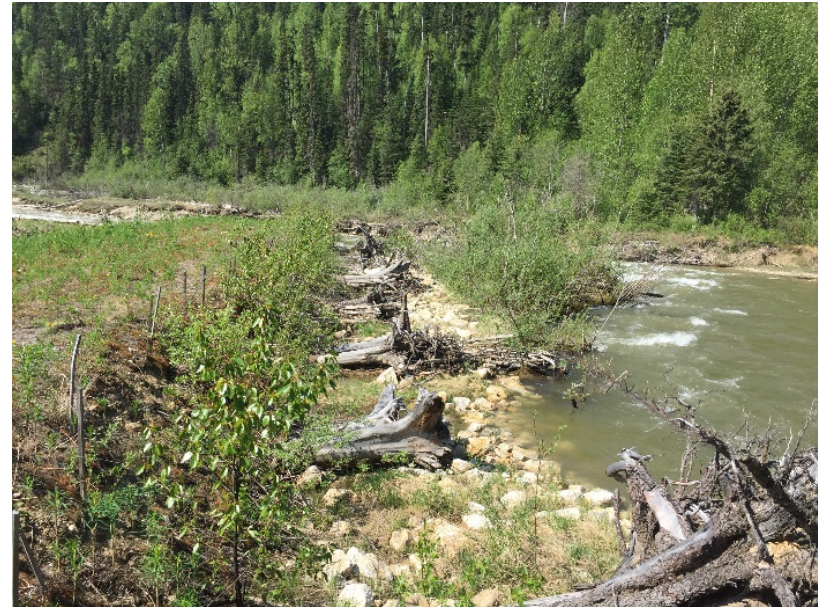
Structure	2019 Structural Integrity	Likely Deterioration Cause	2019 Ecological Function	Action Needed
Berm J: vegetated geogrid soil wrap berm with embedded LWD and stakes with willow stake plantings	Berm structurally sound; embedded LWD present and stable; embedded stakes sprouted; planted willow shoots and other vegetation growing well; coir material in good condition and deteriorating as planned	None observed	Berm J maintained a single channel; embedded LWD stabilized the berm toe; embedded stakes were sprouting and providing shade and cover; willow stakes on berm were growing well and provided shade	Inspection in 2020
Current velocities, water depths, discharge were not measured on May 28, 2019 due to unsafe conditions	Based on visual assessment, current velocities and water depths in Six Mile Creek throughout the works in the DDZ were suitable for fish migration with a minimum thalweg depth of 0.5 m and velocity breaks behind cobbles and boulders	None observed	Facilitated fish migration	Inspection in 2020

Figure 11 From left to right: Berm J with embedded LWD on June 13, 2018 (left picture) and on May 28, 2019 (right picture).
