Peace Project Water Use Plan

WILLISTON TRIAL TRIBUTARIES

PEACE PROJECT WATER USE PLAN

Final Report Year 8 (2018)

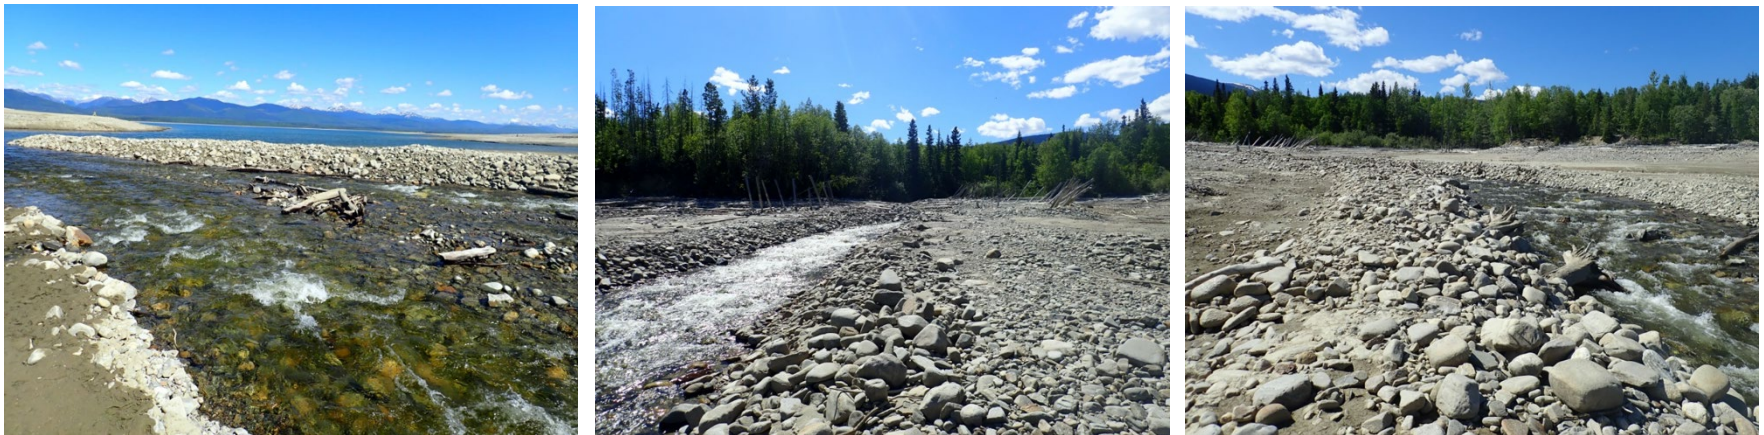
Structure	2018 Structural Integrity	Likely Deterioration Cause	2018 Ecological Function	Action Needed
Berm D: Low gravel-cobble berm	Berm structurally sound; we observed a small amount of cobble erosion on berm crest	Driftwood, ice movement, rising and falling reservoir	Berm D maintained a single channel	Inspection in 2019 to see whether erosion progressed
Berm B: Low gravel-cobble berm; embedded LWD	Berm structurally sound; embedded LWD structures were present and stable	None observed	Berm B maintained a single channel; embedded LWD stabilized berm toe but created little scour, cover or shading because they were elevated above the creek	2019 inspection; detailed elevational survey
Berm C: Low gravel-cobble berm, embedded LWD; WDC	Berm structurally sound; embedded LWD structures present and stable; woody debris catchers were intact; a small amount of erosion and cobble movement on the crest of the downstream berm portion	Driftwood, ice movement, rising and falling reservoir	Berm C maintained a single channel; embedded LWD stabilized berm toe but created little scour, cover or shading because it was elevated above the creek; WDC intact and functional; small amount of driftwood inside WDC did not interfere with works yet	Inspection in 2019 to monitor erosion; possible manual removal of driftwood inside of WDC

Figure 6 From left to right, Berm D, Berm B and Berm C with embedded LWD (Ole Creek, June 12, 2018).

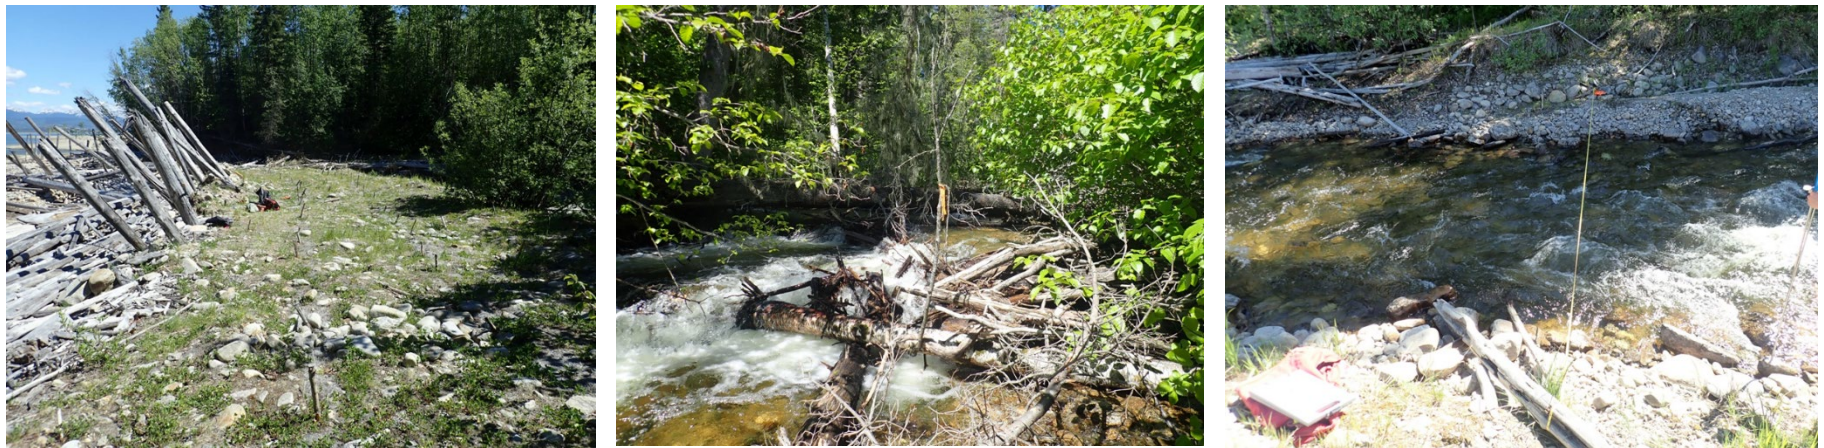
Structure	2018 Structural Integrity	Likely Deterioration Cause	2018 Ecological Function	Action Needed
Berm A: Low gravel-cobble berm; WDC; embedded LWD; planted willow stakes	Berm structurally sound; small amount of cobble erosion at base of upright WDC logs; small amount of driftwood inside of WDC; embedded LWD present and stable; all but 2 willow plantings failed; natural vegetation (mainly grass) was starting to establish	Driftwood, ice movement, rising and falling reservoir	Berm A maintained a single channel; embedded LWD stabilized berm toe but created little scour, cover or shading because it was elevated above the creek; WDC intact and functional; small amount of driftwood inside WDC did not interfere with works yet	Inspection in 2019 to monitor erosion; possible manual removal of driftwood inside of WDC
Log Jam at Long.: 124°31'48.53"W; Lat.: 56°27'15.54"N;	Previously (2016) reported log jam still present but did not create backwatering or an obstacle to fish migration	Logs deposited from upstream at high discharges	Did neither hold water back nor posed obstacle to fish migration	Inspection in 2019 to assess backwatering and passability

Current velocities, water depths, discharge (14.6 m ³ /s) at 56°27'14.00"N; 124°31'43.73"W	Based on visual assessment, Ole Creek current velocities and water depths through the DDZ were suitable for fish migration with a minimum thalweg depth of 0.5 m and velocity breaks behind cobbles and boulders.	None observed	Facilitated fish migration	Inspection in 2019

Figure 7 From left to right: Berm A with WDC and natural revegetation; log jam; discharge measurement site (Ole Creek, June 12, 2018).

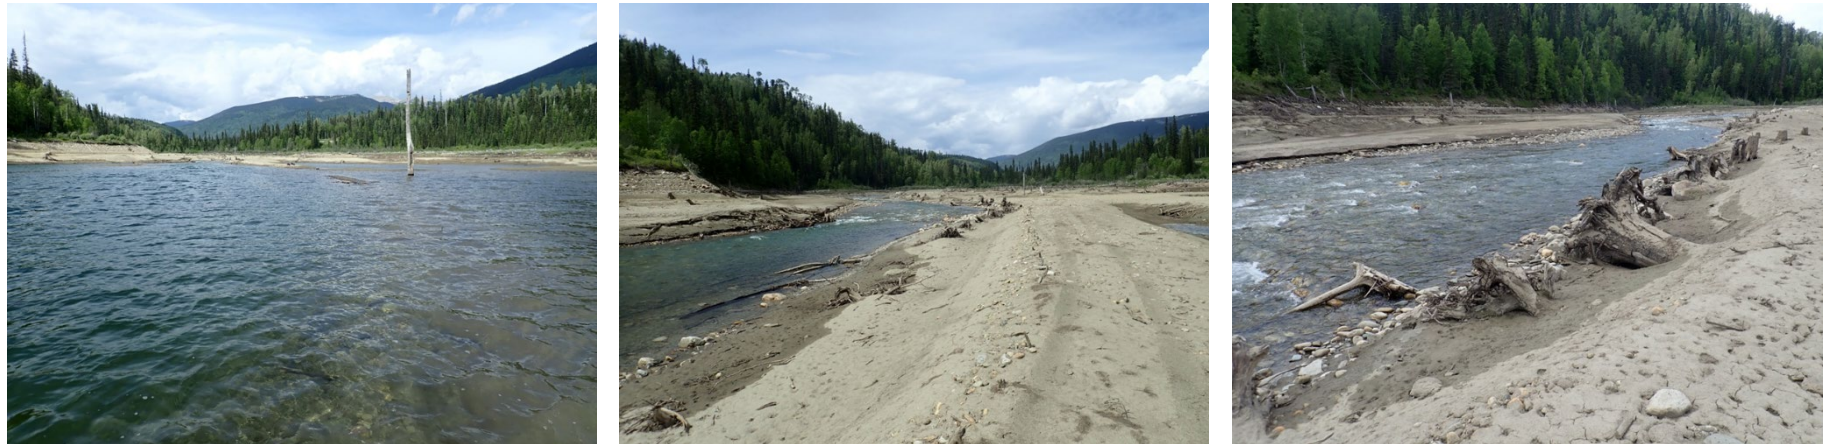
Structure	2018 Structural Integrity	Likely Deterioration Cause	2018 Ecological Function	Action Needed
Berm A: Large buried bulk bag berm with embedded LWD	The submerged berm appeared structurally sound but mild continuous erosion along all of the berm crest (which needs to be confirmed through a detailed elevational survey) was observed	Driftwood, ice movement, rising and falling reservoir	Berm A appears to be still functioning in maintaining a single channel	Detailed elevational survey below reservoir elevation of 663 m to check for berm crest erosion
Berm G: A buried bulk bag berm with embedded LWD	Berm structurally sound; embedded LWD structures present and stable; coir material used in soil wraps was in good condition and stable	Driftwood, ice movement, rising and falling reservoir	Berm D maintains a single channel; embedded LWD stabilized the berm toe	Inspection in 2019
Berm F: Non-vegetated geogrid soil wrap berm with embedded LWD	Berm structurally sound; embedded LWD structures present and stable; coir material used in soil wraps was in good condition and stable	Driftwood, ice movement, rising and falling reservoir	Berm F maintains a single channel; embedded LWD stabilized the berm toe and used to create scour (2016) but scouring function was lost	2019 inspection; detailed elevational survey (to monitor potential accumulations of fines or erosion on berm crest)

Figure 9 From left to right: Submerged Berm A; Berm F with embedded LWD; Berm G with embedded LWD (Six Mile Creek, June 13, 2018).

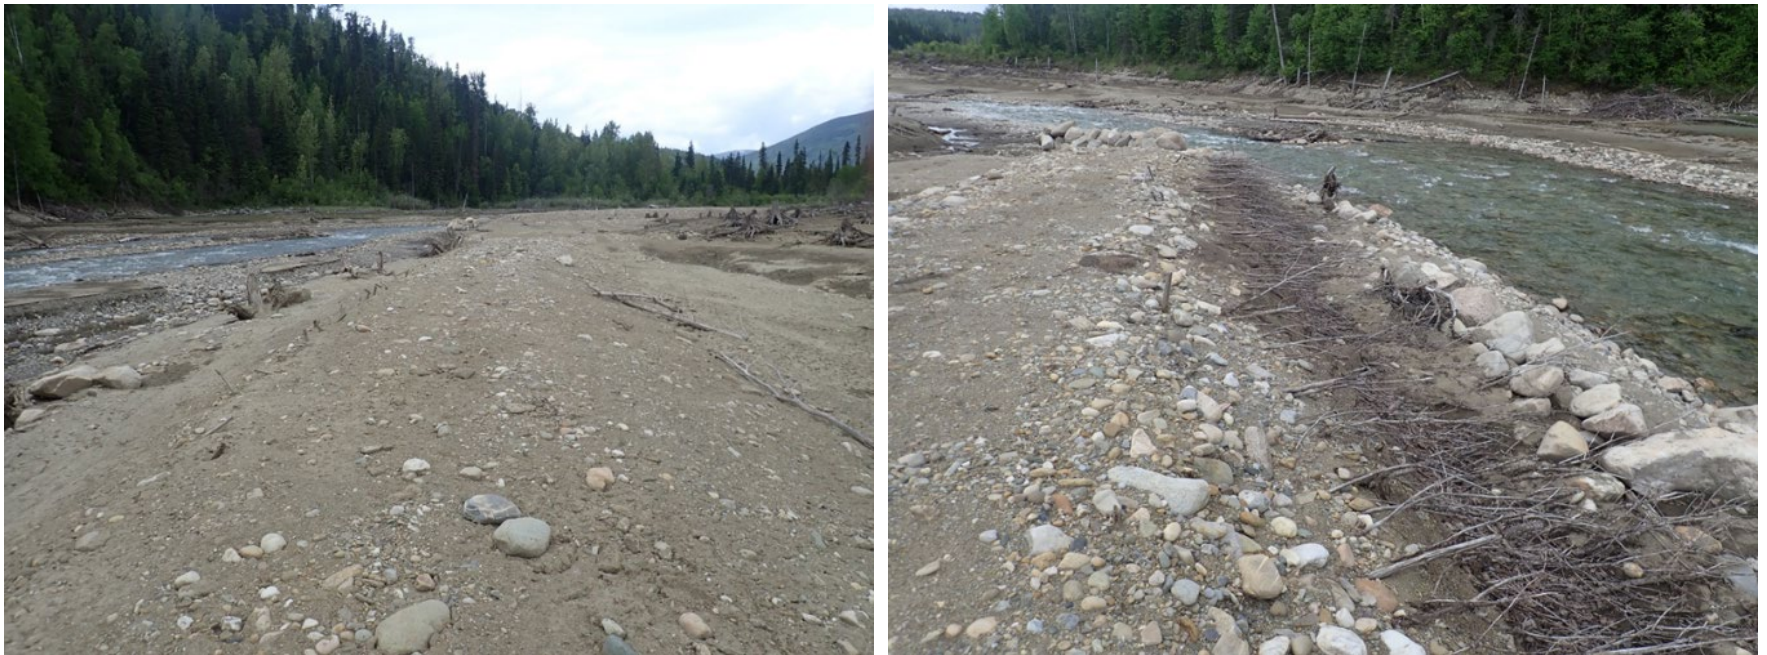
Structure	2018 Structural Integrity	Likely Deterioration Cause	2018 Ecological Function	Action Needed
Berm B: Non-vegetated geogrid soil wrap berm with embedded LWD	Berm structurally sound; embedded LWD structures present and stable; coir material was in good condition and stable	Driftwood, ice movement, rising and falling reservoir	Berm D maintained a single channel; embedded LWD stabilized the berm toe	Inspection in 2019
Berm C: vegetated geogrid soil wrap berm with embedded LWD, willow stake plantings and rock spur	Berm structurally sound; embedded LWD structures present and stable; willow live stakes withered away but grass cover appears healthy; rock spur was structurally sound; coir material in good condition and stable; tie-in to beaver pond was stable	Driftwood, ice movement, rising and falling reservoir	Berm C and the rock spur maintained a single channel; embedded LWD stabilized the berm toe; no larger plants for shading established	2019 inspection, possible re-planting of willow stakes in 2019

Figure 10 From left to right: Berm B with embedded LWD; Berm C with embedded stakes and rock spur; (Six Mile Creek, June 13, 2018).

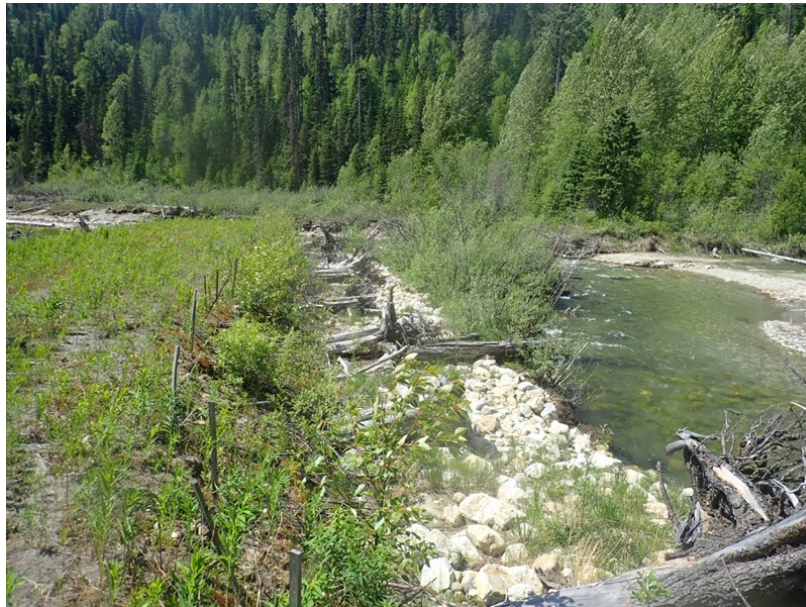
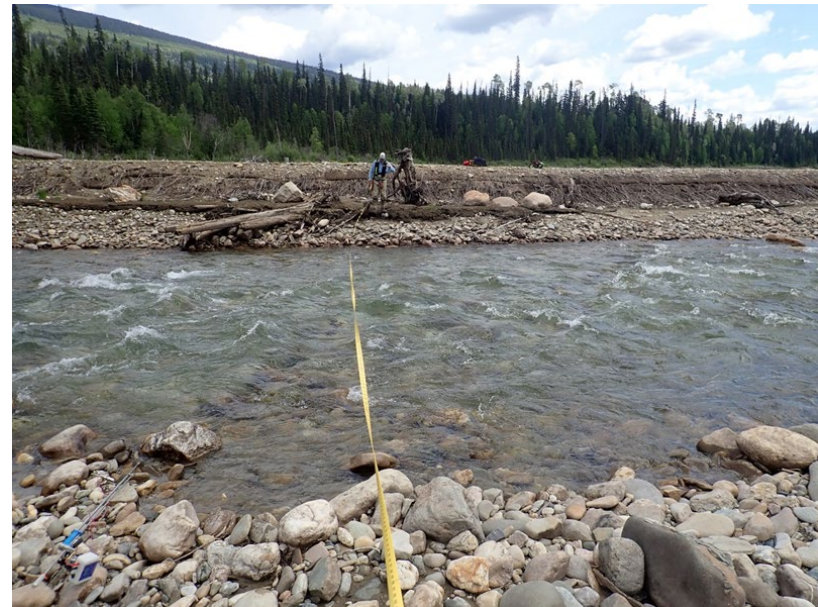
Structure	2018 Structural Integrity	Likely Deterioration Cause	2018 Ecological Function	Action Needed
Berm J: vegetated geogrid soil wrap berm with embedded LWD and stakes with willow stake plantings	Berm structurally sound; embedded LWD present and stable; embedded stakes sprouted; planted willow shoots and other vegetation growing well; coir material in good condition and deteriorating as planned	None observed	Berm J maintained a single channel; embedded LWD stabilized the berm toe; embedded stakes were sprouting and providing shade and cover; willow stakes on berm were growing well and provided shade	Inspection in 2019
Current velocities, water depths, discharge (35.6 m ³ /s) at Lat: 55°36'32.95"N; Long: 123°24'7.76"W	Based on visual assessment, current velocities and water depths in Six Mile Creek throughout the works in the DDZ were suitable for fish migration with a minimum thalweg depth of 0.5 m and velocity breaks behind cobbles and boulders	None observed	Facilitated fish migration	Inspection in 2019

Figure 11 From left to right: Berm J with embedded LWD, sprouting embedded stakes and sprouting willow stakes on berm crest; discharge measurement site (Six Mile Creek, June 13, 2018)
