Peace Project Water Use Plan

Williston Reservoir Trial Tributaries

2019 - Ole Creek Engineering Inspection Report

Site Inspection Report

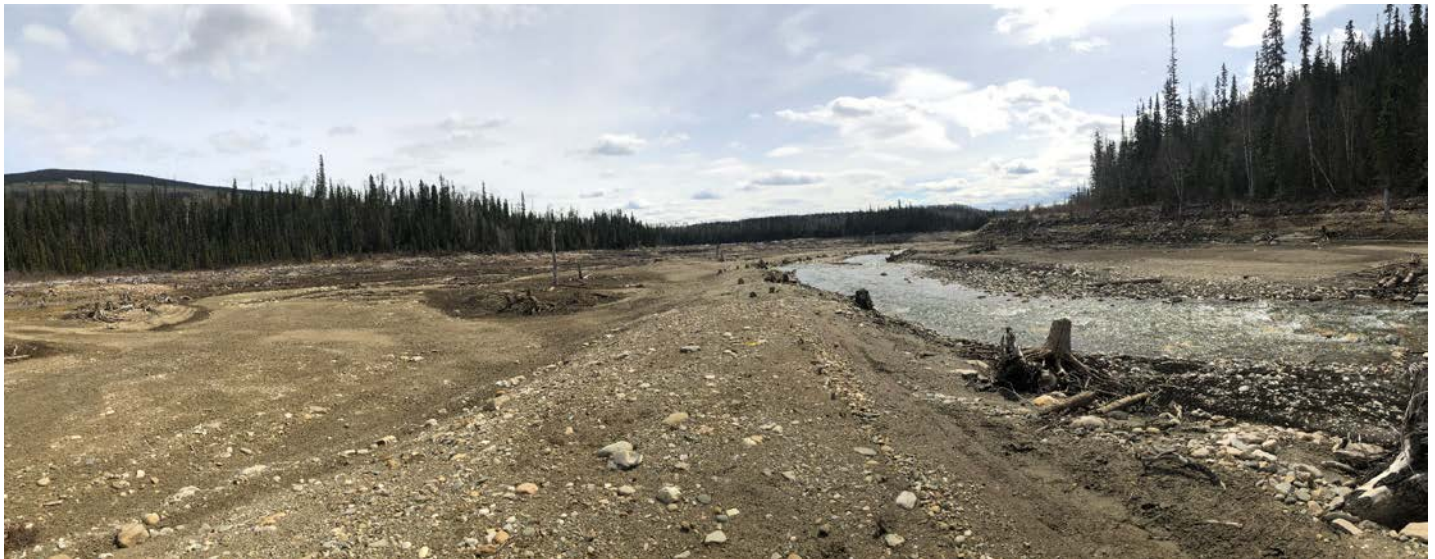
PHOTO 1 (Panoramic): Single Thread Channel Looking Downstream from Berm 'B' (repeat of 2016 Ph#1)

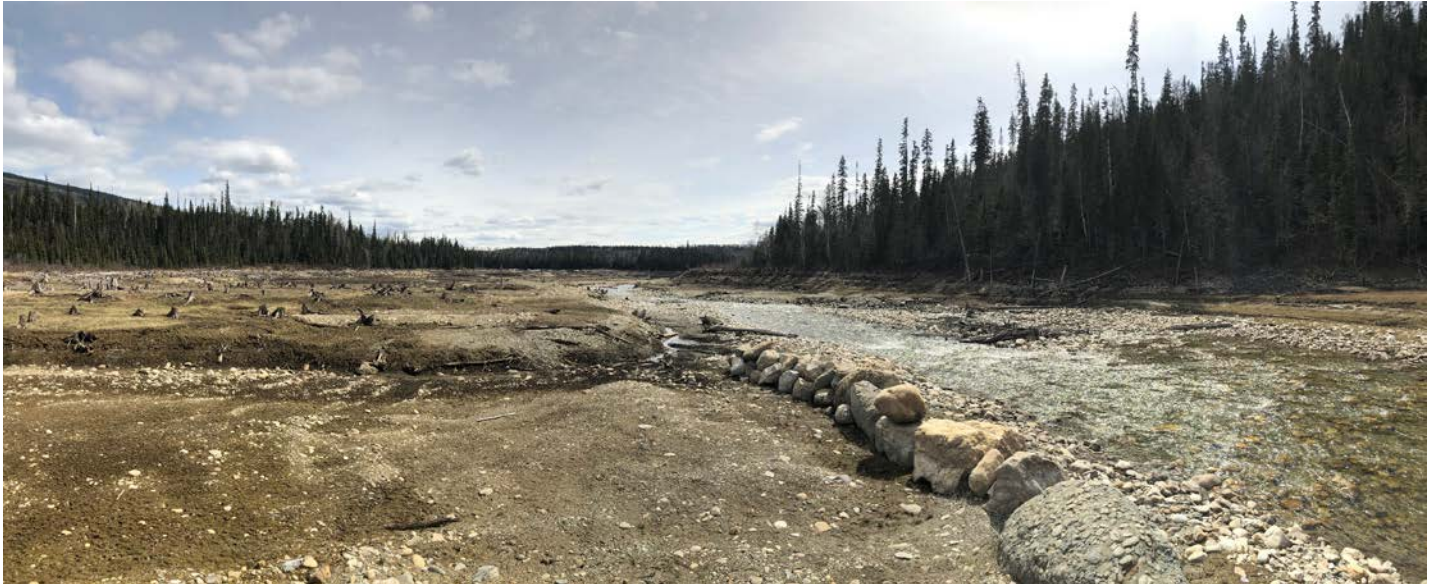
PHOTO 2 (Panoramic): Single Thread Channel Looking Downstream from Downstream End of Berm 'C'
(repeat of 2016 Ph#2)

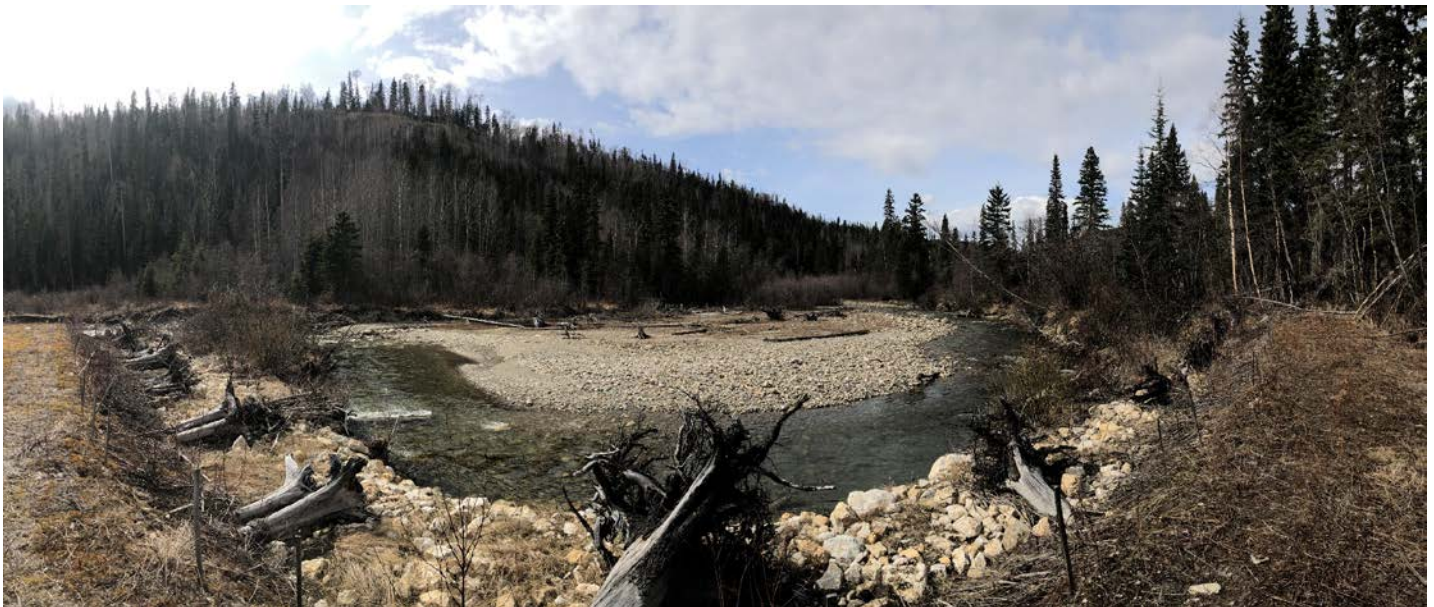
PHOTO 3 (Panoramic): Channel Along Sharp Bend Along Berm 'J' (Note Panoramic Exaggerates Bend)
(repeat of 2016 Ph#3)

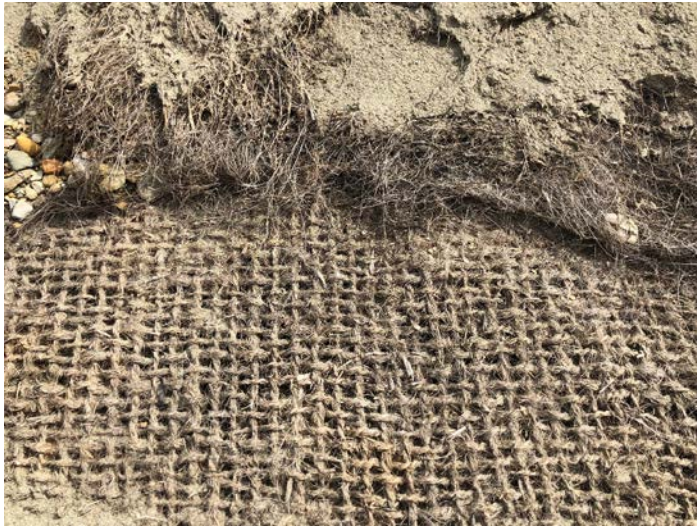
**PHOTO 4: Deteriorating ECM (above) & Coir Soil Wraps in Good Condition (below)
(repeat of 2016 Ph#4)**

- As the ECM has a relatively short lifespan and has deteriorated significantly, the berm surfaces covered by the ECM, may experience some erosion. These areas should be monitored during future annual monitoring. If significant erosion occurs, then BC Hydro could consider protecting those areas.

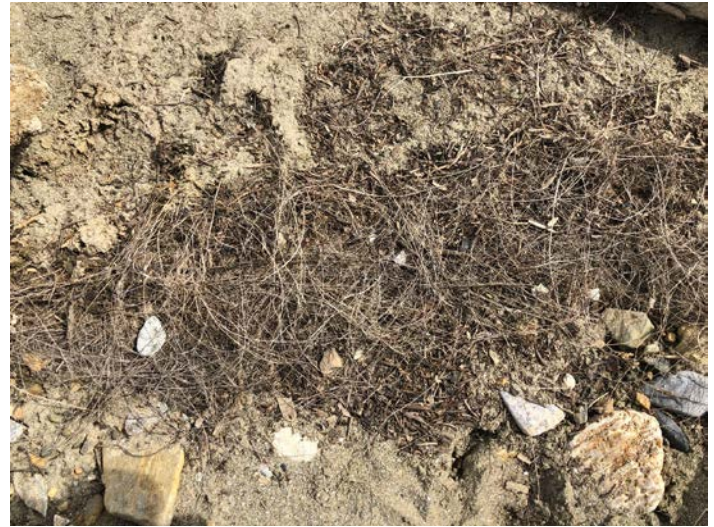
**PHOTO 5: Decomposing ECM
(repeat of 2016 Ph#5)**

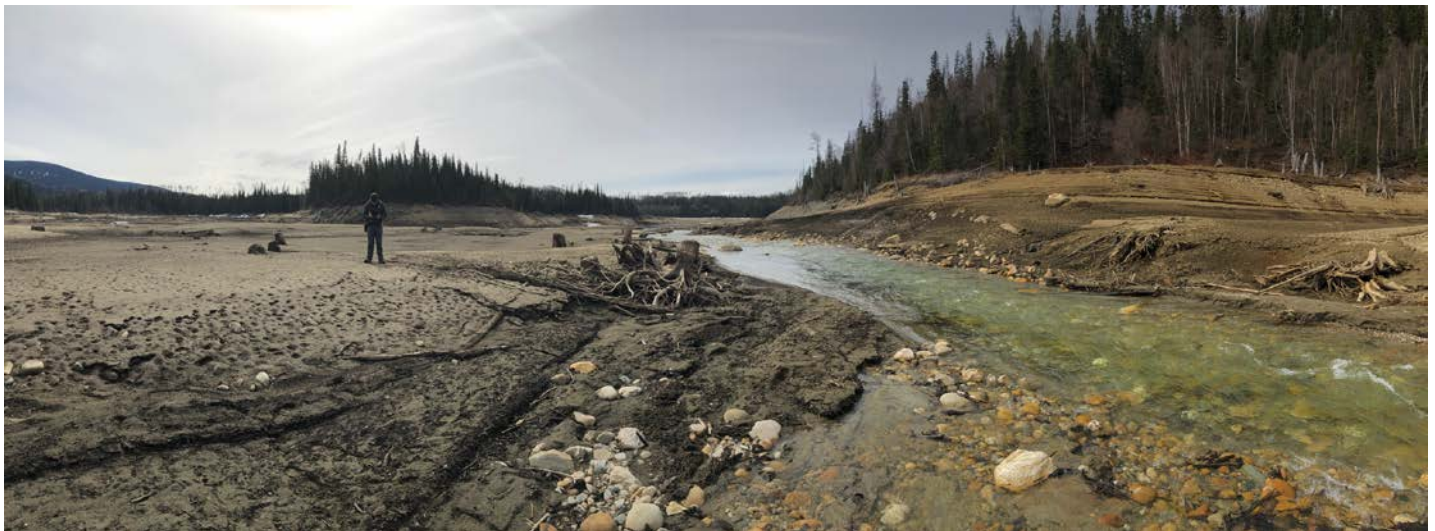
PHOTO 6 (Panoramic): Looking Downstream at Berm 'A'

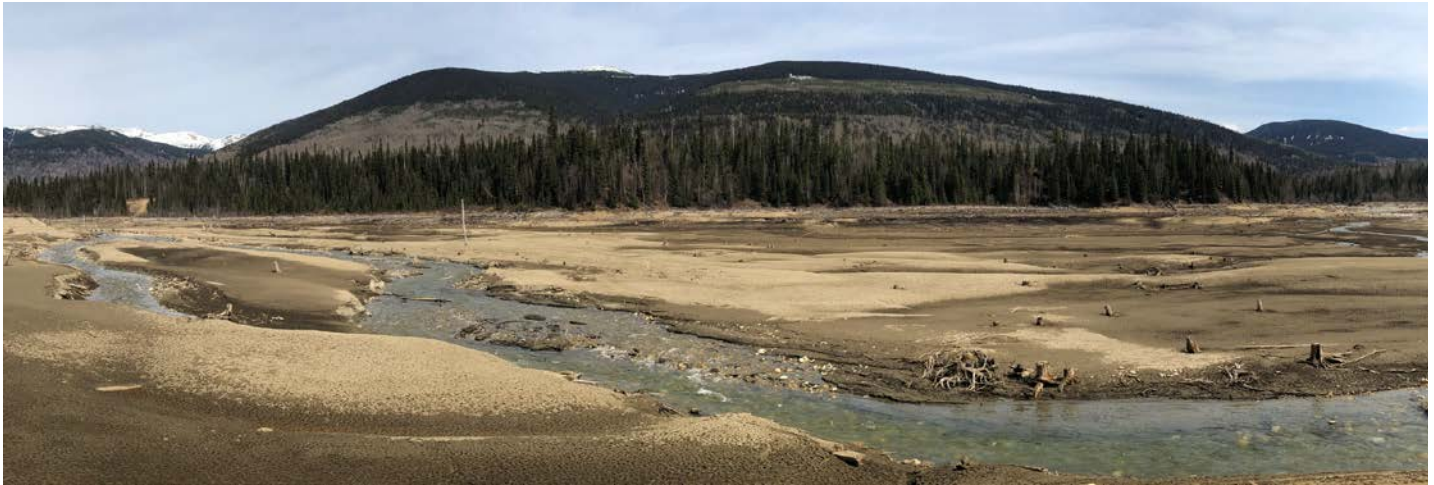
PHOTO 7 (Panoramic): Looking at Berm 'A' from Across the Creek (Right Bank)

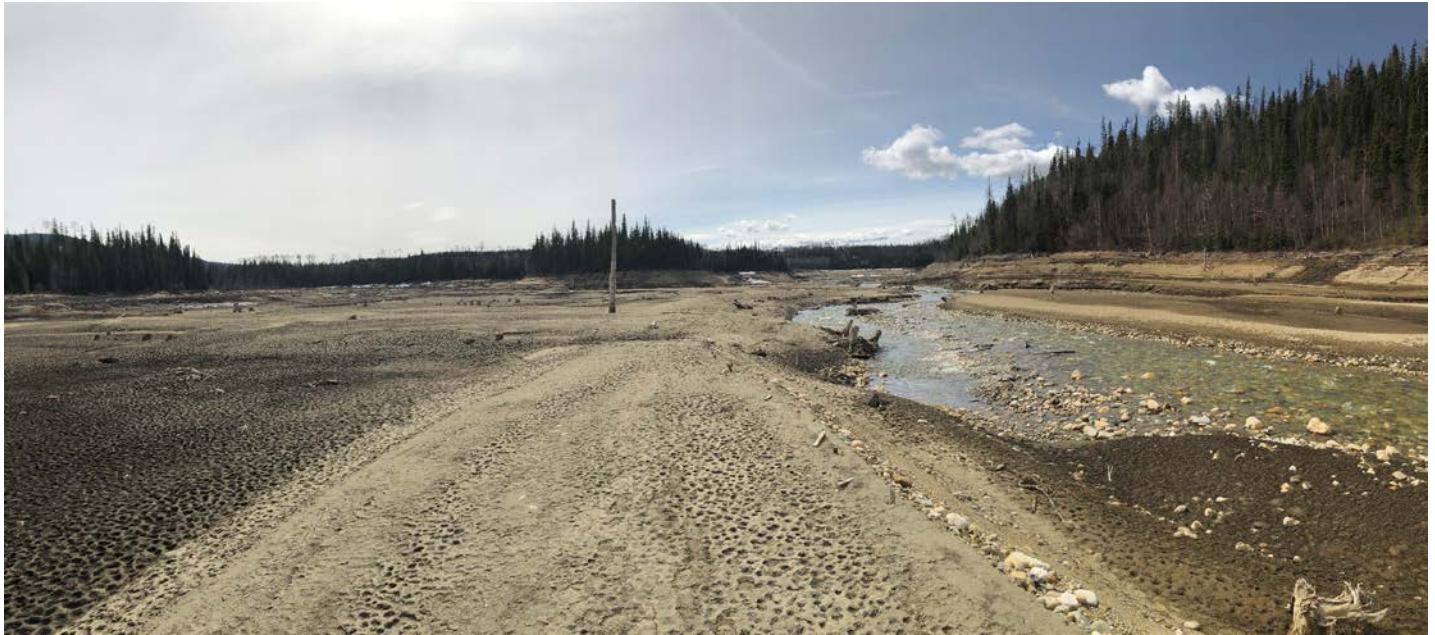
PHOTO 10: Looking Downstream at Berm 'A' and Berm 'G' (repeat of 2016 Ph#6)

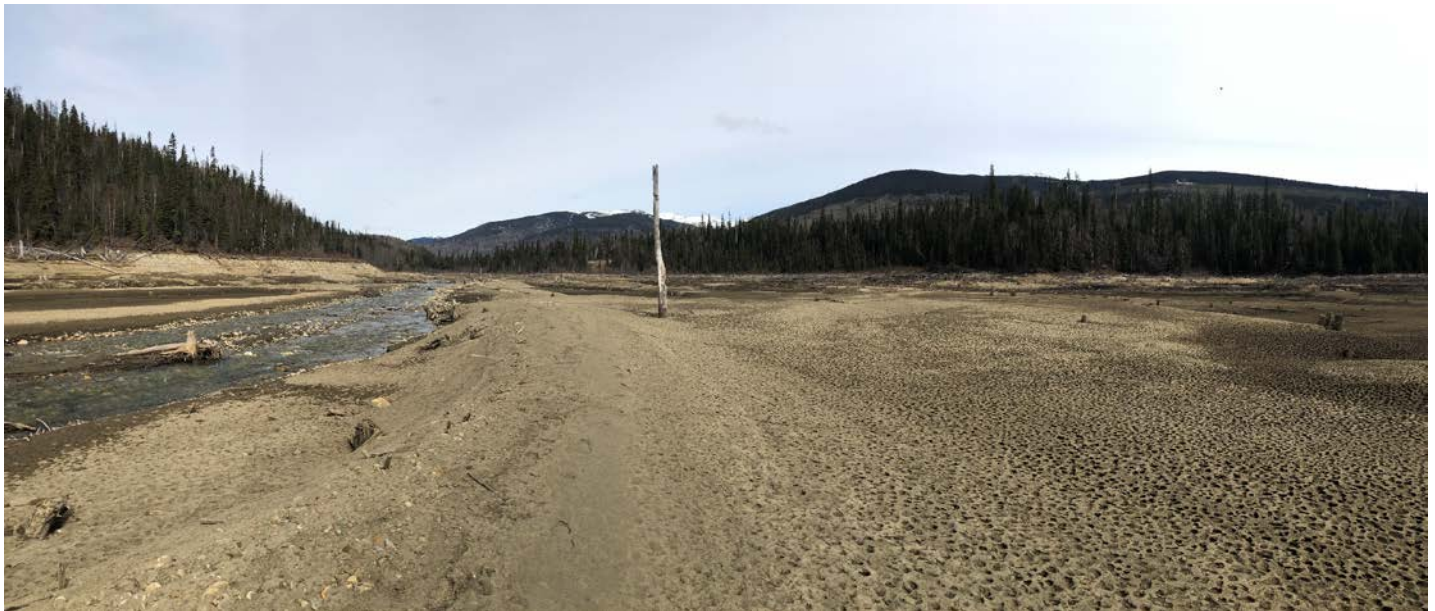
PHOTO 11 (Panoramic): Looking Upstream at Berm 'G' (repeat of 2016 Ph#7)

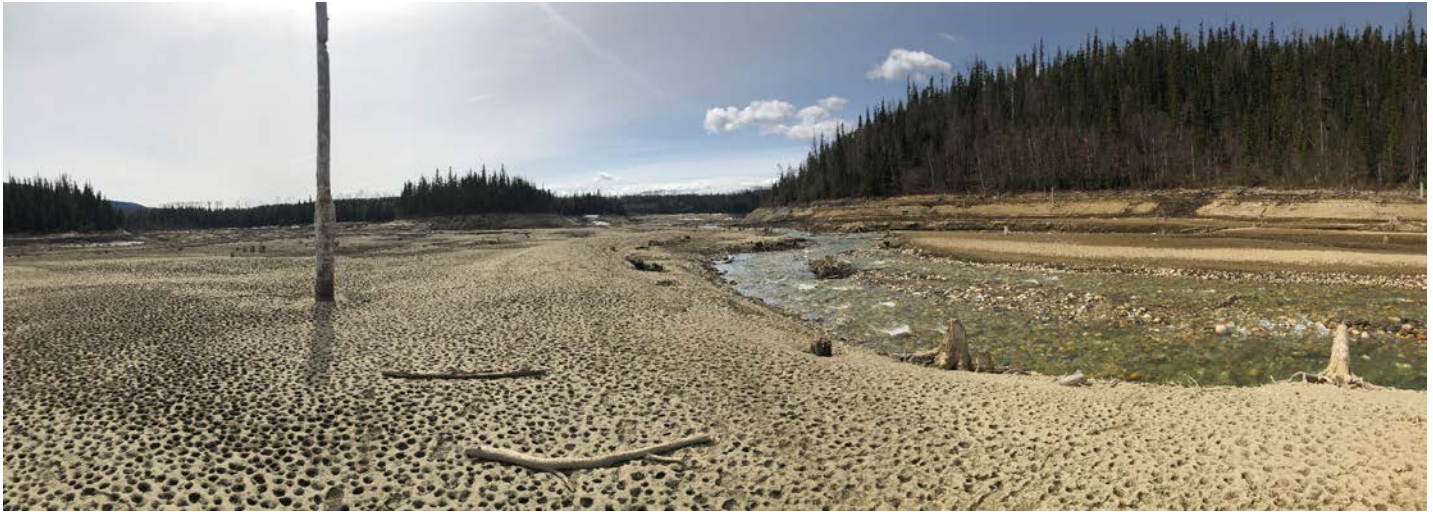
PHOTO 12 (Panoramic): Looking Downstream at Berm 'G' (repeat of 2016 Ph#8)

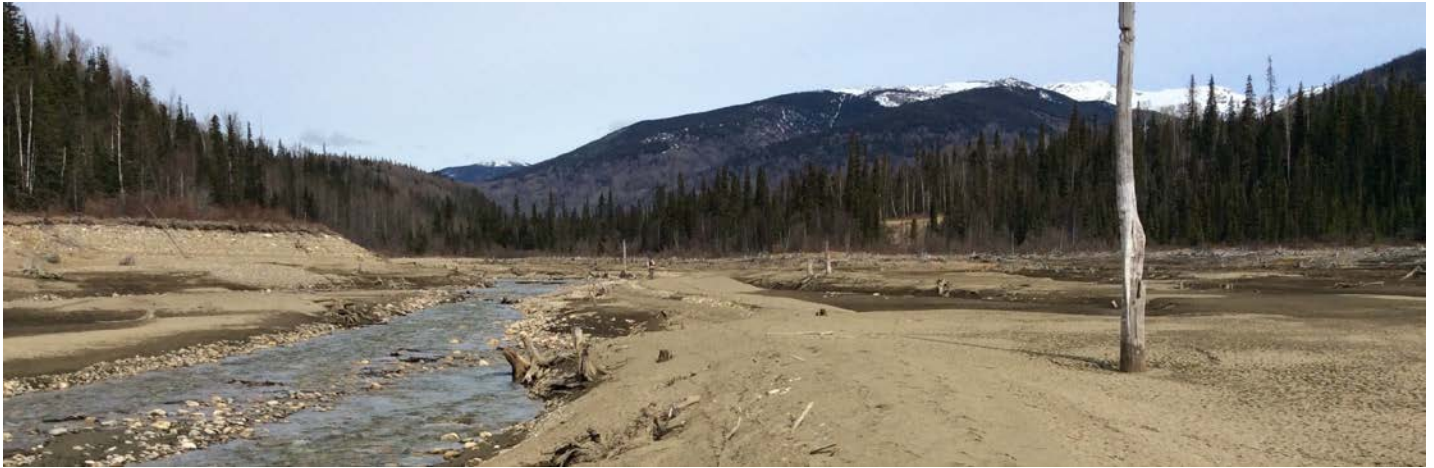
PHOTO 15 (Panoramic): Looking Upstream from Berm 'G' to Berm 'F'(repeat of 2016 Ph#11)

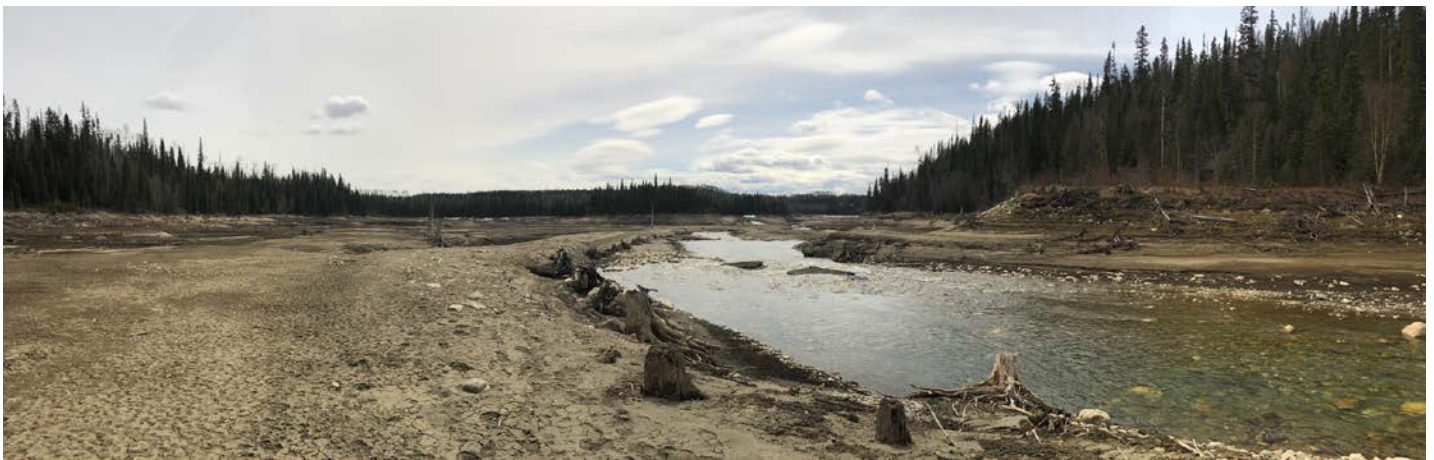
PHOTO 16 (Panoramic): Looking Downstream at Berms 'D' and 'F'

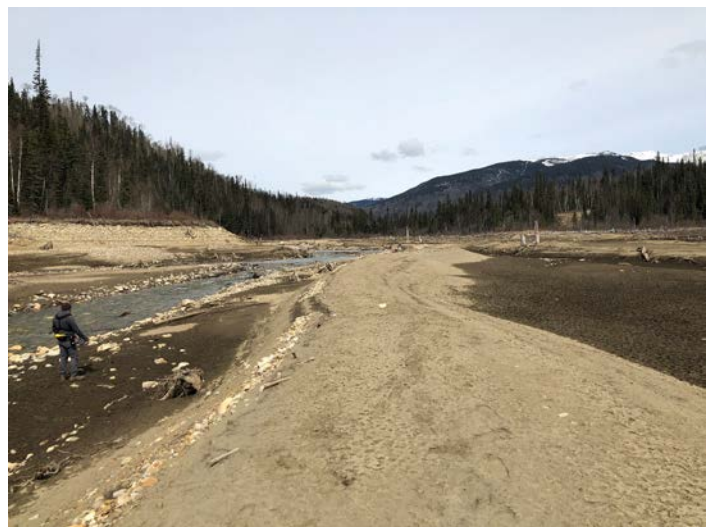
PHOTO 18: Berm 'F' Looking Upstream (Note Damaged/Decomposing ECM) (repeat of 2016 Ph#13)

- There is very little accumulation of woody debris.
- Some isolated pieces and logs observed, such as at Berm 'F' as noted in Photo 18 above.

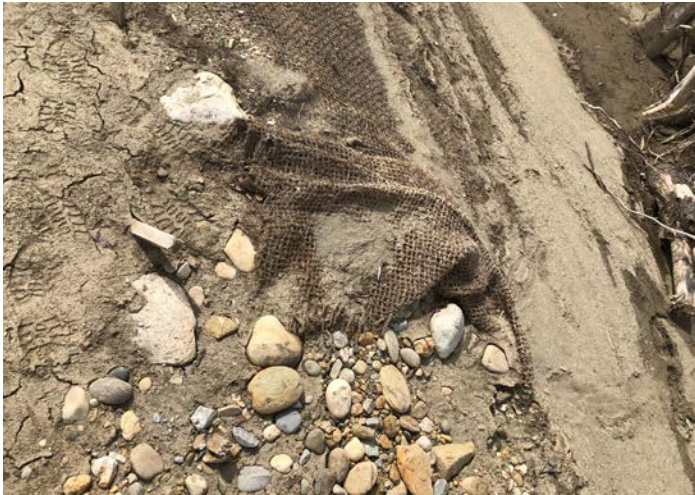
- Coir geogrid tie-in at upstream end of Berm 'F' has become exposed at the tie-in with Berm 'D'. This could result in a local failure of the coir in the future, and should be monitored. (See Photo 19).

PHOTO 19: Coir Geogrid Matting becoming loose at the tie in between berm 'F' & 'D'

- In future inspections monitor the two areas of interest for the coir geogrid matting: at the exposed tie-in location between Berms 'D' and 'F'; and at the damaged coir at the downstream end of Berm 'C'.

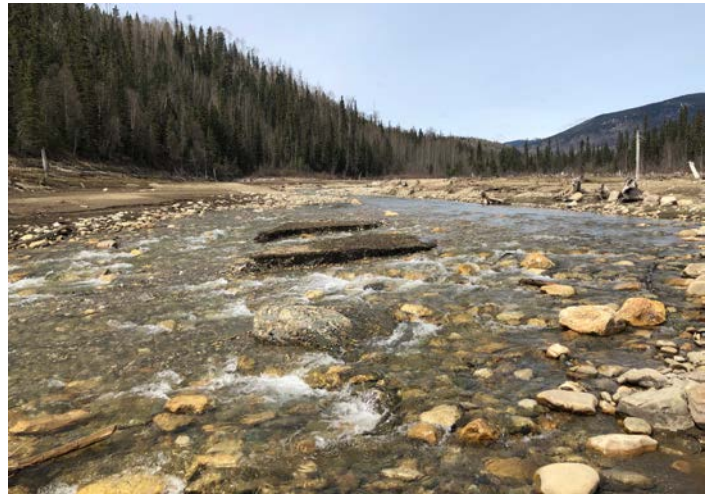
PHOTO 20: Sediment and Riffle at Approx. 0+640

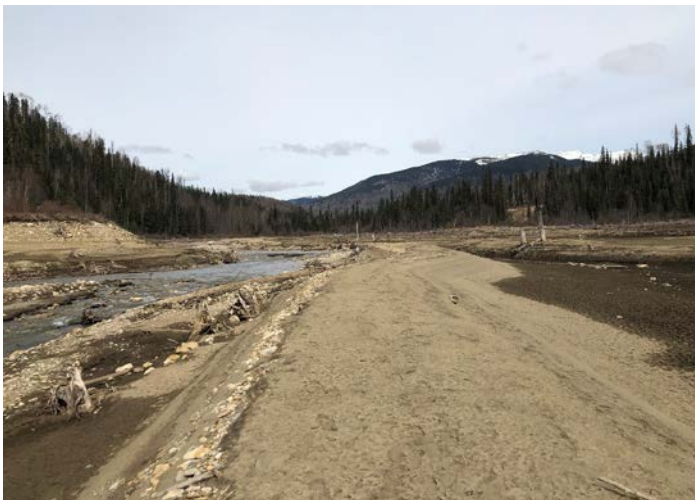
PHOTO 21: Berm 'F' Looking Upstream (Note Damaged/Decomposing ECM) (repeat of 2016 Ph#14)

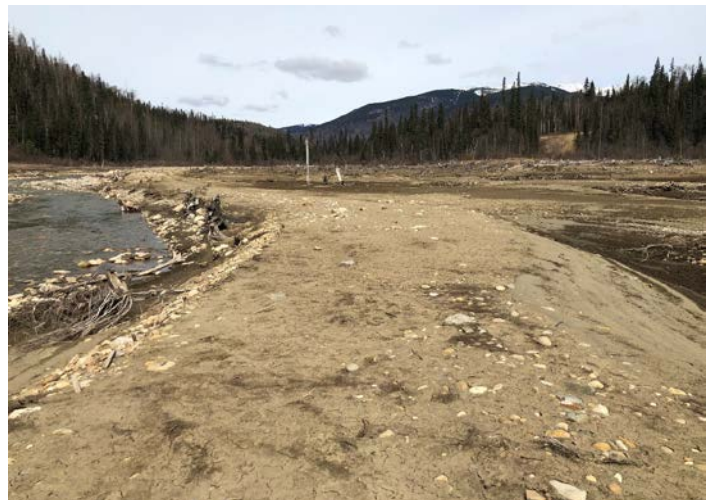
PHOTO 22: Upstream End of Berm 'F' Looking Upstream (repeat of 2016 Ph#15)

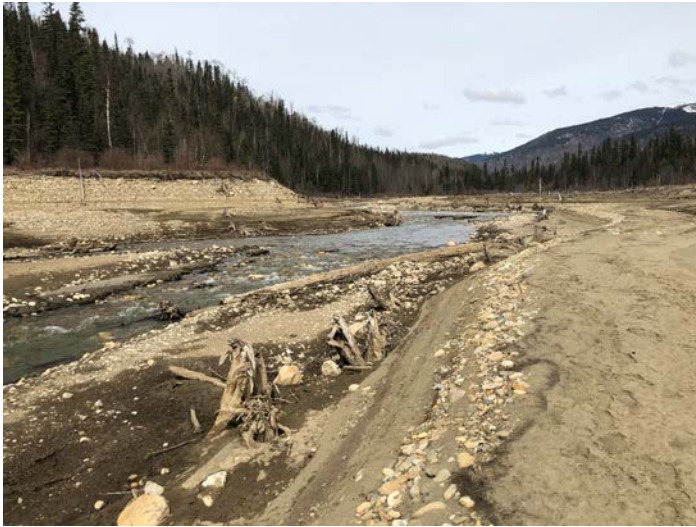
PHOTO 25: Deposited Log Along LWD and Deteriorating ECM (repeat of 2016 Ph#18)

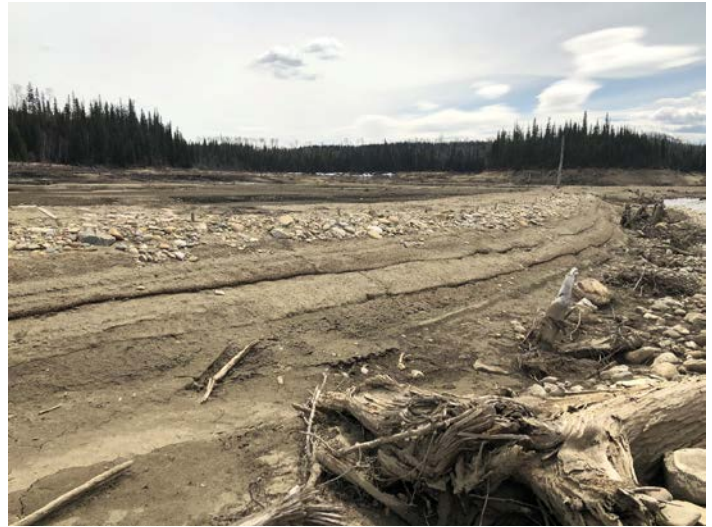
PHOTO 26: Coir Geogrid "Soil Wrap" Layers in Good Condition. Note Upper Layer is ECM (repeat of 2016 Ph#19)

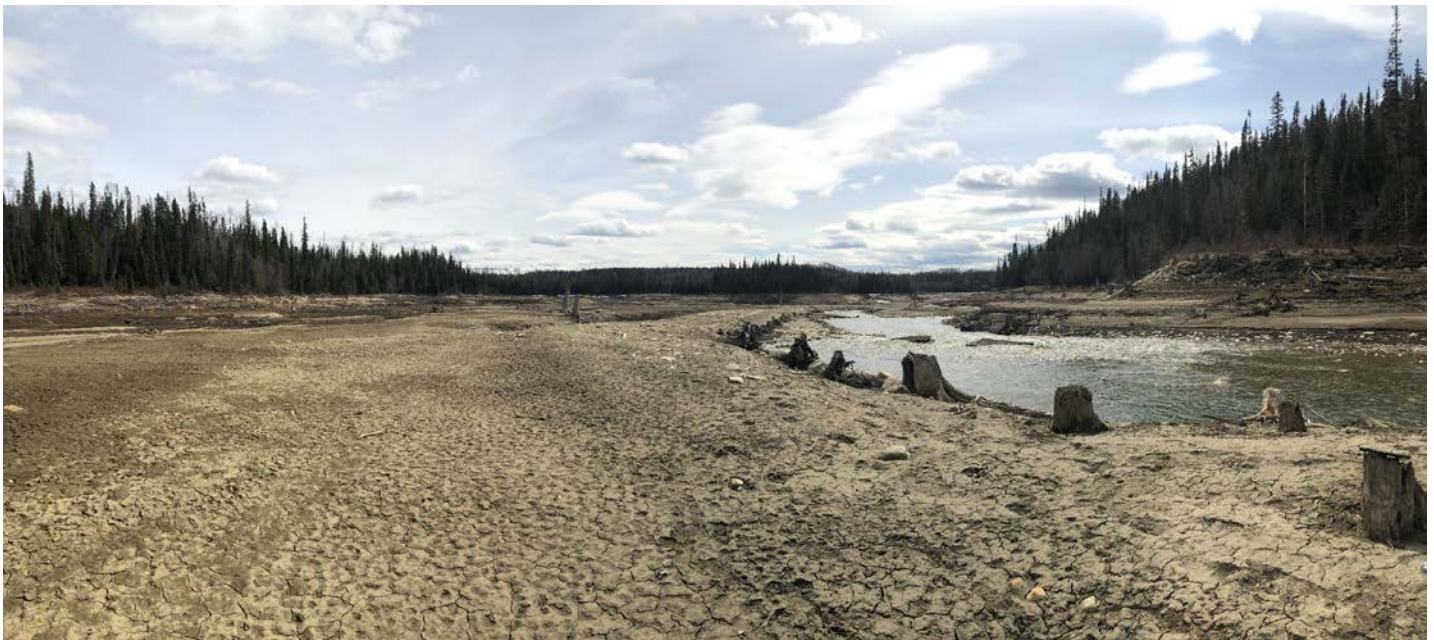
PHOTO 27 (Panoramic): Looking Downstream at Berm 'D' (repeat of 2016 Ph#20)

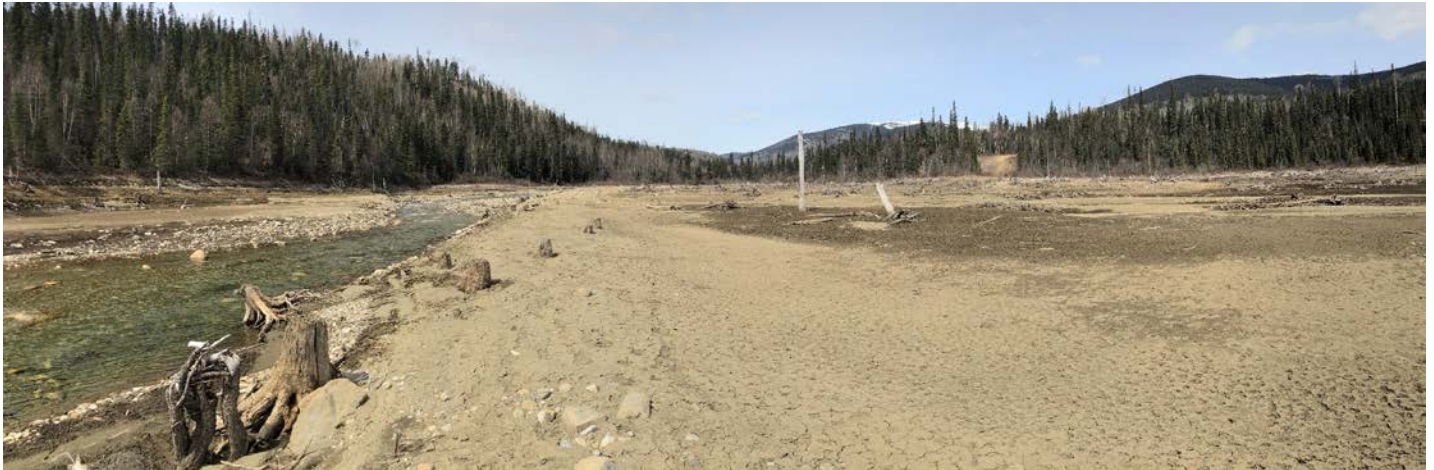
PHOTO 28 (Panoramic): Looking Upstream from Upstream End of Berm 'D' (repeat of 2016 Ph#21)

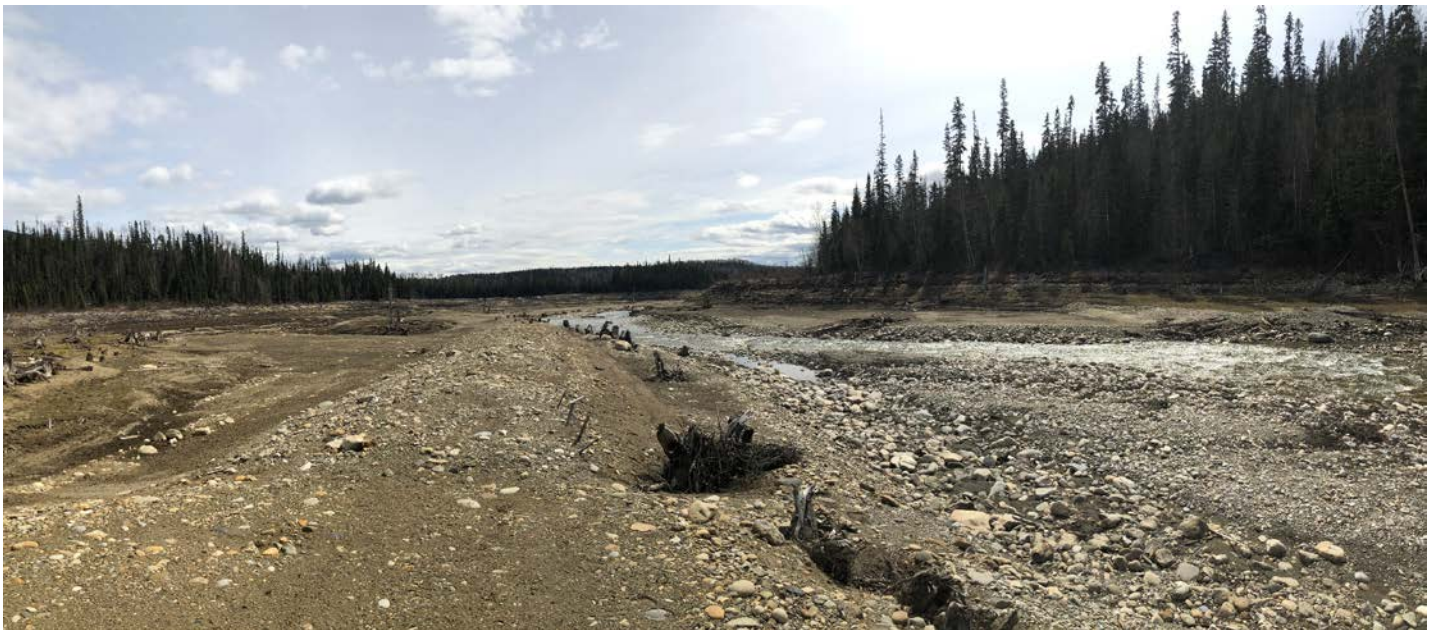
PHOTO 33 (Panoramic): Looking Downstream at Berm 'B' (repeat of 2016 Ph#26)

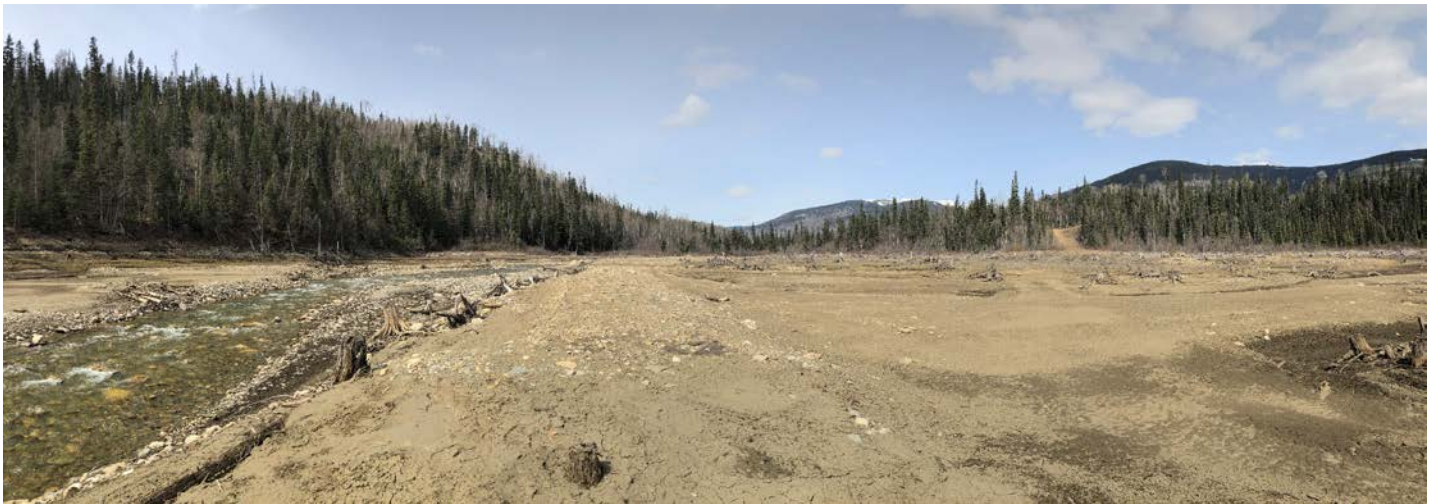
PHOTO 34 (Panoramic): Looking Upstream at Berm 'B' (repeat of 2016 Ph#27)

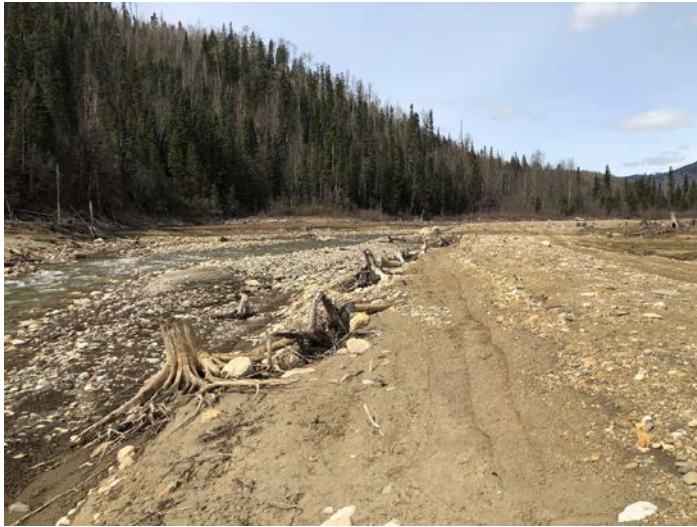
PHOTO 35: Coir Soil Wraps in Good Condition (repeat of 2016 Ph#28)

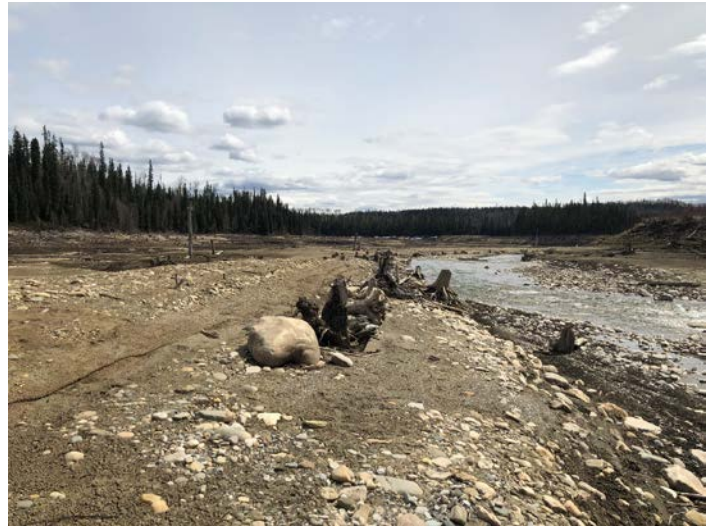
PHOTO 36: Some Channel Deposition and Erosion (repeat of 2016 Ph#29)

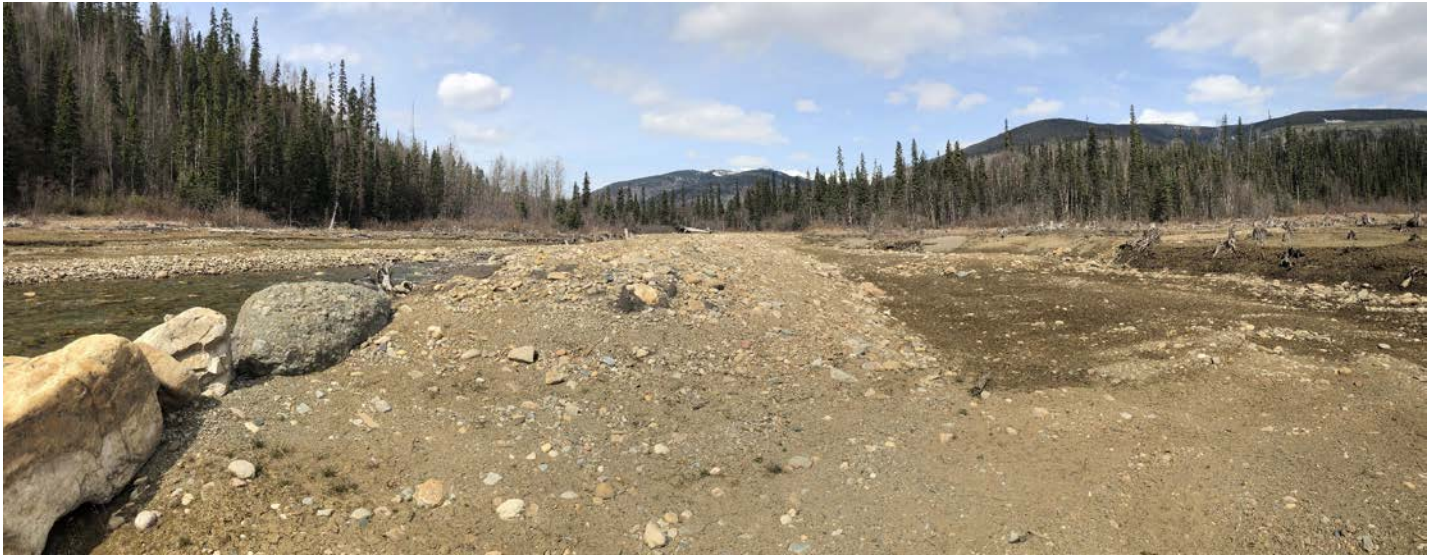
PHOTO 39 (Panoramic): Downstream end of Berm 'C' looking upstream (repeat of 2016 Ph#30)

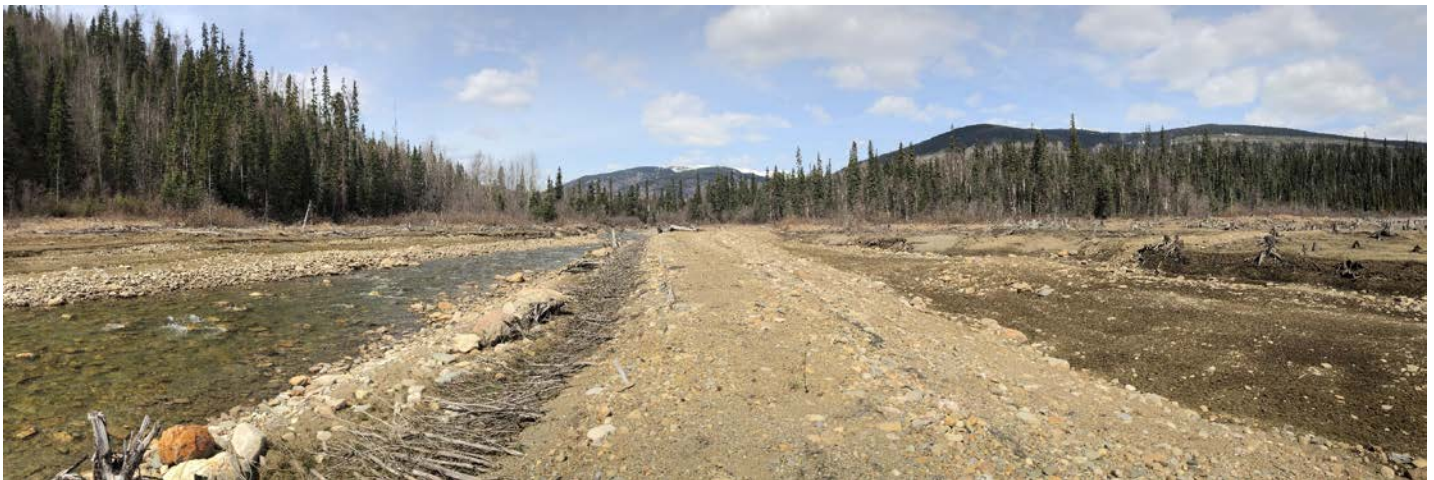
PHOTO 40 (Panoramic): Berm 'C' looking upstream from downstream end (repeat of 2016 Ph#31)

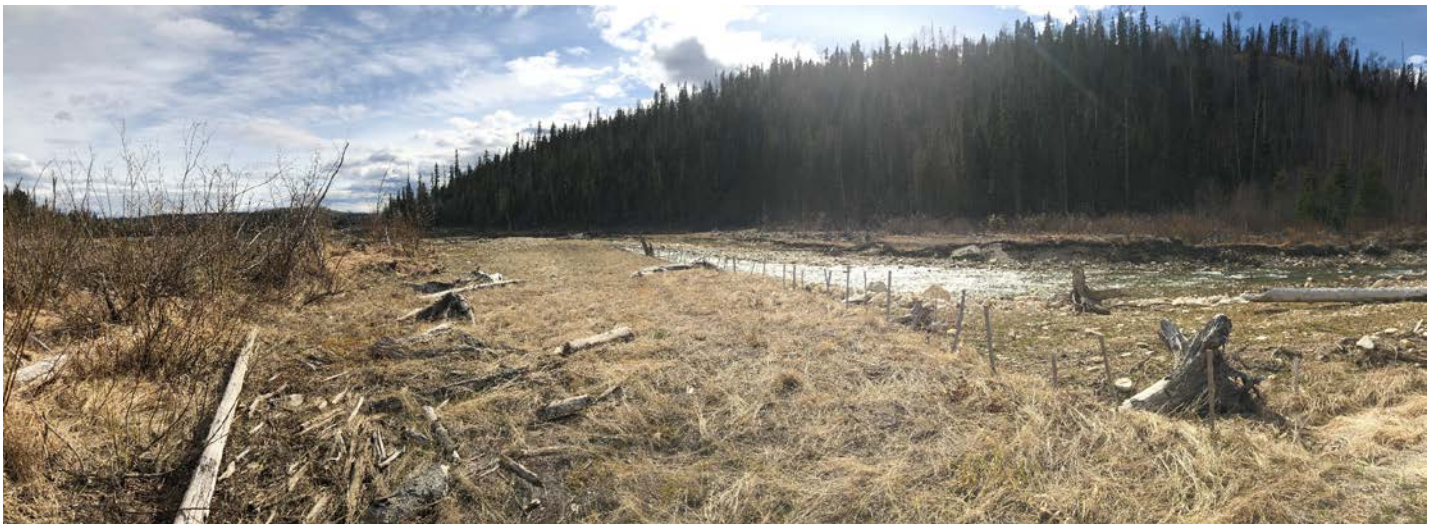
PHOTO 41 (Panoramic): Looking downstream from upstream end of Berm 'C' (repeat of 2016 Ph#32)

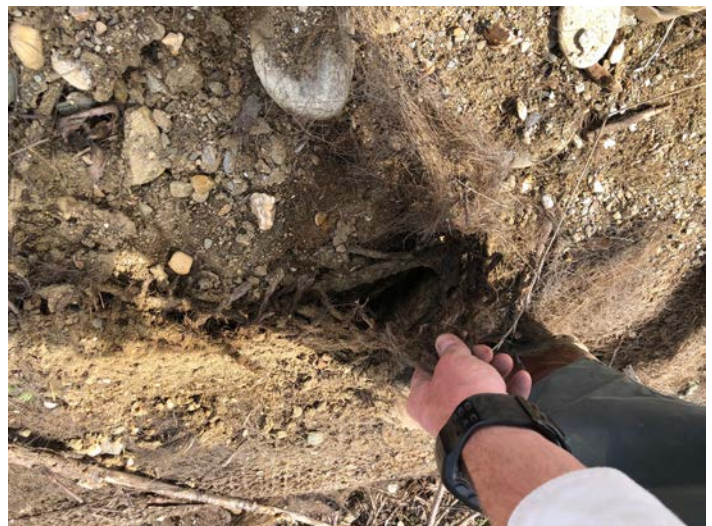
- The upstream half of the berm had good grass growth on the crest (see Photos 49 & 50).
- The coir geogrid is generally in good condition, however there is a section of damaged coir approximately 5 m long 3 to 4 m upstream from the downstream end of Berm 'C' (See Photo 46). The damage is potentially from ice, wave action, or debris. The damaged coir is considered to still be stable and it is not an issue at this time, however it should be monitored in future inspections.

PHOTO 46: Damaged coir, perhaps due to ice or waves

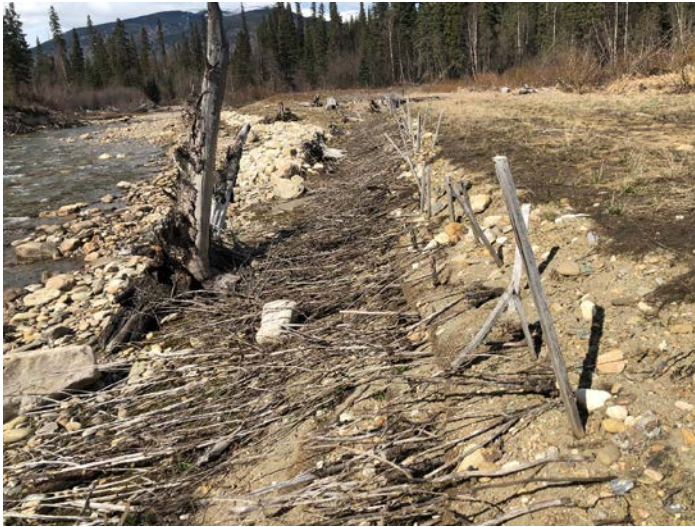
- The LWD is in good condition and has not displaced.
- Most of the willows (2014 live brush and stakes) do not appear to have survived however there are a few areas where the willow has taken (see Photo 47). It was also early in the season, so it is likely that additional growth will take hold above the reservoir this summer.

PHOTO 47: Few willow stakes took hold downstream berm area, but some growth (repeat of 2016 Ph#38)

- Consider installing additional planting on the upper berms (Berms 'C' and 'J') to further stabilize the upper works, particularly as the coir geogrid ages in the future. The potential extent and density of additional planting would best be determined in the early to midsummer, when the amount of existing planting can be better assessed.

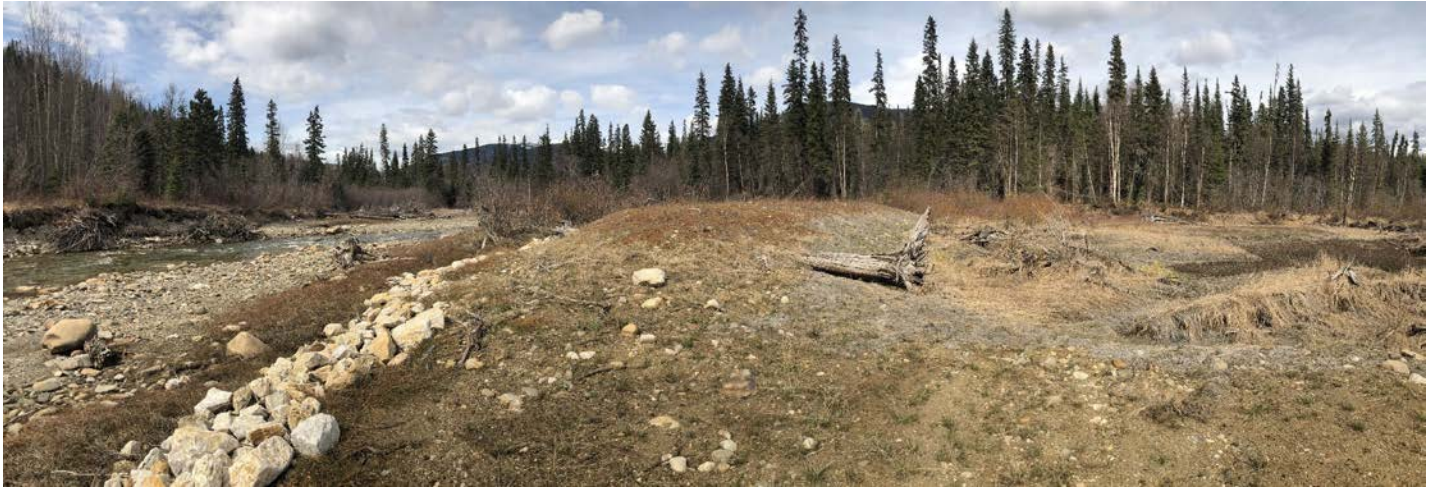
PHOTO 51 (Panoramic): Downstream end of Berm 'J' looking upstream (repeat of 2016 Ph#42)

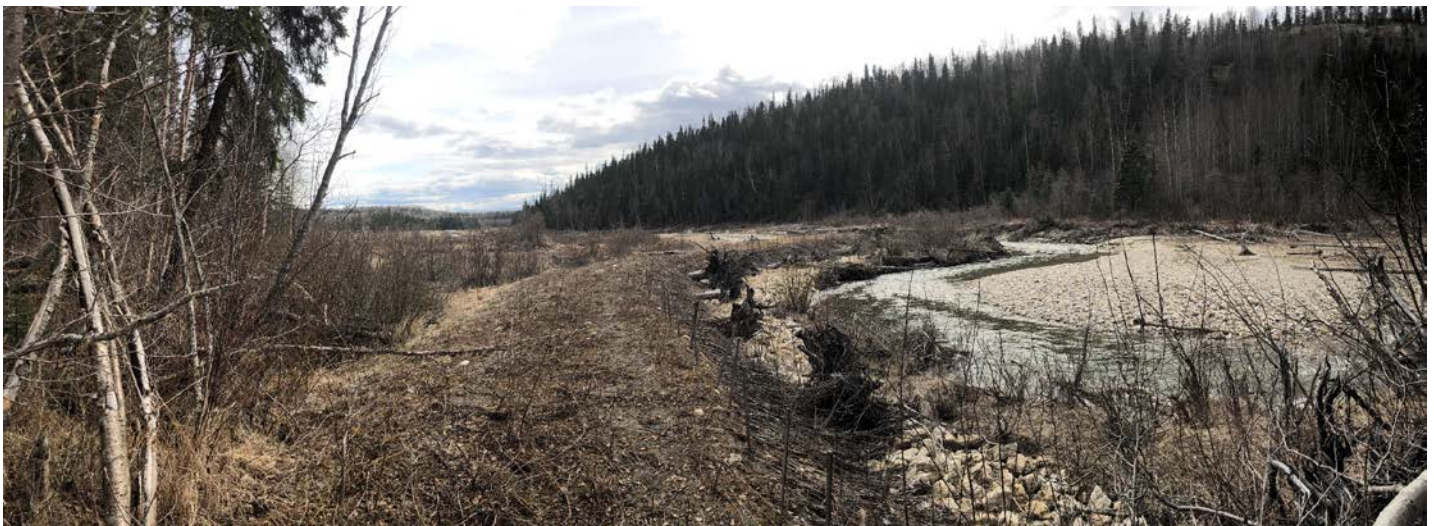
PHOTO 53 (Panoramic): Looking downstream at Berm 'J' (repeat of 2016 Ph#44)

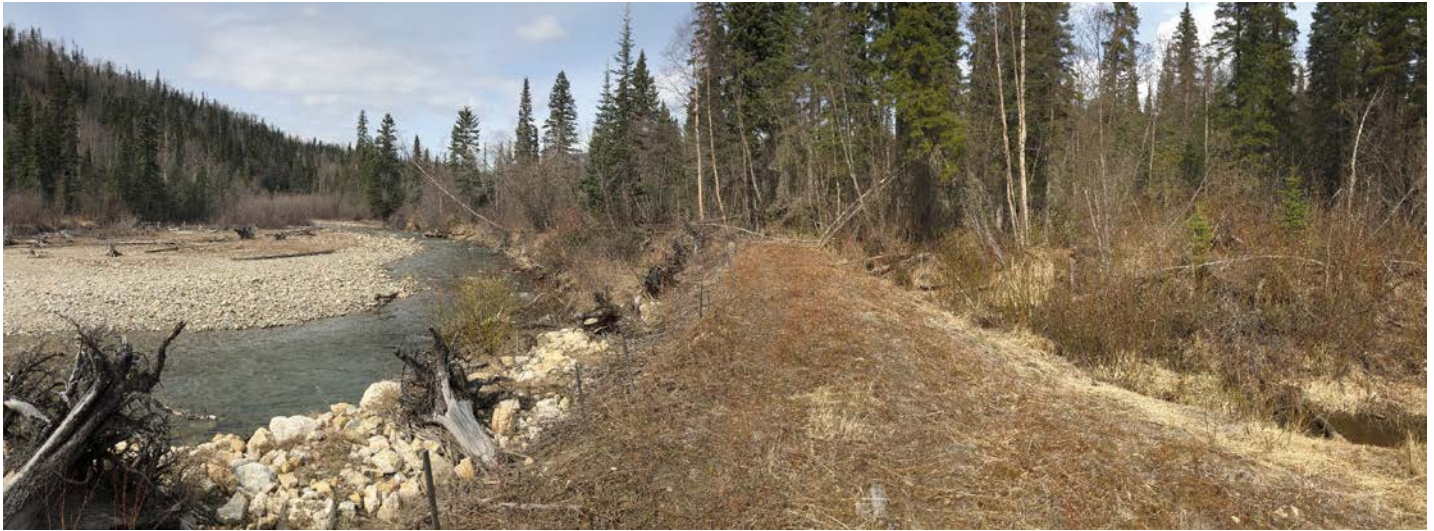
PHOTO 54 (Panoramic): Upstream end of Berm 'J' looking upstream (repeat of 2016 Ph#45)

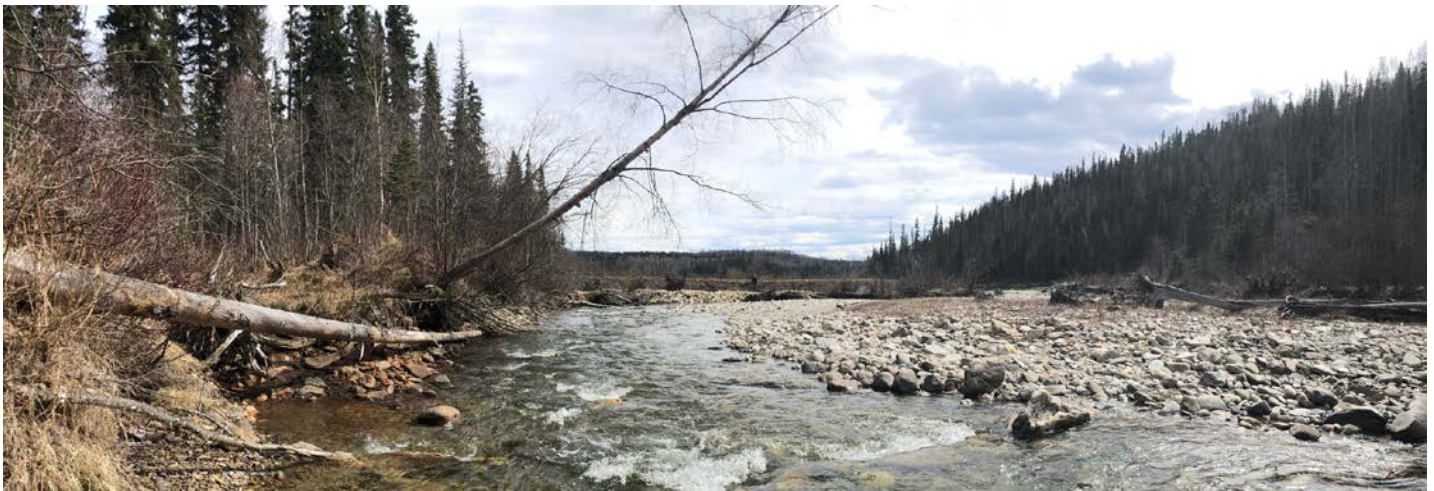
PHOTO 55 (Panoramic): Looking Downstream at Berm 'J' from Left Bank of Creek

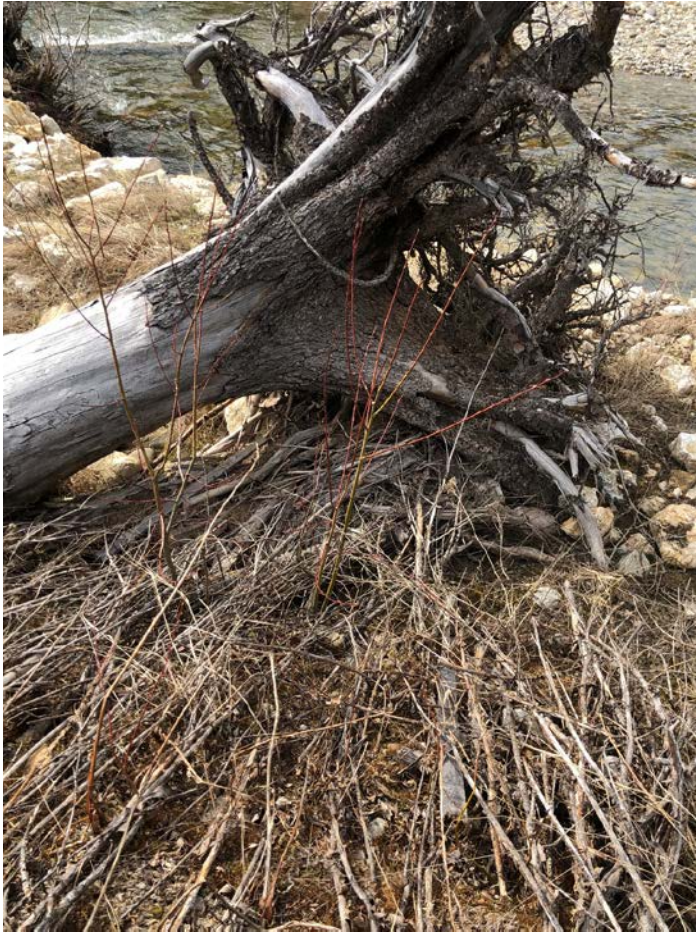
PHOTO 63: Willow starting to take in brush layers (repeat of 2016 Ph#52)
