Peace Project Water Use Plan

Williston Reservoir Trial Tributaries

2019 - Ole Creek Engineering Inspection Report

Site Inspection Report

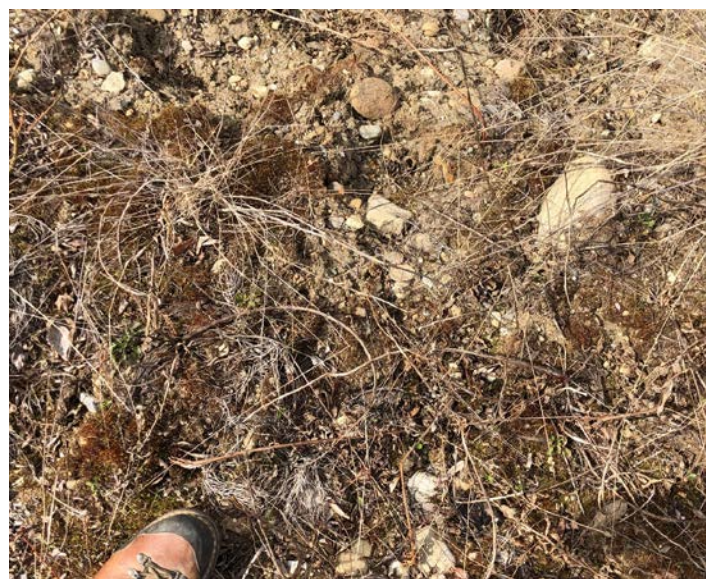
- Evidence of moose damage to crest of berm as noted in 2016.

PHOTO 66: Moose related damage on back-side slope of berm (repeat of 2016 Ph#55)
