Peace River Water Use Plan

**Peace River Spill Total Gas Pressure/Temperature
Monitoring Program – July/August 2020**

Reference: GSMON-11

January 2021

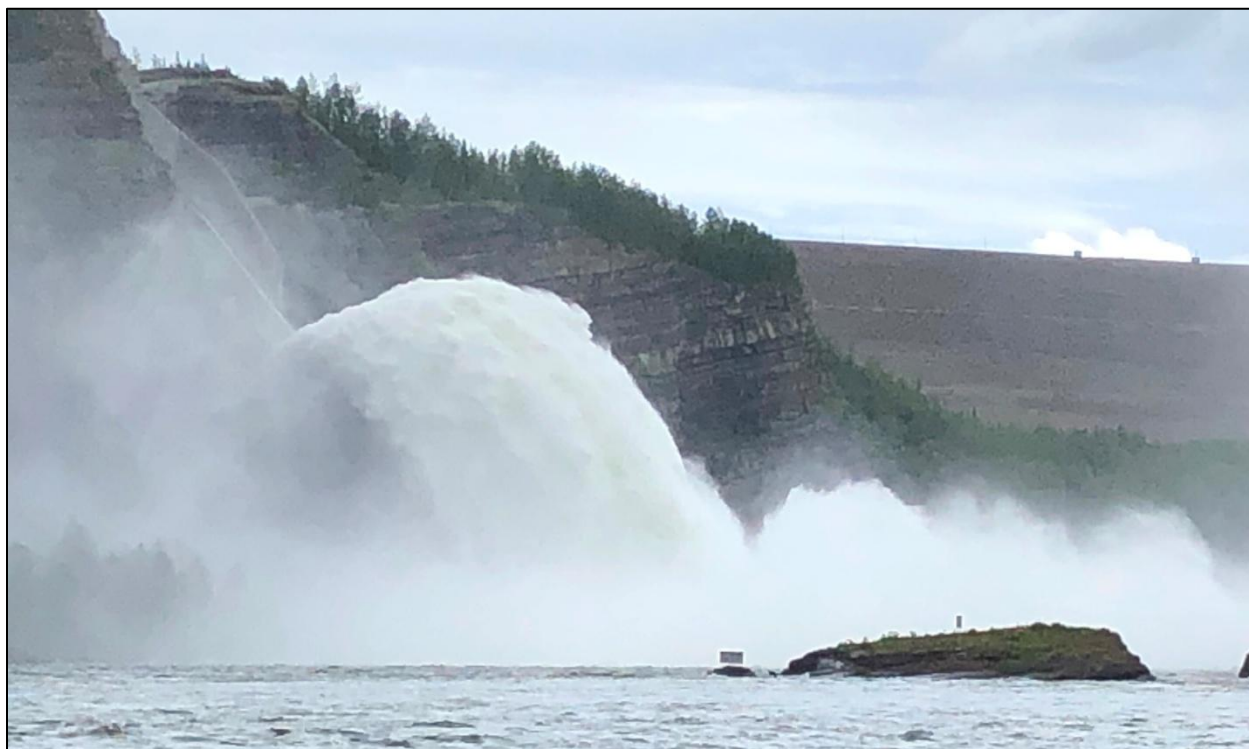
Figure 2. WAC Bennett Dam Spillway, July 17, 2020; 570 cms.

The design of the WAC Bennett spillway appears to be particularly conducive to the entrainment of air bubbles within the spillway discharge stream after it leaves the deflection bucket and prior to its contact with the plunge pool below (Fig. 2). Additionally, a prominent scour hole has developed below the spillway over the 50-year life of the facility. During an assessment of Lake Trout spawning habitat in the WAC Bennett Dam tailrace, Euchner (2006) characterized the spillway plunge pool as resembling a “blast crater” approximately 100 m by 150 m across, with sides plummeting sharply to 65 m depth. The outer rim of the crater was surrounded with unconsolidated bedrock rubble displaced from the scour hole by the force of the spillway discharge falling vertically into the channel.

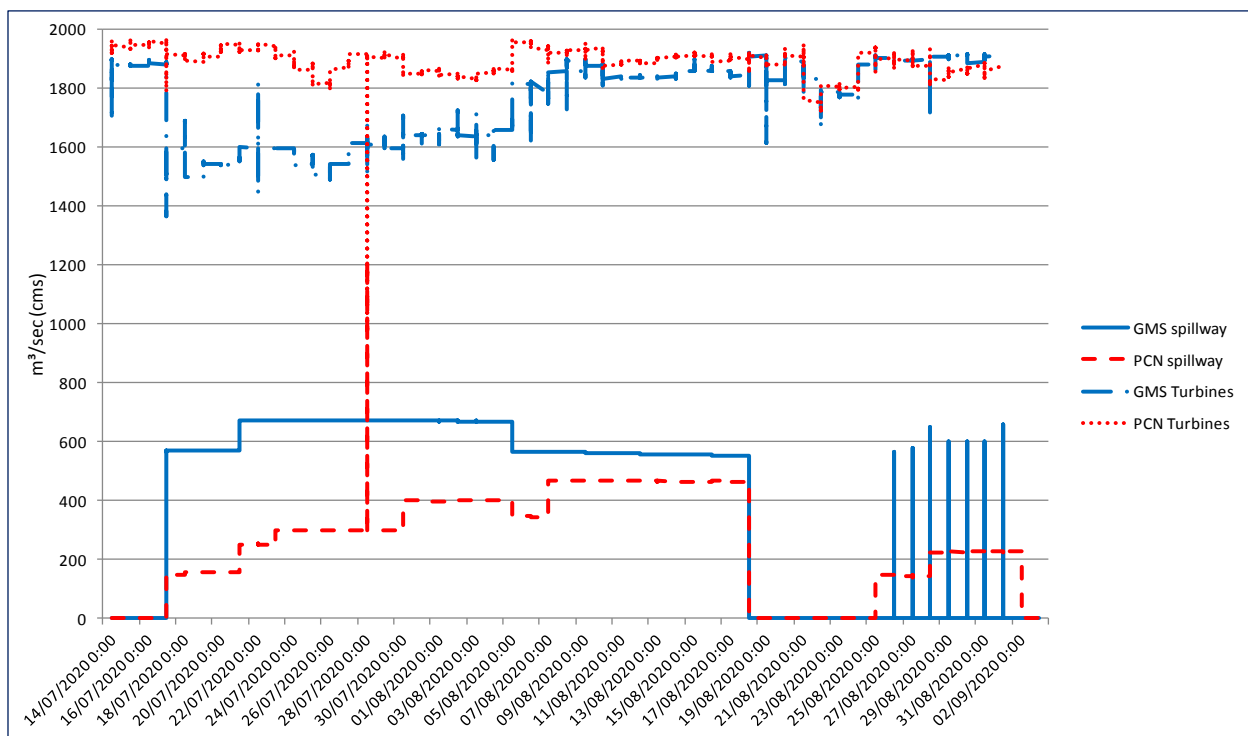
Figure 3. Spillway and turbine discharge from GMS and PCN generating station during the 2020 spill event, July 17 – September 2, 2020.

In July 2020, BC Hydro determined it was necessary to release water from the WAC Bennett and Peace Canyon dam spillways in order to arrest the rising elevation of Williston Reservoir at approximately 670.5 m (ASL). The spill was initiated on the morning of July 17, 2020 and ran continuously, at both dams, for 32 days until the afternoon of August 18. All spill operations then ceased for 7 days, after which, the Peace Canyon spillway was re-opened for 8 days from August 25 to September 2. During this 8 day period, a corresponding volume was released from the WAC Bennett Dam spillway through a series of seven once-daily pulse spills each lasting 6-7 hours (Fig. 3).

Turbine output volumes from both generating stations remained relatively stable throughout the spill period (Fig. 3). Between July 17 and September 01, mean turbine output rate from GMS varied between 1,365 cms and 1,924 cms with a mean rate of 1,745 cms. With the exception of a 7-hour period on July 28, turbine output from PCN was slightly greater and more stable than GMS output, fluctuating between 1,715 cms and 1,969 cms (mean 1,884 cms). On July 28, PCN turbine output was decreased from 1,900 cms to 985 cms between 0800-1500 hrs.

The spill rate at the WAC Bennett Dam spillway remained within 2 relatively tight ranges (Fig. 3). The spill was initiated on July 17 at approximately 570 cms and remained at that rate for 4 days before being increased to 674 cms on July 21. This rate was maintained for 15 days until reduced to the original rate for the remaining 18 days of the continuous spill period. The 7 once-daily pulse spills occurring in the second phase of the spill period were conducted at a rate of approximately 600 cms.

With the exception of July 28, spill rate at the Peace Canyon Dam increased in a series of steps over the spill period, starting at 150 cms on July 17 and ending at 470 cms on August 18 (Fig. 3). A 7-hour spike on July 28 saw the spill rate increase from 300 cms to 1,217 cms and coincided with the previously mentioned reduction in PCN turbine output. The second phase of the Peace Canyon spill was similarly stepped, flowing at 145 cms for the first 3 days and 230 cms for the remaining 5 days until September 2.

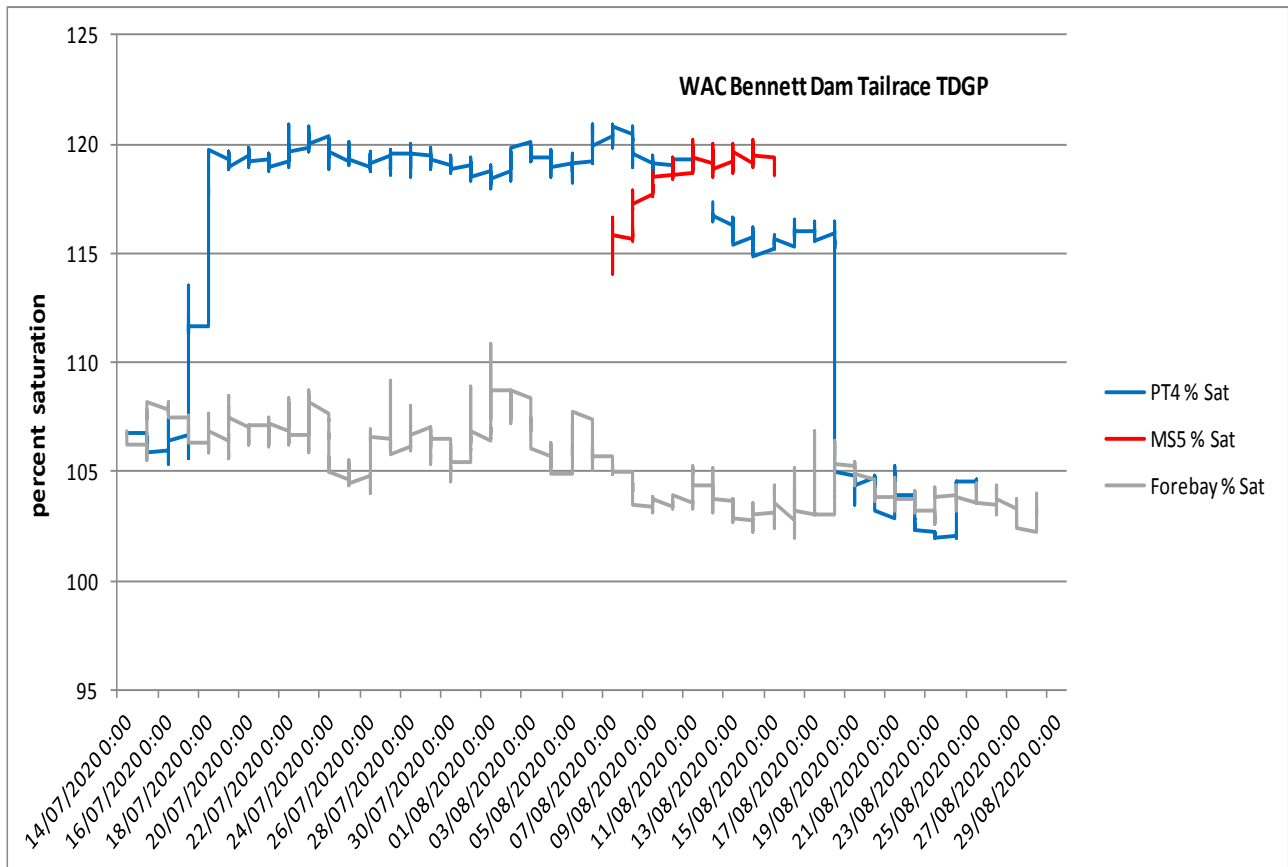
Figure 6. Percent air saturation levels recorded in the WAC Bennett Dam tailrace 500 m downstream of spillway plunge pool, July 14 – August 28, 2020; (Williston Forebay TDGP added for reference).

TDG pressure was monitored in the WAC Bennett Dam tailrace, approximately 500 m downstream of the spillway plunge pool between July 14 and August 29, using a Model PT4 TPG meter, and from August 7 to 29 using a Model MS5 meter. This was the only site where the Model MS5 recorder appears to have malfunctioned; the unit died after 8 days of operation. As illustrated in Figure 6, TDGP levels immediately before and after the spill matched those recorded above the spillway in the Bennett Dam forebay, including the 3-4% decrease in background saturation levels documented in the forebay during early August. Commencement of the spill on July 17 resulted in a 13% incremental increase in TDGP from approximately 106% to 119% saturation. A corresponding 13% decrease was recorded at the end of phase 1 of the spill, as TDPG declined sharply from 116% to 103%.

The Model PT4 meter ceased logging data on Aug 25, one day before the start of the phase 2 once-daily pulse spills.

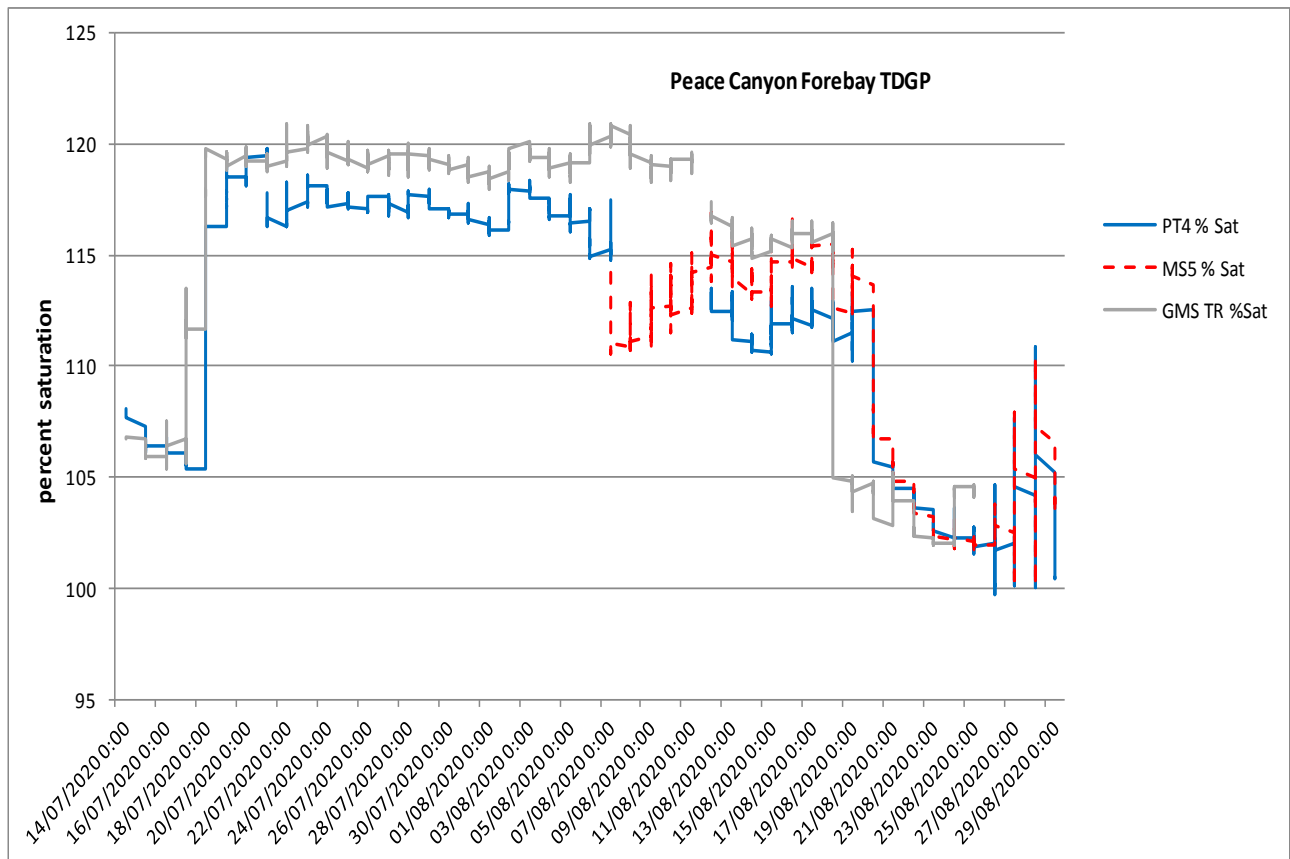
Figure 7. Percent air saturation levels recorded at the Peace Canyon forebay, July 14 – August 29, 2020; (GMS tailrace TDGP added for reference).

probe re-positioned on August 12, saturation readings dropped instantly by 4%, indicating the clearing of a temporary glitch. Suspect data recorded between August 7 and 12 was discarded.

As with the Bennett Dam tailrace, pre- and post-spill air saturation levels in the Peace Canyon forebay mirrored natural background levels in the Bennett Dam forebay and reflect a 3-5% decline in background saturation between mid July and mid August (Fig. 7). Elevated TDGP values were detected at the Peace Canyon forebay within 36 hours of commencement of the Bennett Dam spill on July 17. Saturation levels rose to 119% within 48 hours then stabilized at an average level of 117% until declining slightly, in line with declining background levels in Williston Reservoir. During spillway operations, mean saturation levels tracked 2% lower than those recorded immediately below the Bennett Dam spillway. Within 3-4 days after the end of the continuous phase of the Bennett Dam spill, Peace Canyon forebay saturation levels had recovered to baseline values of 103-104% (Fig. 7). Figure 7 also illustrates the Peace Canyon forebay response to the first 2 of the 7 once-daily pulse spills conducted at the Bennett Dam spillway starting Aug 25. Monitoring was discontinued August 29, just before the August 28 pulse spike arrived at Peace Canyon. Although the Model PT4 and MS5 records for the period after the closing of the Bennett Dam spillway on August 18 match closely, no explanation for the divergence in values prior to August 18 was evident.

In contrast, limited data from the Hudson's Hope site indicated TDGP levels slightly higher than the Peace Canyon forebay for the same period (115% vs 113%; Fig 7). Unfortunately, data from the Hudson's Hope site in 2020 was inadequate to establish a robust relationship between saturation levels downstream of the Peace Canyon tailrace and those in the Peace Canyon forebay.

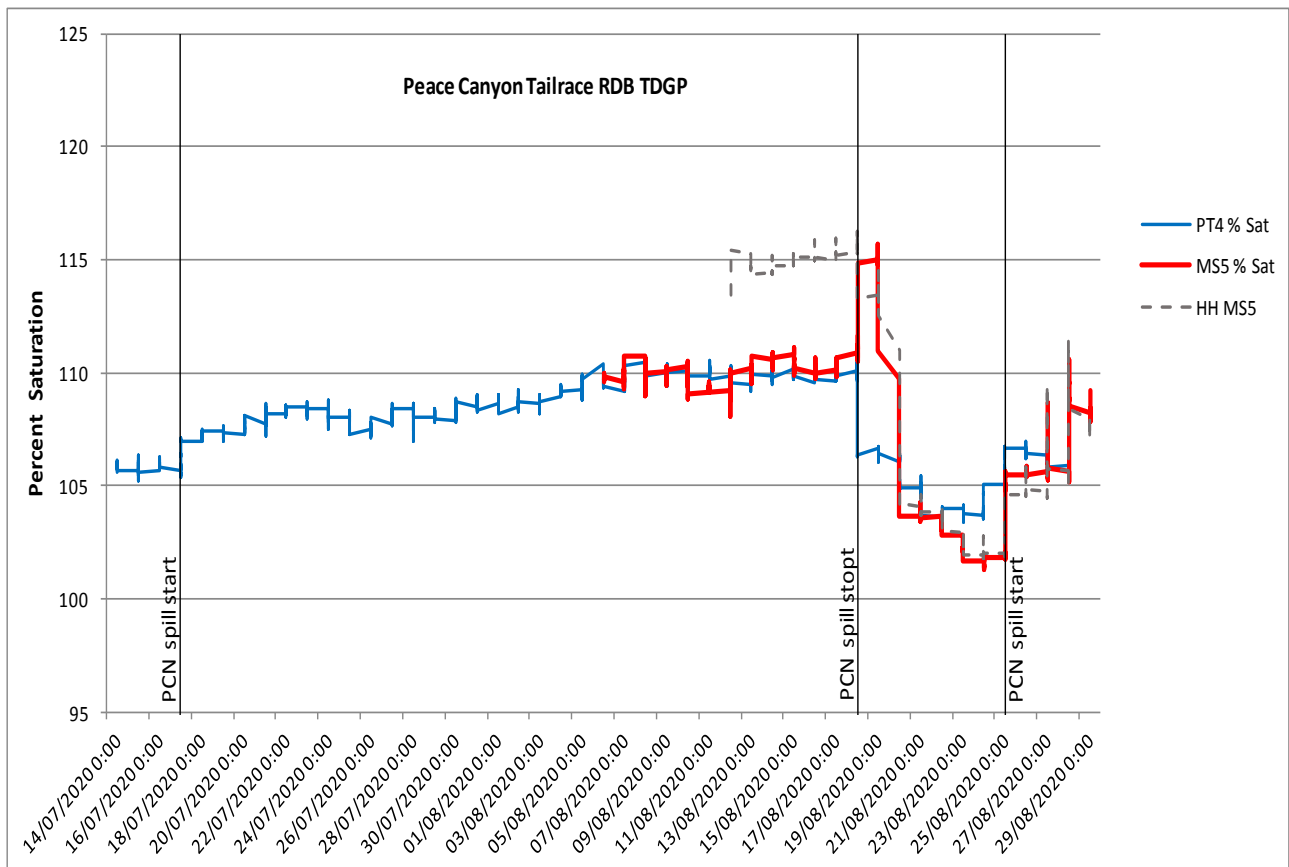
Figure 9. Percent air saturation levels recorded at the Peace Canyon tailrace RDB, July 14 – August 29, 2020.

Although somewhat contradictory, the 2020 data appears to support the 2012 assertion that while operation of the Peace Canyon Spillway may result in a relatively small incremental increase in air saturation levels (2%) when Dinosaur Reservoir TDGP is low (i.e., comparable to Williston background levels), the Peace Canyon spillway may partially attenuate high TDGP levels received from Dinosaur Reservoir during simultaneous operation of the WAC Bennett Dam spillway. For example, the MS5 meter on the Peace Canyon tailrace RDB recorded a sudden spike from 111% to 115% when the Peace Canyon spillway was closed on August 18 (Fig. 9).

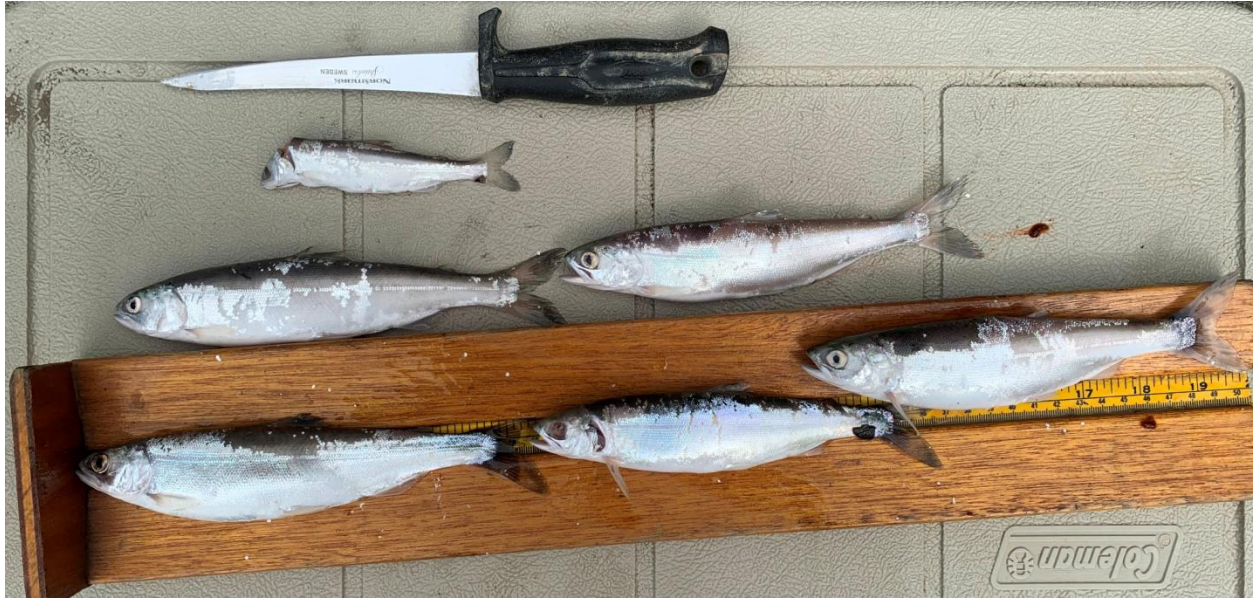
Figure 11. Subsample of 32 juvenile Kokanee recovered below the Bennett Dam spillway, July 19, 2020.

During the day 3 patrol (July 19), a cluster of 32 dead juvenile Kokanee were collected along a 500 m segment of the reservoir near the bottom of the narrows, approximately 6.5 km downstream of the spillway. Fork lengths ranged from 87-191 mm (mean 130 mm). Most had sustained injuries

suggesting outright spillway mortality, including severe scale loss, dislocated eyes, ripped operculums, and disarticulated heads (Fig. 11). Based on estimated mean surface velocity and the spatial distribution of the carcasses, the fish had likely been entrained as a school of mixed-age juveniles approximately 2 hours earlier. No other fish were observed during the remainder of the day 3 patrol.
