Peace River Project Water Use Plan

*Williston Reservoir Wetland Demonstration Site 6-2 Airport
Lagoon. Final Report*

BC HYDRO - WILLISTON RESERVOIR WETLAND DEMONSTRATION SITE 6-2 AIRPORT LAGOON

Completion Report BC Hydro Report # N3589

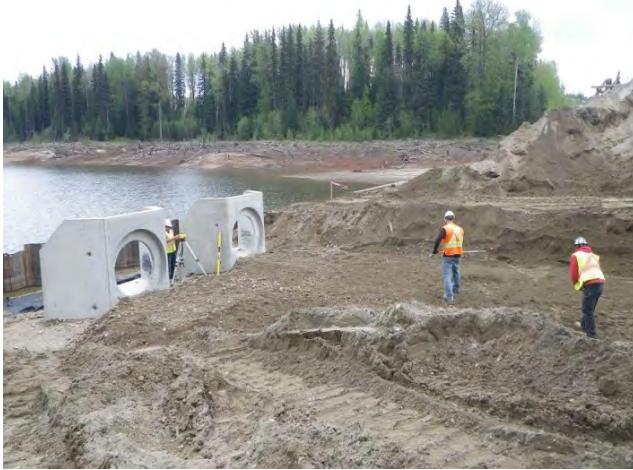
Photo 5 – Placement of culvert headwalls & geotextile.

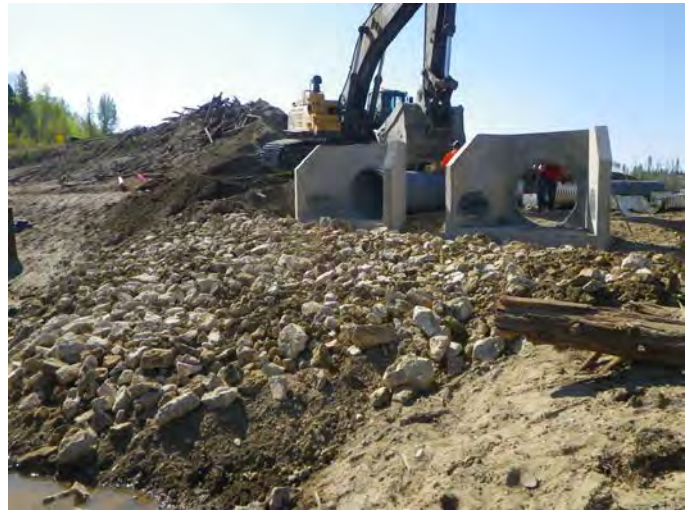
Photo 6 – Placement of Class 10 kg riprap.

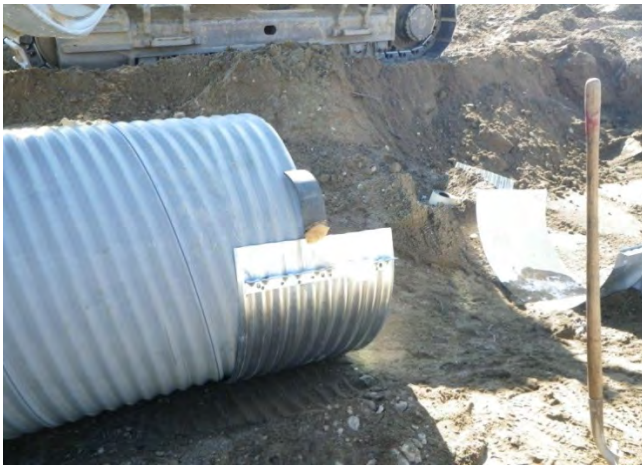
Photo 7 – Culvert couplings and neoprene gaskets.

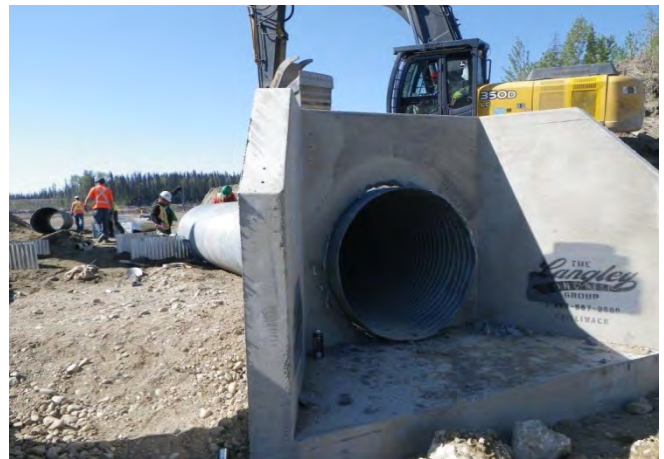
Photo 8 – Placement of anti-seepage collars.

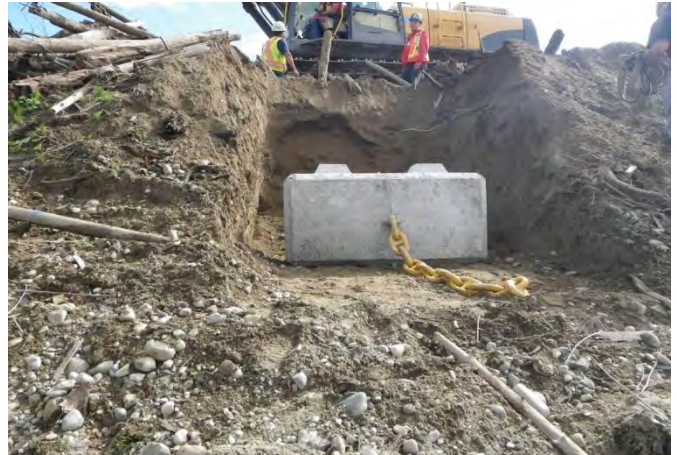
A modification to the design of the concrete anchor blocks was requested by the Contractor to replace the proposed 25 mm (1") diameter galvanized steel coil rod that was to be cast into the block with 37.5 mm (1.5") diameter stud link anchor chain that was cast into the anchor block. The 37.5 mm anchor chain extended 1.5 m from the face of the concrete block for the embankment anchors and each link was welded together to form a rigid 1.5 m long chain from which a shackle could be installed for connection to the log boom chain. This request was reviewed and approved by Golder as the service life with the thicker chain was expected to be similar to the galvanized material specified.

Photo 22 – Embankment anchor & 37.5 mm chain.

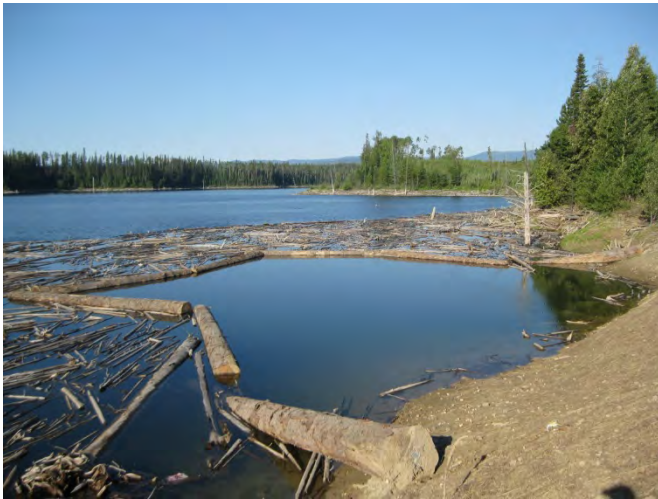
Photo 23 – Log boom installed south side, reservoir.

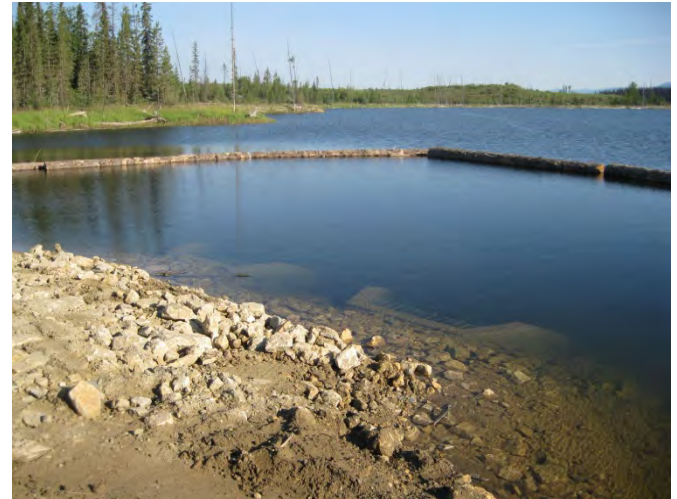
Photo 24 – Log boom installed north side, Lagoon.

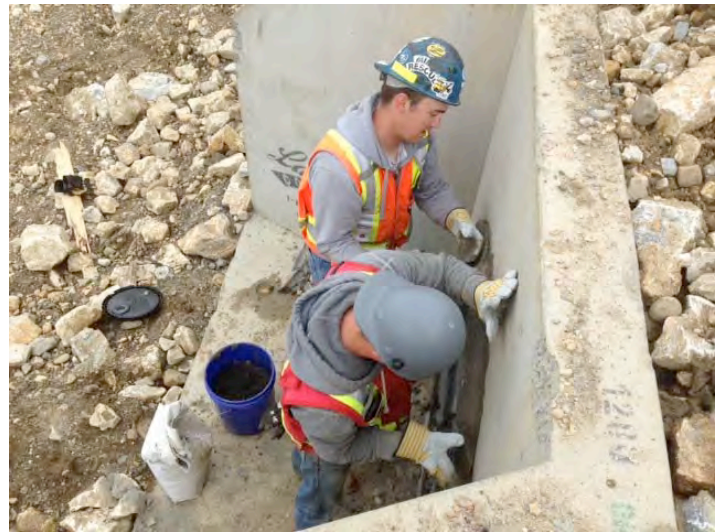
Daily comment: Held tailgate safety meeting. Finish graded and packed the Causeway FSR. Some of the grout around the culverts had cracked and pulled away, so those sections were re-grouted. The environmental monitor hand seeded an erosion control mix and spread weed free straw on all exposed work areas above the culvert headwalls. All supplies and materials were removed from the site. As per discussions with Ray Normandeau, the original ¾” crushed gravel with calcium additive that was salvaged off the road at the beginning of the project (approximately 7-10 cm lift) was re-spread, and, rather than putting on the 550 mm lift of 40mm minus crushed gravel sub-base and 150mm lift of 19mm minus crushed sand and gravel, Ray is going to arrange to have another lift of the calcium crush mix spread at a later date in conjunction with other road maintenance activities in the area. The road was re-opened to traffic in the early afternoon.

Re-grouting headwalls

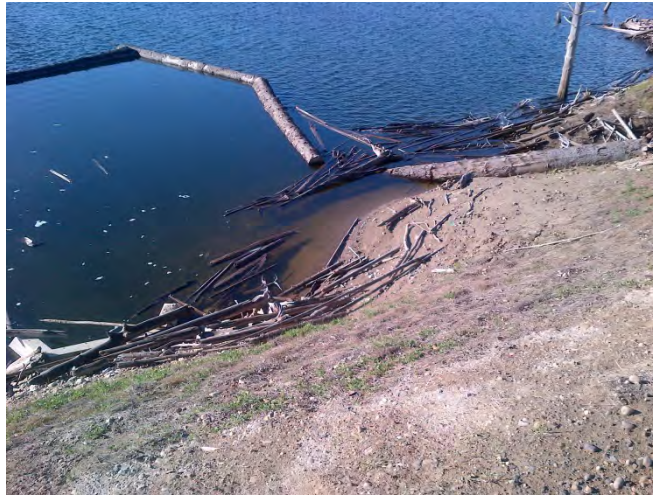
Golder understands that BC Hydro has inspected the site in October 2013 to confirm that the structures are performing as intended. BC Hydro noted that logs were bypassing the log boom located on the Williston Reservoir side of the causeway. A photograph was provided and has been included in Appendix E – Post Construction Inspection Photos, Photo 1. It appears that the log booms that have been installed near the embankment slope are too long and when the water levels are low, one end of the log sits up on the embankment slope while the other end is submerged allowing logs and debris to bypass the log boom. Golder recommends that the log booms located near the embankment slope, on both sides of the causeway road, be shortened, (perhaps into two sections) to allow more flexibility in the log booms as water levels rise and fall.

Photo 1 – October 2013 Post Construction Inspection – Logs bypassing log boom on reservoir side.

An inspection by the design engineer is recommended during snow free conditions, possibly in April 2014, if snow and ice conditions permit, or as late as mid-May 2014 in conjunction with the proposed work at the BC Hydro WDS 34, if reservoir levels permit. Recommendations regarding modifications to the log booms could be made at that time. In the meantime, Golder recommends cleaning out any logs that have bypassed the log boom as and when necessary.
