Peace Project Water Use Plan

Williston Reservoir Trial Tributaries

Ole Creek 2016 Engineering Inspection Report

Site Inspection Report

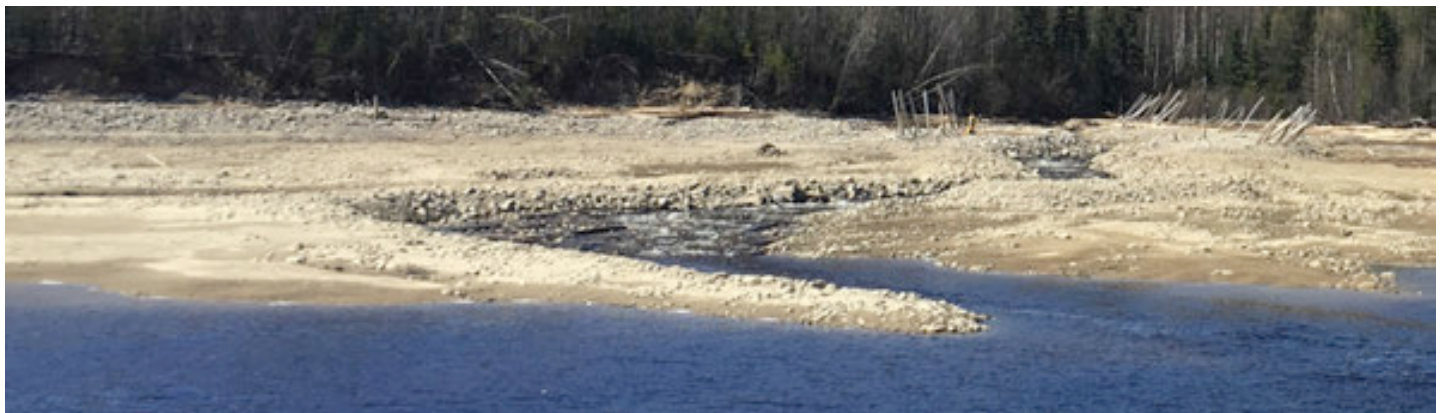
PHOTO 6 (Panoramic): Looking upstream at Berm 'D' from right bank

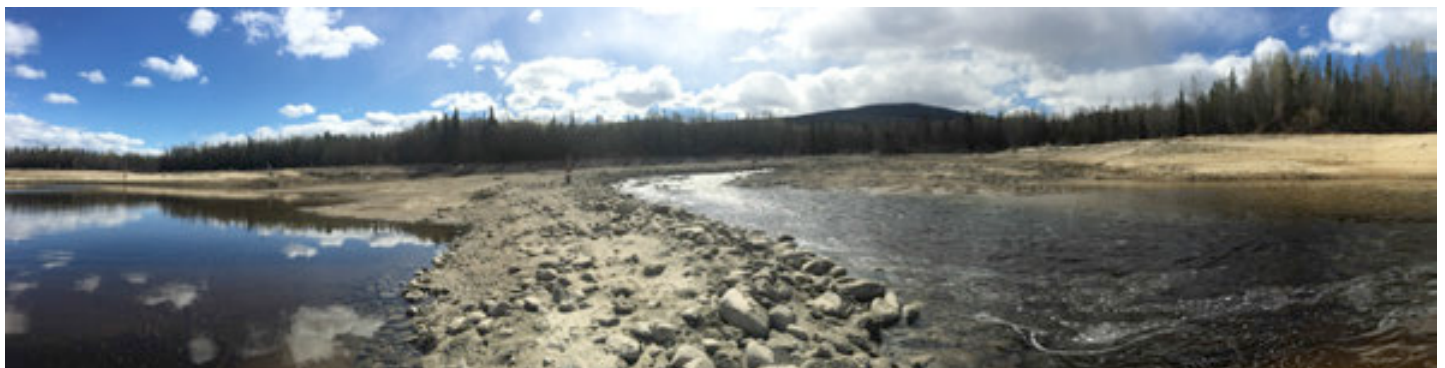
PHOTO 7 (Panoramic): Looking upstream along Berm 'D' from downstream end of berm

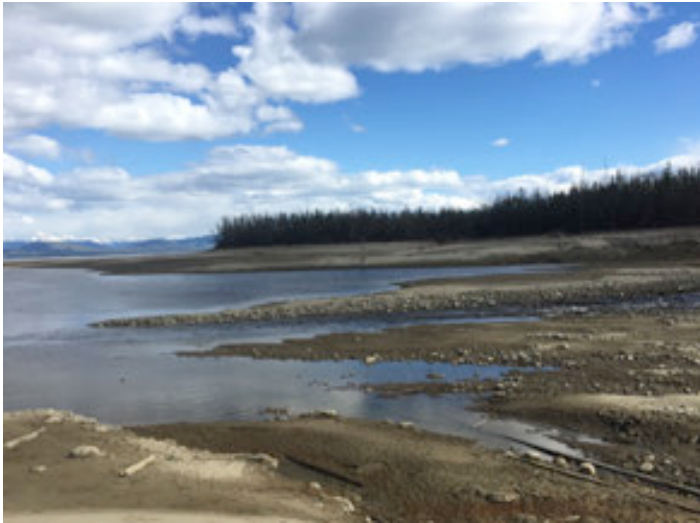
- The berm is generally in good condition; however, there has been some settlement/displacement and erosion of the finer fraction of material from the berm crest based on visual observations and the survey (see Profile on DWG 1000-C1800061-R2, and Sections 0+360 and 0+380 on 1000-C1800066-R0).

- The top of berm is slightly uneven in some locations with some large cobble proud of crest.
- The erosion, settlement and displacement of some material could be caused by large woody debris movement, wave action, ice movement, and creek flow over the berm as the reservoir level rises.

PHOTO 8: Berm 'D' looking from left bank

- The settlement/displacement on Berm 'D', should be monitored during the annual monitoring work. It is possible that the settlement / erosion could have been greatest in the first season, and may lessen with time. If the berm height becomes less than 0.8 m above the creek, then repairs should be considered.

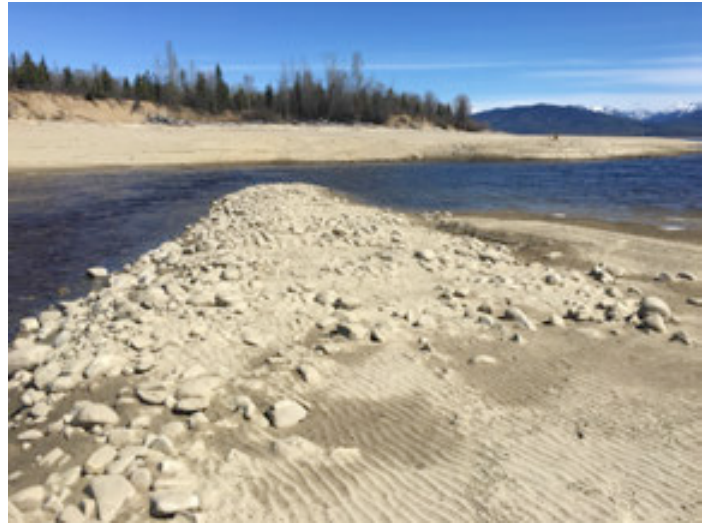
PHOTO 9: Berm 'D' looking downstream

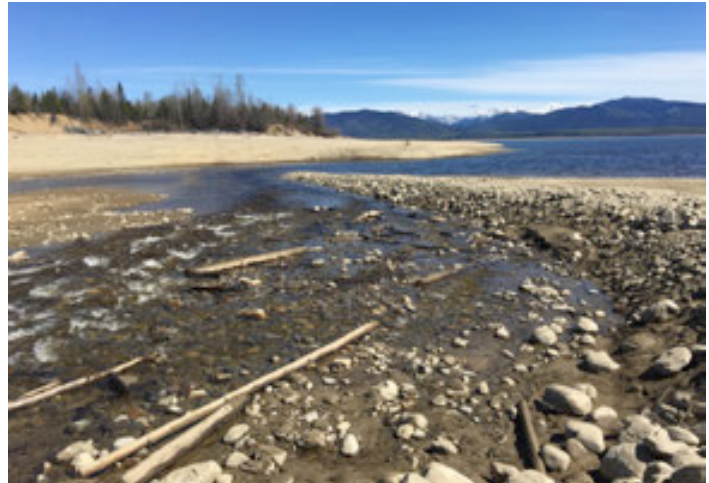
PHOTO 11: Looking downstream at Berm 'D'

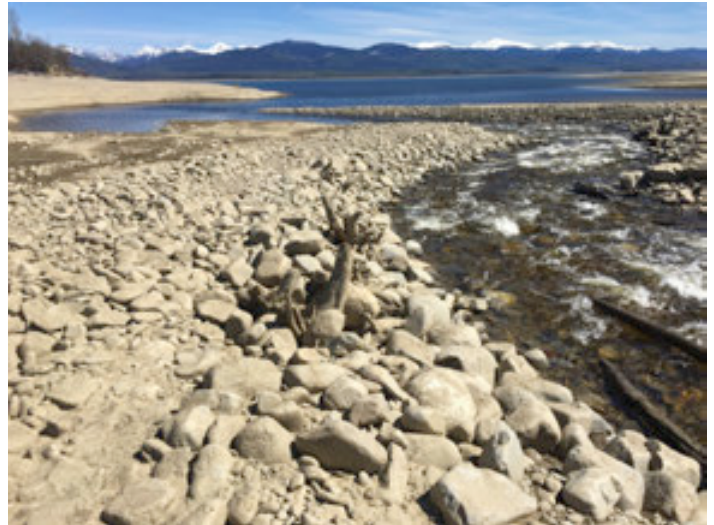
PHOTO 16: Buried LWD in Berm 'B'

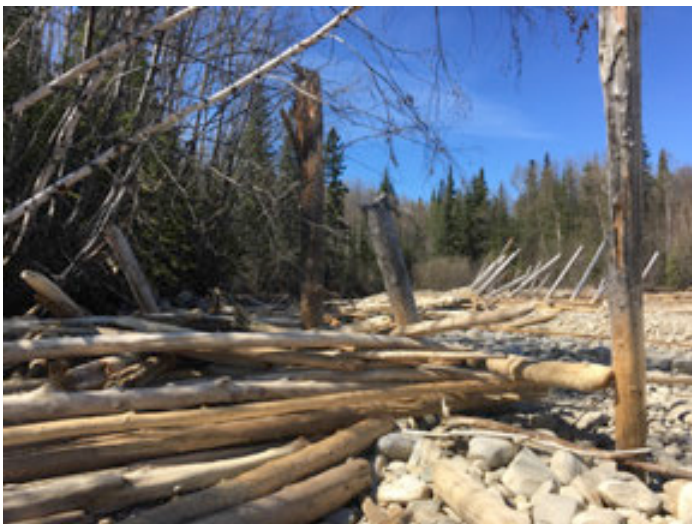
- The woody debris catcher has sustained some impact damage resulting in two broken upright logs.
- There is also frictional damage on the wood debris catchers (tan coloured where rubbed, see Photo 30).

PHOTO 25: Captured woody debris & broken logs

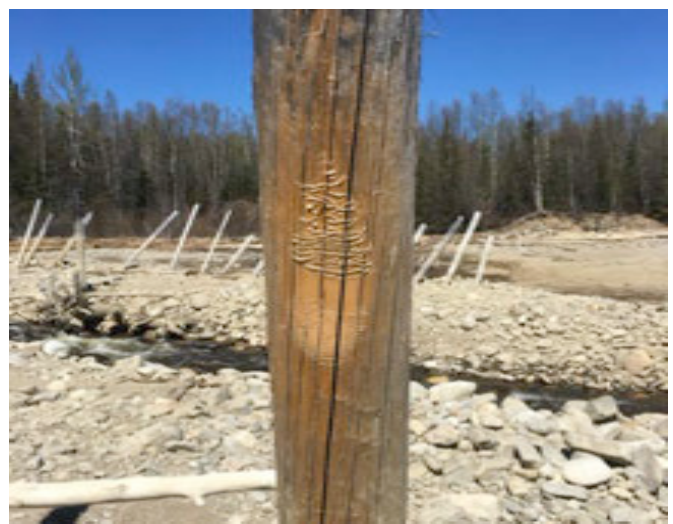
PHOTO 26: Damage to woody debris catcher

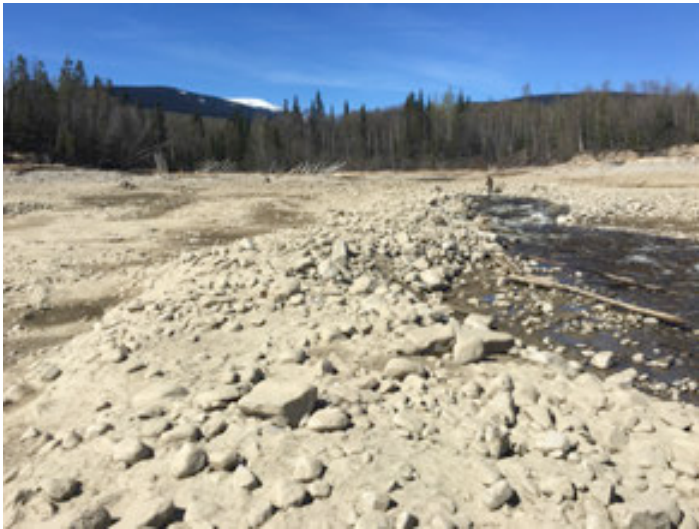
- The berm is still functioning well and serving the purpose of maintaining a single thread channel.
- The top of berm is slightly uneven in some locations with some large cobble proud of crest.

PHOTO 27: Looking upstream at lower Berm 'C' from downstream end of berm. Note uneven top of berm, some large cobble proud of crest.

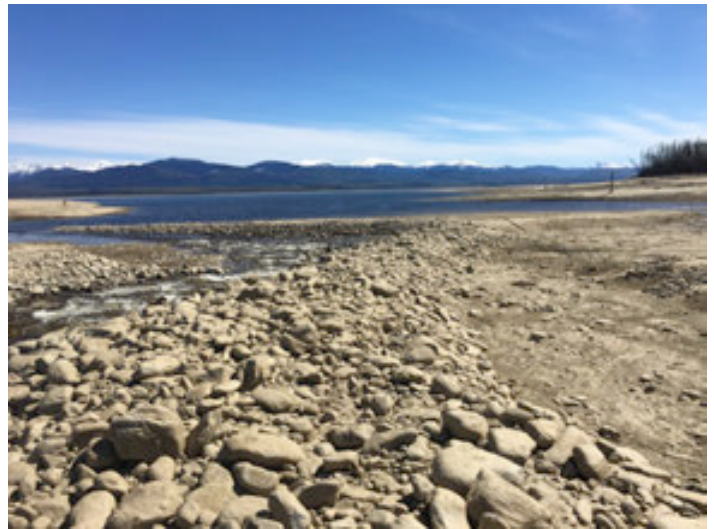
PHOTO 28: Looking downstream at Berm 'C'. Armour layer of cobble in good condition.

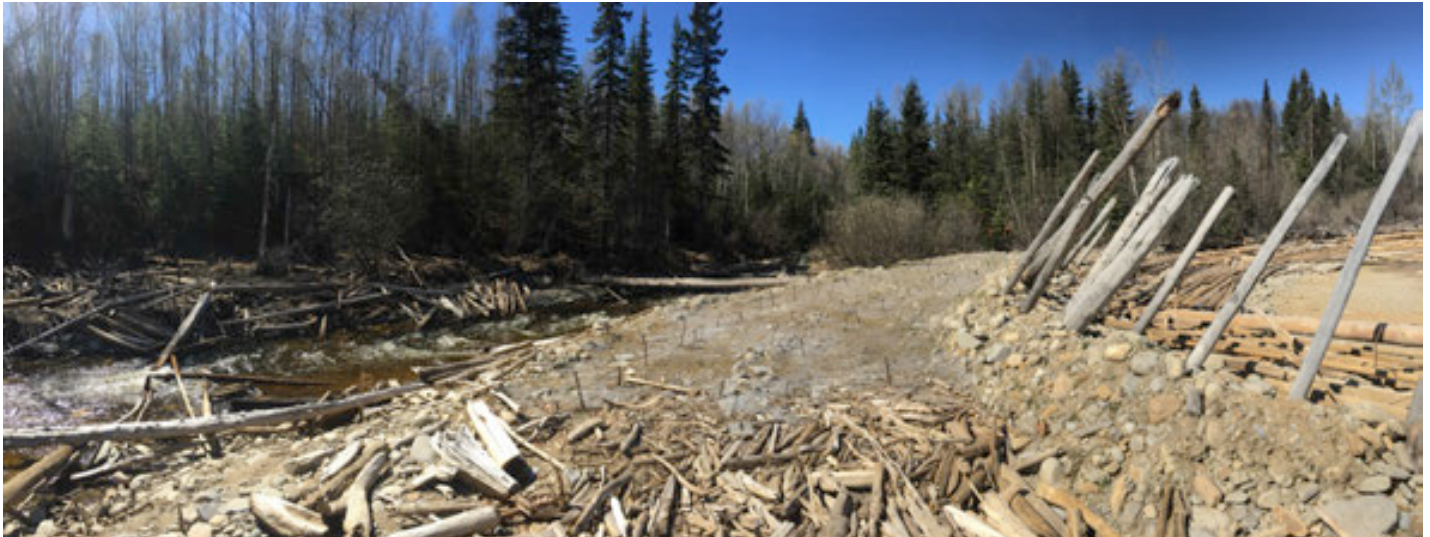
- The woody debris catcher has largely been effective and has captured much log debris and has prevented blockage of the creek mouth (see Photos 33, 34 & 39). Some of the upright logs in the woody debris catcher have sustained impact damage. Three upright logs have broken and a few have shifted by log impact, many show rubbing and impact damage near the base of the logs (see example Photos 40 & 41).

PHOTO 33 (Panoramic): Downstream end of Berm 'A' (note flotsam) and woody debris catcher

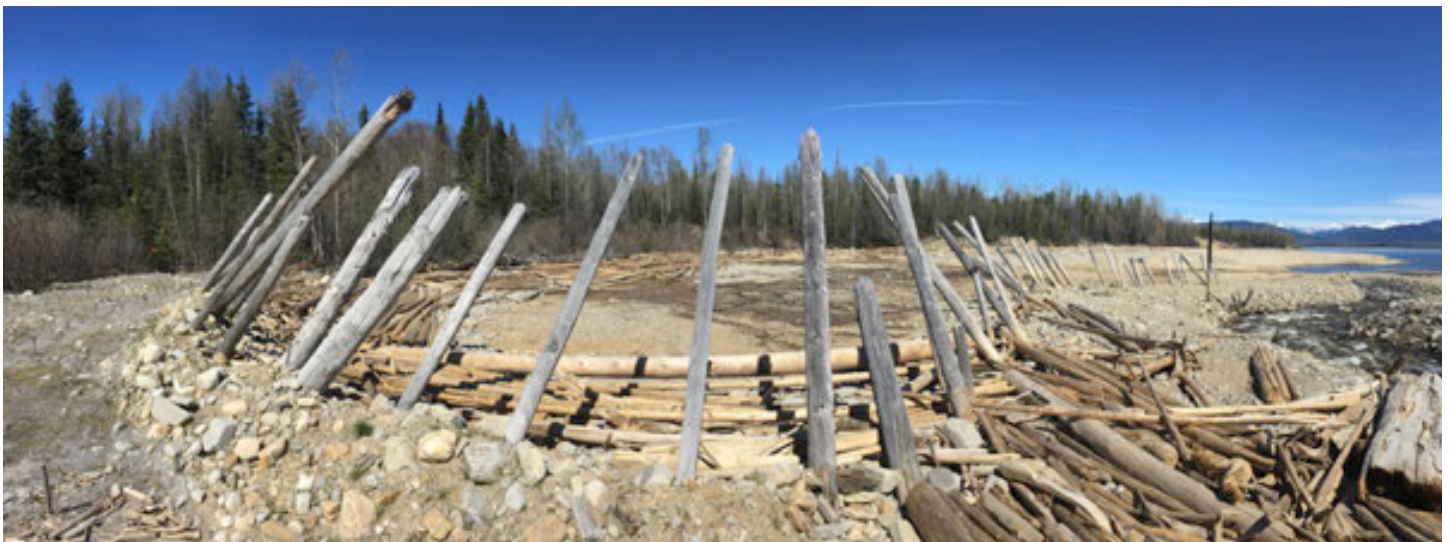
- There is some log debris that has managed to float between the left (berm 'A') and right bank (Berm 'C') woody debris catchers, but this is limited and could be manually removed if it becomes an issue (see Woody Debris Observations section below).

PHOTO 34 (Panoramic): Woody debris catcher with captured wood visible behind the upright logs. Some wood debris not captured is visible to the right (note bend is exaggerated in panoramic).

- The log debris that floated between the woody debris catchers and has come to rest on the berm crest should be monitored during annual inspections. If it continues to accumulate, then it should be removed.

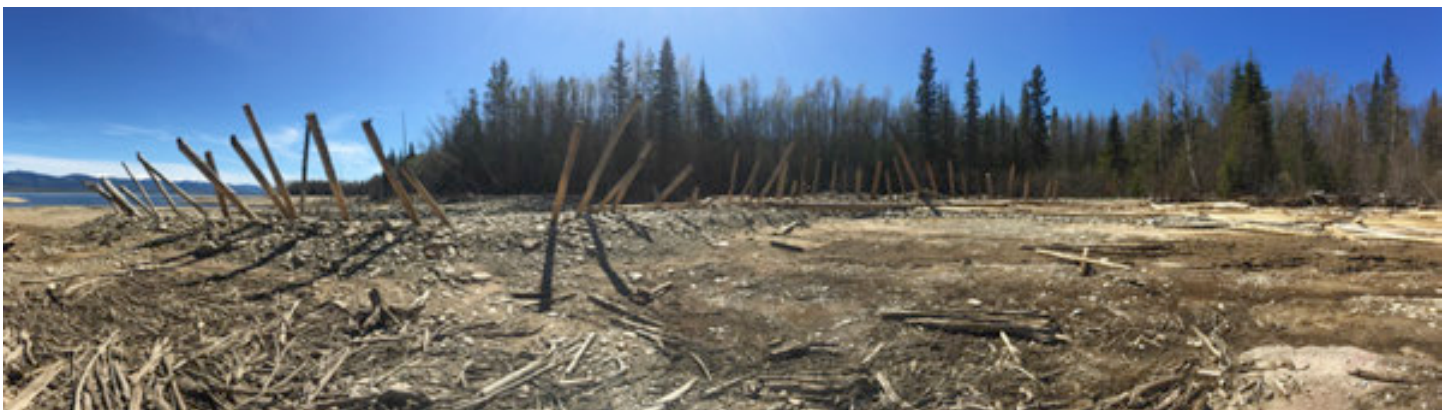
PHOTO 35 (Panoramic): Berm A and left bank woody debris catcher looking from left bank. Note some shifted and broken upright logs.

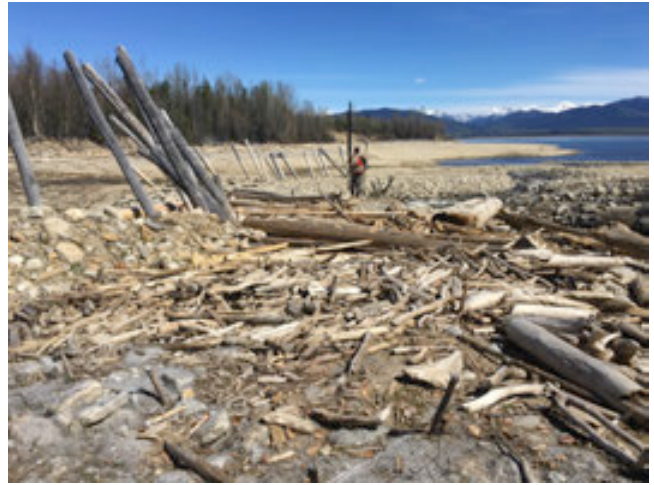
PHOTO 37: Flotsam at downstream end of Berm 'A' looking downstream

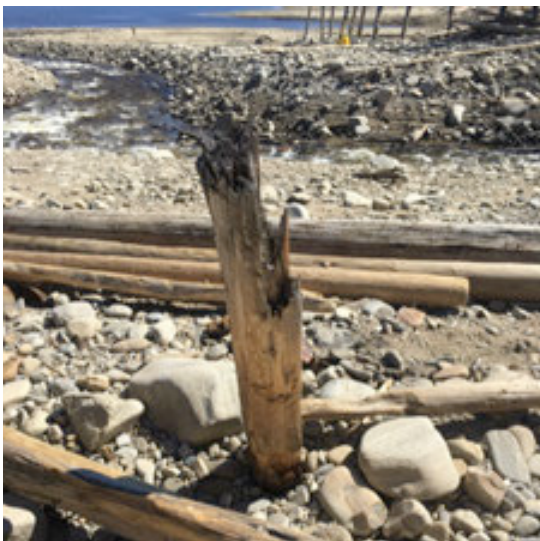
Photo 40: Broken upright log of the woody debris catcher

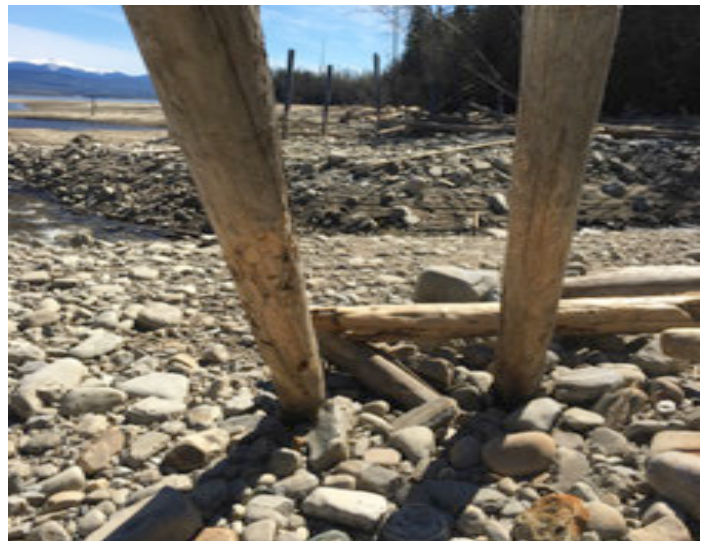
Photo 41: Damage to base of woody debris catcher upright logs

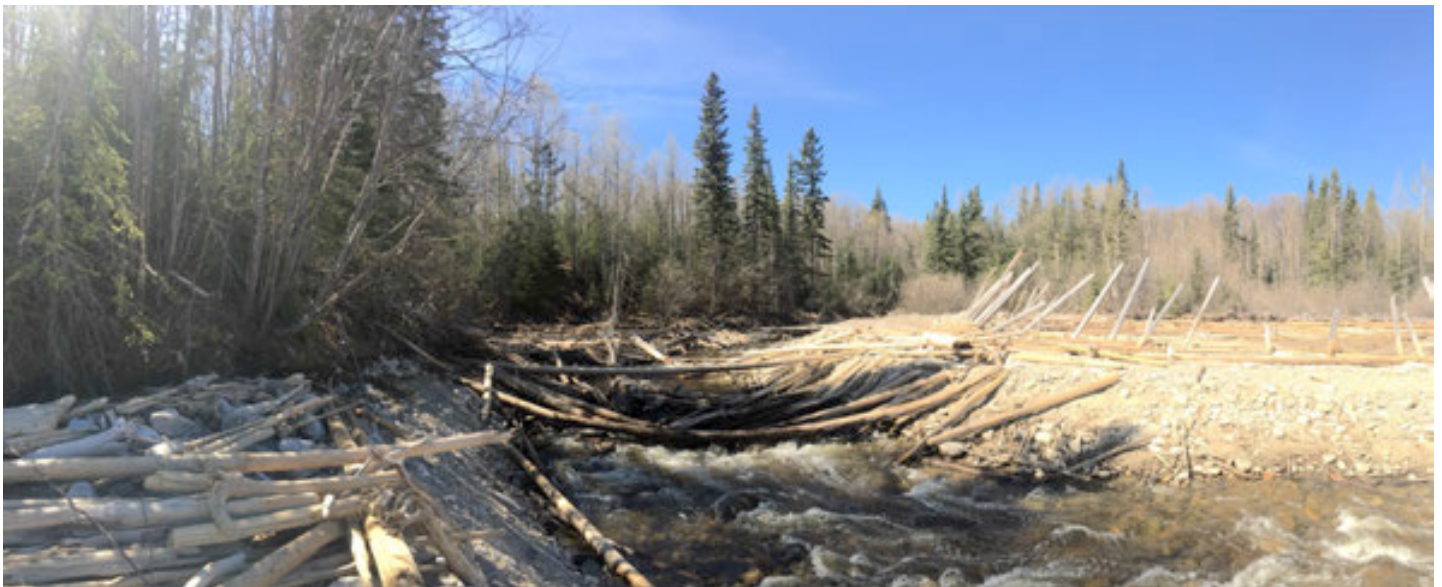
- There is a small logjam that has formed just upstream of Berm 'C' and along Berm 'A'. It is in the vicinity of where some log debris was able to pass between the woody debris catchers, so it is likely a combination of log debris transported by the creek and logs floated from the reservoir.

- The environmental monitoring contractor noted that the logjam is not presently a barrier to fish passage, but could become one if it accumulates material. This logjam should be monitored and could be removed if it becomes a barrier to fish passage.

PHOTO 44 (Panoramic): Looking upstream at logjam from right bank

- The logjam in the creek channel between Berm 'A' & Berm 'C', should be monitored. If it accumulates more material and becomes a barrier to fish passage, then it should be removed.

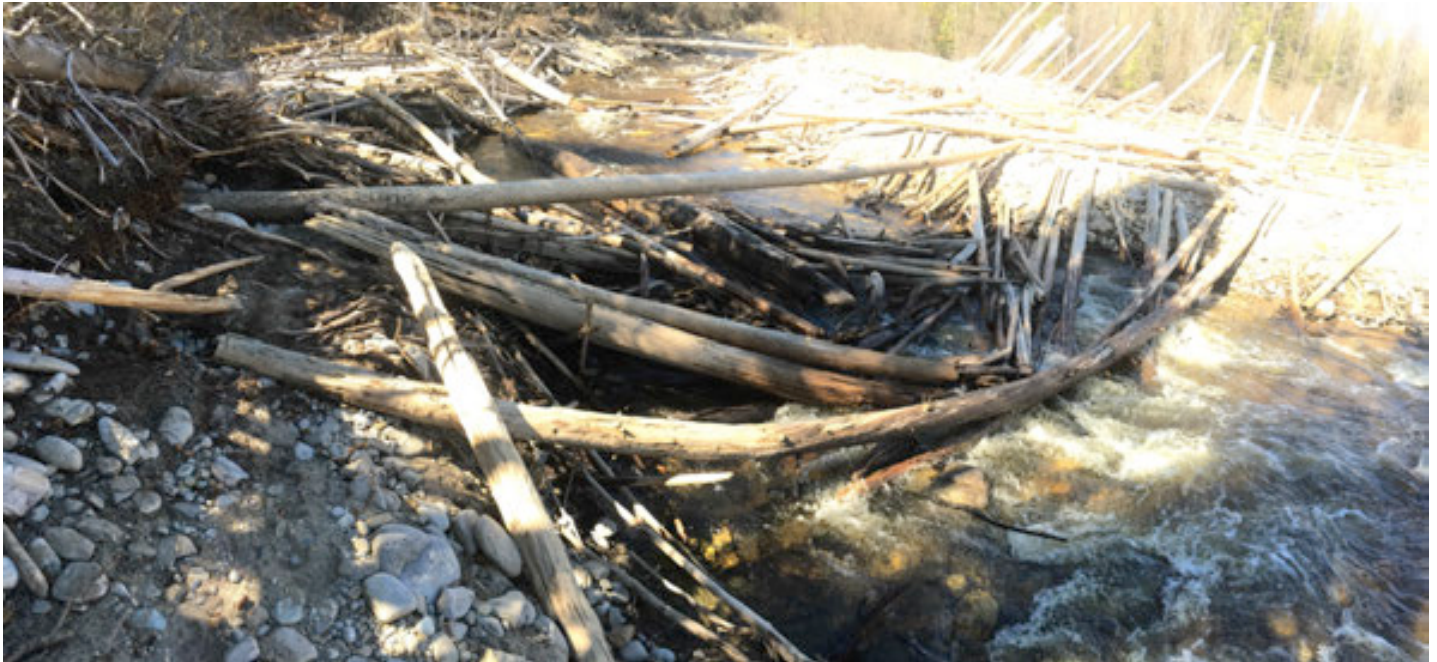
PHOTO 45 (Panoramic): Looking upstream at logjam from right bank

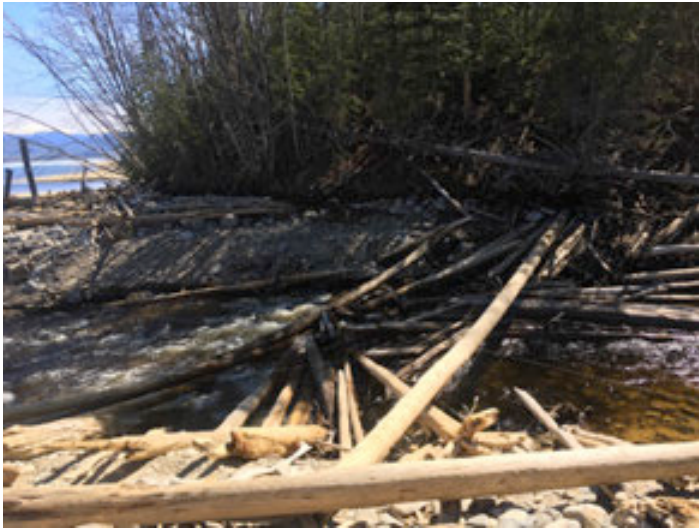
PHOTO 47: Looking at logjam from left bank

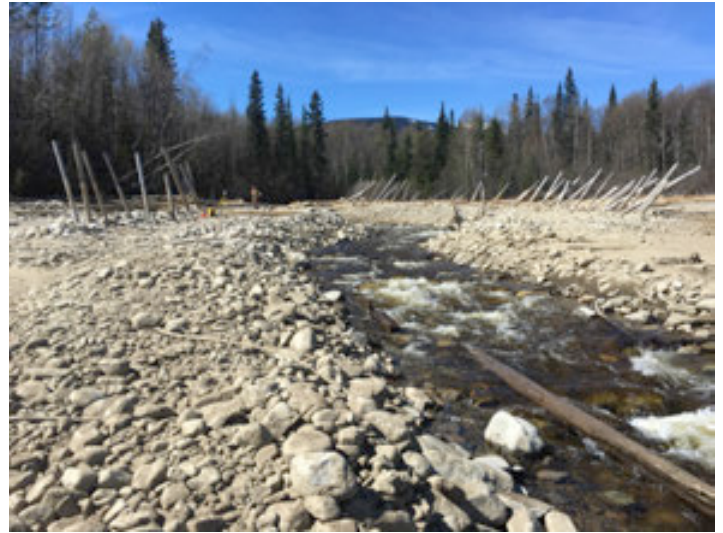
- If the opening at the creek between the left and right bank wood debris catcher were narrower, then there may have been less material floated upstream along the creek, however if it were narrower, it could have encouraged a logjam at the debris catcher opening around the creek.

PHOTO 48: Looking upstream opening between left and right bank woody debris catchers

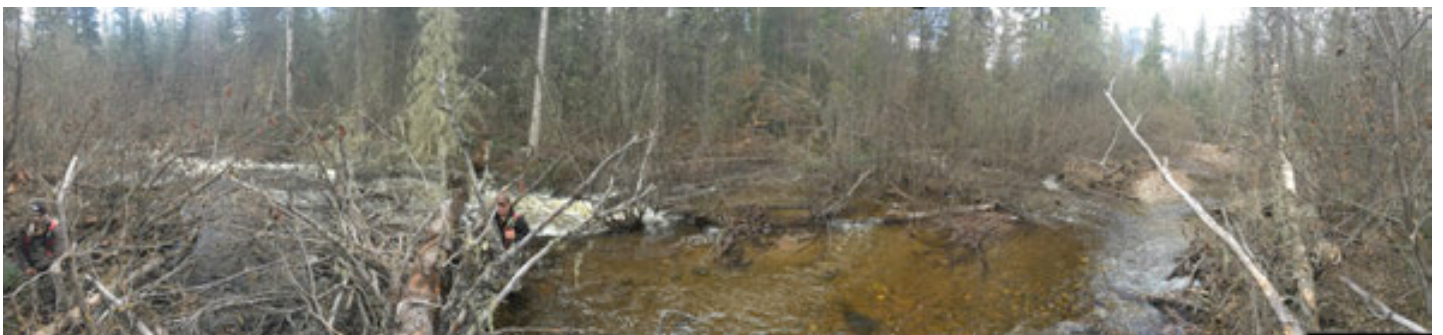
- As noted in 2014 during construction, there is a log jam located just downstream of gravel/cobble deposition that could encourage an avulsion around the creek works constructed in 2014, rendering them ineffective. The log jam accumulated additional debris since 2014. The logjam is located at Long. 124°31'48.53"W & Lat. 56°27'15.54"N (GPS Waypoint). It is recommended that the logjam be monitored and potentially removed where it spans stream.

PHOTO 49 (Panoramic): Logjam creating backwater that could cause an avulsion around the Ole Creek works downstream

- The logjam located at Long. 124°31'48.53"W & Lat. 56°27'15.54"N (GPS Waypoint) should be monitored and potentially removed. It could be removed in the late summer or winter when creek flows are much less.

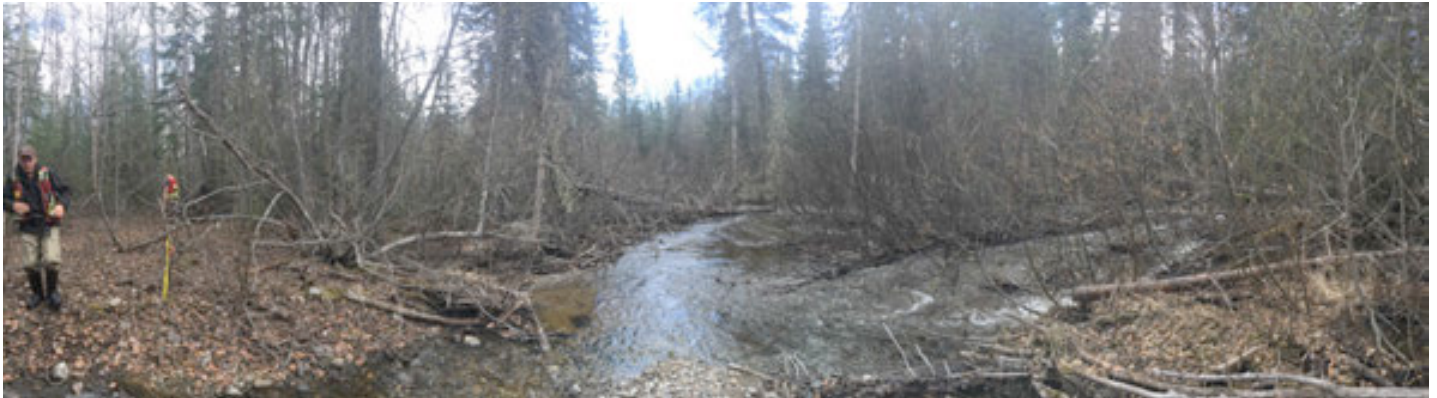
- As noted in the construction completion report¹, there is a gravel bar and logjam upstream of the constructed works that could result in an avulsion along a historical dry channel (see Figure 1 enclosed).

PHOTO 50 (Panoramic): Logjam at centre and potential avulsion path (to the left) looking downstream

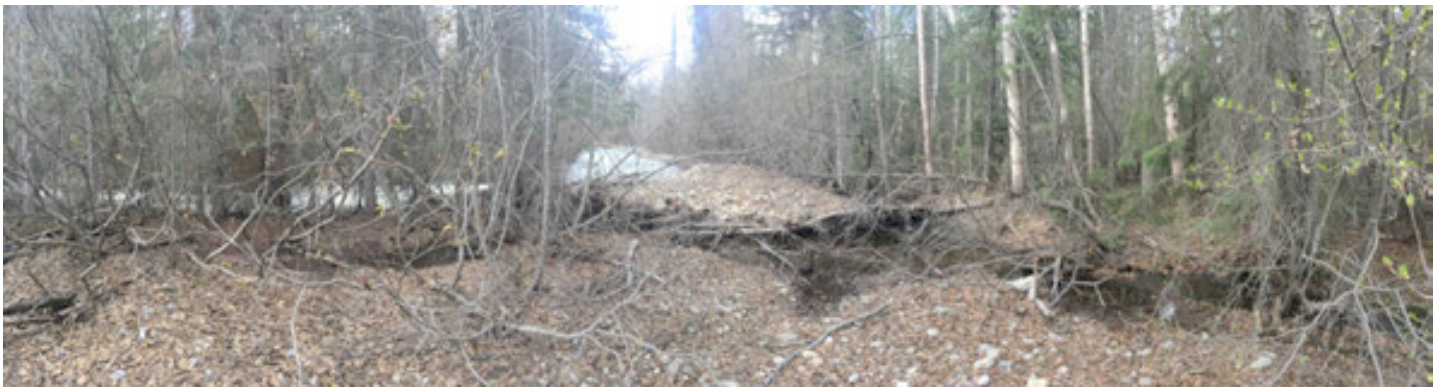
- Gravel/cobble deposited during a large event perhaps about 5 years ago (The environmental monitoring contractor commented that 2011 flow was high in this area). This has changed the course of the creek and it is now undermining tree roots, which will cause trees to fall over and potentially create log jams. The channel has become less defined and more unstable since the 2014 observation. Selective removal of trees at risk of falling across channel could be considered and monitoring is recommended during the annual inspections.

PHOTO 51 (Panoramic): Former creek channel blocked by gravel, looking upstream

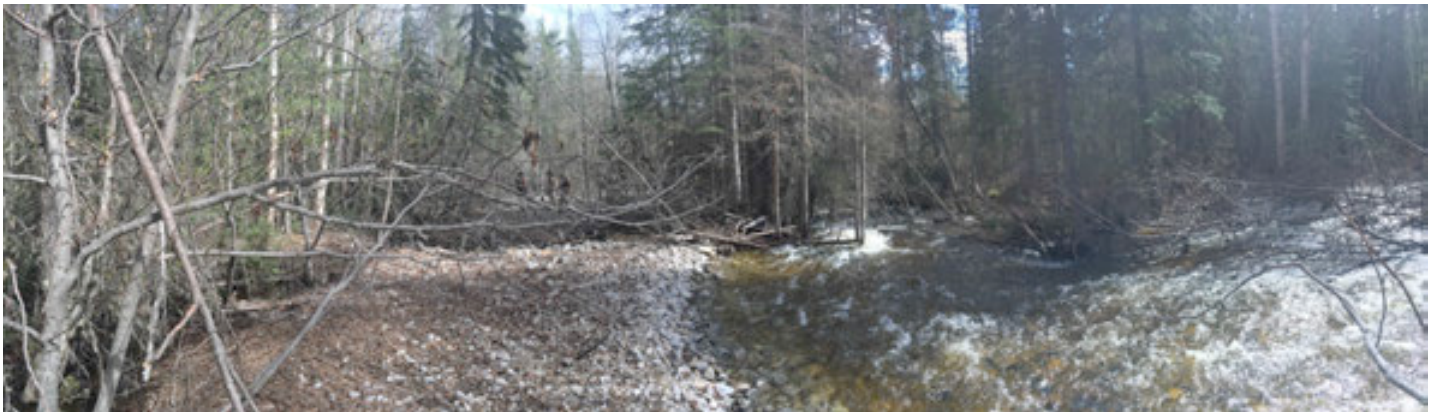
PHOTO 52 (Panoramic): Upstream end of gravel bar on left and altered creek path to right looking downstream. Trees at right could fall and create additional logjams.

- The creek channel upstream of the logjam proposed for removal should be monitored for additional logjams created by trees falling due to the change creek alignment.

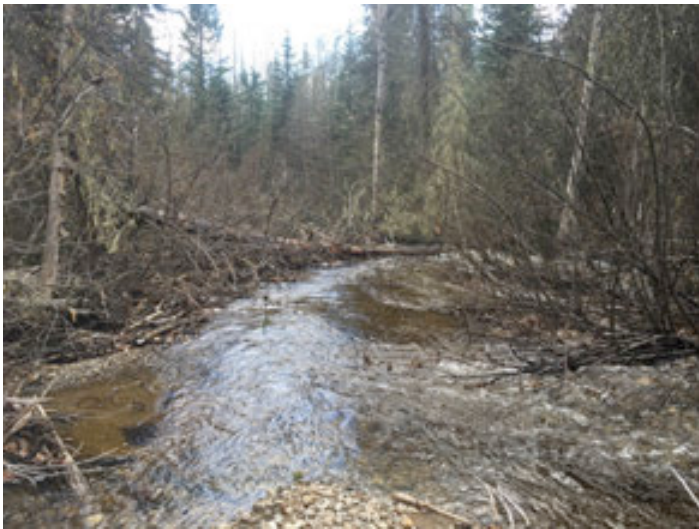
PHOTO 54: Looking downstream at logjam

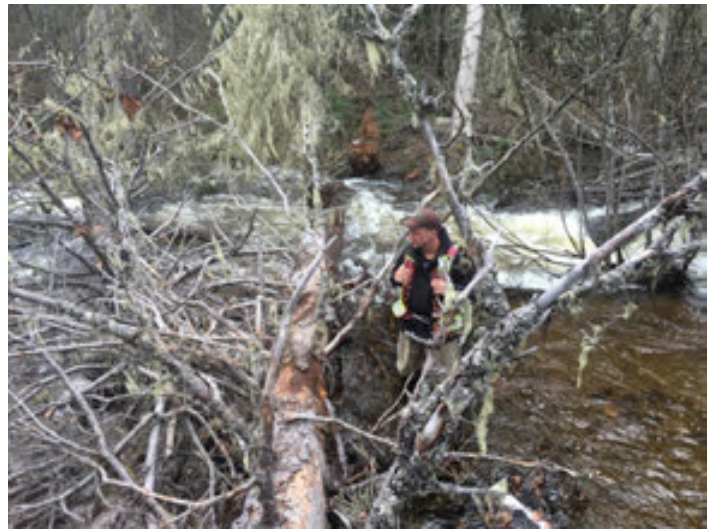
PHOTO 55: Primary log in logjam recommended for monitoring and potential removal

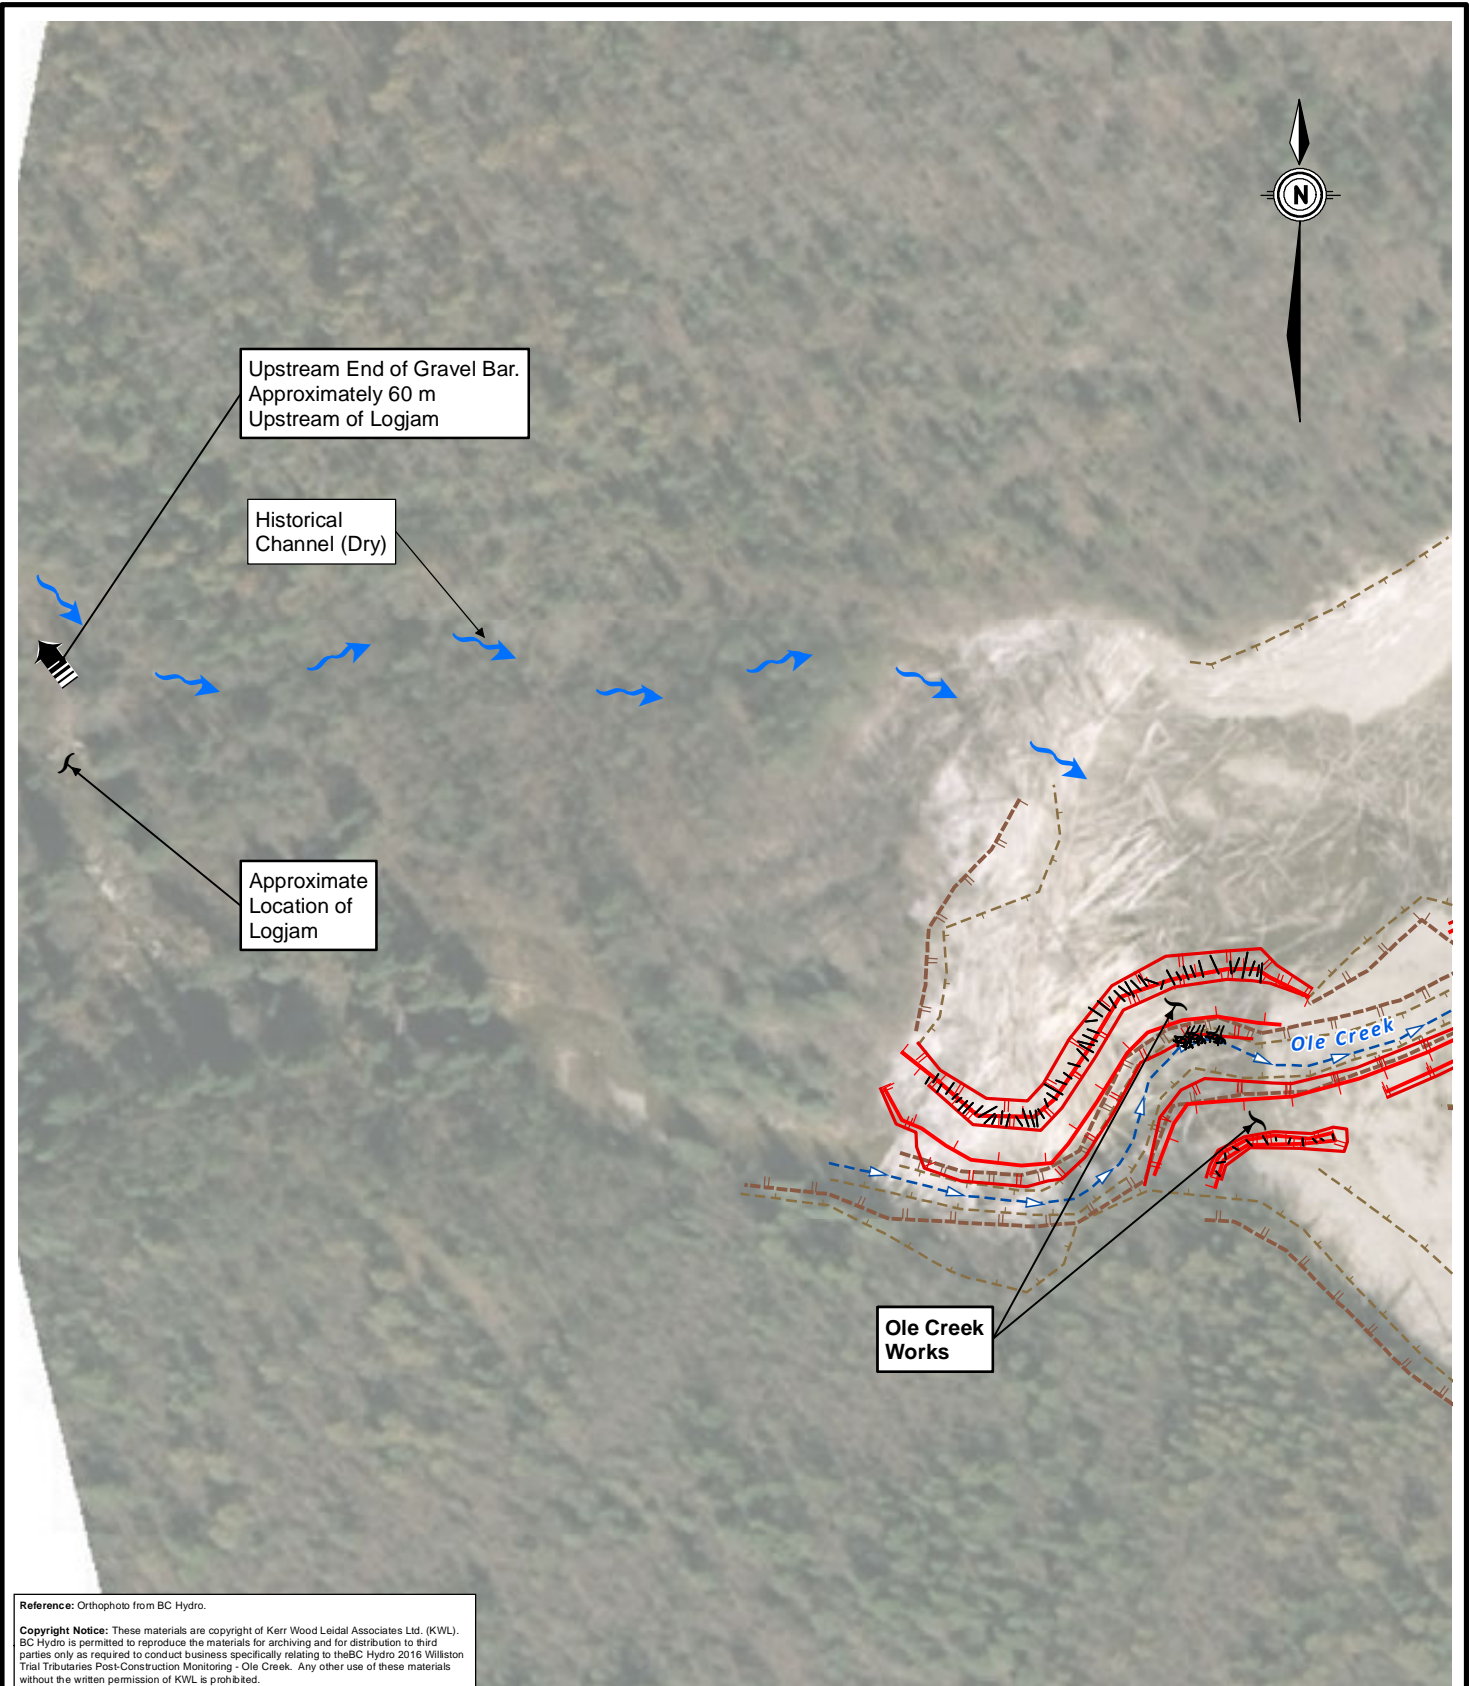
Figure 1

**Location of the Logjam, Gravel Bar,
and Potential Avulsion Path**
