Peace Project Water Use Plan

Williston Reservoir Trial Tributaries

6 Mile 2016 Engineering Inspection Report

Site Inspection Report

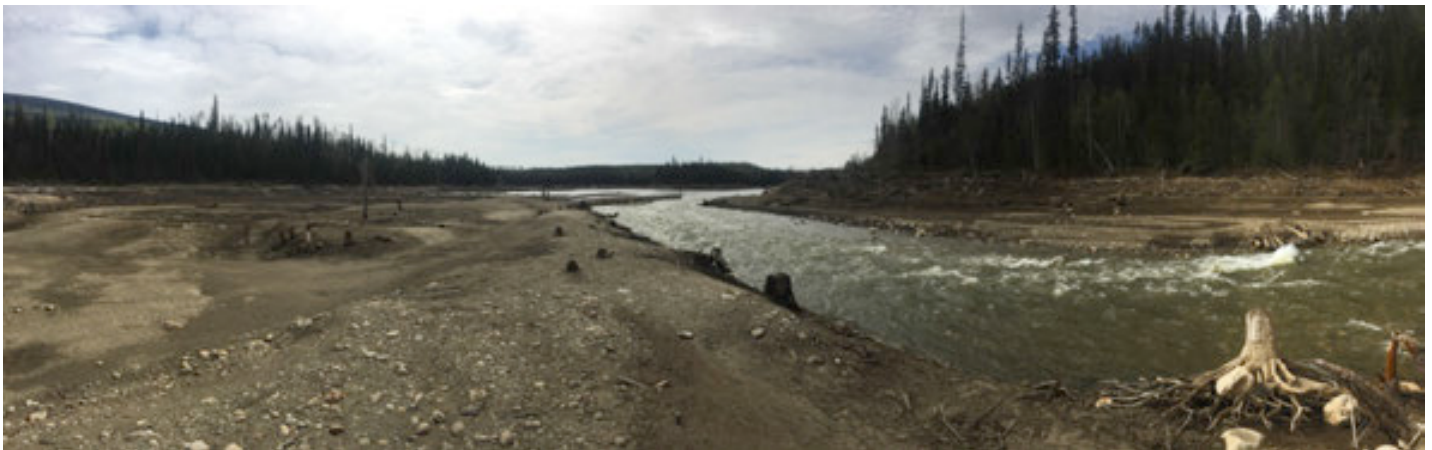
PHOTO 1 (Panoramic): Single Thread Channel Looking Downstream from Berm 'B'

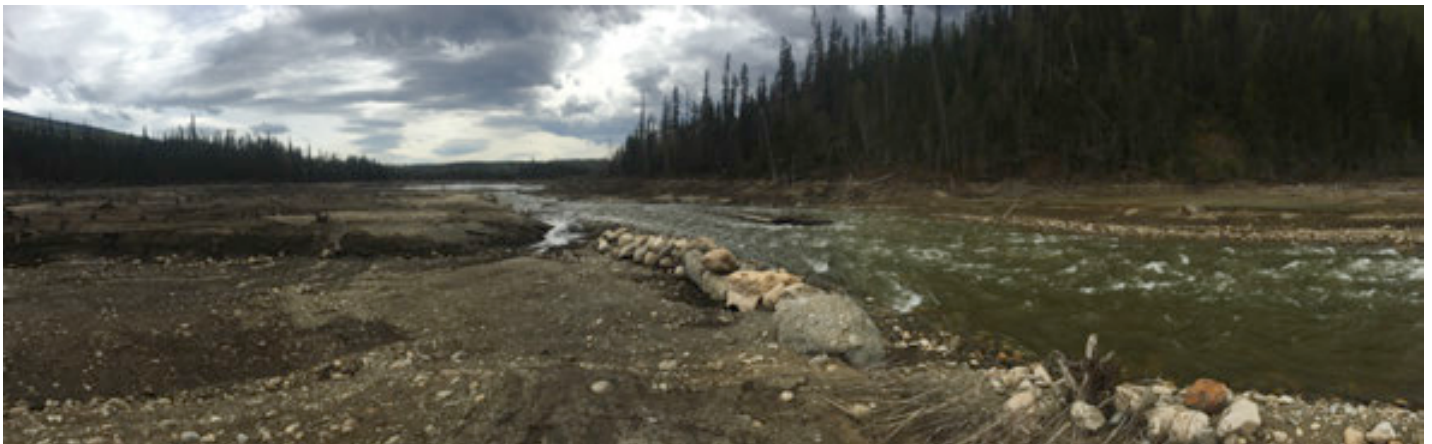
PHOTO 2 (Panoramic): Single Thread Channel Looking Downstream from Downstream End Of Berm 'C'

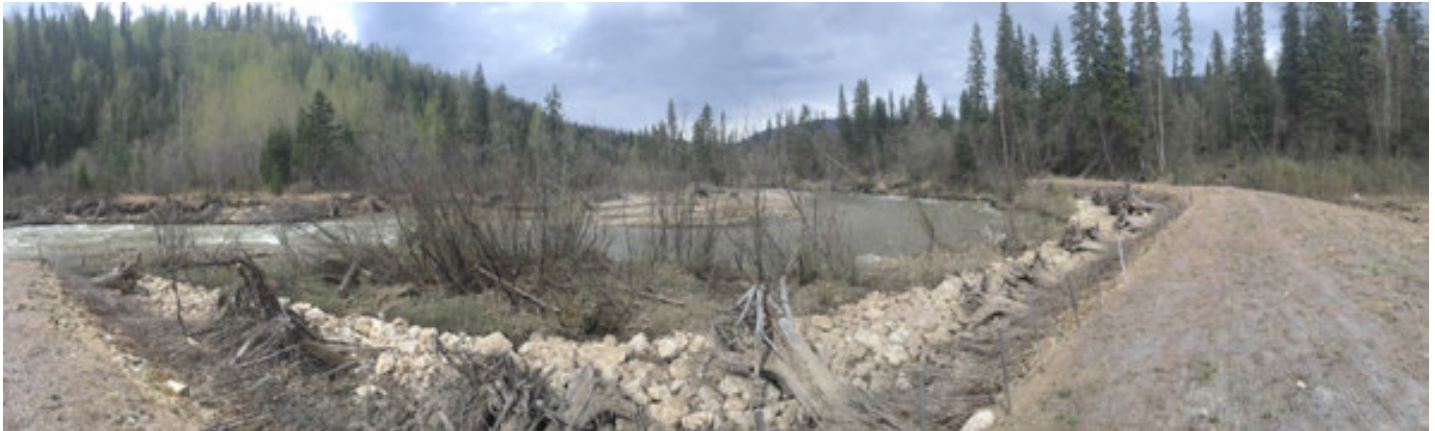
PHOTO 3 (Panoramic): Channel Along Sharp Bend Along Berm 'J' (Note Panoramic Exaggerates Bend)

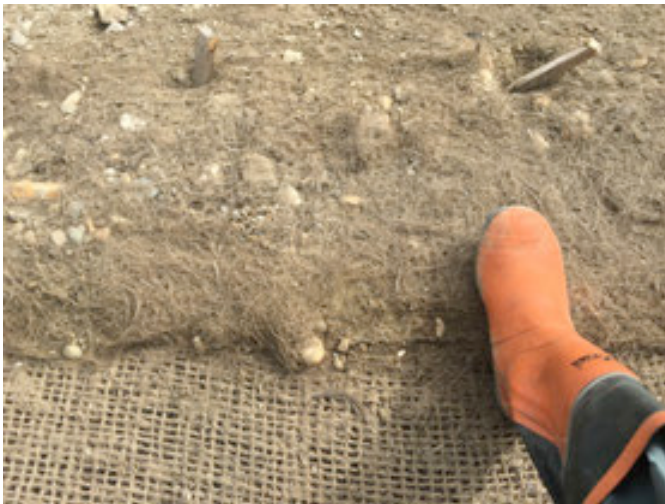
- The coir of the soil wraps is holding up well and no bulk bags (white material) have become exposed.
- The erosion control matting (ECM) is deteriorating (as expected) and will not float as a mat any longer where it had previously become buoyant and caused a concern as a potential trapping hazard to fish. The ECM no longer poses a hazard for fish.

PHOTO 4: Deteriorating ECM (above) & Coir Soil Wraps in Good Condition (below)

- As the ECM has a relatively short lifespan and has deteriorated significantly, the berm surfaces covered by the ECM, may experience some erosion. These areas should be monitored during future annual monitoring. If significant erosion occurs, then BC Hydro could consider protecting those areas.

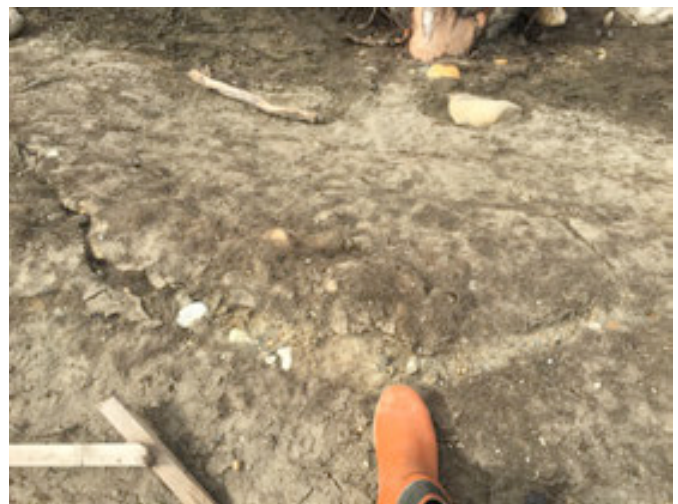
PHOTO 5: Ice Damage to ECM.

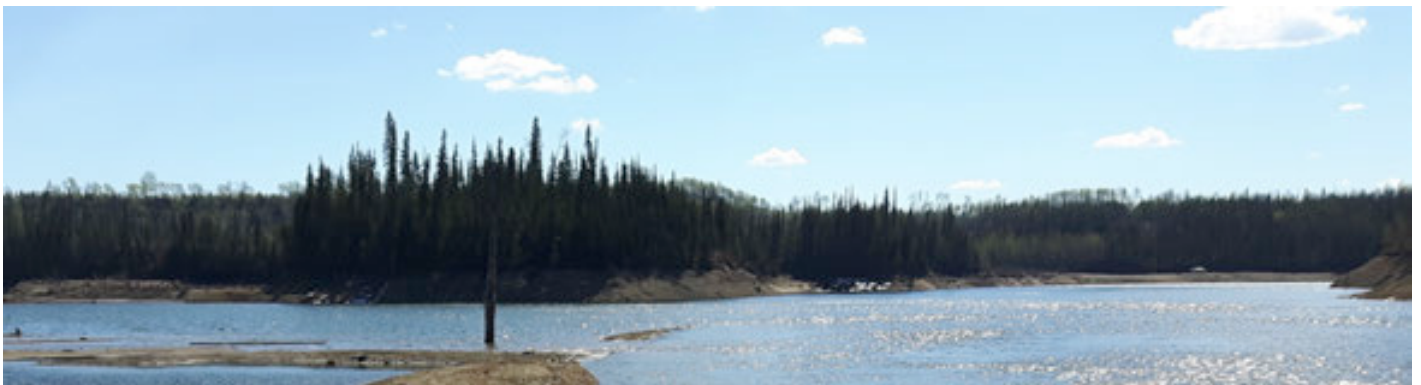
- Berm 'A' was fully submerged, KWL was unable to perform an inspection.
- This berm is considered to be less critical than the upper berms relative to the overall function of the works.

PHOTO 6: Looking Downstream at Berm 'A' (fully submerged) and Berm 'G' (mostly submerged)

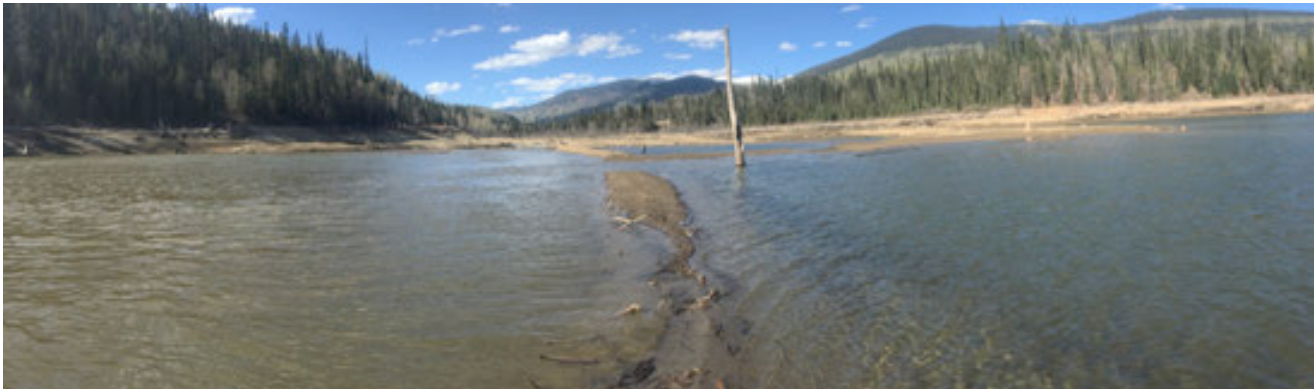
PHOTO 7 (Panoramic): Looking Upstream at Berm 'G'

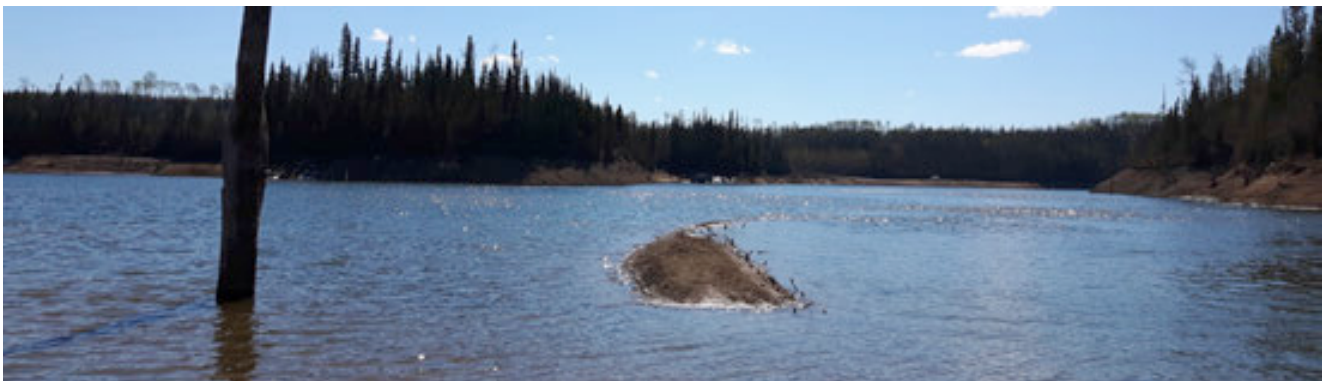
PHOTO 8 (Panoramic): Looking Downstream at Berm 'G'

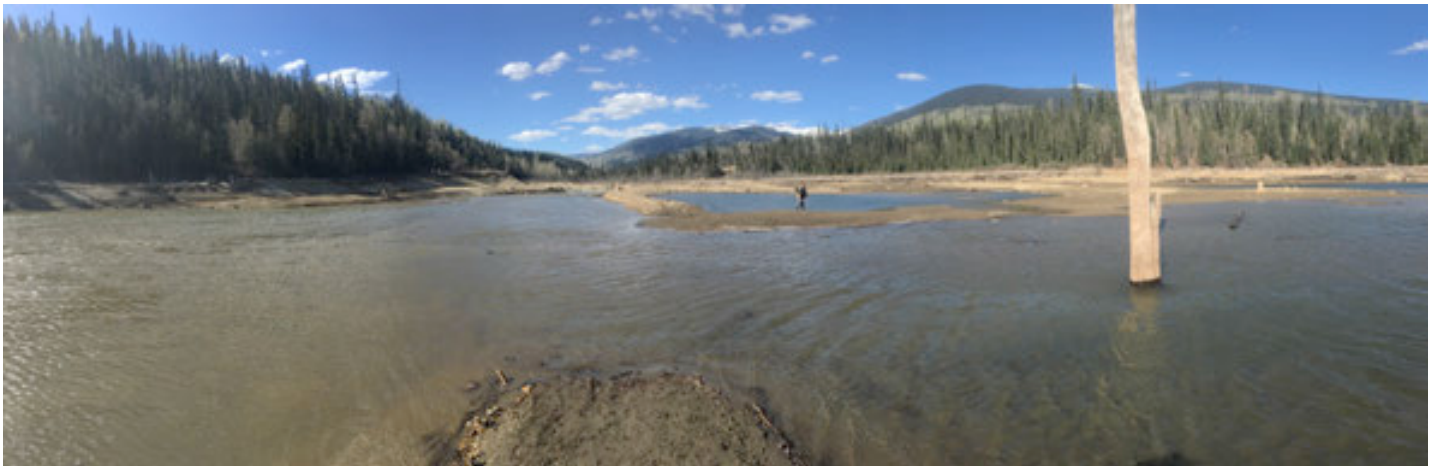
PHOTO 11 (Panoramic): Looking Upstream from Berm 'G' to Berm 'F'

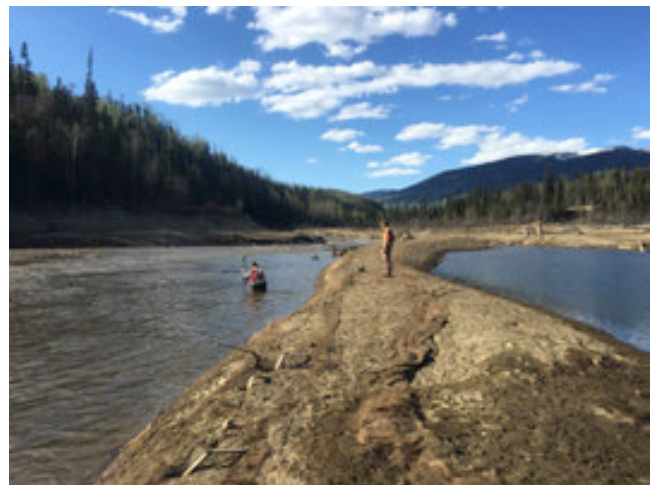
- The ECM is deteriorating and has been rolled up along the crest in locations, most likely due to becoming buoyant and the creek overtopping of the berm crest as the reservoir level rises.

PHOTO 13: Berm 'F' Looking Upstream (Note Damaged/Decomposing ECM)

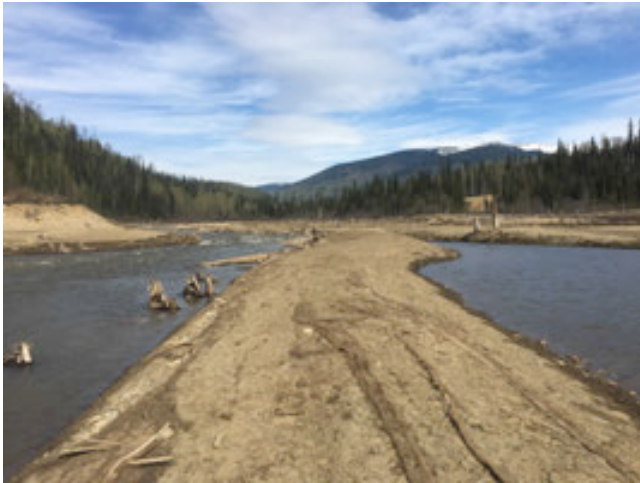
PHOTO 14: Berm 'F' Looking Upstream (Note Damaged/Decomposing ECM). Water on Right Side of Photo is Backwater from Reservoir, Not a Side Channel.

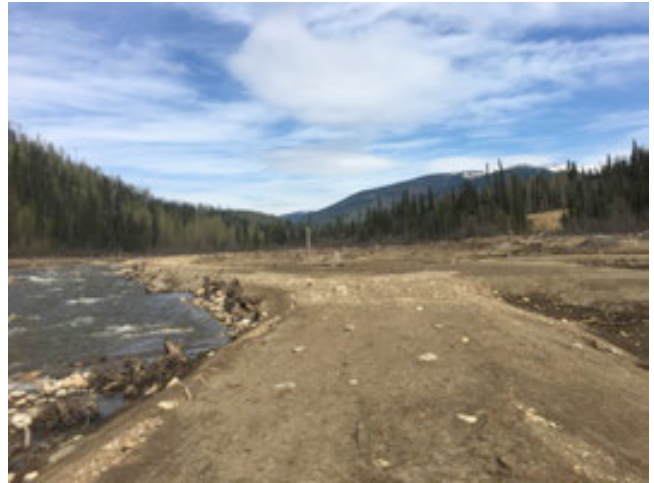
PHOTO 15: Upstream End of Berm 'F' Looking Upstream

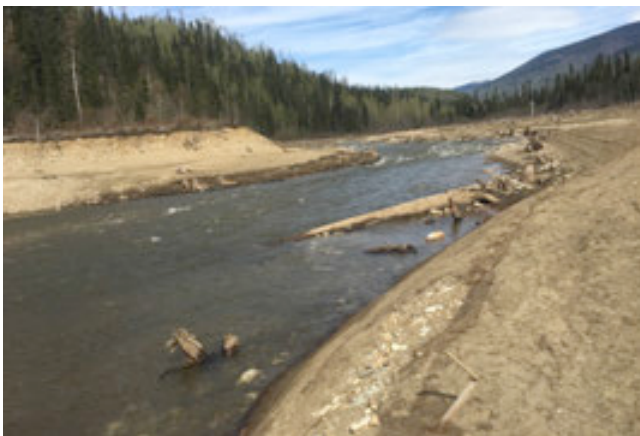
PHOTO 18: Deposited Log Along LWD and Deteriorating ECM

- There is very little accumulation of woody debris.
- Some isolated pieces and logs observed, such as at Berm 'F' as noted in Photo 18 above.

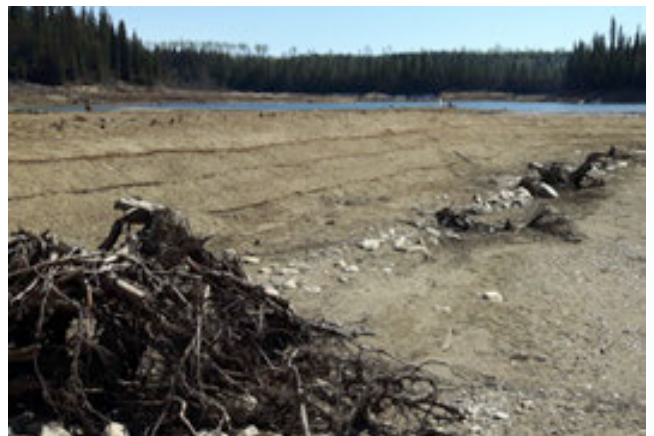
PHOTO 19: Coir Soil Wrap Layers in Good Condition. Note Upper Layer is ECM.

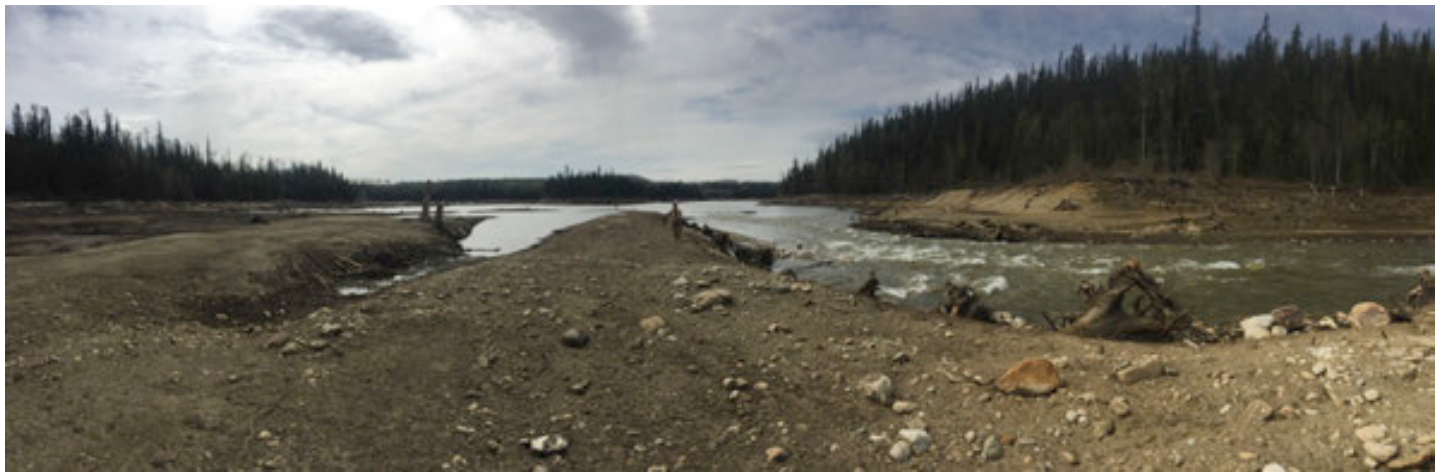
PHOTO 20 (Panoramic): Looking Downstream at Berm 'D'

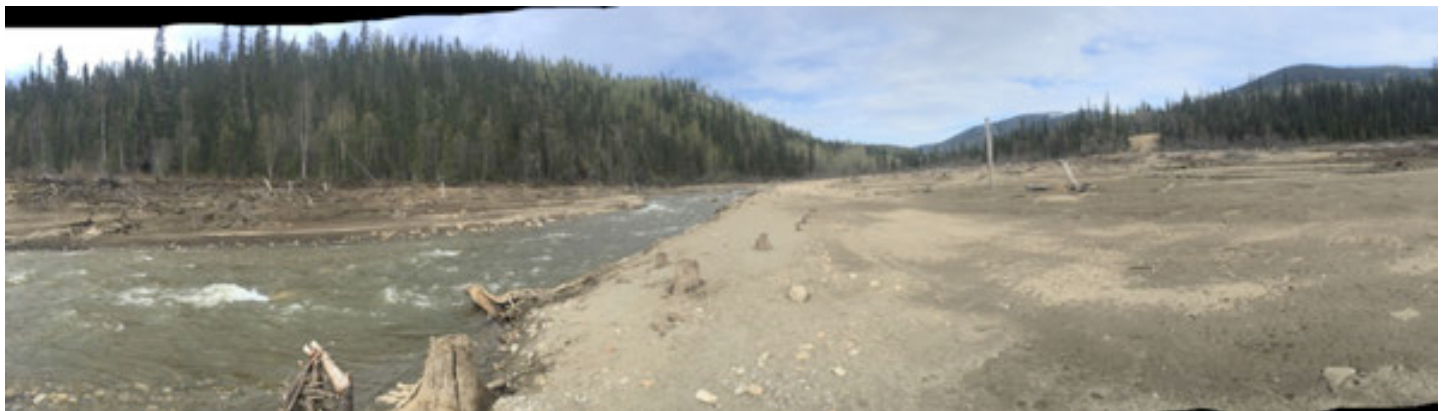
PHOTO 21 (Panoramic): Looking Upstream from Upstream End of Berm 'D'

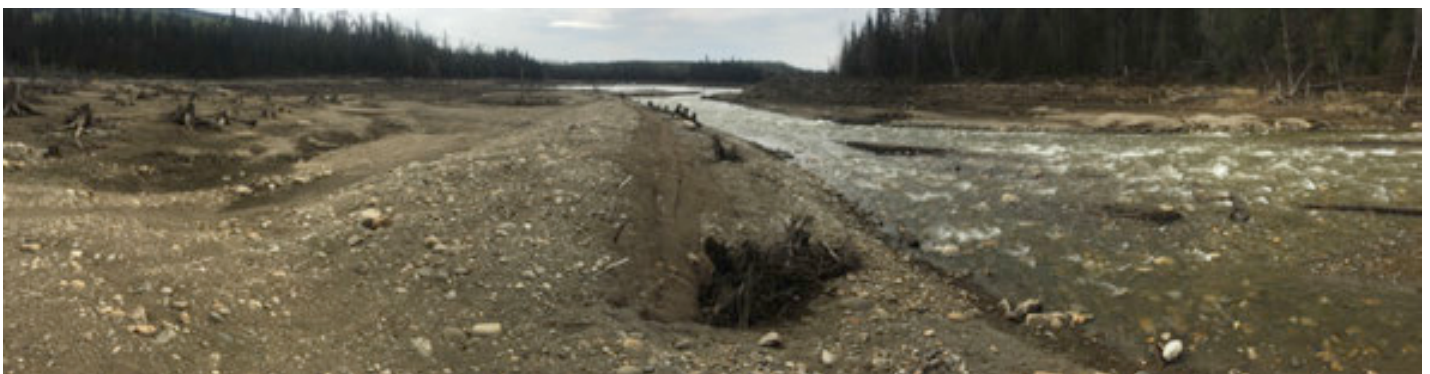
PHOTO 26 (Panoramic): Looking Downstream at Berm 'B'

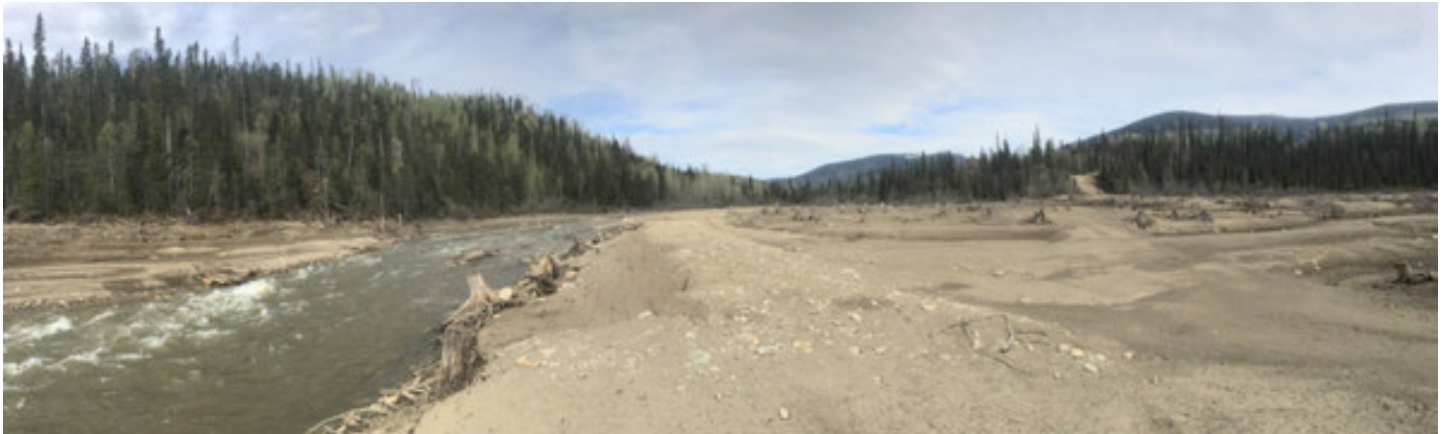
PHOTO 27 (Panoramic): Looking Upstream at Berm 'B'

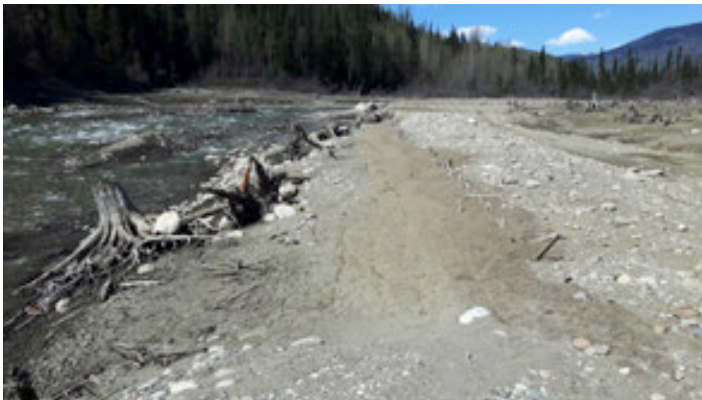
PHOTO 28: Coir Soil Wraps in Good Condition

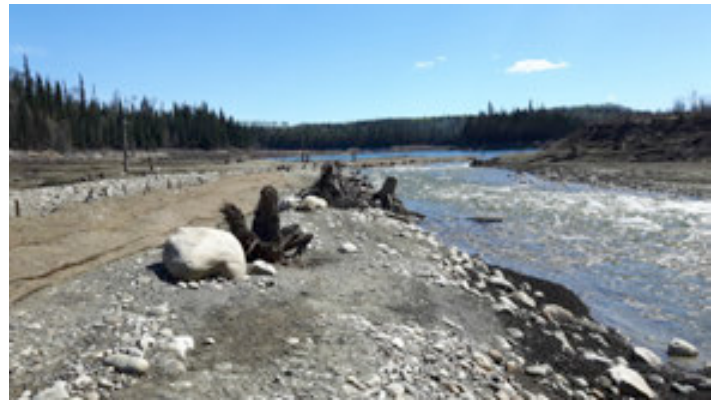
PHOTO 29: There Appears to be Some Deposition at the Berm Toe (and Channel Erosion in Thalweg)

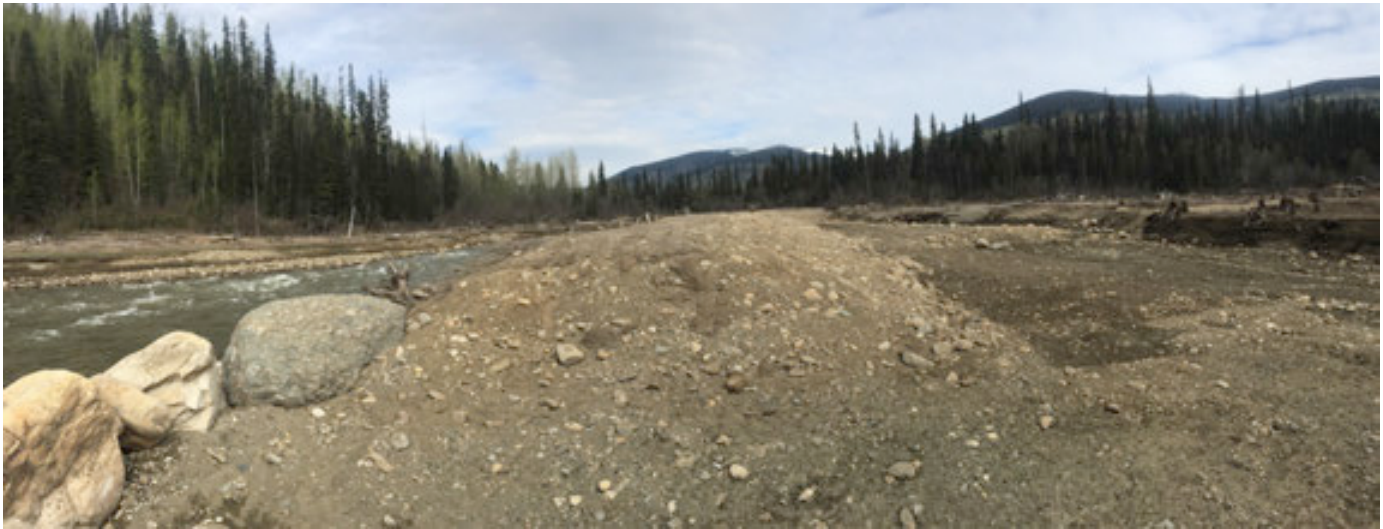
PHOTO 30 (Panoramic): Downstream end of Berm 'C' looking upstream.

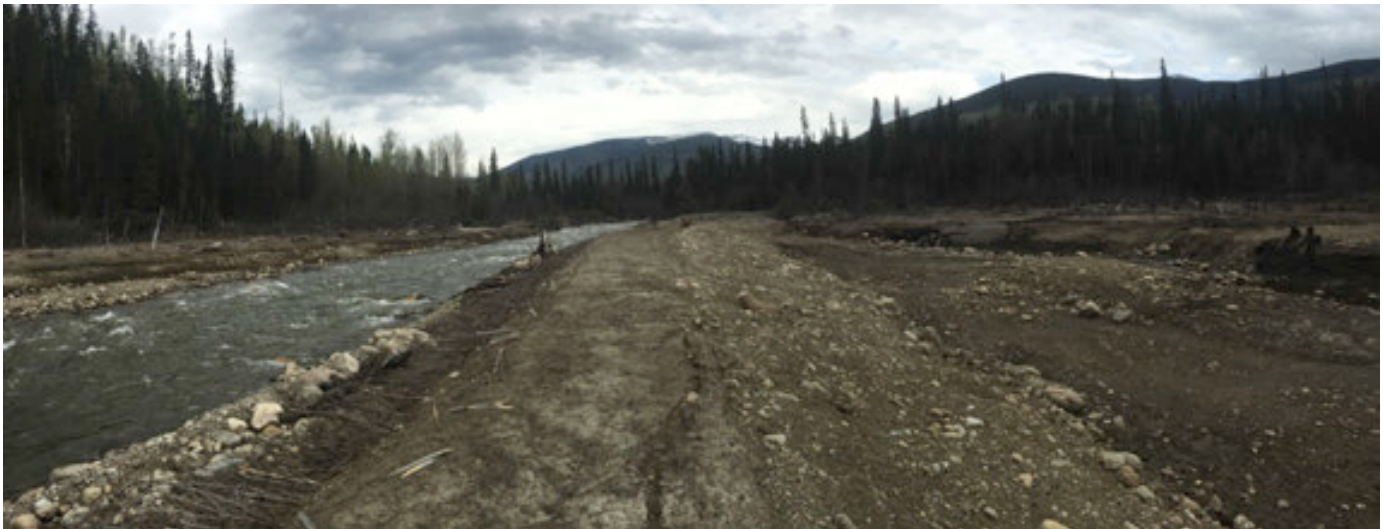
PHOTO 31 (Panoramic): Berm 'C' looking upstream from downstream end.

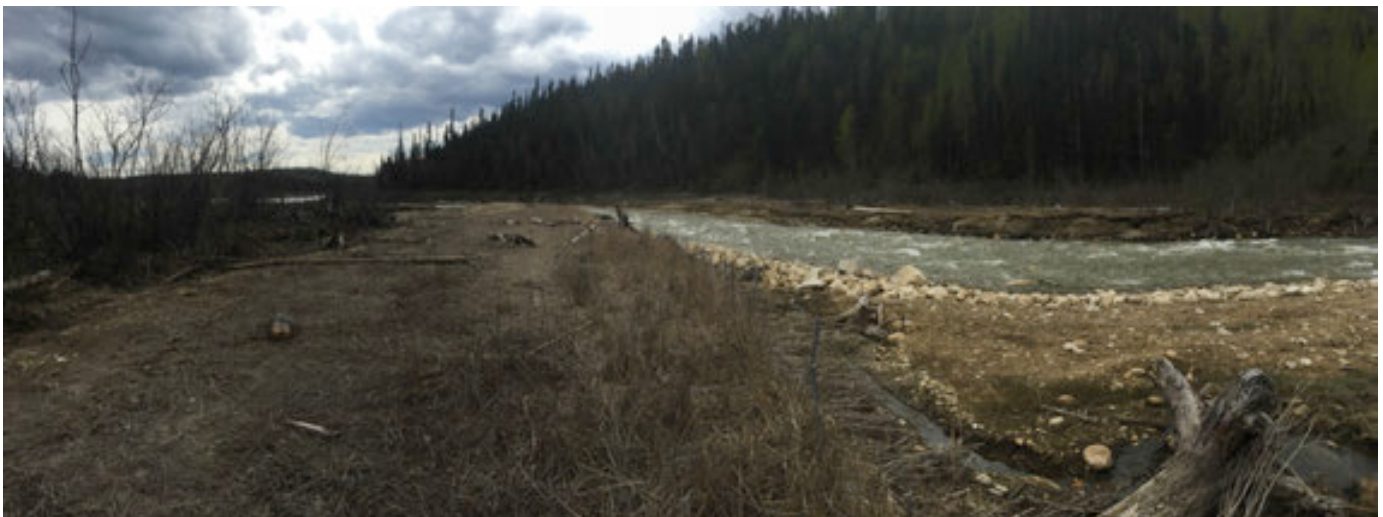
PHOTO 32 (Panoramic): Looking downstream from upstream end of Berm 'C'

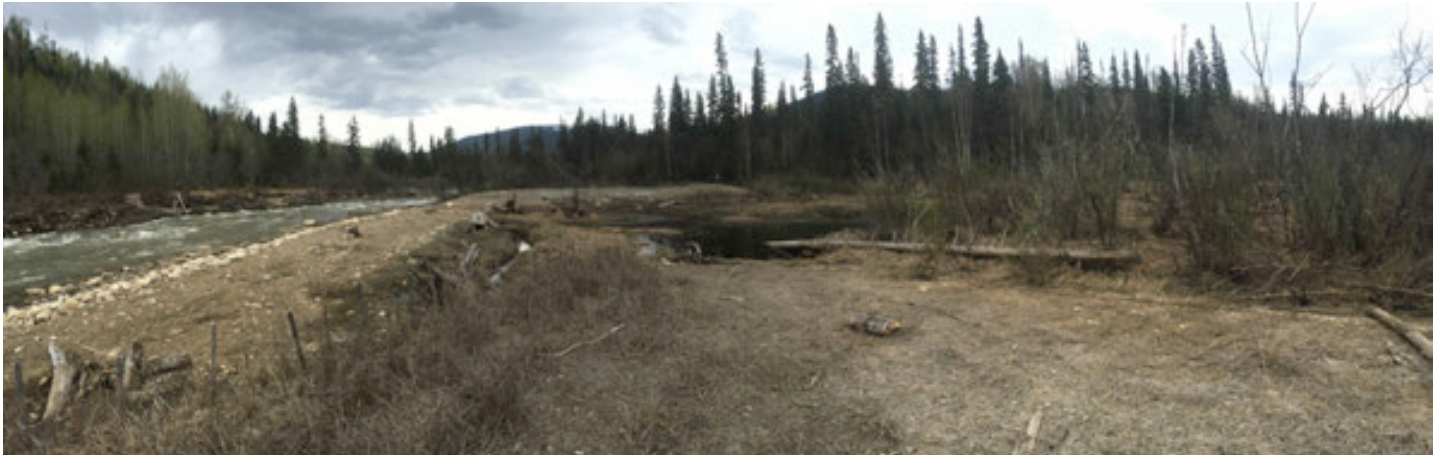
- The upstream tie-in location for Berm 'C' to the beaver pond is stable and has not changed since construction.

PHOTO 33 (Panoramic): Intact beaver/habitat pond upstream of Berm 'C'.

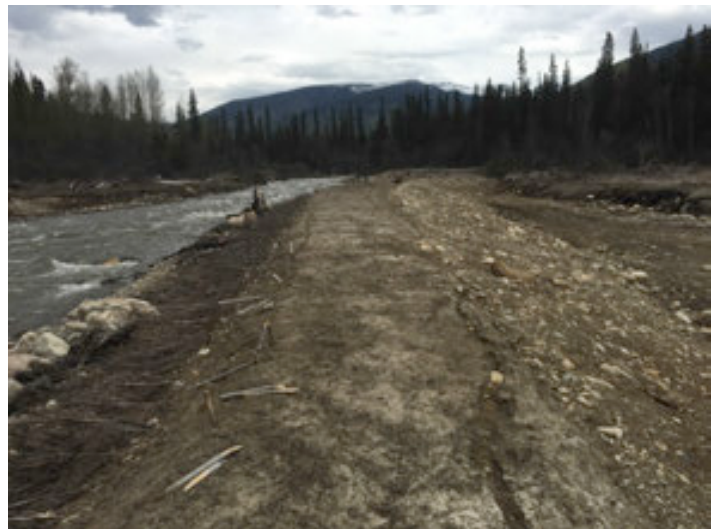
PHOTO 35: Downstream end of Berm 'C' looking upstream

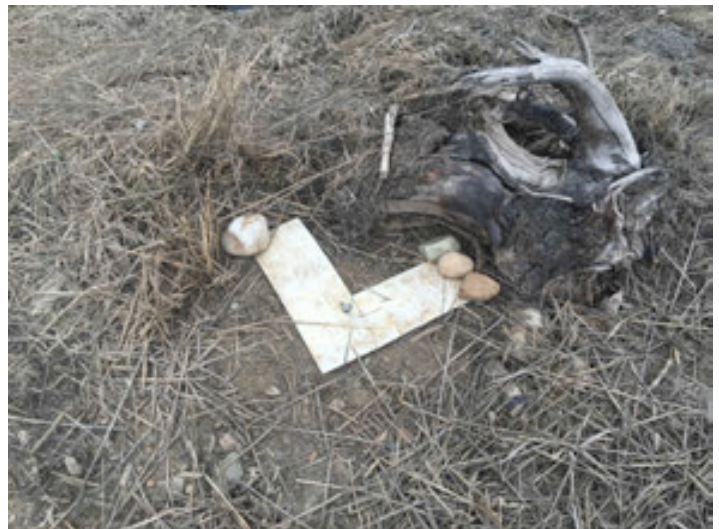
PHOTO 37: UAV Marker (surveyed)

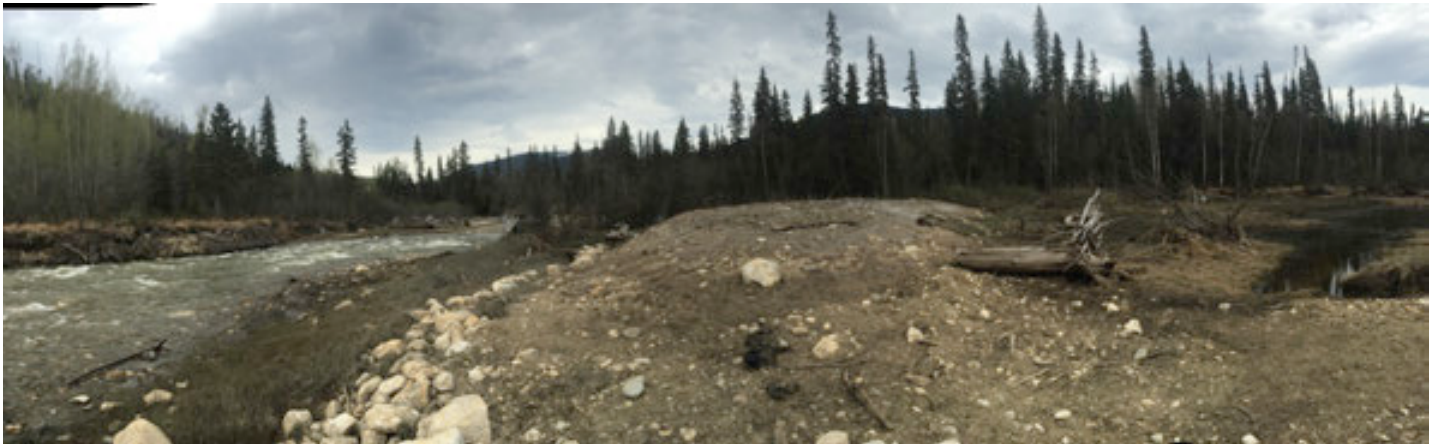
PHOTO 42 (Panoramic): Downstream end of Berm 'J' looking upstream. (Note black geotextile in foreground which is likely silt fence material, not bulk bag material, which is white.)

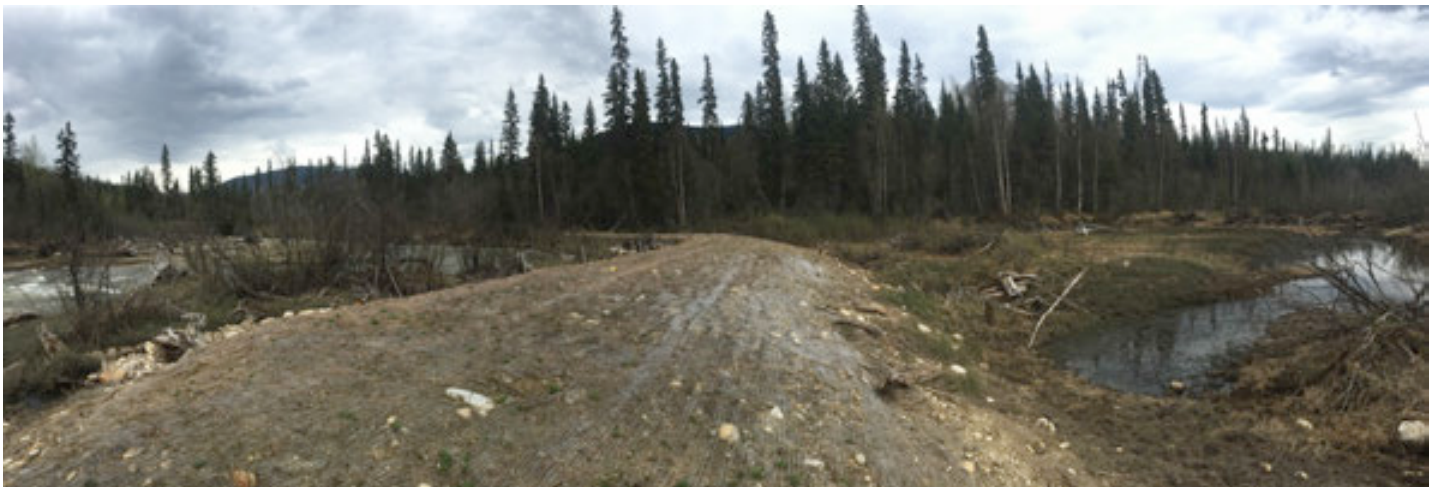
PHOTO 43 (Panoramic): Berm 'J' looking upstream. Beaver / habitat pond at right of the photo

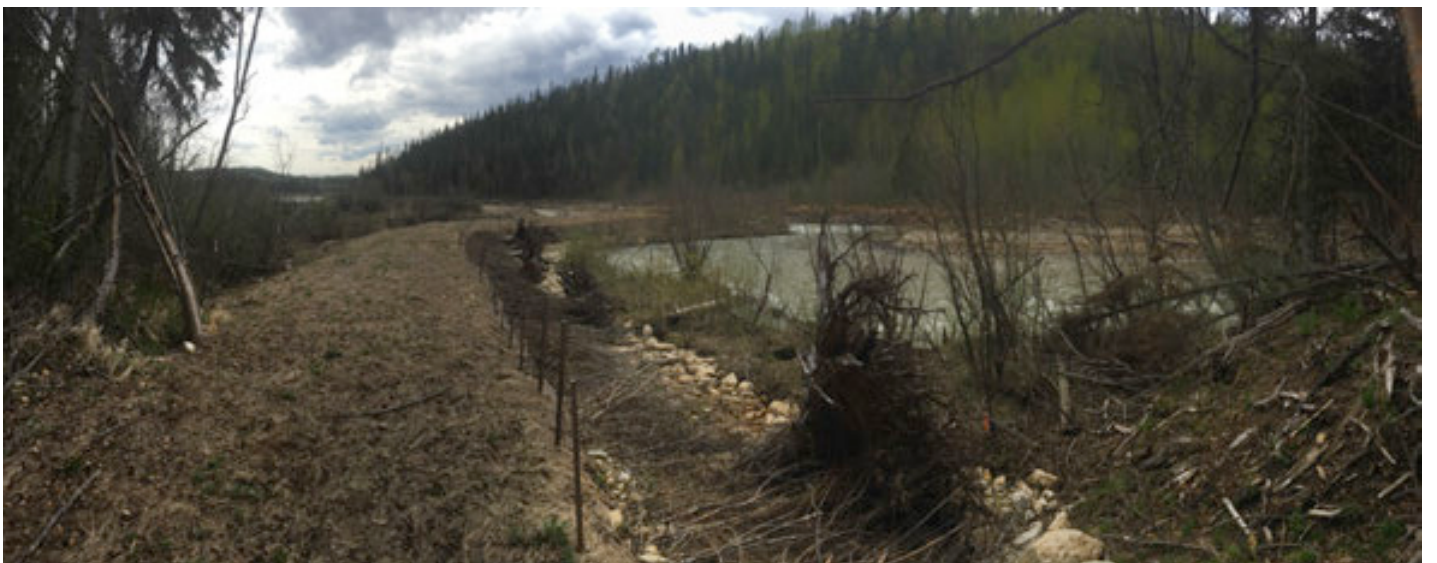
PHOTO 44 (Panoramic): Looking downstream at Berm 'J'

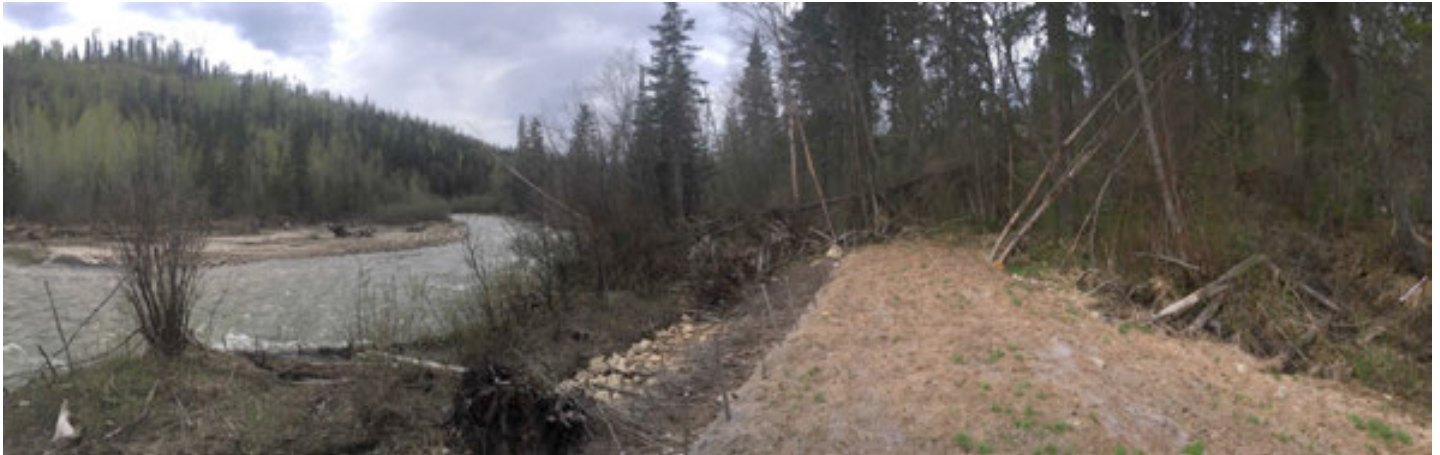
PHOTO 45 (Panoramic): Upstream end of Berm 'J' looking upstream

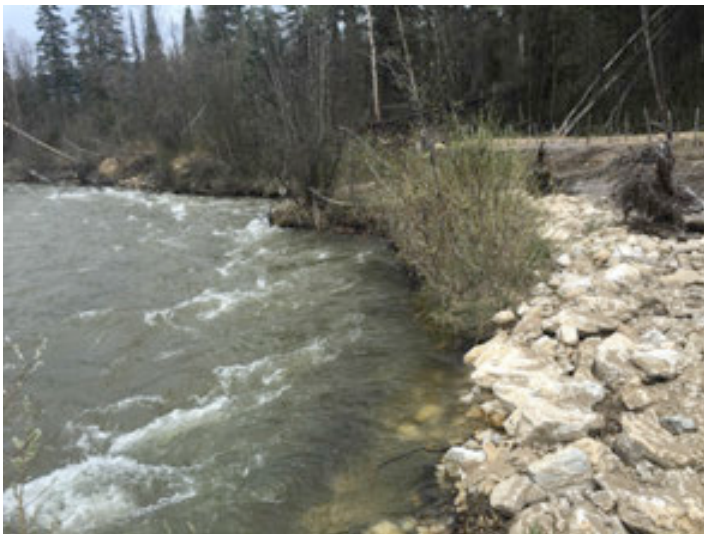
- The LWD is in good condition and has not displaced.
- The creek has eroded away the bank in front of the berm and there is now a ~2m long section of riprap exposed to the water (see Photos 46 & 47).

PHOTO 46: Eroding Bank and 'launching' riprap toe trench looking upstream

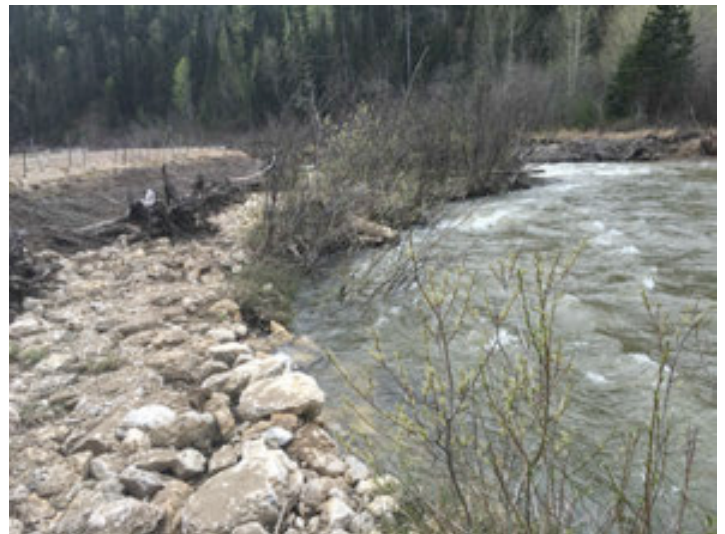
PHOTO 47: Eroding bank and 'launching' riprap toe trench looking downstream

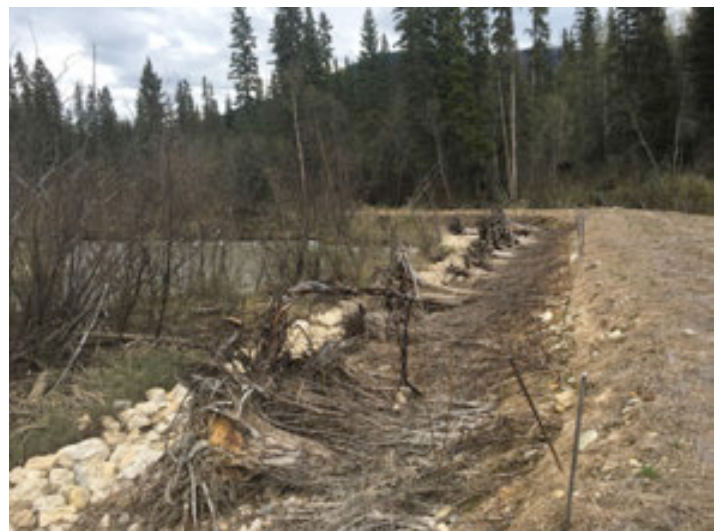
PHOTO 49: Coir soil wraps, willow brush layers, LWD, and riprap toe looking upstream

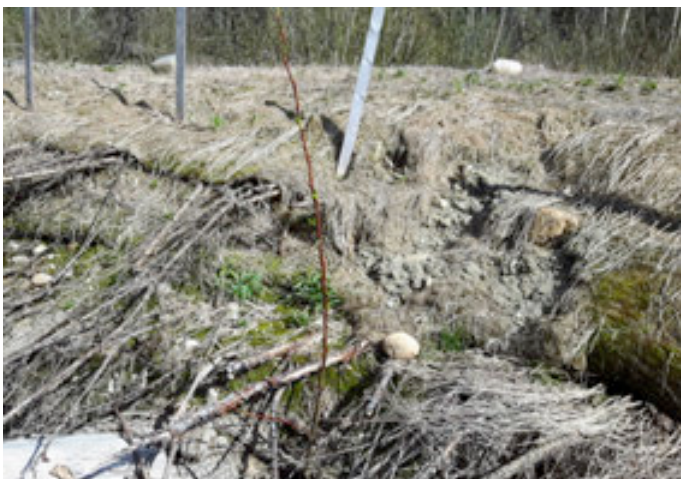
- Grass and other vegetation growing on top and on back side of berm.
- The ECM has deteriorated as expected.
- Evidence of moose damage to crest of berm (hoof prints observed, see Photos 53, 54 & 55).

PHOTO 54: Moose related damage on creek-side slope (mostly to ECM layer)

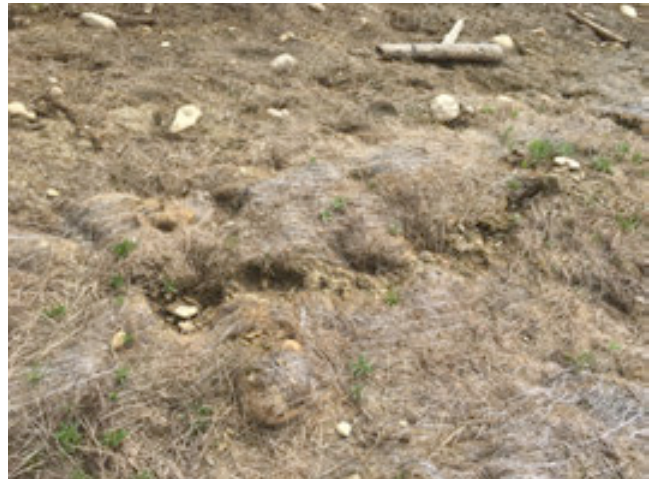
PHOTO 55: Moose related damage on back-side slope of berm

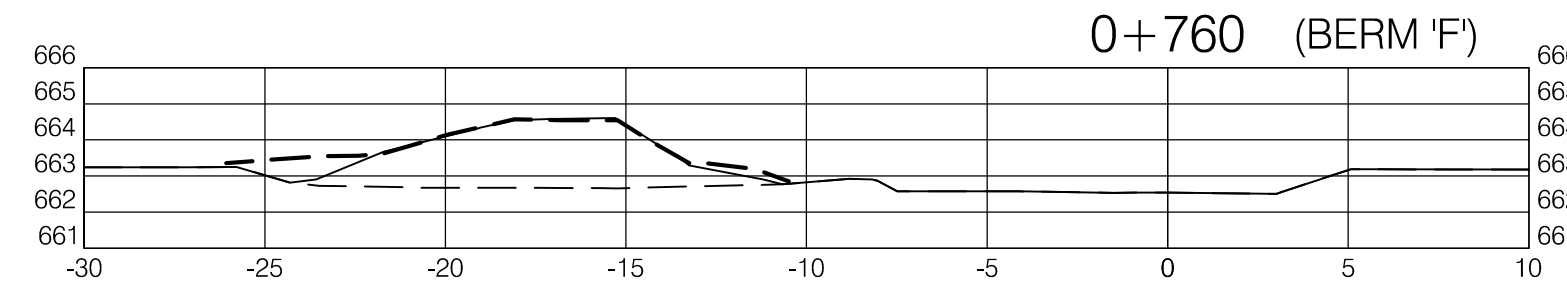
POSSIBLE LOCAL EROSION OR SETTLEMENT. VISUAL CONFIRMATION NOT POSSIBLE AS MUCH OF THE BERM WAS SUBMERGED DURING 2016 INSPECTION

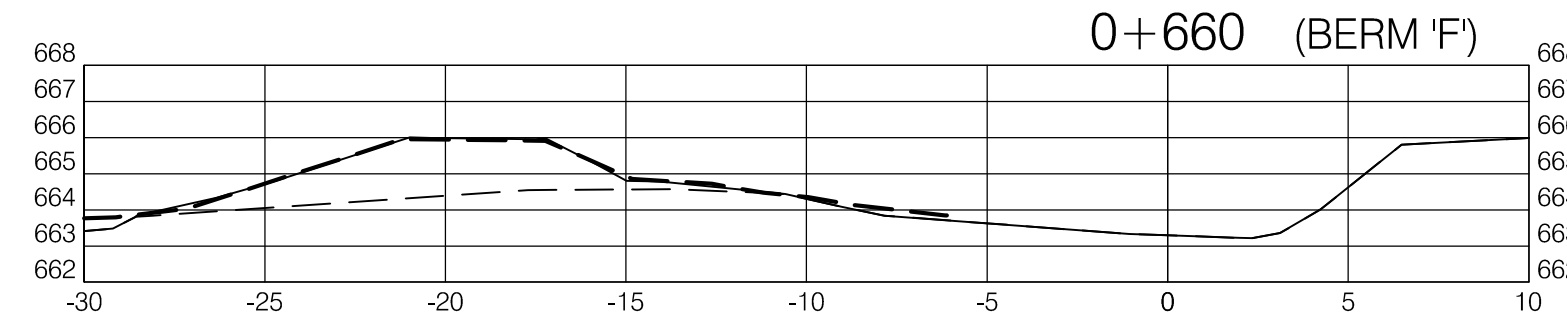
POSSIBLE LOCAL EROSION OR SETTLEMENT. VISUAL CONFIRMATION NOT POSSIBLE AS MUCH OF THE BERM WAS SUBMERGED DURING 2016 INSPECTION
