**Peace Project Water Use Plan**

**Peace River Trial Side Channels**

***Peace River Side Channel Restoration Hydrotechnical  
Monitoring - 5 Year Post Construction Inspection***

Re: **Peace River GMSWORKS3 Trial Side Channel KM 102.5R  
Hydrotechnical Monitoring 2019**

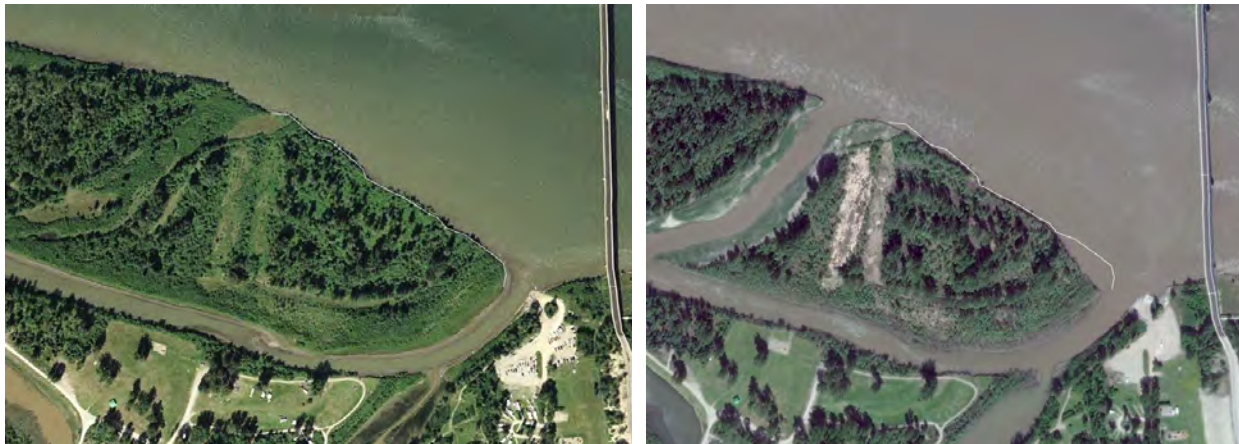
**Figure 4.2** Progression of erosion (estimated at 45 m) along downstream end of island from March 2010 (left image) to June 2015 (right image) (©GoogleEarth)

A third area of erosion that is impacting the site is erosion of the riverbank on the north side of the island, that is the south bank of the Peace River downstream of the 102.5R side channel (Figure 2.1). This erosion was initially identified at the downstream end of the island in 2015 (NHC, 2015b). It appears to be a direct result of flow being directed towards the south bank from the development of a mid-channel bar (Figure 4.2). The bar appears to have migrated or grown upstream from its original location under the Taylor Bridge. Review of the past @GoogleEarth images suggests that erosion at the downstream end of the island has been as rapid as 10 m/y (Figure 4.2).

Over the past couple of years, this erosion has migrated upstream. Immediately downstream of the 102.5R site, the bank has eroded 17 m since June 2016 leaving the base of the utility towers at a distance of 43 m from the top of bank as of 30 September 2019, and the guy wires 22 m from the bank (Photo 21 to Photo 34). The average erosion rate is 4 to 5 m per year since 2016. At this rate, the utility towers could be undermined or threatened within the next 5 to 10 years. An increased rate of erosion that approaches that seen downstream would expose the guide wires within 2 years and expose the tower foundations in as little as 4 years. Increased or sustained high flow or further bar growth, which can be reasonably expected to be possible with continued sediment loading from the Pine River and/or further reductions in flushing flows from Site C construction, could lead to further accelerated erosion rates.

**Due to the potential for rapid erosion and a reduced buffer between the top of bank and the guide wires and utility towers, it is recommended that mitigation measures be developed as soon as possible.** These could include increased monitoring frequency, installation of remote monitoring (such as real-time accessible field cameras), bank armouring, or flow redirection. NHC is working in the area and can provide support if required for any of these approaches.

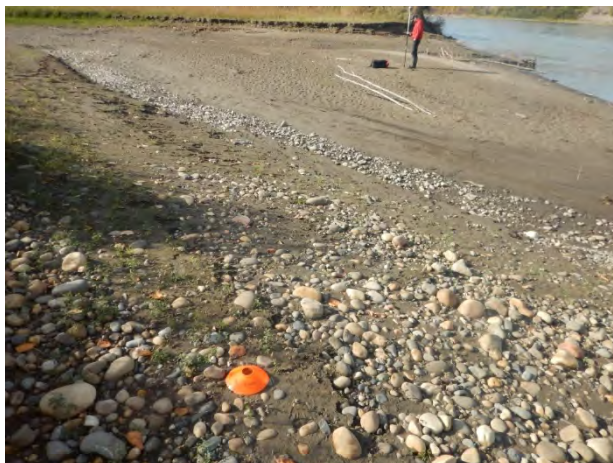
Most of the noted bank retreat (20 m) at the northeast site occurred within the first week of active flow through the channel as the bank adjusted to increased flow through 102.5R. The rate of erosion slowed considerably over the next 3 weeks and by 2016 was found to regress at a rate of 1.5 to 2.0 m/y. The 2019 inspection found a continued reduction in erosion rates. The toe of the slope appears relatively constant with regrading of the slope resulting in further regression of 1.0 to 1.5 m from 2016 to 2019 (rate of 0.3 to 0.5 m/y). The maximum bank retreat from 1 May 2014 to 30 September 2019 was 11.5 m. As of the 30 September 2019 site inspection, the bank is 75 m away from the nearest utility line pole and 75 m away from the nearest guide wire.

Given the reduction in the rate of lateral bank erosion and remaining distance to the utility line poles, erosion at the northeast site does not present an immediate threat to the BC Hydro assets.

Photo 1 Section 5, view west from left bank at the mouth of 102.5R (northeast bank erosion)

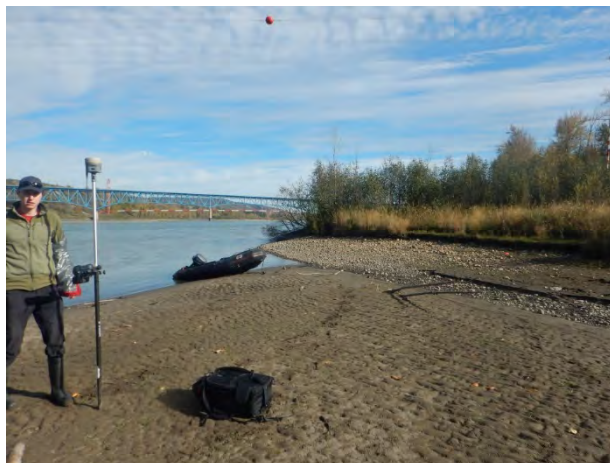
Photo 2 Section 5, view east from right bank at the mouth of 102.5R 5R (northeast bank erosion)

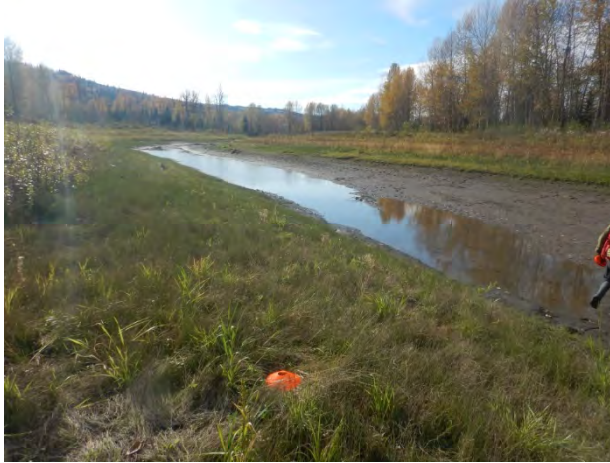
Several large pools were evident during site inspection (Photo 5, Photo 6, Photo 8, Photo 10, Photo 12, and Photo 14). Fish stranding may occur in these pools, leaving fish susceptible to suffocation and predation. No evidence of fish stranding was seen during the site inspection.

Photo 5 Section 4.5, view southeast from left bank

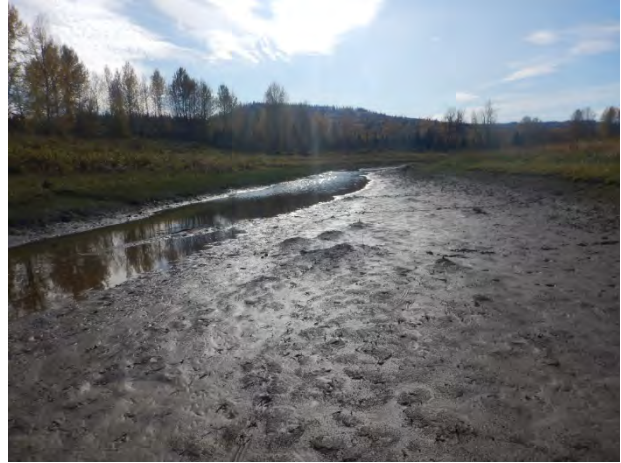
Photo 6 Section 4.5, view south from mid channel

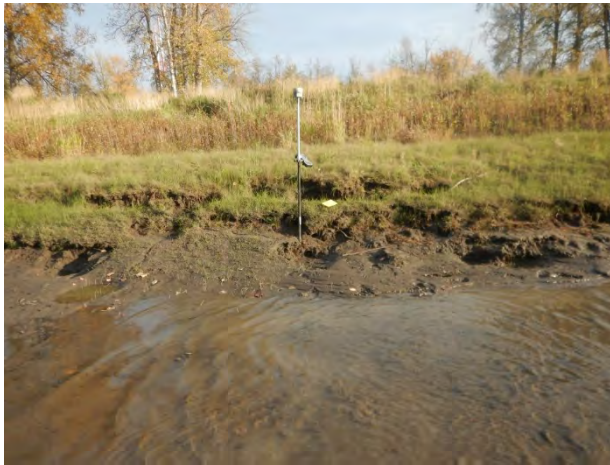
Photo 7 Section 4.5, left bank slumps

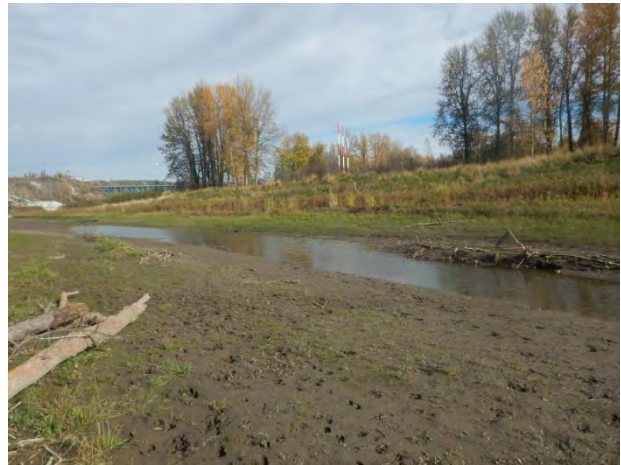
Photo 8 Section 3, view east from right bank

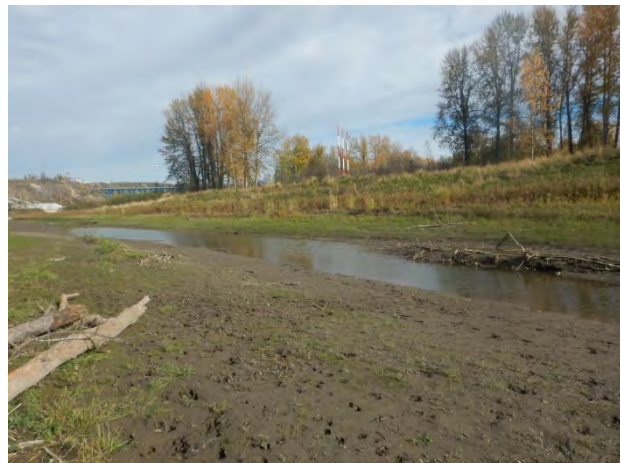
Photo 10 Section 3, view northeast from right bank

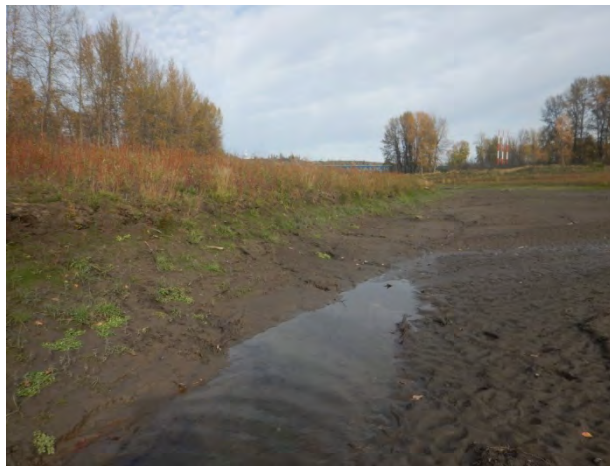
**Photo 12** Section 2, view north from right bank

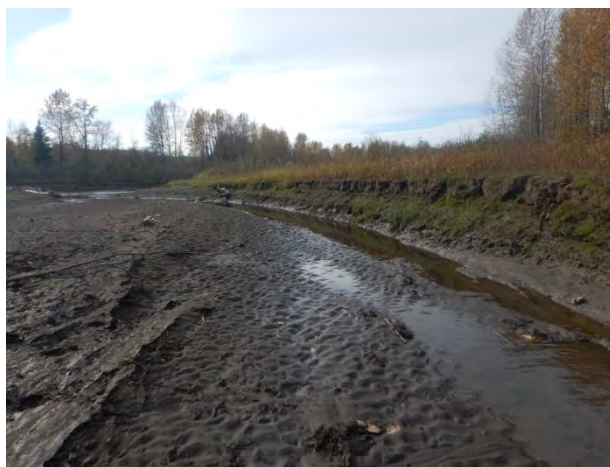
**Photo 14** Section 1.5, view south west of right bank erosion

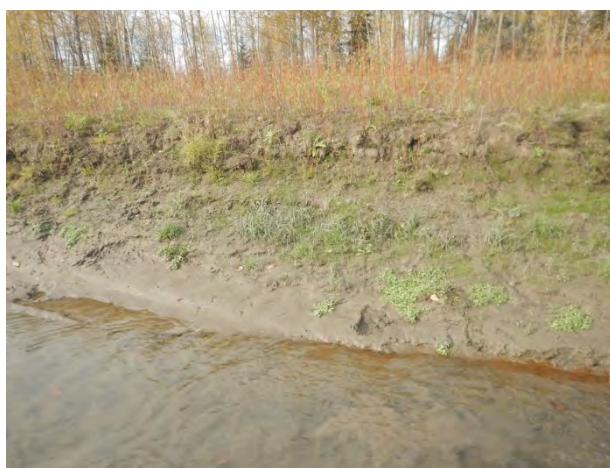
**Photo 16** Section 1.5, right bank erosion

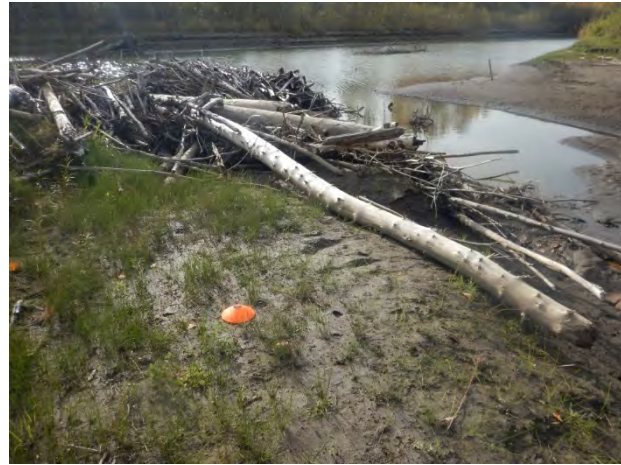
**Photo 18** Section 1, log jam on left bank of channel at confluence with pre-existing side channel

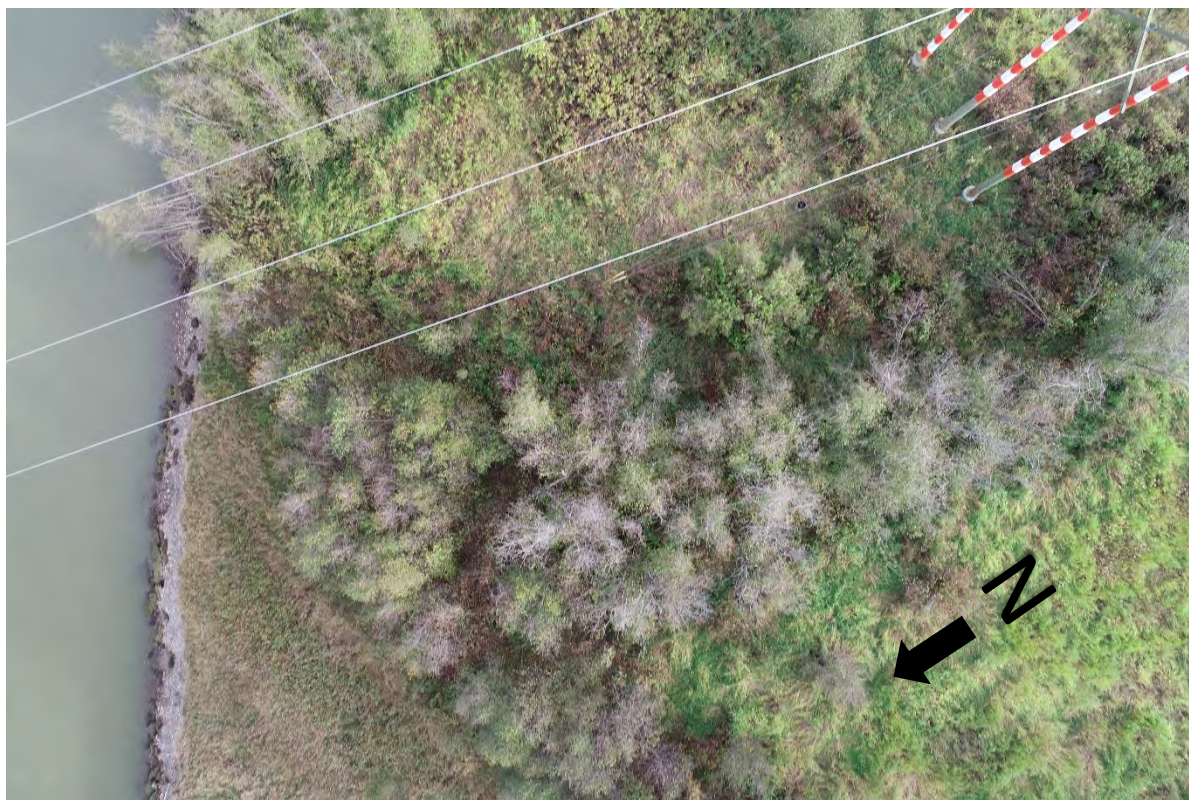
Photo 22 Drone photo of BC Hydro utility towers and eroding right (south) bank of Peace River (north side of island)

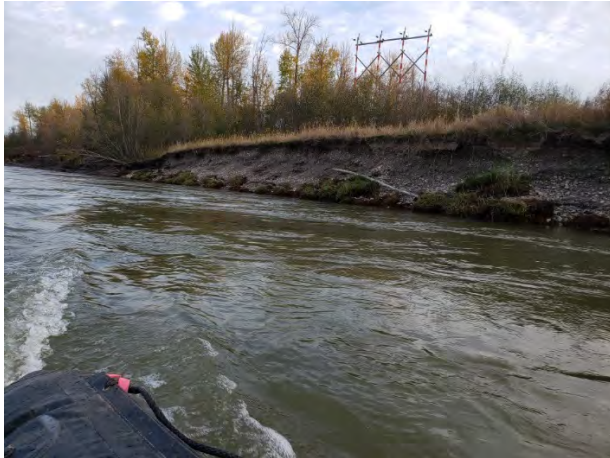
**Photo 23** Peace River south bank erosion (north side of island) downstream of 102.5R

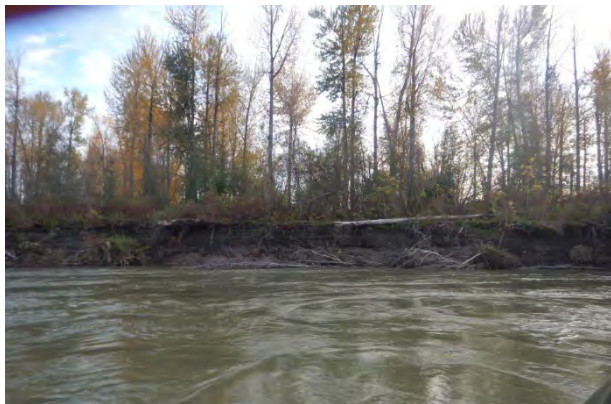
**Photo 33** View of erosion of south bank of Peace River channel approximately 300 downstream from 102.5R

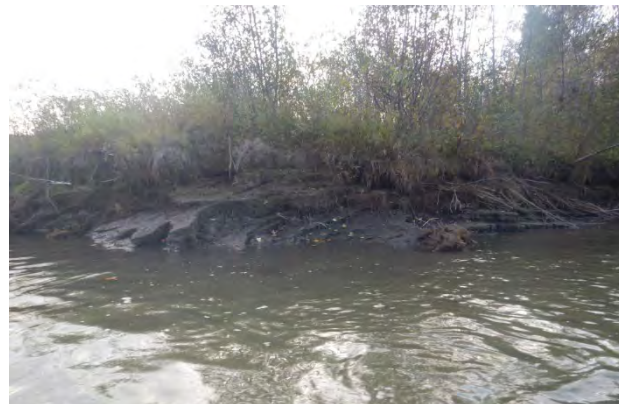
**Photo 34** View of erosion of south bank of Peace River channel approximately 380 downstream from 102.5R

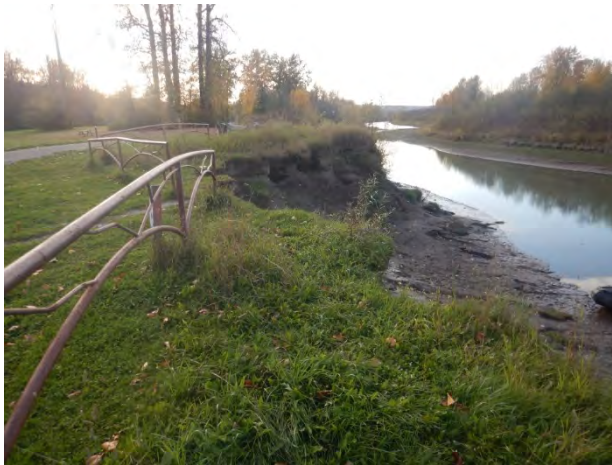
Localized erosion was identified on a 10 m long section of bank on the pre-existing side channel downstream of 102.5R along the campground road at the northeast end of Peace Island Park. The June 2016 topographic survey found no further progression in the bank line erosion compared to the September 2014 topographic survey (NHC, 2016). However, the bank was found to be over steepened, devoid of vegetation and the soils were exposed, making it susceptible to further slope regression.

The September 2019 topographic survey found a maximum of 1.5 m of additional bank retreat since 2016 (sheet 4 in Appendix B). The bank continues to be over steepened and exposed; continued erosion at this location is expected even if toe erosion ceases because the over steepened bank will regress back to a more stable slope angle (Photo 35 to Photo 38). The banks that are upstream and downstream of this site are less steep, well vegetated, and appear more stable.

Photo 35 View west, Peace Island Park bank erosion

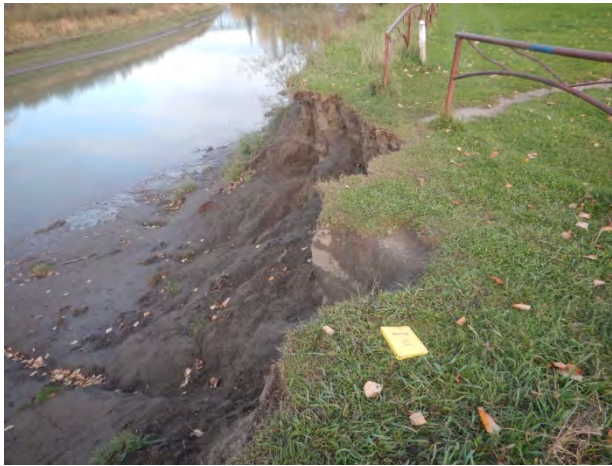
Photo 37 View east, Peace Island Park bank erosion

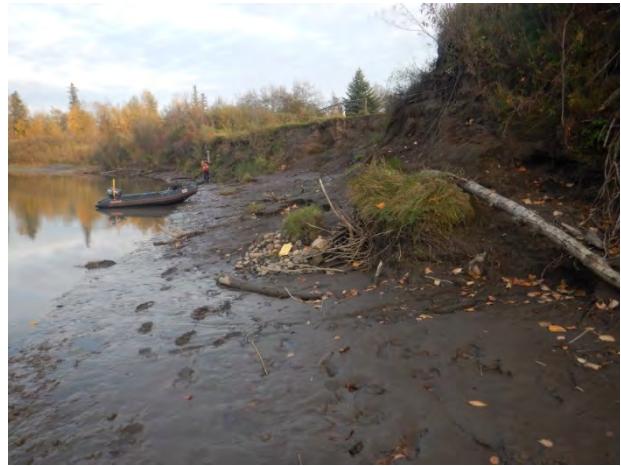
Photo 38 View east, Peace Island Park bank erosion

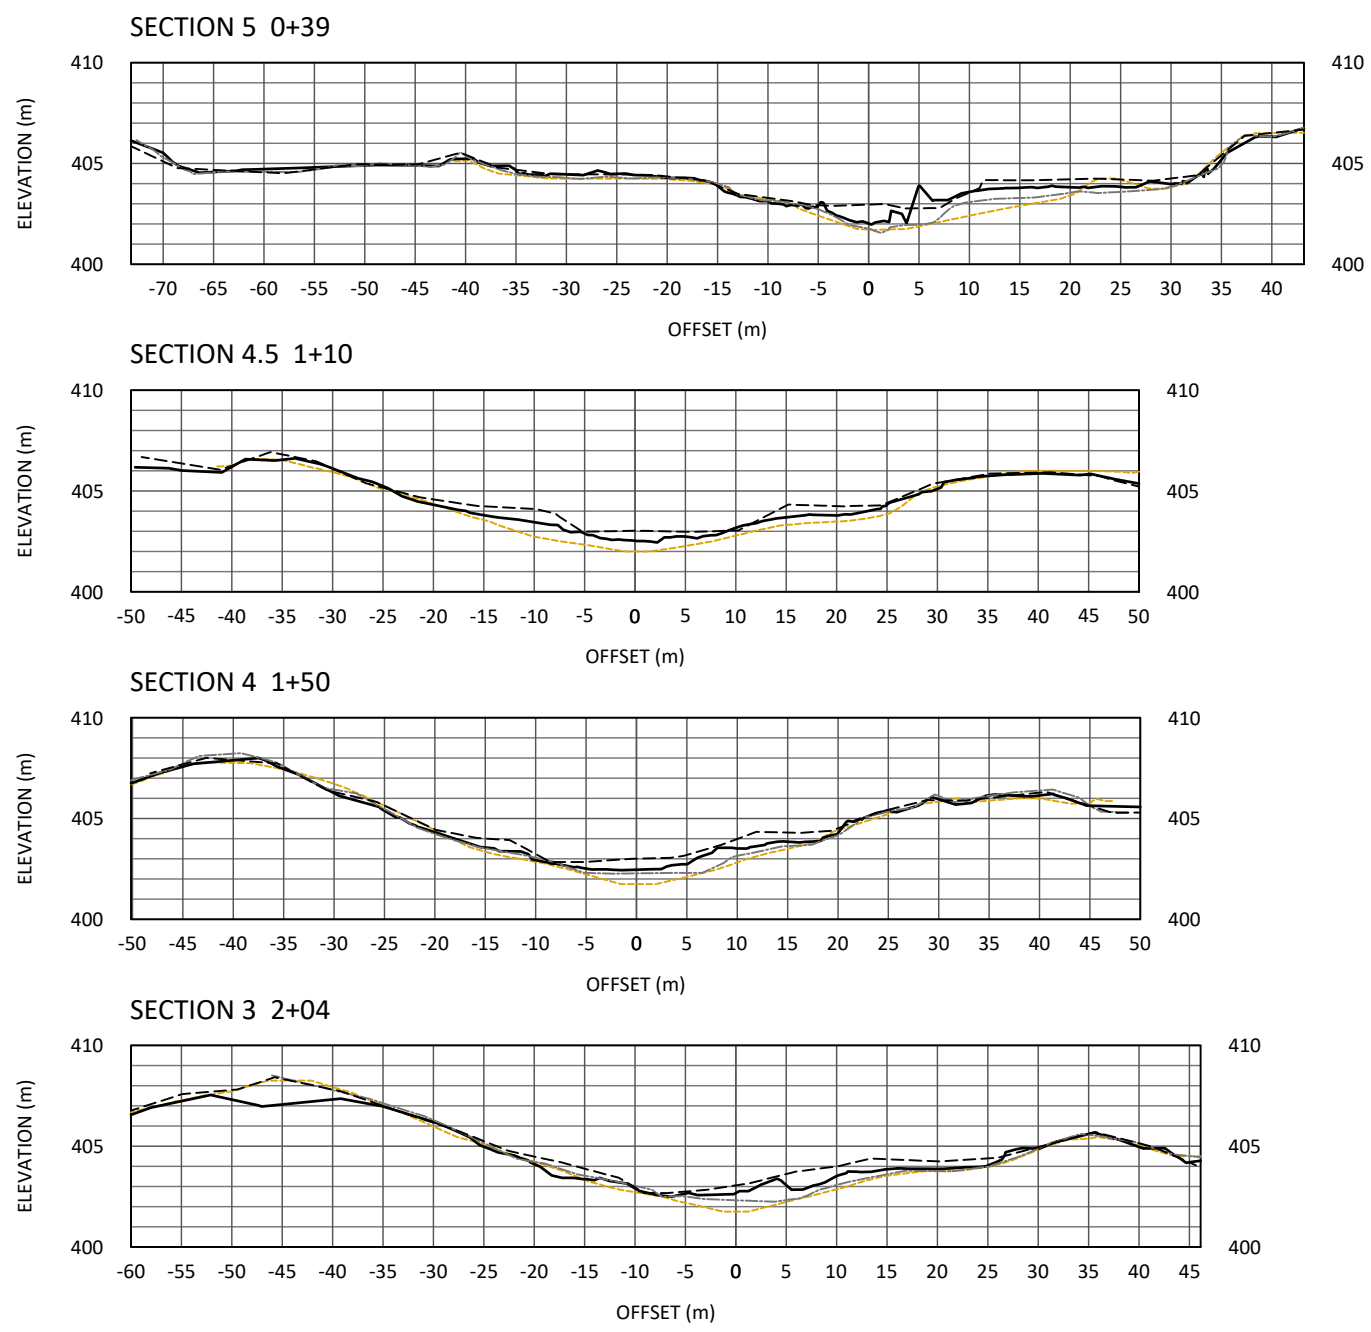
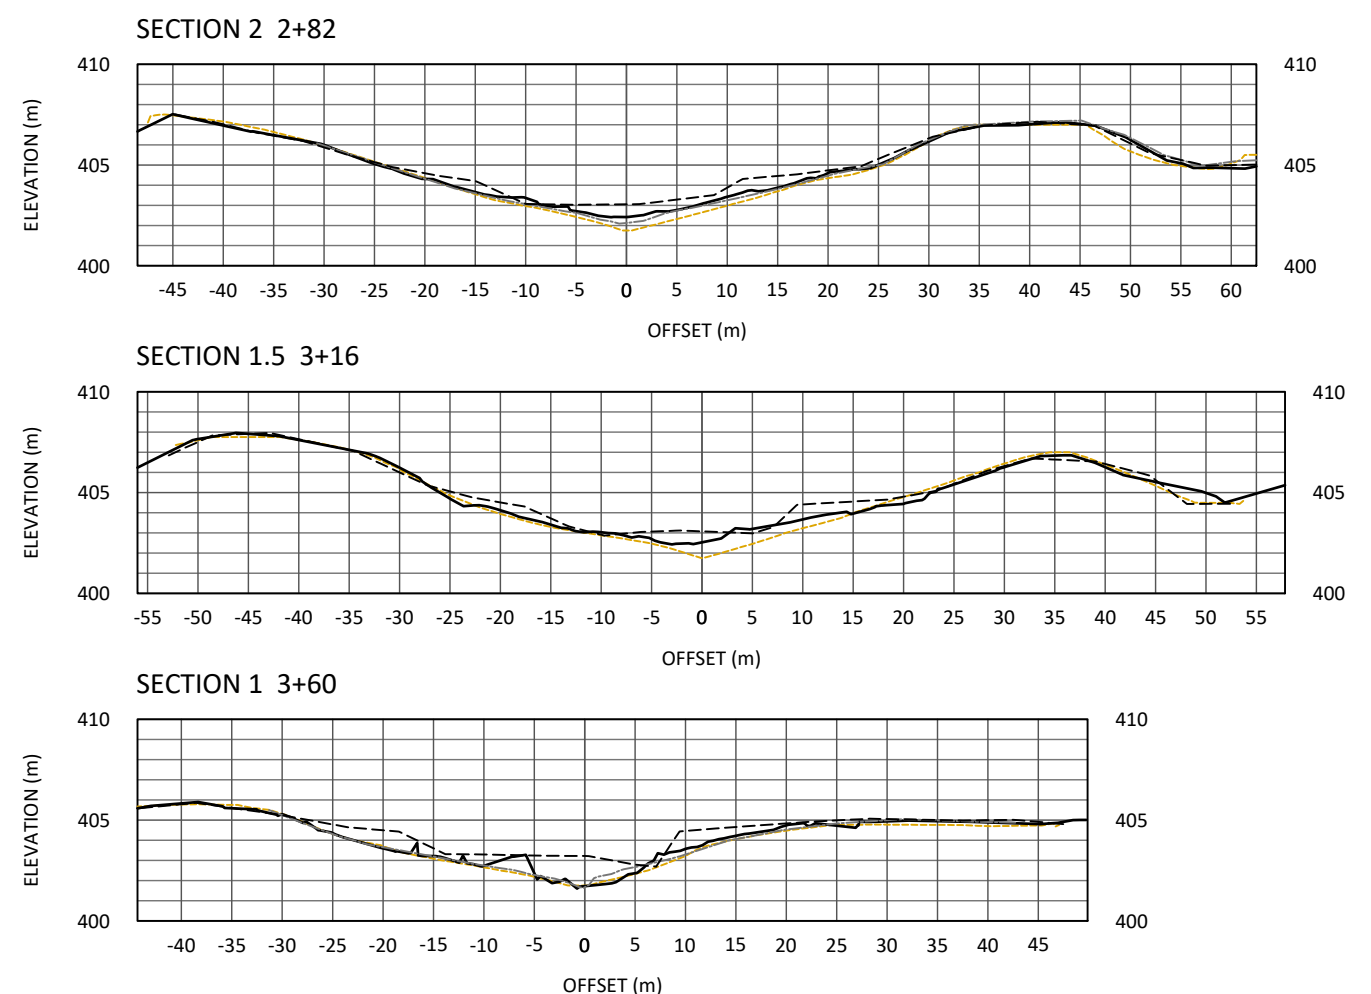
PROJECT NUMBER	3004999
DRAWING NUMBER	3004999-002
SHEET NUMBER	<b>2</b>
REVISION	1

The point comparisons in Table 4.1 did not capture the maximum thalweg elevation (lowest portion of a channel cross section) as the reference point is the center of the channel and the thalweg has laterally migrated since development. The maximum thalweg elevation was determined using the DEM (Figure 4.1) and is now 402.85 m with an average of approximately 402.75 m. This is 20 and 40 cm, respectively, above the maintenance triggers, and the average is higher than the 2016 maximum thalweg elevation of 402.63 m (NHC, 2016). The bed has aggraded approximately 1.25 to 1.5 m since channel construction. Previous surveys showed that up to 0.5 m of deposited sediment occurred within the first 5 months. The rate of aggradation has since slowed to an average rate of 0.15 m to 0.30 m per year between 2016 and 2019 (sheet 2 of Appendix B).
