Columbia River Project Water Use Plan

CLBWORKS-30A Cartier Bay Site 15a Engineering Services

Construction Completion Report

Final Report
June 21, 2024
KWL Project No. 0478.237

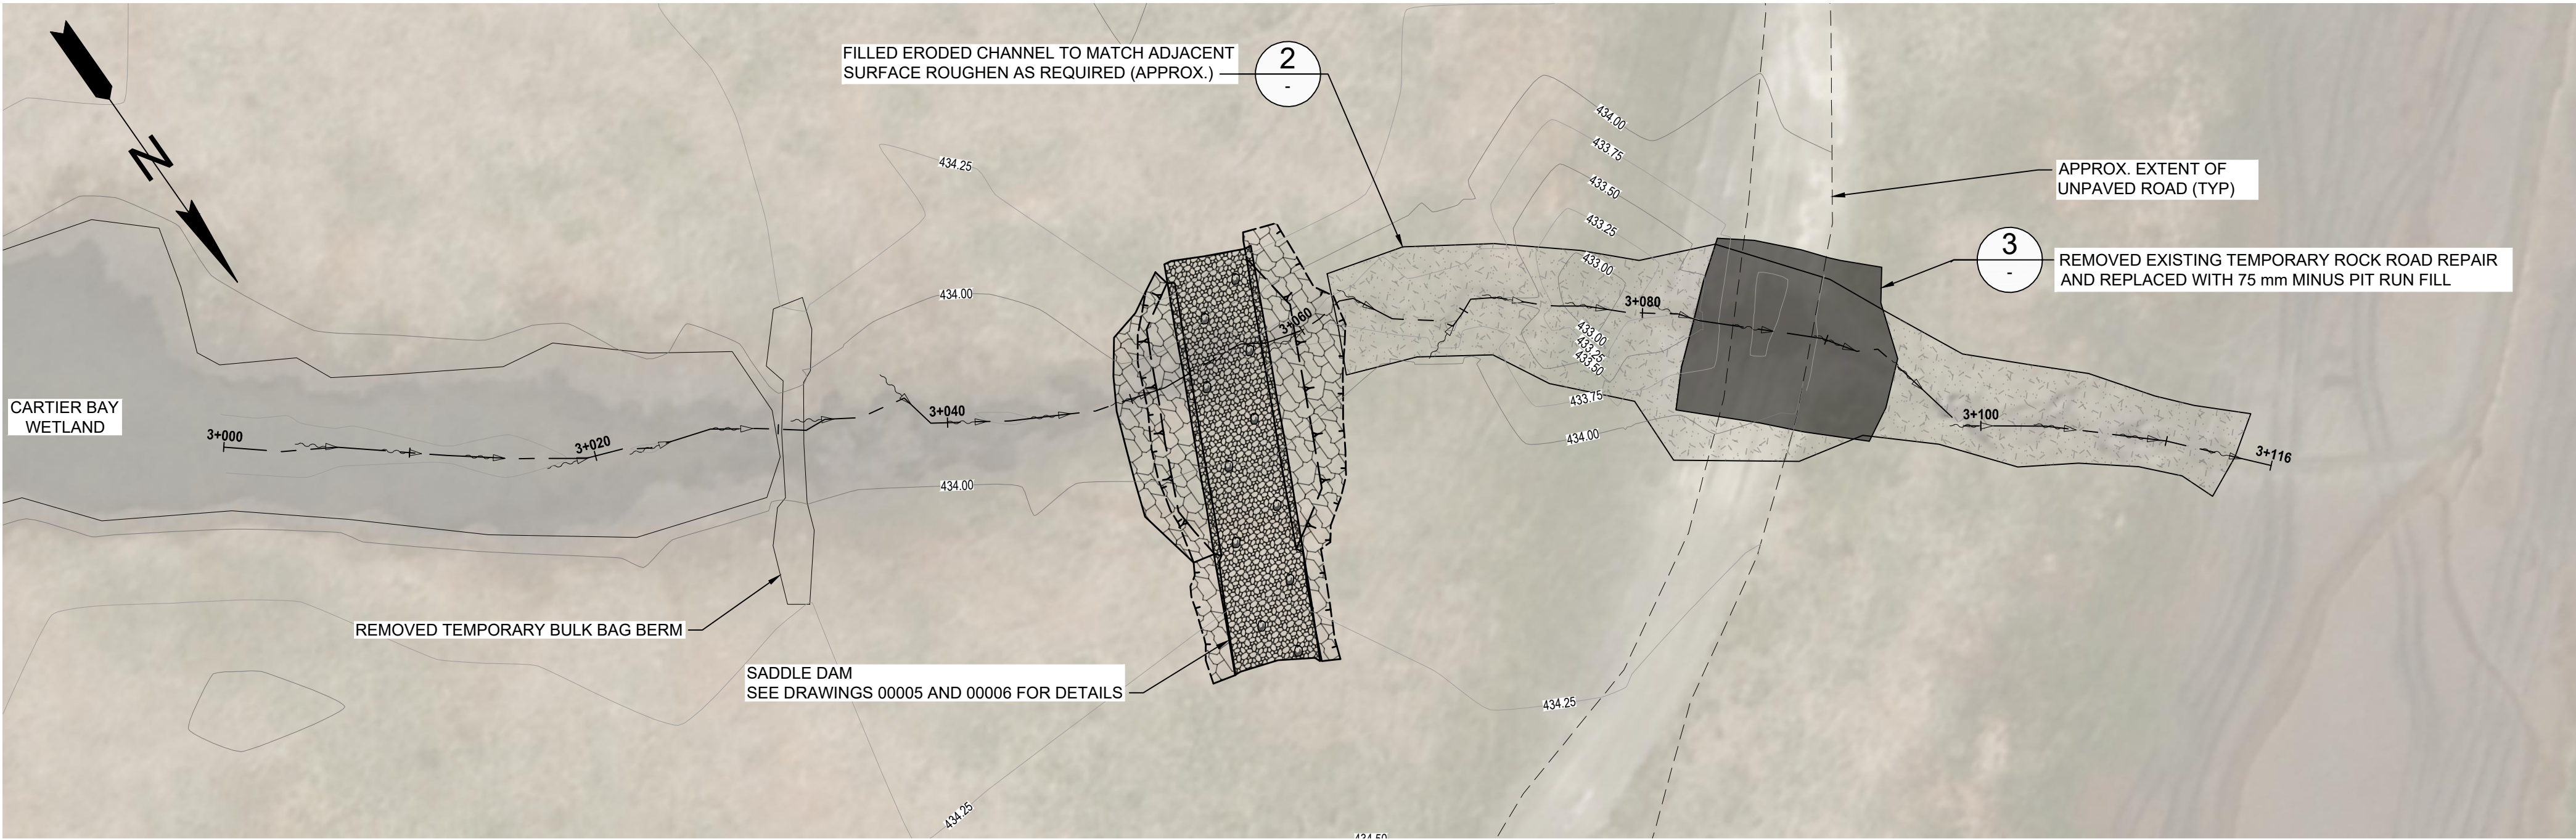
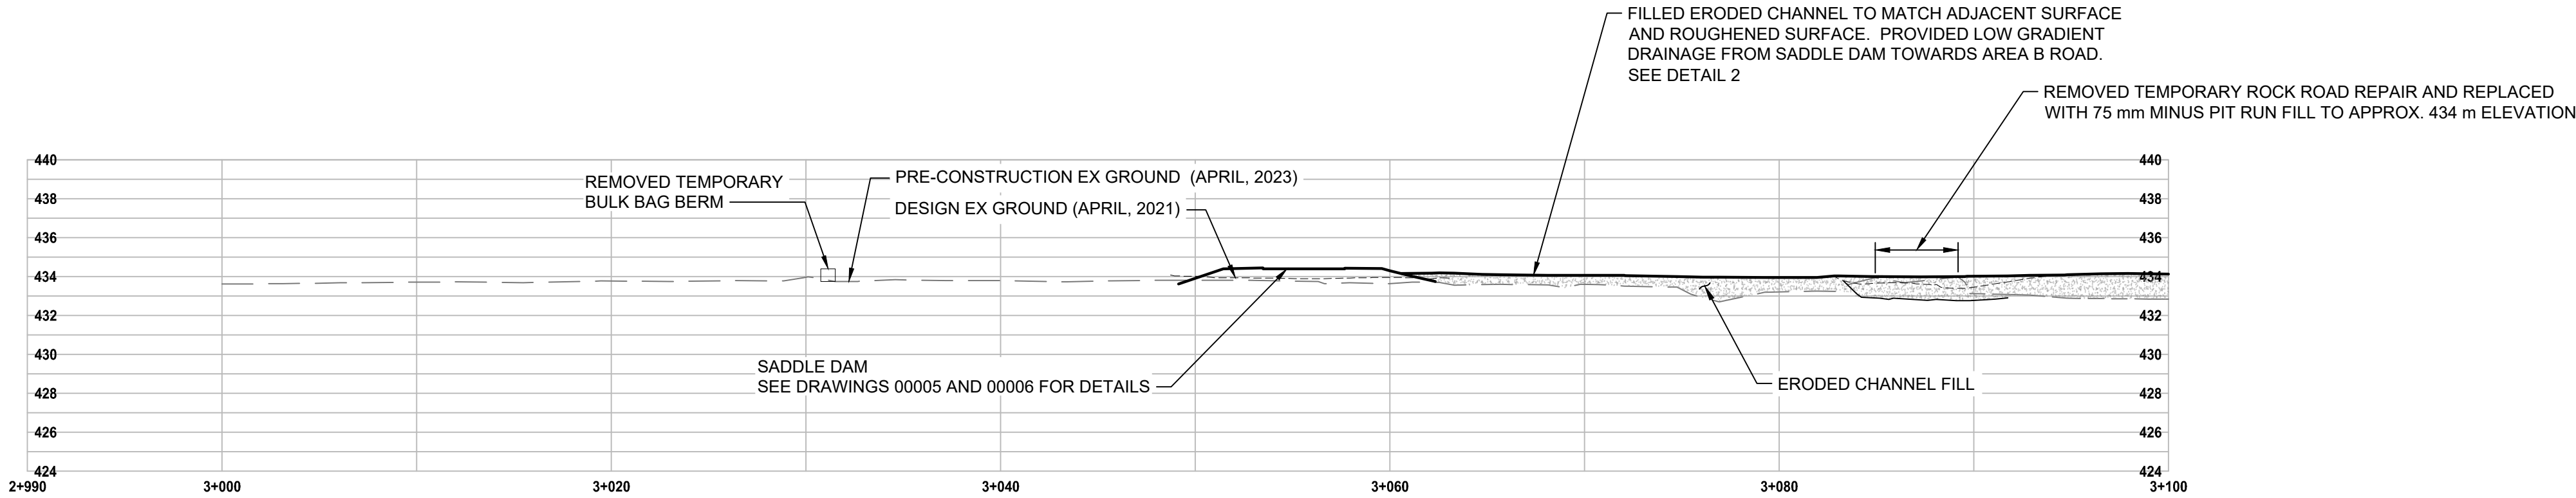
AREA B ERODED CHANNEL FILL - PLAN
1:250

The road at Area B was repaired by removing the riprap that was temporarily placed in the eroded channel, filling the eroded channel (to an approximate thickness of 800 mm) with 75 mm minus pit run fill, and re-surfacing the road with 25 mm minus surfacing aggregate (approximately 400 mm thick). The final elevation of the road surface at Area B where the road was repaired is approximately 434.0 m.

The completed Area B eroded channel fill and road repair is presented on Drawing 201B-C09-00007 included in Appendix A.

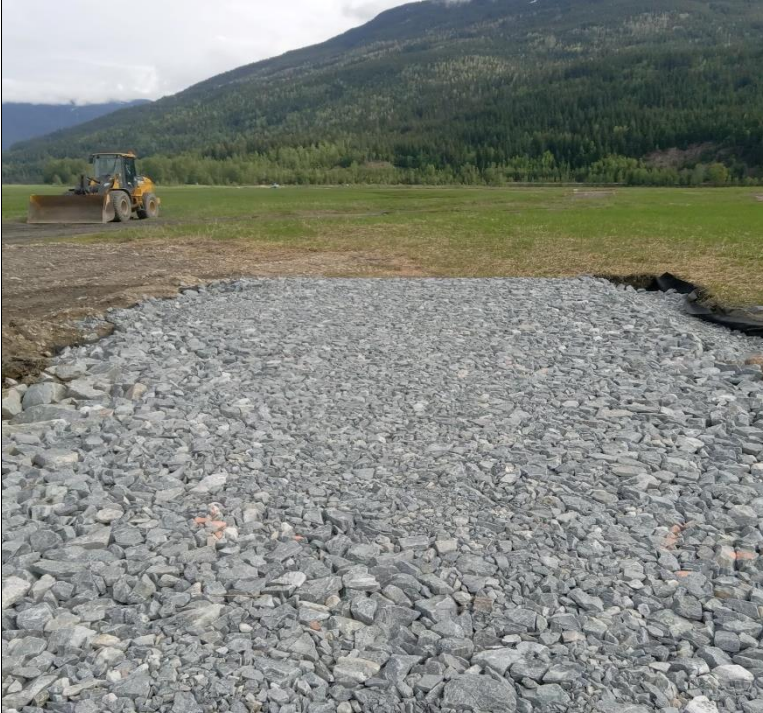
Saddle dam crest, looking east. Riprap on the side slopes does not extend to the eastern end of the saddle dam

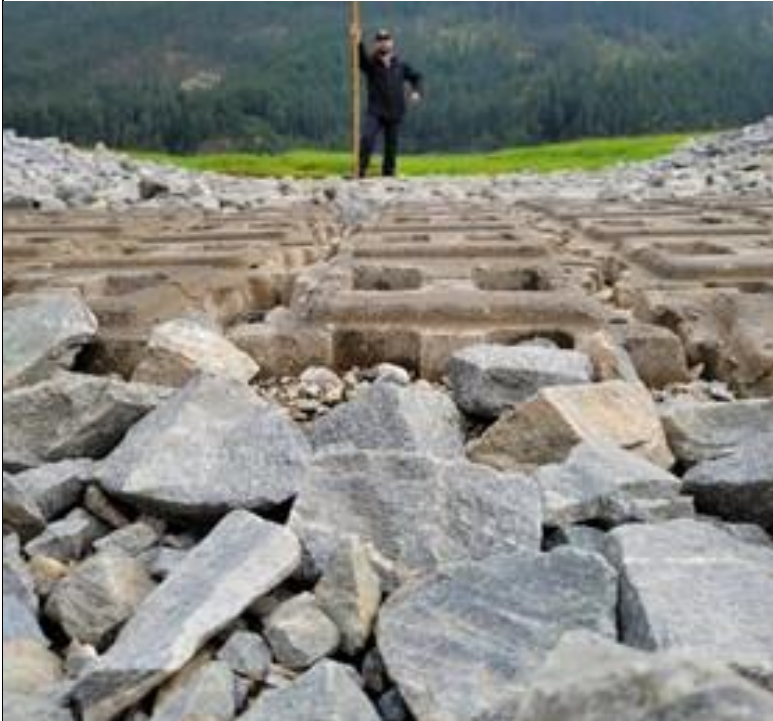
A site visit was conducted by Liam Mackle (KWL) and Tysyn Olynyk (BC Hydro) on September 25, 2023 to assess the site and take some elevation point measurements across the outlet. It was found that while the top of the ACBM met the design elevations and fell within the specified tolerance, the 200 mm minus fill on the wetland side of the outlet had several low areas of up to 12 cm below the design elevation. KWL recommended using excess fill that had been placed on the north and south embankment side slopes at the top of the dam outlet to fill the low spots and create a more uniform surface across the outlet length and within the specified design tolerance. These findings are summarized in a Daily Field Review Report in Appendix B, and shown in Appendix C, Photos 17-20. The repair work was completed by a BC Hydro crew in November 2023.

Site 15a looking towards the reservoir – the wetland side section of rock shown here is lower than the ACBM:

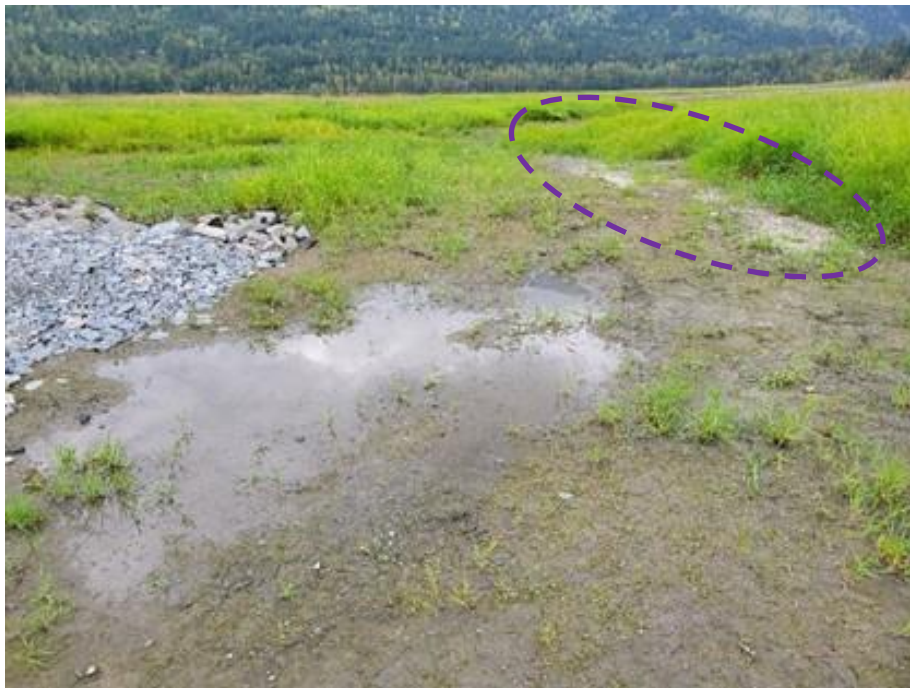
During reservoir inundation in spring 2023, water was observed by BC Hydro staff to be flowing around the south end of the saddle dam to enter the wetland, leading to concerns about potential erosion in the area as it is unvegetated in that location. This area may have been a low point before construction of the saddle dam; however construction equipment and activities likely compacted the area further creating a depression that allows for a localised concentrated water flow. Some flow was also observed around the north end of the saddle dam, however that area is vegetated with established reed canary grass and erosion is less of a concern at that location.

The site visit conducted on September 25, 2023 with Liam Mackle (KWL) and Tysyn Olynyk (BC Hydro) found no evidence of erosion on either end of the dam, and it was recommended that the south side of the saddle dam be planted with reed canary grass to reduce the risk of future erosion per the Daily Field Review Report in Appendix B.

South end of the saddle dam where flow was observed outflanking it. The area is still predominantly bare of vegetation. Deposited material is circled on the photograph. See photograph below:

- Place additional soil and reed canary grass (seed or transplant) at the low area on the south side of the Area B Saddle Dam. Following this work, the area should be monitored for signs of erosion, and the potential need for additional mitigation or repairs.
- Conduct monitoring as recommended in the Detailed Design Report (Table 5-2) to evaluate project success in the long term.
- The north bank should continue to be monitored to identify if any other potential topographic low areas with concentrated flow that could potentially lead to erosion develop over time (in addition to Area C).
- An updated operations and maintenance plan should be developed by a qualified professional(s).

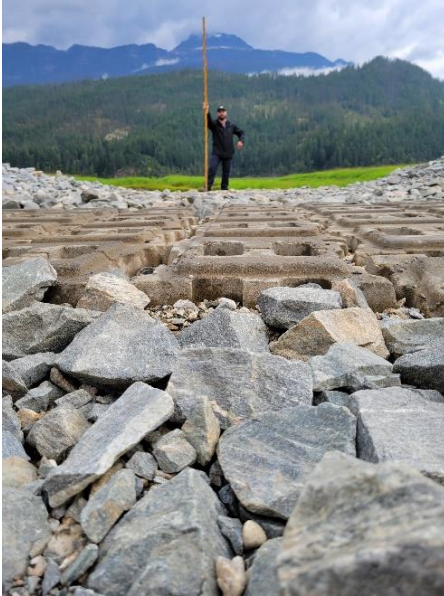
Photo 17: Site 15a looking towards the reservoir – the wetland side section of rock shown here is lower than the ACBM. September 25, 2023.

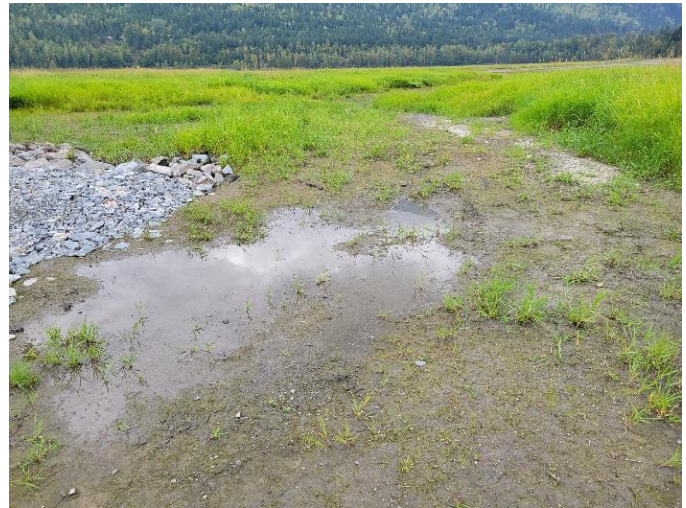
Photo 18: South end of the saddle dam where flow was observed flanking it. The area is still predominantly bare of vegetation. September 25, 2023.

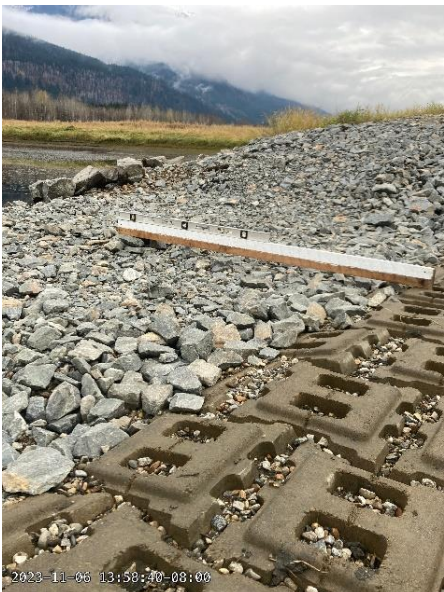
Photo 19: Site 15a outlet before post-construction remedial work on the upstream (wetland) side. November 6, 2023.
