Columbia River Project Water Use Plan

CLBWORKS-30C Arrow Lakes Reservoir Wildlife Enhancement Program – Physical Works

2024 Burton Wetlands Engineering Monitoring & Inspection

RE: CLBWORKS-30C – WILDLIFE ENHANCEMENT PROGRAM AT BURTON FLATS
2024 Burton Wetlands Engineering Monitoring & Inspection
Our File 0478.229-300

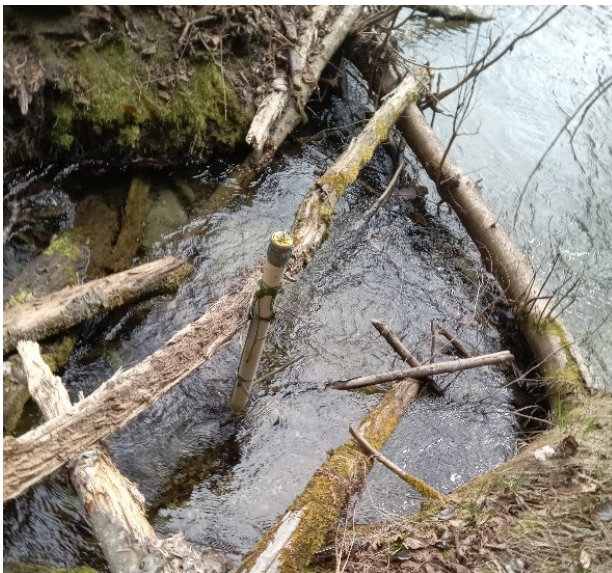
The Burton Creek water level gauge was originally constructed as a PVC standpipe piezometer partially embedded in the creek bed and attached to a fallen log with ropes and hose clamps. The Burton Creek gauge did not have a metal casing like the wetland piezometers. Over time the condition of the fallen log had continued to deteriorate to a rotted state, leading to concerns that the log would no longer provide adequate support to the Burton Creek gauge and, if the log had failed, the attached gauge would be damaged or washed down the creek. Following the Spring 2024 inspection, these concerns were discussed with BC Hydro and through a subsequent change order, additional scope was provided to relocate and secure the gauge so that it was no longer attached to the rotting log.

Photo 1: 2024-04-17 Gauge attached to rotting log

During the Fall 2024 monitoring visit, the ropes and hose clamps attaching the log to the gauge were removed and the log and other debris were cleared from the area surrounding the gauge. Although the original intent was to relocate the gauge, the PVC pipe was found to be in good condition and securely embedded into the creek bed. Therefore, the gauge was left in place and secured with additional supports. Three T-posts were installed in the creek bed and bank to anchor the gauge. The posts were secured to the gauge with metal hose clamps and U-bolts. The top of the PVC pipe was re-surveyed to capture any shifting or movement resulting from installing the additional supports. The works resulted in a minor shift of the top of the pipe elevation from 441.75 m to 441.78 m. Pictures of the gauge before and after rehabilitation are shown in Photo 1 and Photo 2 below, respectively.

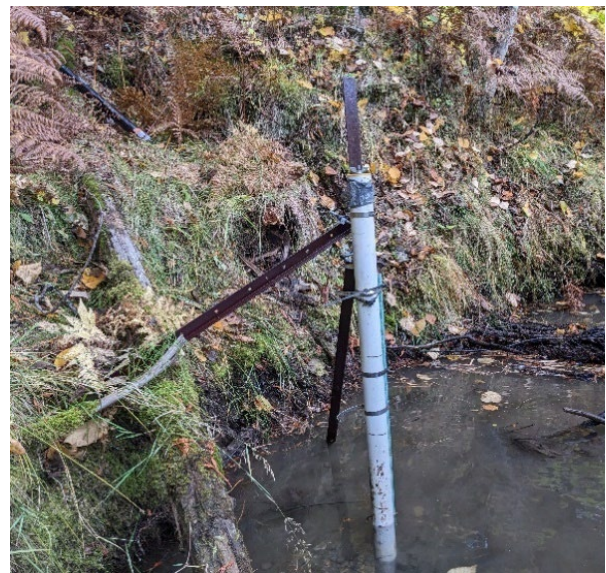
Photo 2: 2024-10-17 Gauge after Relocation

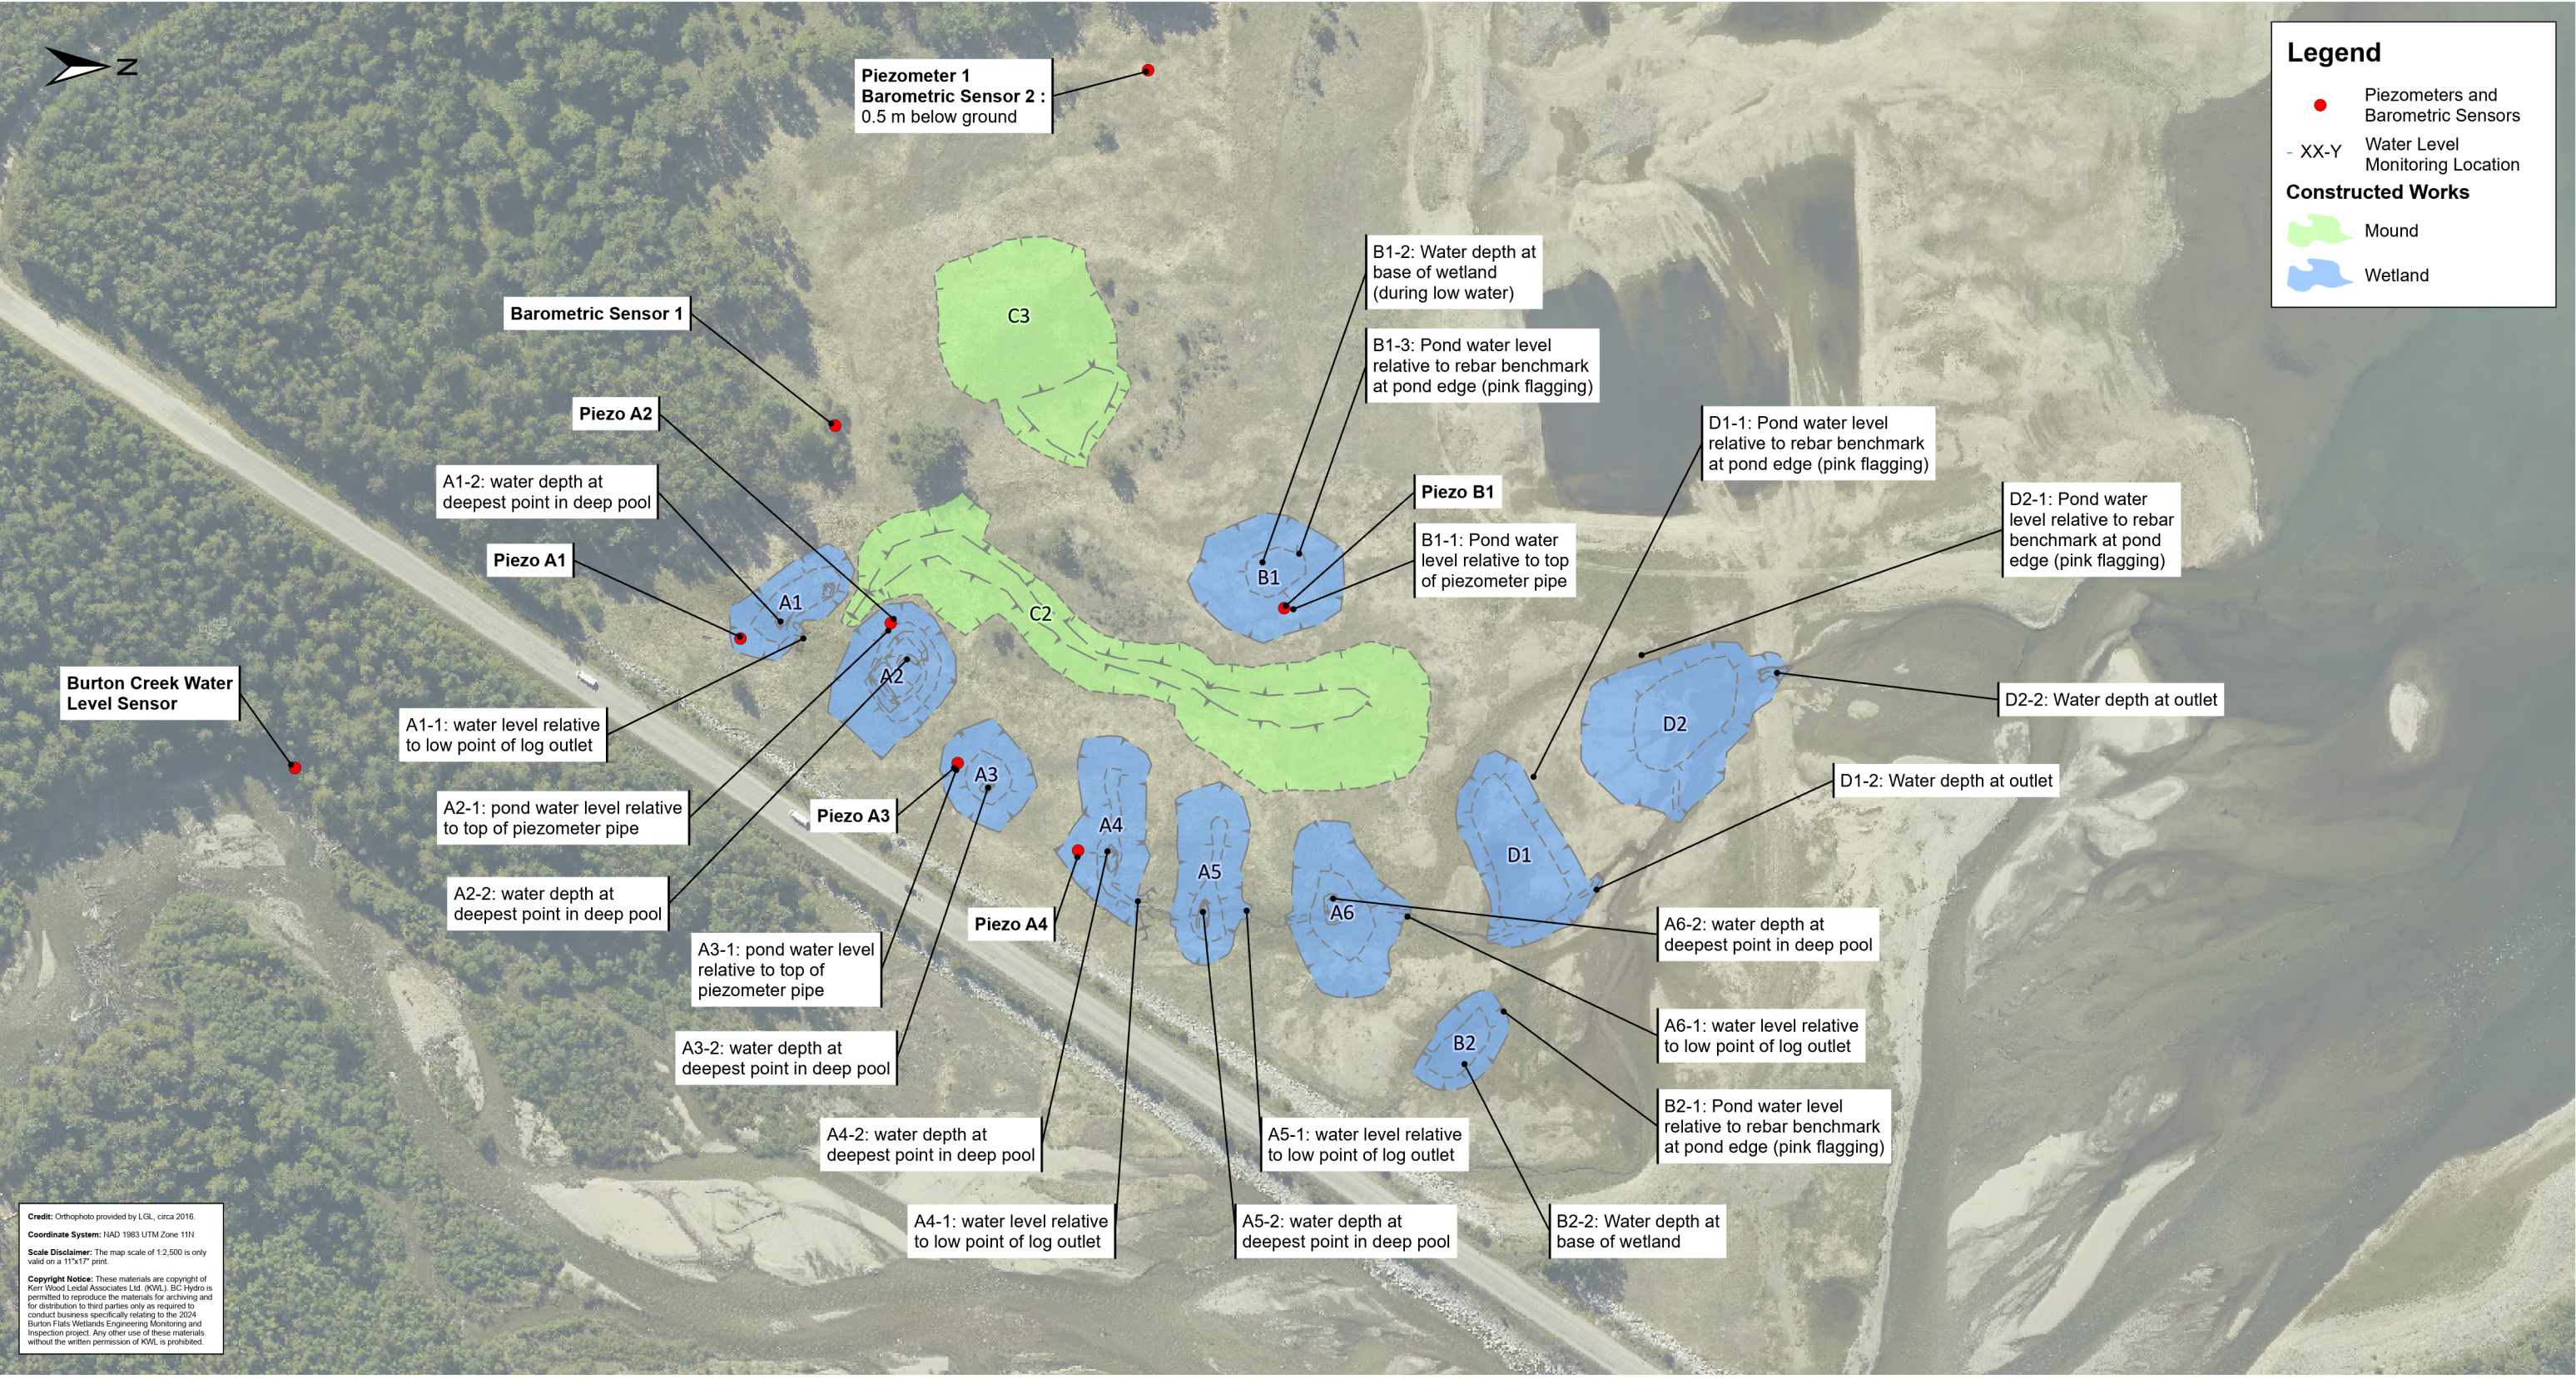
Figure 2

Burton Wetlands - Water Level Monitoring Locations

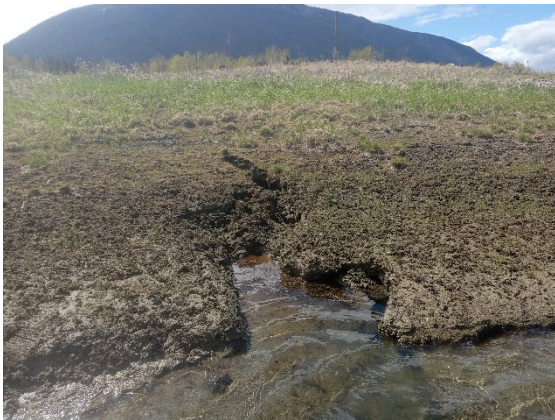
- There is an erosion feature that has formed at the southwest part of the pond, in the direction of the slope up to Mound C2. The erosion feature is approximately 2 m long and 30 cm deep. There appears to be groundwater seepage causing piping of the fine soils on this slope. The slope was saturated and very soft. Erosion was noted to have increased in the Fall 2024 monitoring visit; however, it seems to be limited to an area with fine soils and presently does not appear to be impacting the function of the works.

Photo 33: Erosion Feature at South End of D1, Potentially Caused by Groundwater

2. Monitor the erosion that is occurring on the south slope of Pond D1. The erosion is not presently a concern as it does not appear to be presently impacting the function of the works. However, if the erosion continues above the high-water line/edge of vegetation, input from a qualified professional should be sought to recommend remedial measures, which may include placing coarse granular material along the slope and eroded areas to prevent cutback into Mound C2 and/or connection to an upstream pond. This feature should be inspected during the yearly (or twice-yearly) monitoring visits in the Spring to note potential increases in the rate of erosion.

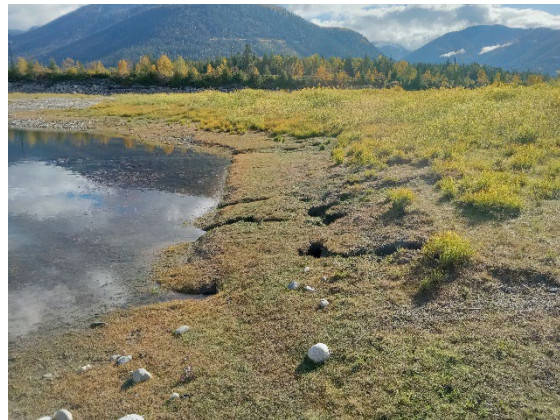
Photo 34: Increase in Erosion Observed at South End of D1 During Fall Visit (October 17, 2024)
