Columbia River Project Water Use Plan

Mid Columbia Erosion Protection and Monitoring

Reference: CLBWORKS-35

2013 Progress Report

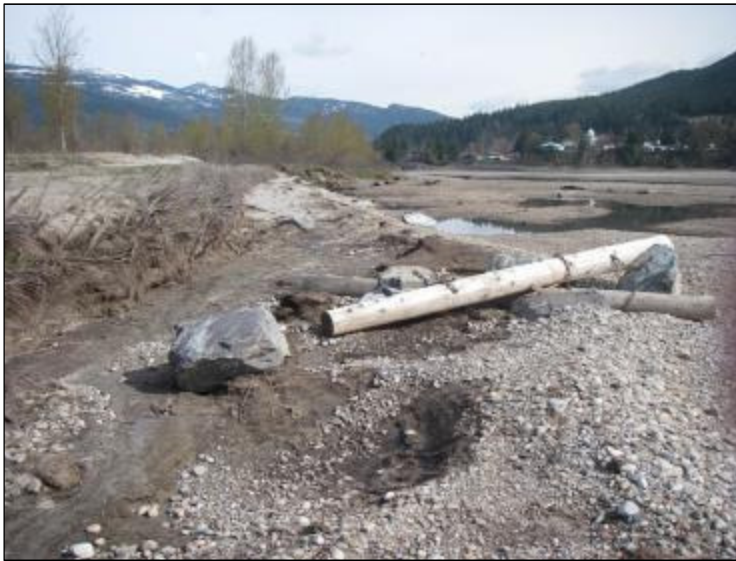
Photo 4-1: Eroded aquatic bench, exposed woody debris and boulder cluster at station 0+340. (April 23, 2013)

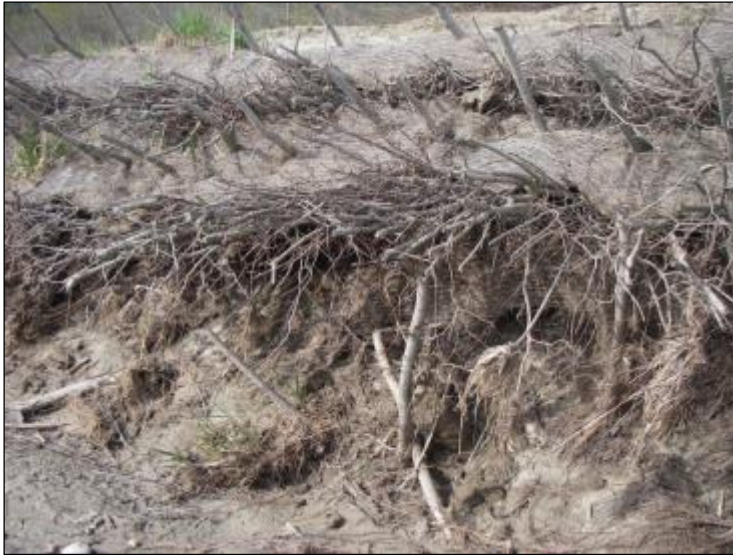
**Photo 4-2: Undermined soil wraps and brush layers at station 0+340.
(April 23, 2013)**

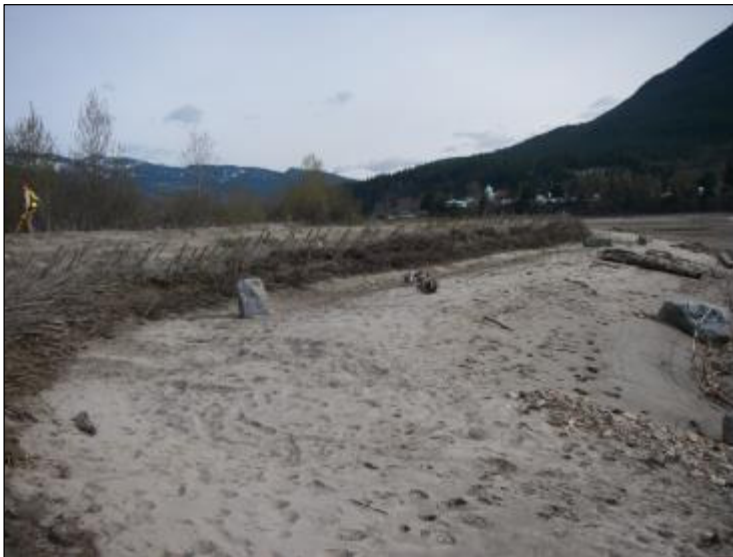
**Photo 4-3: Aquatic bench at downstream end with planted grasses and sedges washed away.
(April 23, 2013)**

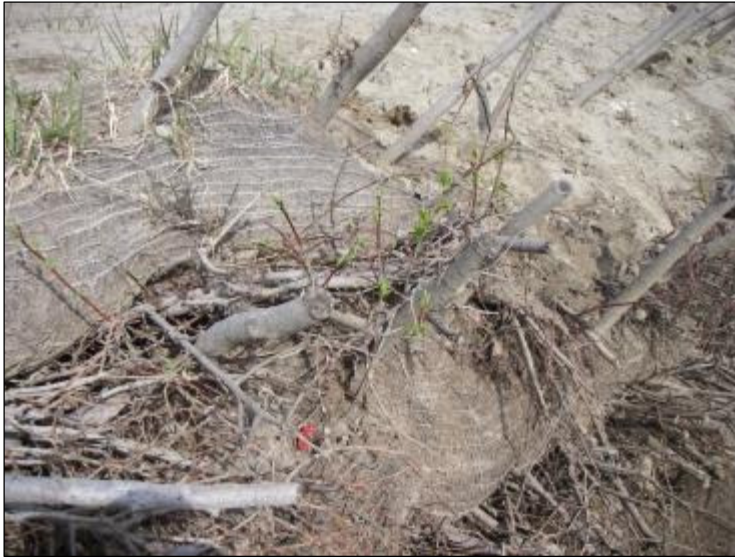
Photo 4-4: Growth in willow stakes and brush layer.
(April 23, 2013)

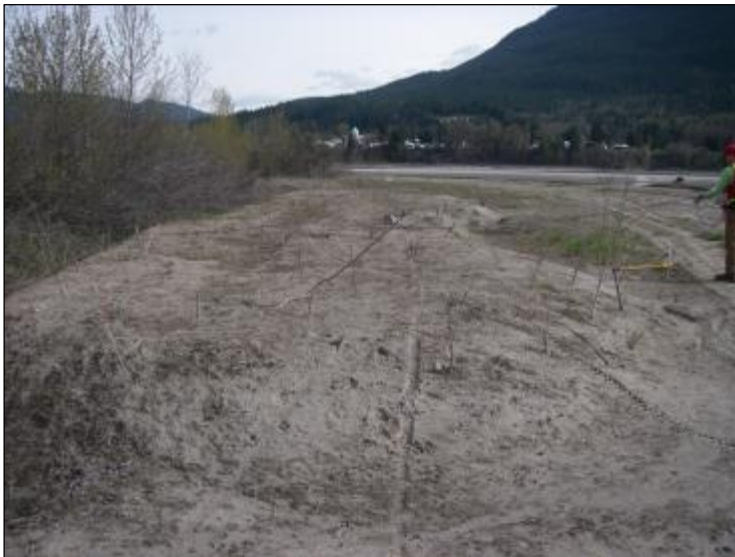
Photo 4-5: Planted soil mound vegetation.
(April 23, 2013)

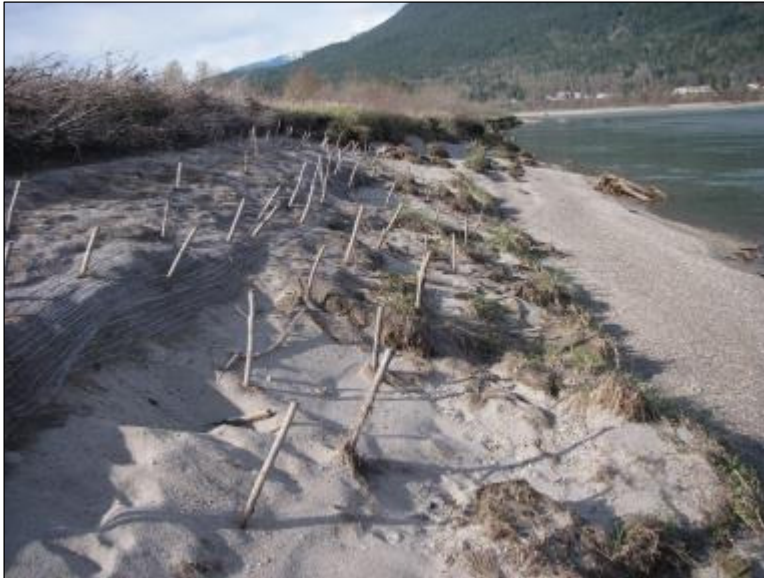
Photo 4-8: Upstream Half: mid bank with willow staking and cocomat in place.
(April 23, 2013)

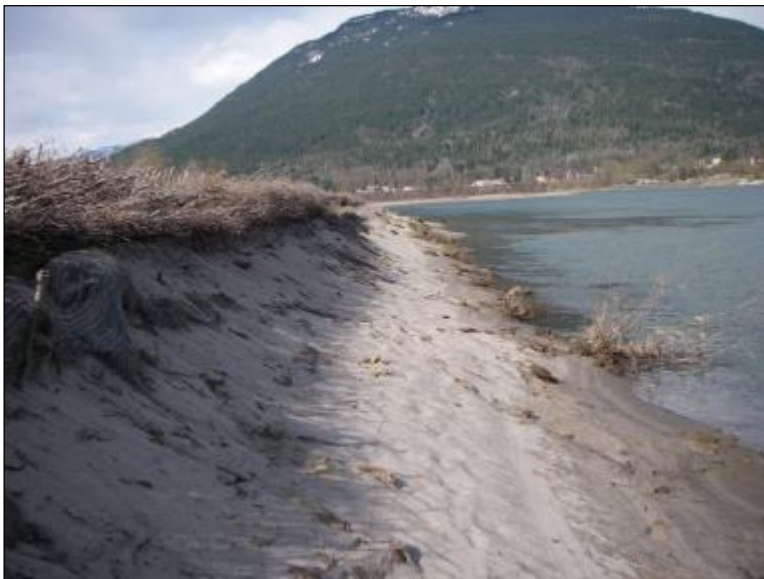
Photo 4-9: Downstream Half: mid bank with willow staking and cocomat washed away.
(April 23, 2013)

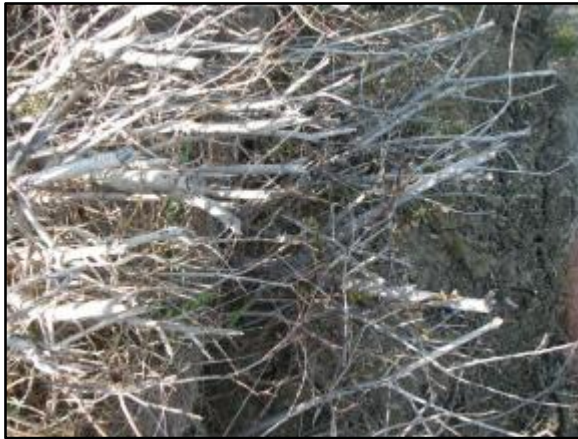
**Photo 4-10: Growth in brush layer.
(April 23, 2013)**

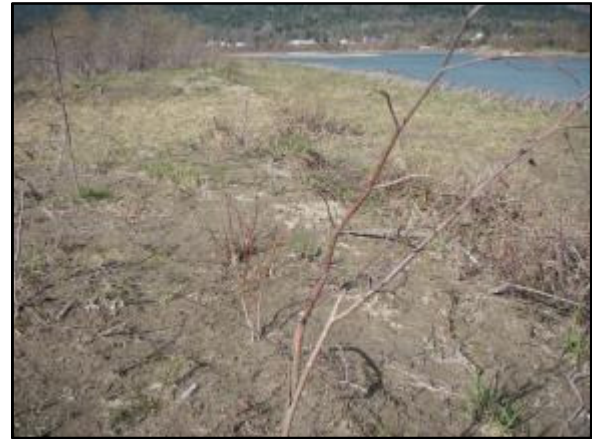
**Photo 4-11: Planted soil mound vegetation.
(April 23, 2013)**

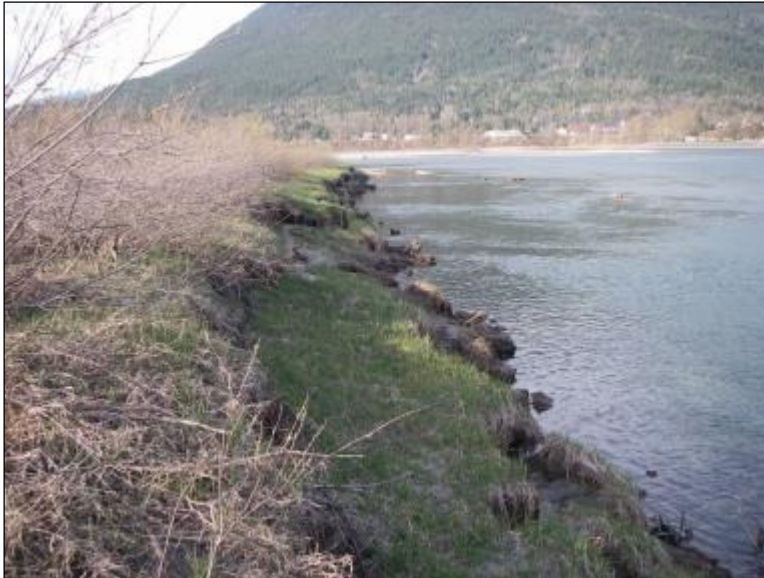
Photo 4-12: Site A2 Upstream Control
(April 23, 2013)

- Some undercutting leading to toppling of grassy blocks has occurred at the toe of the lower and upper banks in the upstream control site; and
- Some brush clusters have broken away from the top of bank and toppled onto the mid and lower banks.

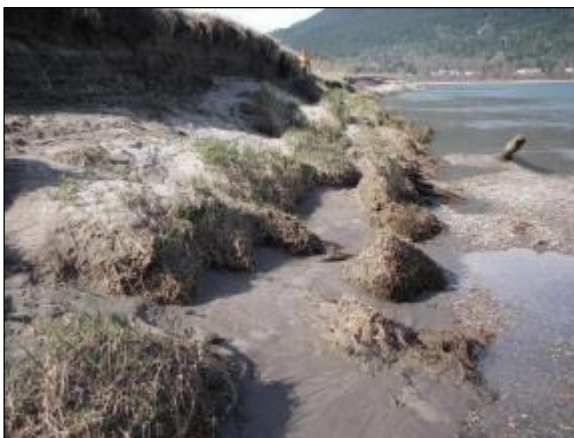
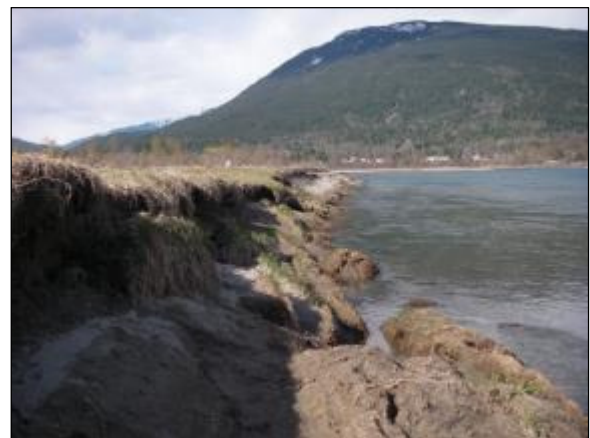
- Erosion at the toe of the lower bank has caused continuous migration of toppled grassy blocks down the mid and lower slopes (Photos 4-13 and 4-14);
- Steep (near vertical) upper bank continues to undercut top grassy layer leading to breaking off and toppling of grassy blocks (Photo 4-15); and
- A large tension crack has formed approximately three to five meters behind the top of bank in the downstream portion of the site (Photos 4-16 & 4-17).

Photos 4-13 & 14: Site A2 Downstream Control, migration of grassy blocks.
(April 23, 2013)

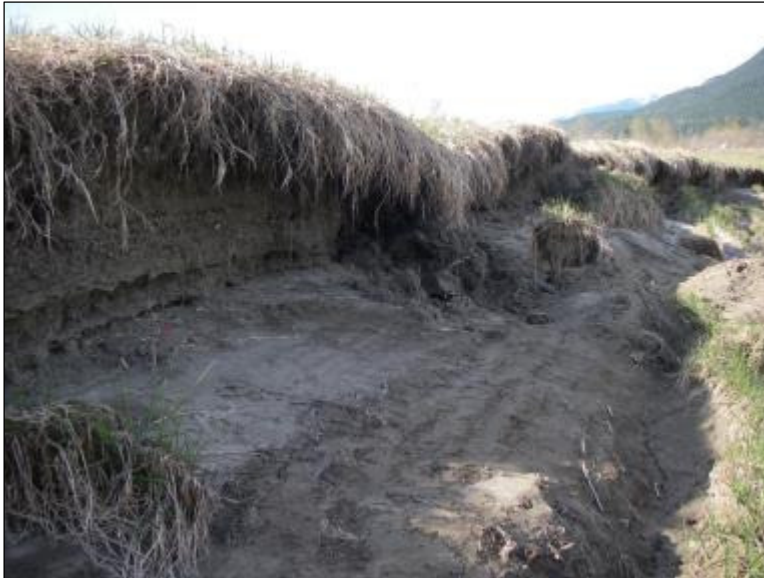
Photo 4-15: Site A2 Downstream Control, steep (near vertical) upper bank.
(April 23, 2013)

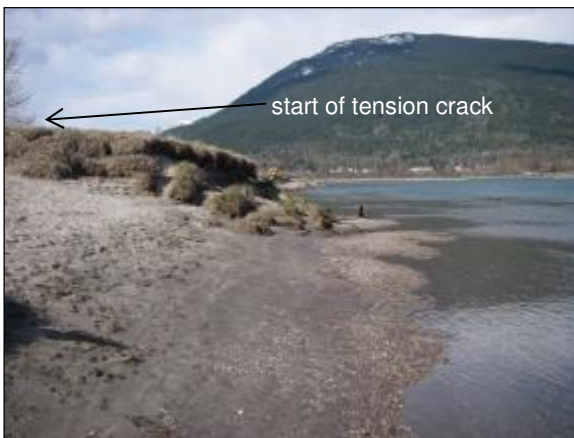
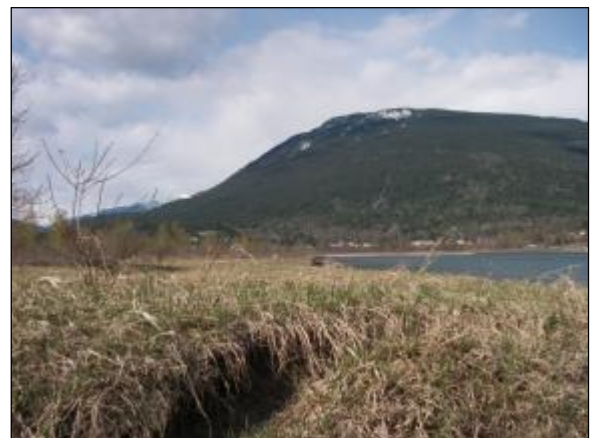
Photos 4-16 & 17: Site A2 Downstream Control, tension crack behind top of bank.
(April 23, 2013)

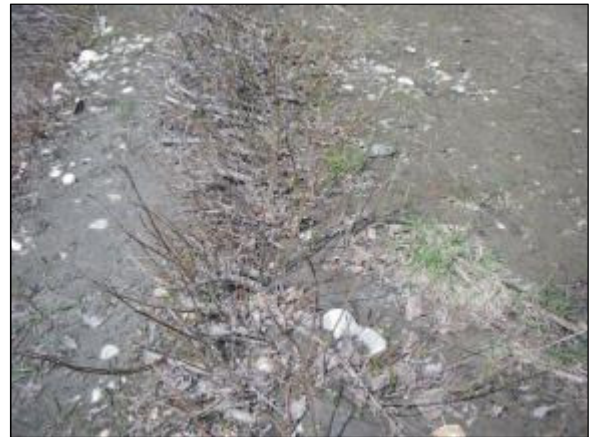
Photo 4-19: Brush layer growth (April 24, 2013)

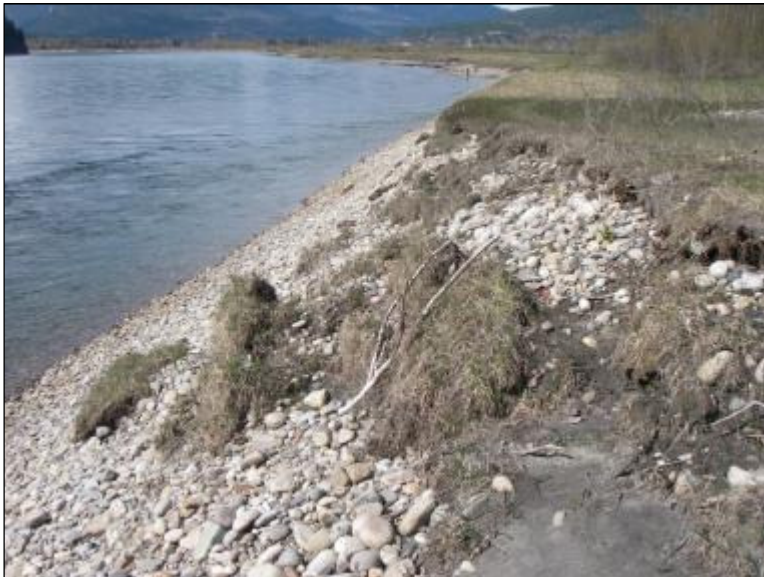
- Minor erosion/deposition has occurred on the bank; and
- Some grassy blocks have broken off the upper bank and migrated down the mid bank slope (Photo 4-20).

Photo 4-20: Site B Control, grassy blocks migrating down mid bank slope. (April 24, 2013)

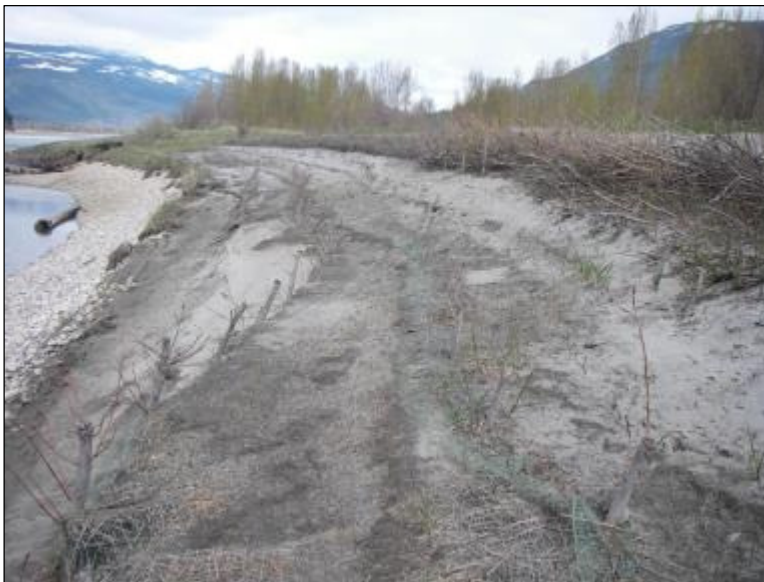
Photo 4-21: Upstream half of site, erosion of silty sand at mid bank, cocomatt and willow stakes in place. (April 24, 2013)

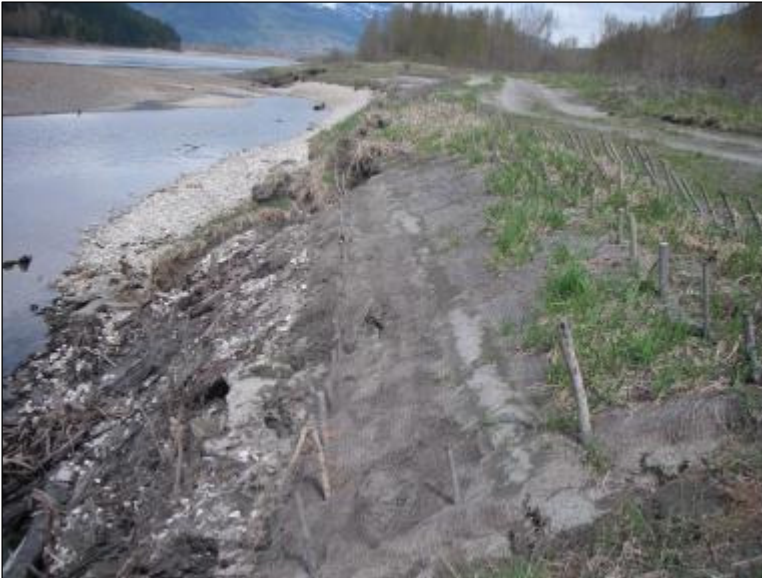
Photo 4-22: Downstream half of site, erosion at the toe of the re-graded sections in the downstream half of the site with coco-matting and willow stakes in place. Photo also shows natural deposition of woody material near the waterline. (April 24, 2013)

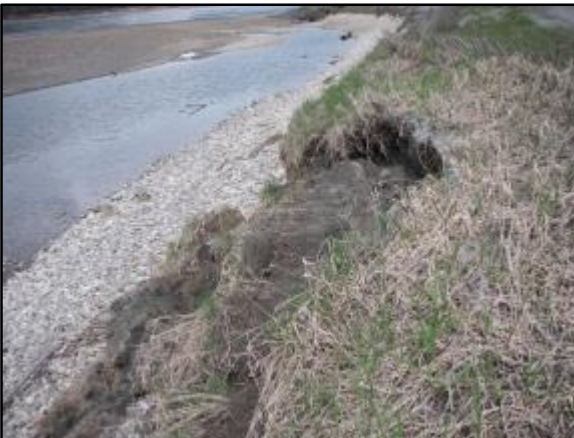
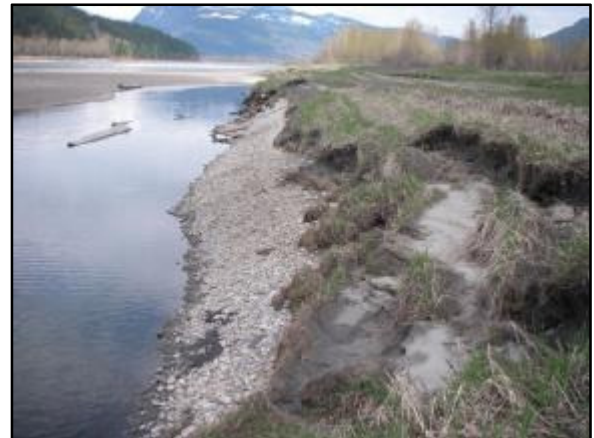
Photo 4-23 & 24: Erosion and toppling of untreated bank below brush layer (Sta. 0+700 to 710 & 0+785 to 0+805). (April 24, 2013)

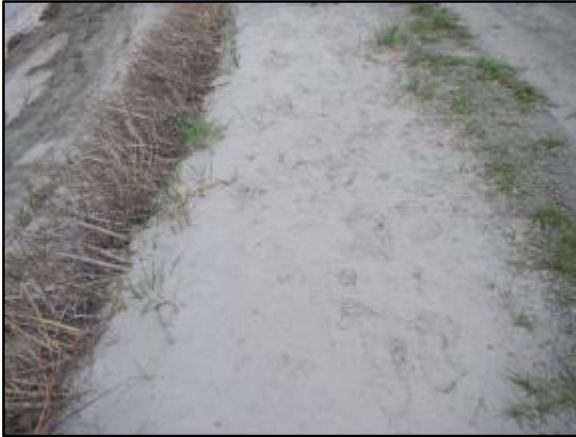
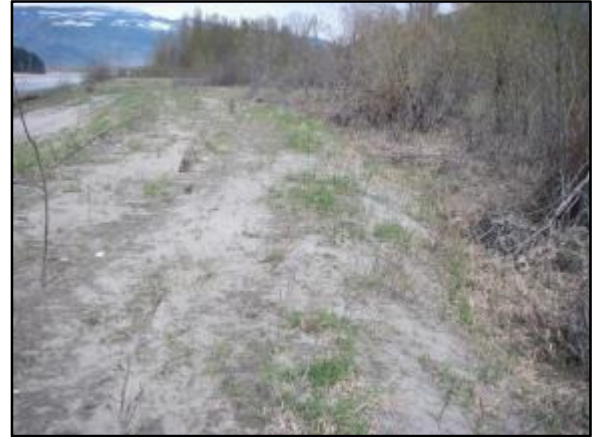
Photo 4-25 & 26: Silty sand deposition in upper bank and upland areas.
(April 24, 2013)

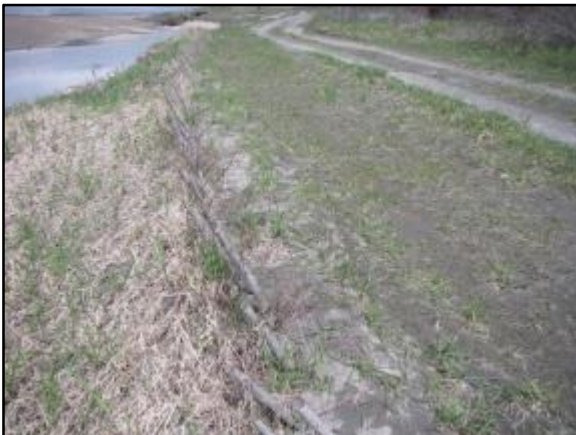
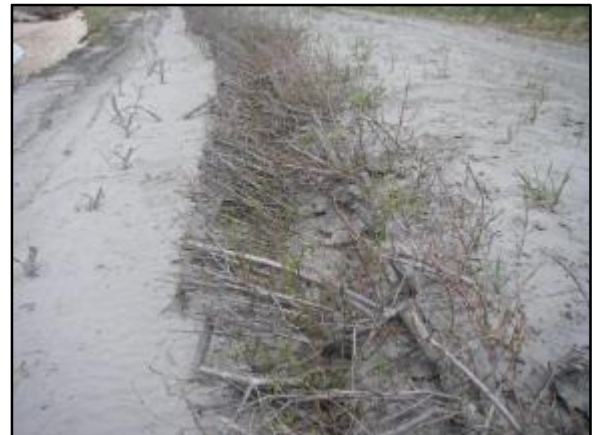
Photo 4-27 & 28: Growth in willow stakes (downstream half) and brush layer (upstream half).
(April 24, 2013)

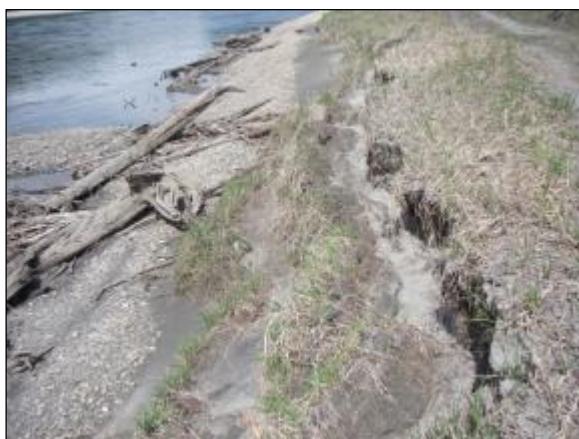
Photo 4-29 Site C Upstream Control
(April 24, 2013)

- Steep (near vertical) mid and upper bank continues to undercut top grassy layer leading to breaking off and toppling of blocks.
