Columbia River Project Water Use Plan

**Mid-Columbia River Bank Erosion Protection and Monitoring
Program**

Reference: CLBWORKS #35

Final Report

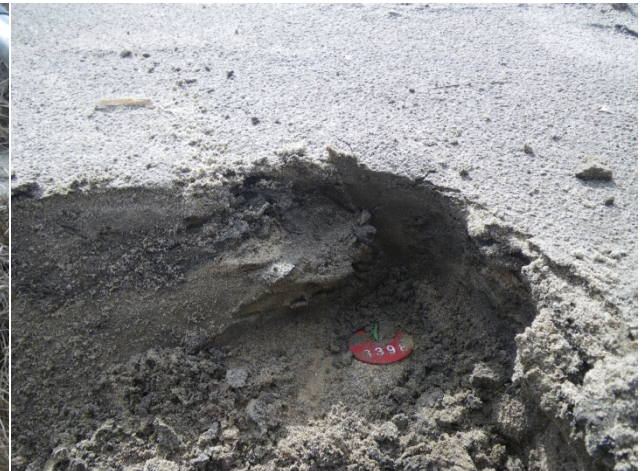
Photo 4-2: Erosion Pin Covered by Deposition of Sediment (April 2012).

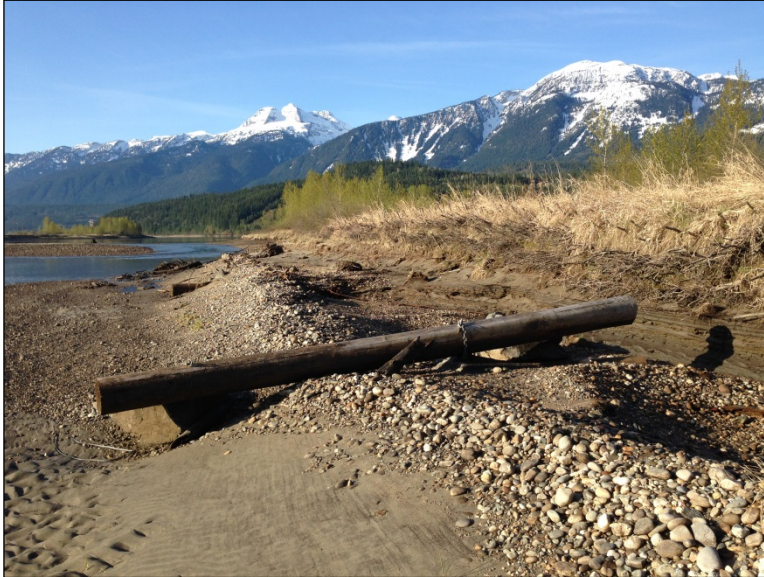
Photo 1: Site A1 Treatment Eroded Aquatic Bench, Exposed Woody Debris and Boulder Ballast (April 21, 2015)

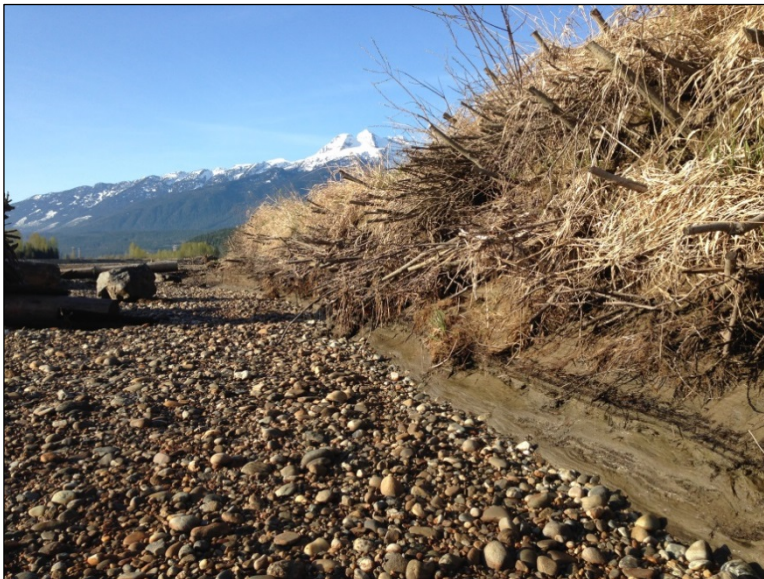
Photo 2: Site A1 Treatment Eroded Aquatic Bench, Soil Wraps and Brush Layers (April 21, 2015)

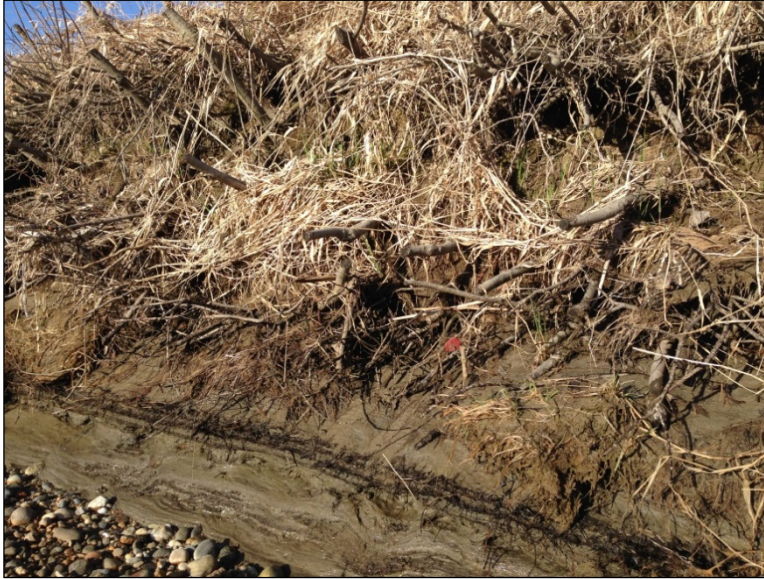
Photo 3: Site A1 Treatment Minimal New Growth of Willow Stakes and Brush Layers (April 21, 2015)

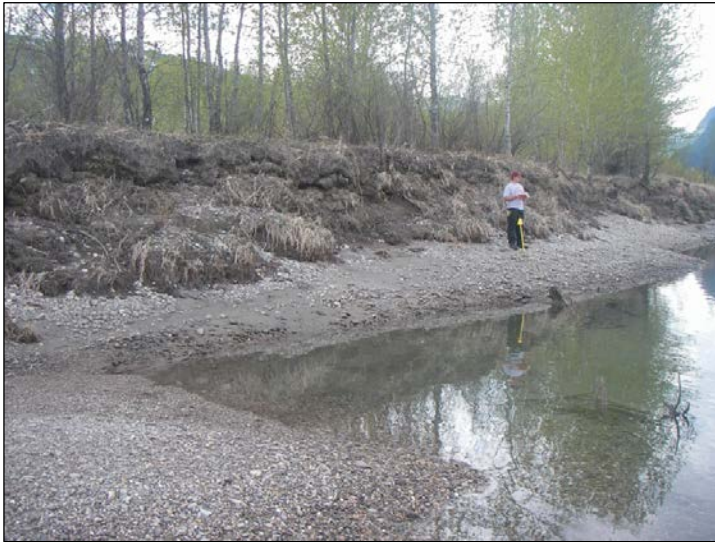
Photo 4: Bank Condition at Site A1 Upstream Control (April 21, 2015).

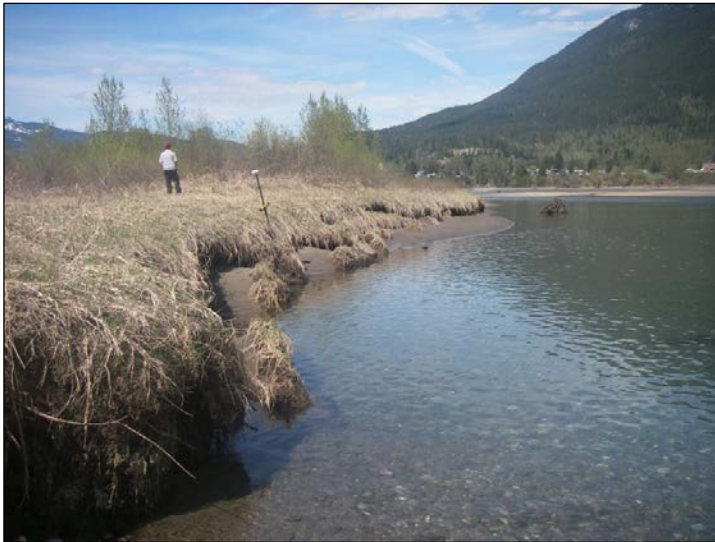
Photo 5: Bank Condition at Site A1 Downstream Control (April 21, 2015).

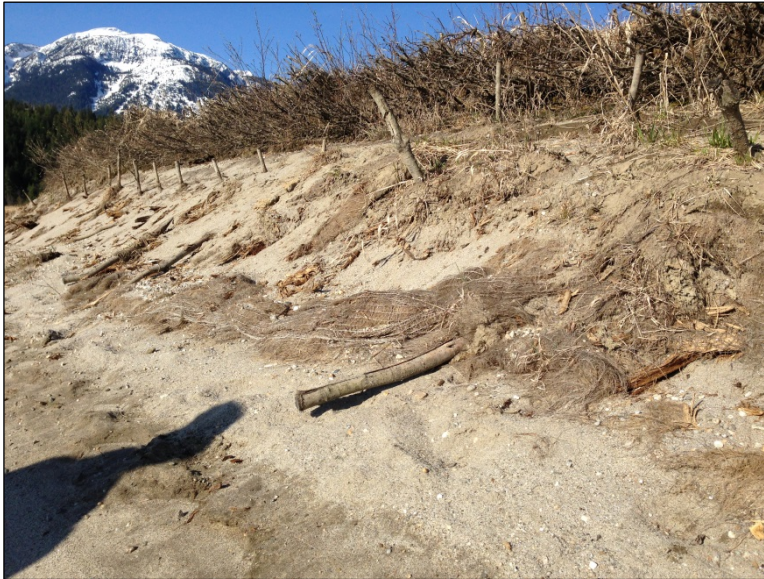
Photo 6: Site A2 Treatment Erosion of Erosion Control Blanket and Willow Stakes (Treatment Remnants Visible Mid-Photo) (April 21, 2015)

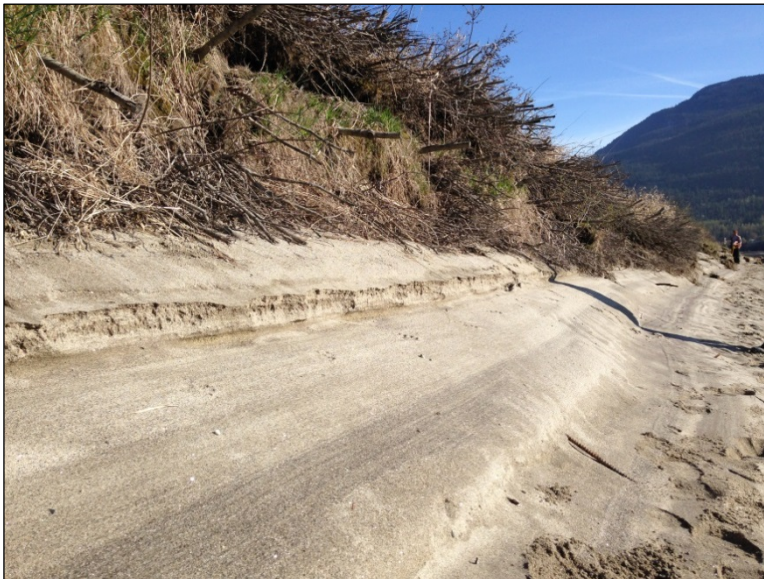
Photo 7: Site A2 Treatment Complete Erosion of Erosion Control Blanket and Willow Stakes (April 21, 2015)

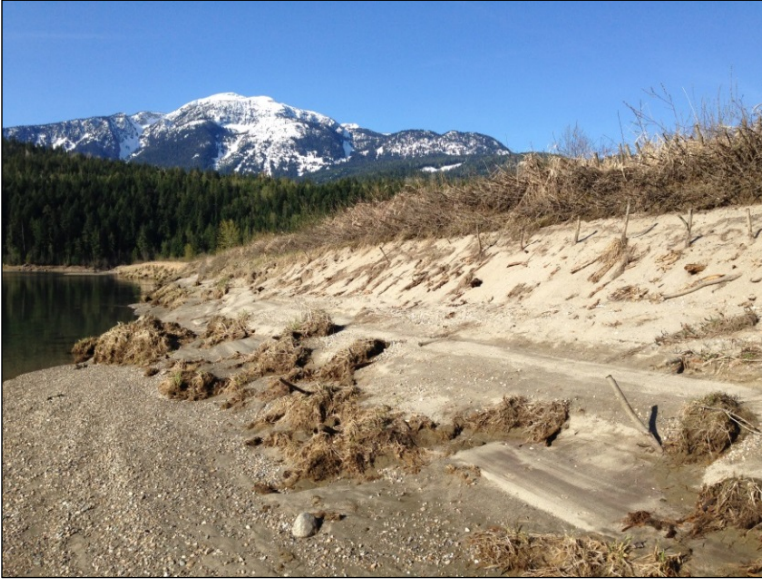
Photo 8: Site A2 Treatment Erosion of Toe and Mid-Bank, Upper Soil Wraps and Brush Layers Intact (April 21, 2015)

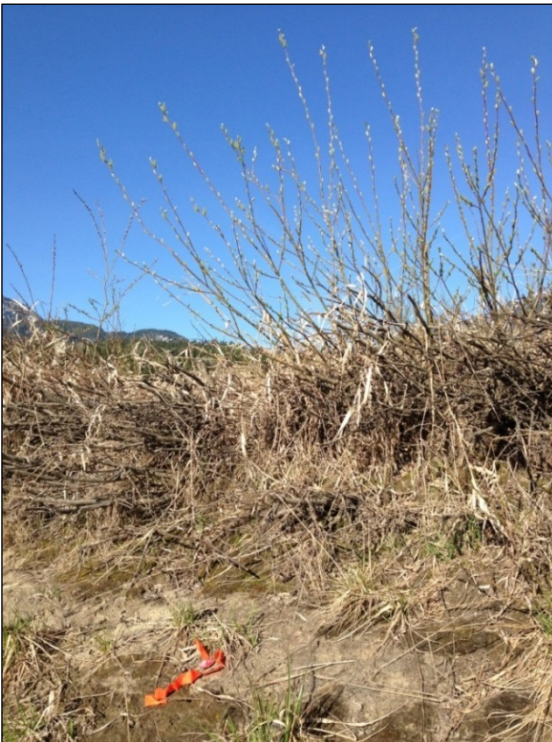
Photo 9: Site A2 Treatment New Growth on Willow and Brush Layers (April 21, 2015)

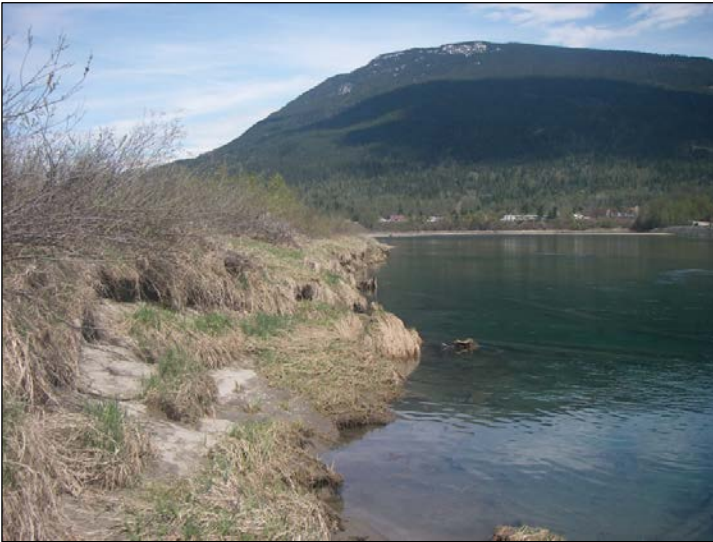
Photo 10: Bank Condition at Site A2 Upstream Control (April 21, 2015).

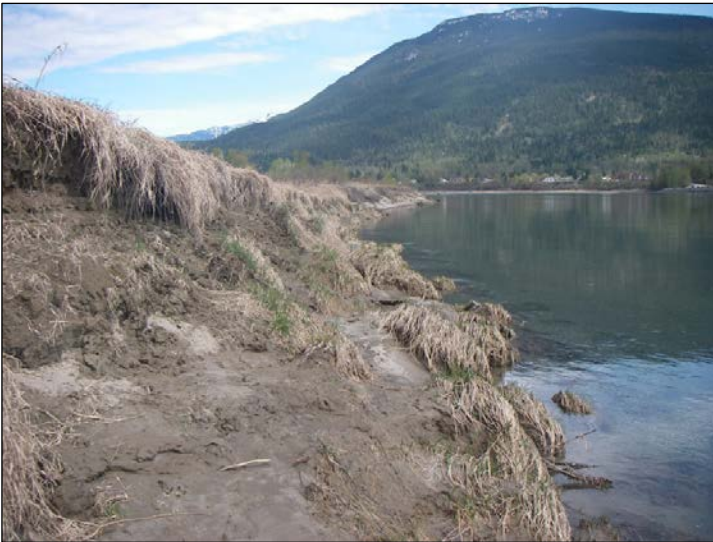
Photo 11: Bank Condition Site A2 Downstream Control (April 21, 2015).

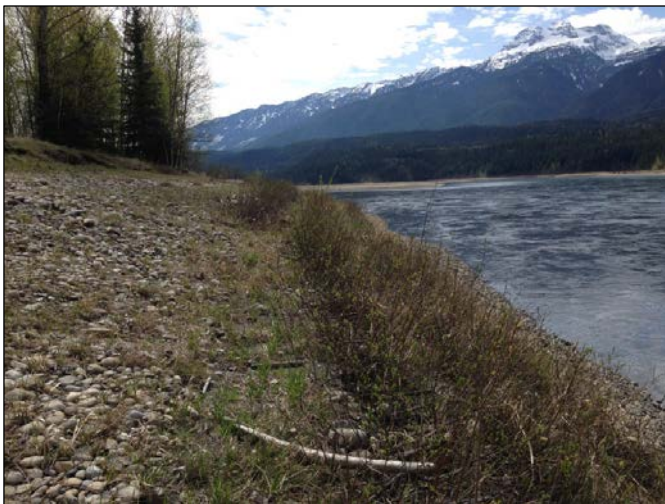
1. Brush layers appear stable.
2. New growth on brush layers is evident (Photo 12);

Photo 12: Site B Treatment New Growth on Brush Layers (April 21, 2015).

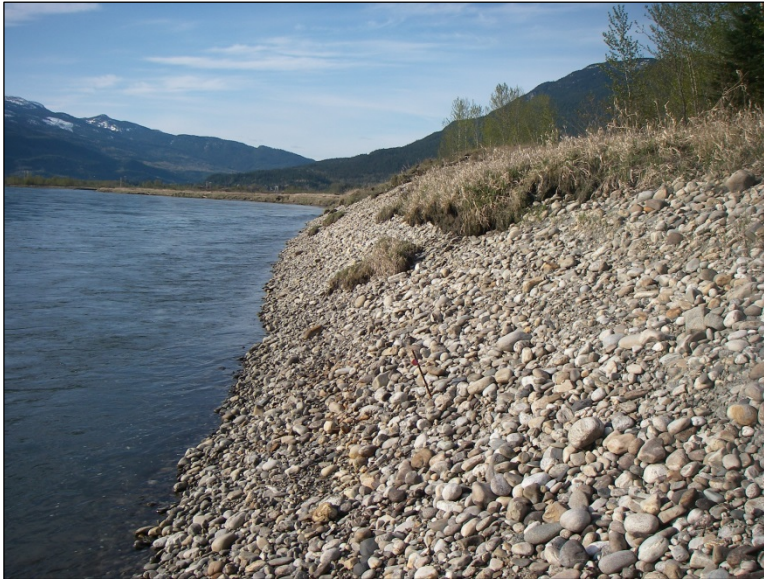
1. Erosion has occurred on the mid bank: some grassy blocks have broken off the upper bank and migrated down the mid bank slope (Photo 13).
2. Deposition is more common in the upper bank.

Photo 13: Site B Control, Grassy Blocks Migrating Down Mid Bank Slope, Erosion Pin in Foreground (April 20, 2015)

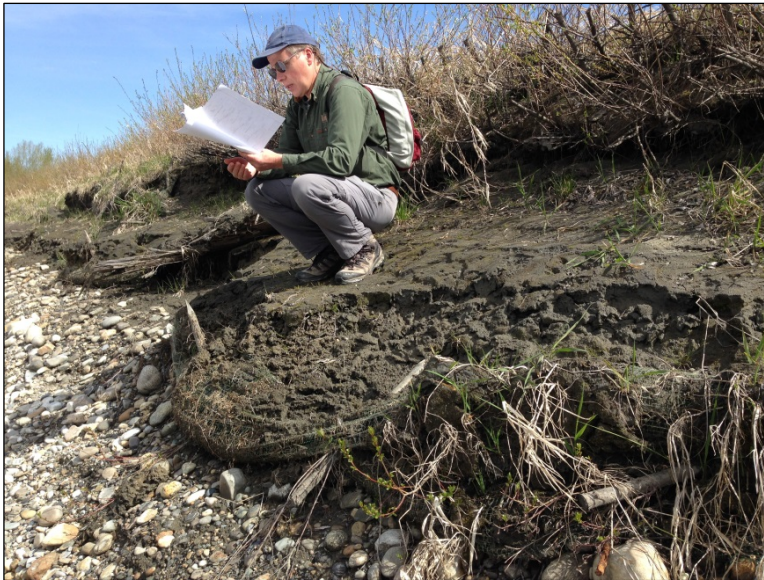
Photo 14: Site C Treatment Erosion in Mid Bank (April 21, 2015)

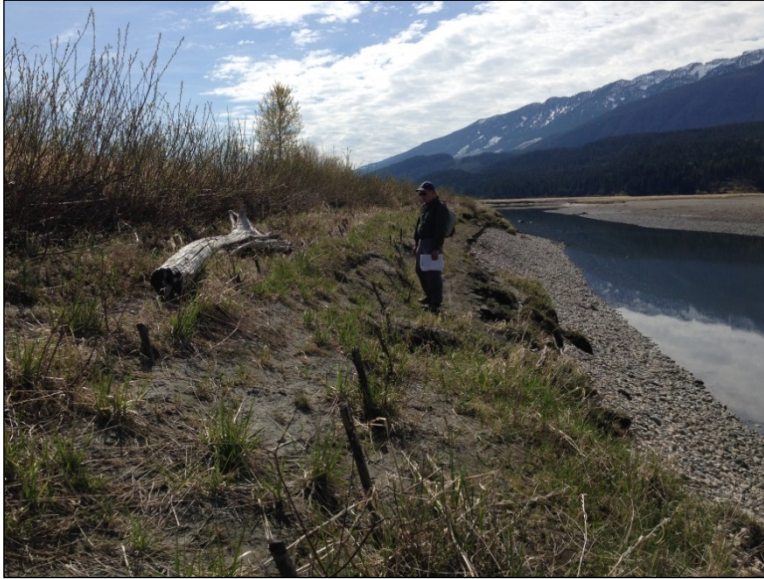
Photo 15: Erosion Control Blanket and Willow Stakes in Place Mid-Bank Toward Upstream End of Site (April 21, 2015)

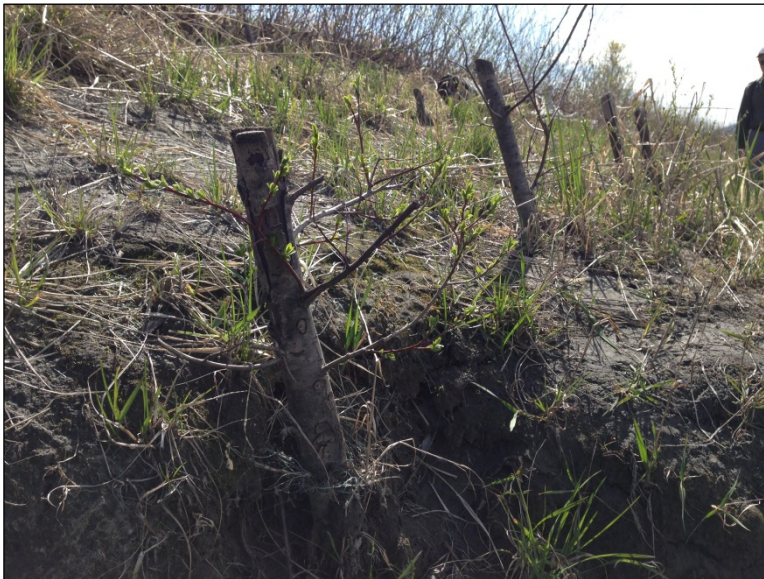
Photo 16: Growth on Willow Stakes and Brush Layers (April 21, 2015)

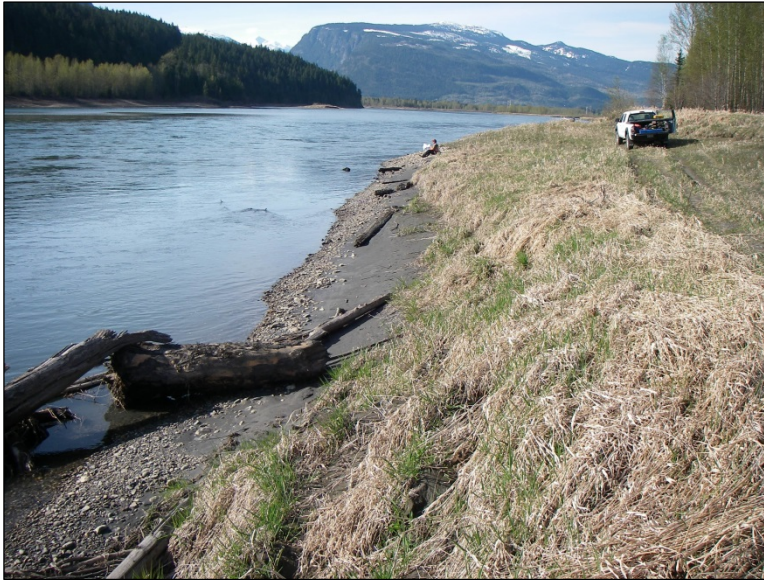
Photo 17: Site C Upstream Control Bank Condition (April 20, 2015).

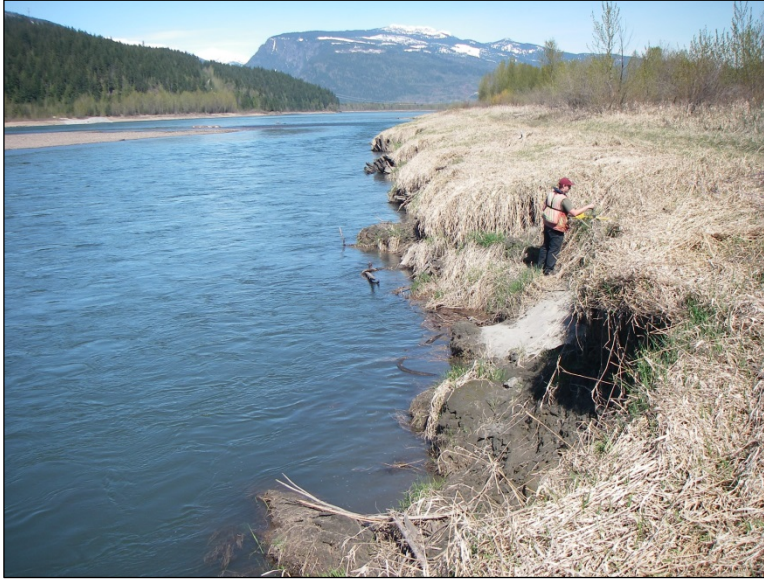
Photo 18: Site C Downstream Control Bank Condition
