Columbia River Project Water Use Plan

Kinbasket & Arrow Recreation Management Plan

Mid Columbia Erosion Protection and Long-Term Monitoring

2012 Progress Report

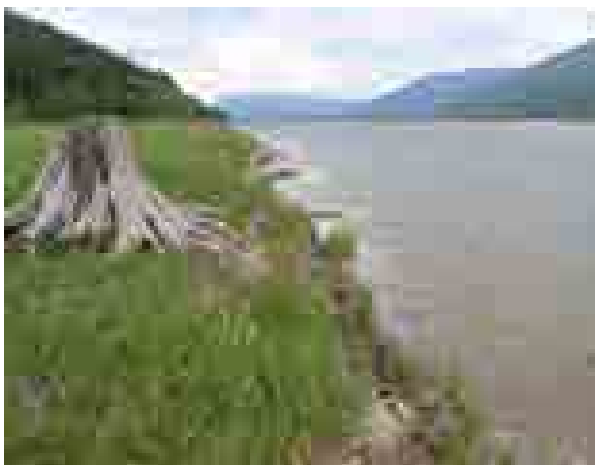
Based on the cross-sections, substantial erosion is occurring on the upper slope between about 433 and 435 m, which can be seen on the photos shown below. Based on the survey analysis, average cross-sectional erosion is -0.81 m and -0.54 for 2011 and 2012 monitoring respectively, with a total erosion of -0.52 m for the total period.

Photo 3-15: Looking upstream at steep, eroding bank (MON 8, June 1, 2011).

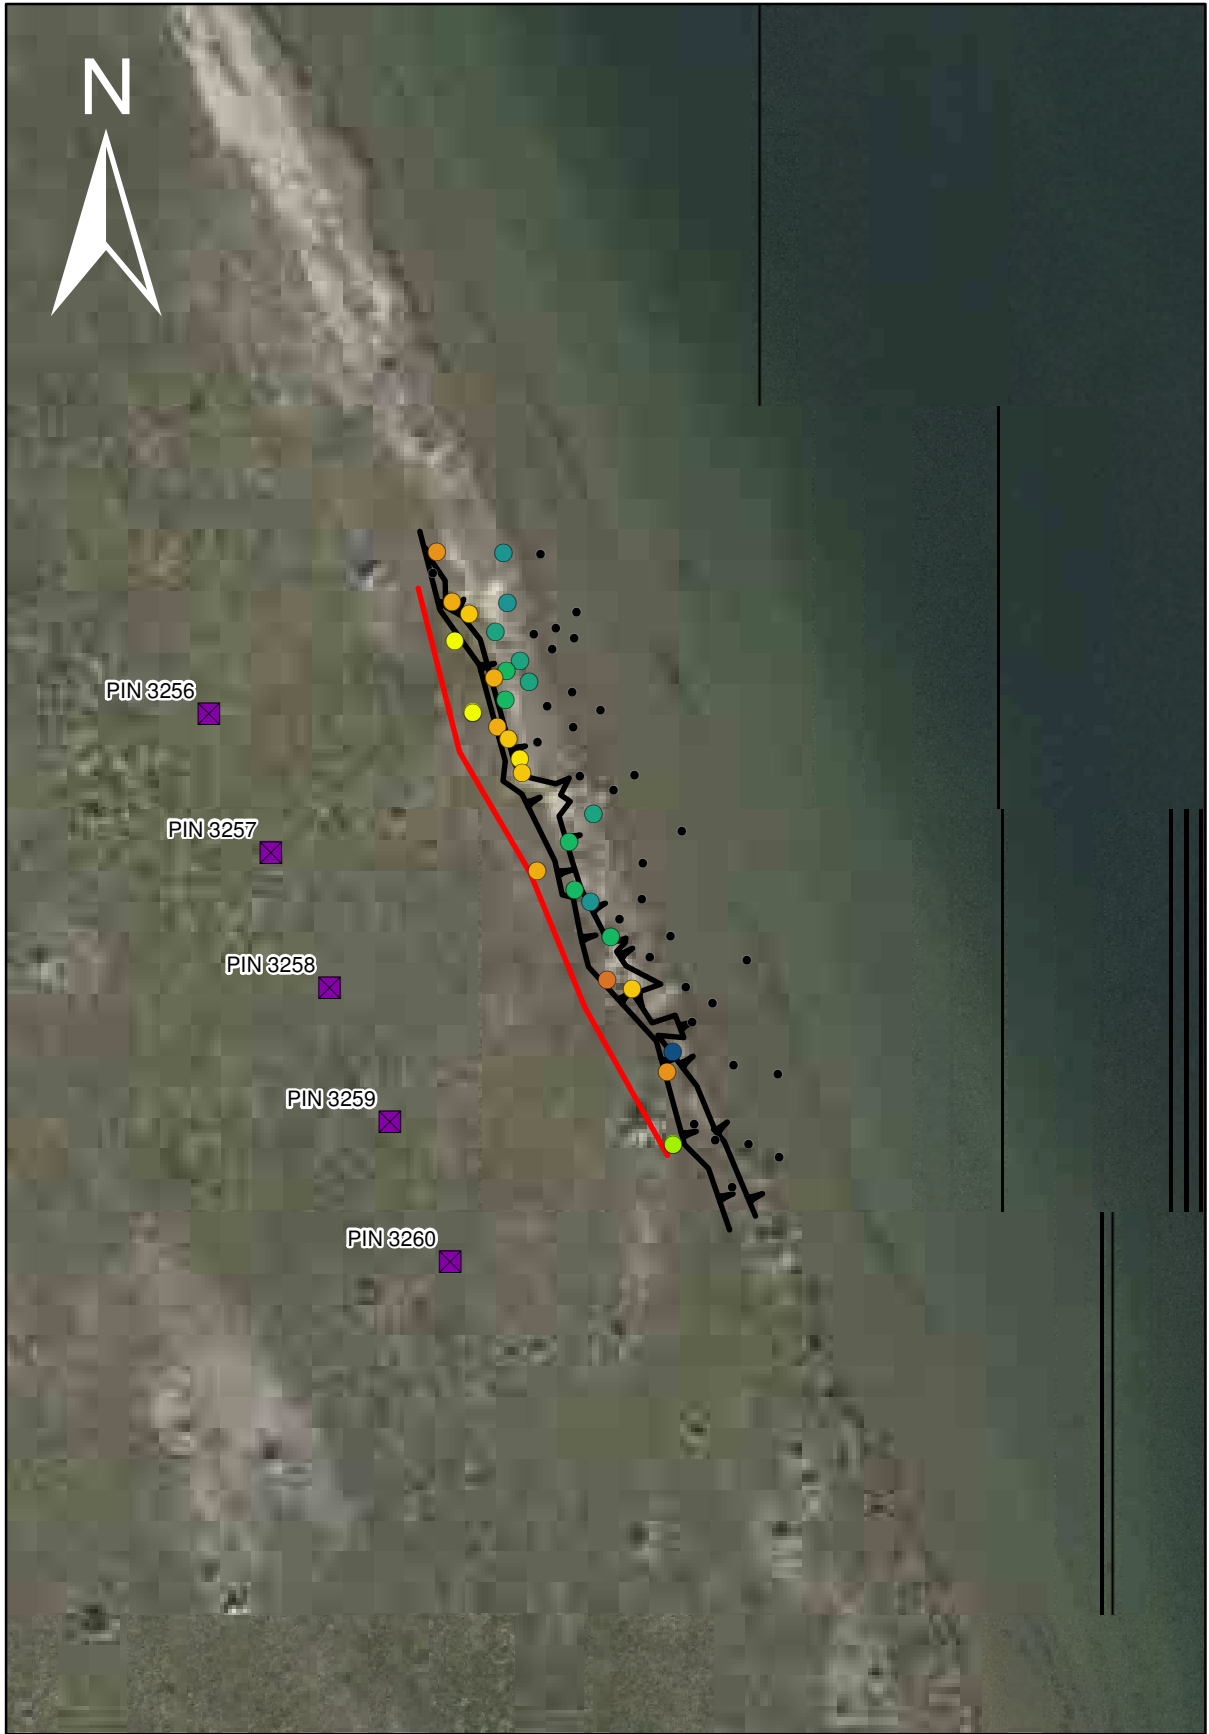
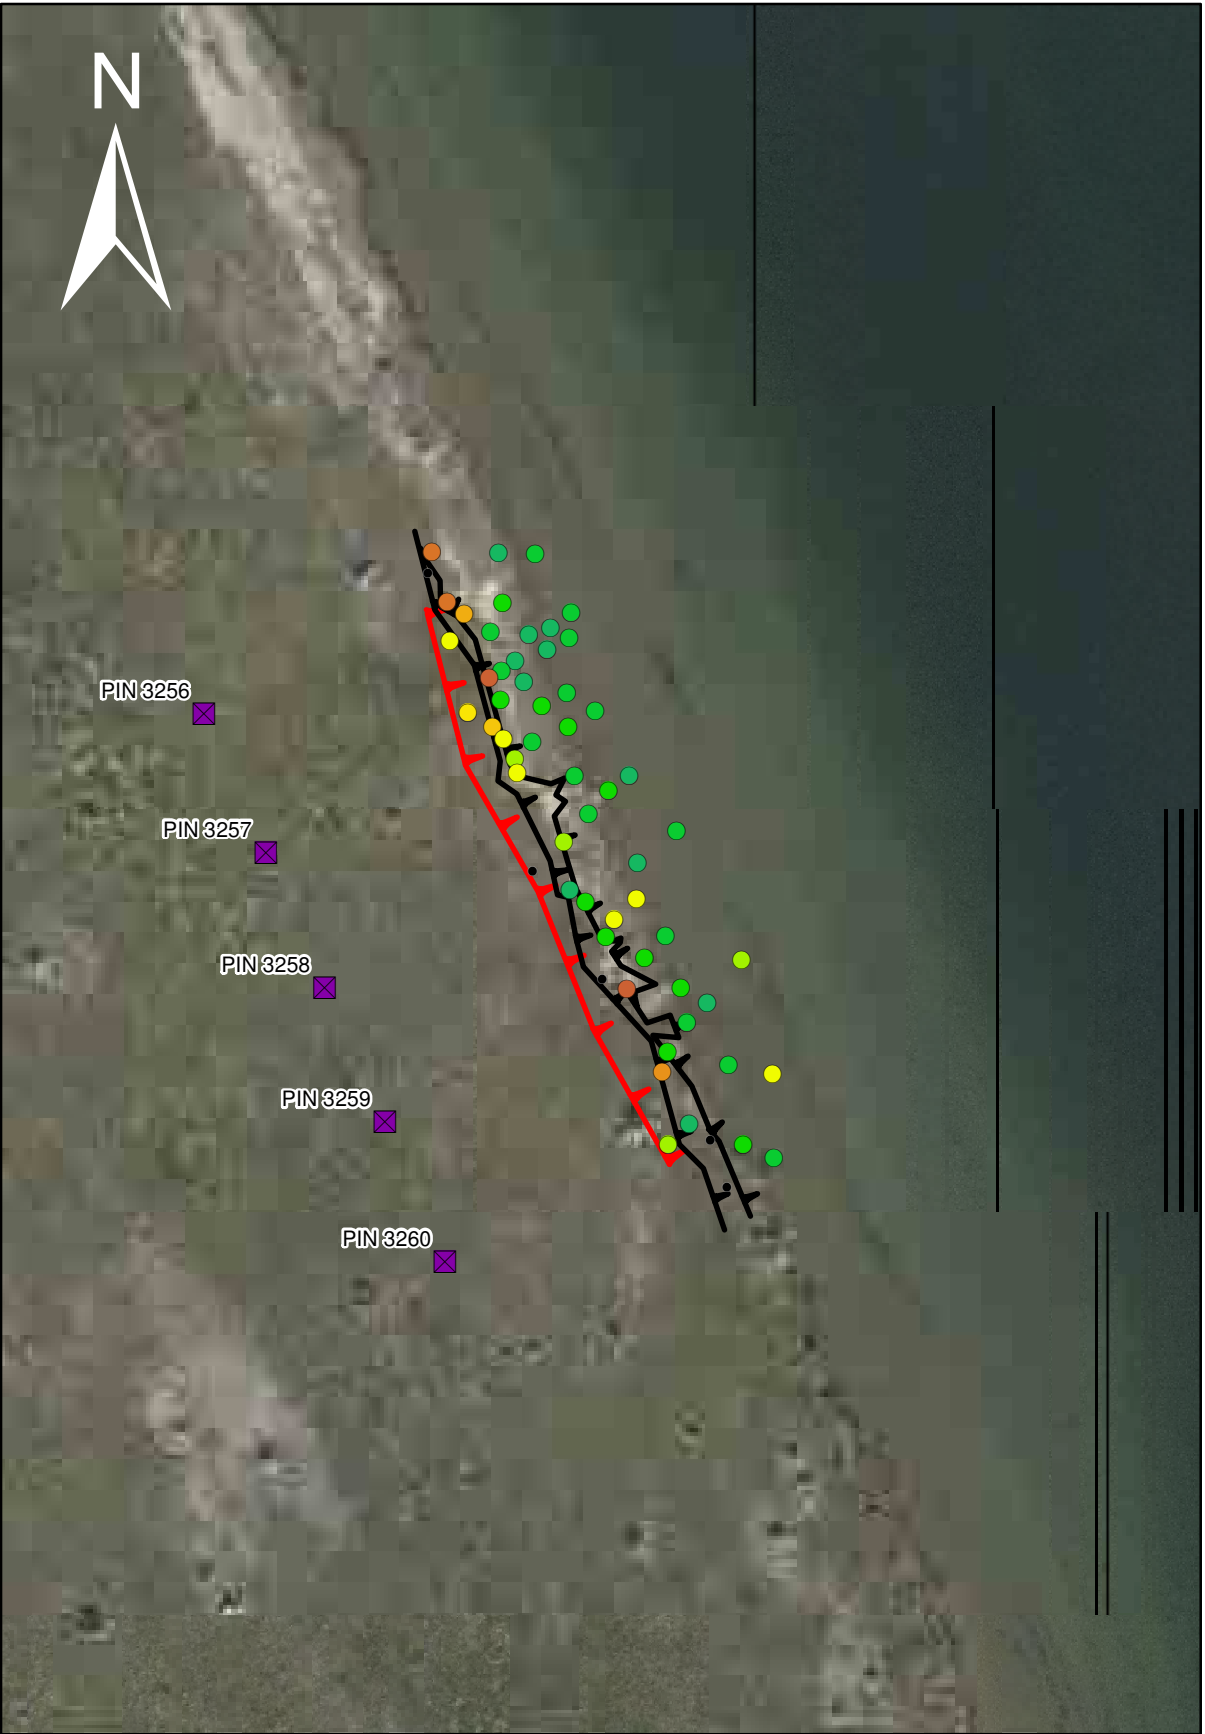
As indicated in Figure 3-10 almost all of the pins placed in 2010 were found, with measurements indicating a total erosion of -2.2 cm for the two year period and a maximum erosion pin exposure of -10.8 cm. The 2012 exposed pin lengths are influenced by the process where the erosion at the top of bank is causing deposition lower down on the bank (Figure 3-10).

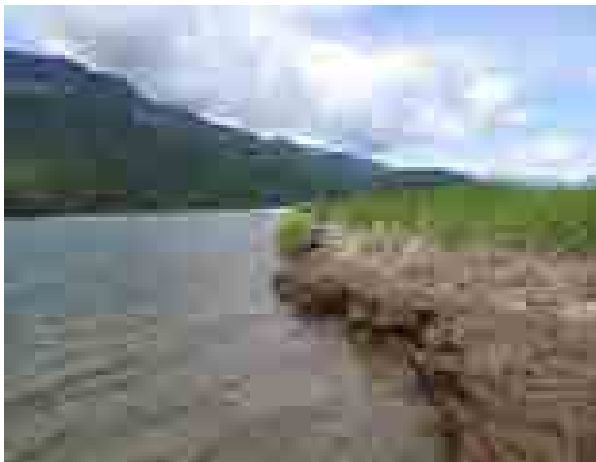
In 2011, very few pins could be measured due to high water conditions, and five were found to be toppled, but were reset. In 2012, 24 of the original pins could be recovered, predominately at lower elevations. The 2010 to 2012 pin exposure comparisons report an average of +11.2 cm (deposition); however, this does not account for large erosion at the top of the bank indicated by the red line on Figure 3-13. The cross-sectional data reflects the larger changes, where an average change of -1.25 m was observed between 2010 and 2011 and -1.21 between 2011 and 2012. The total change is -2.38 m for both years, or as much as 10 m at the top of bank at one cross-section, which is the largest observed erosion from all 15 sites.

Photo 3-21: Looking upstream along eroding bank
(MON 11, June 2, 2011).

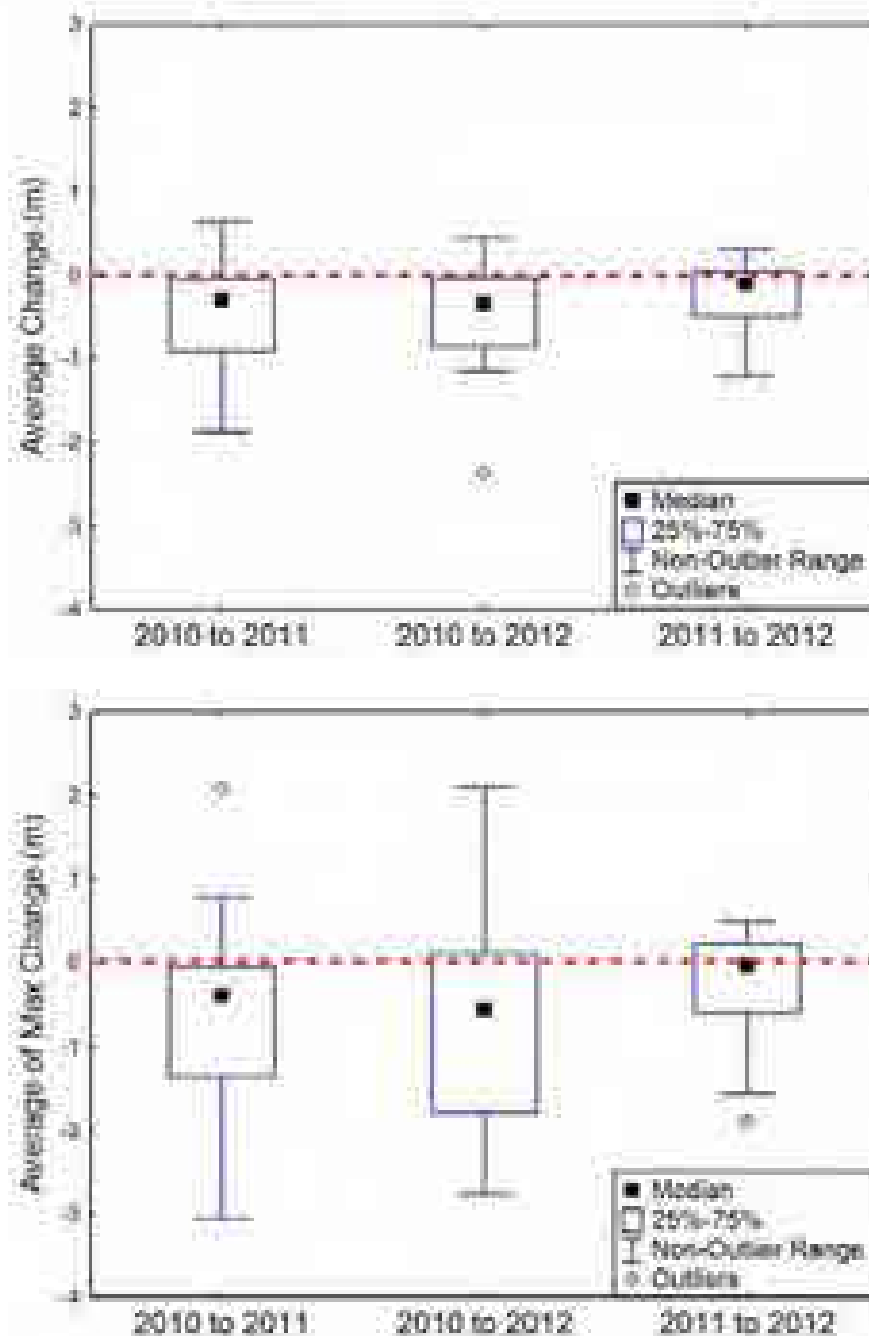
Statistical comparisons showed a significant difference for measures made at the midpoint from 2010 to 2011 and for 2010 to 2012 (-0.5 and -0.47 m, Student's paired t-test, $p < 0.05$; Table 5). Comparisons based on the maximum changes within each elevation band were not statistically significant for any of the three time periods. High variability in the maximum values contributed to the lack of significance when the sites were compared (Figure 3-5). Nonetheless, whether calculated at the midpoint or as the maximum, both provided very similar measures of site condition because the average values based on midpoint and maximum measurements were highly correlated (Pearson's correlation = 0.93, $N = 42$ [14 sites x 3 elevations]).

Figure 3-23: Average change at the 14 monitoring sites measured as change at the midpoint of the elevations (upper panel) and measured as the maximum observed difference (lower panel). Shown are changes in elevation for three time periods.
