**CLBWORKS-30A Arrow Lakes Reservoir: Implementation of
Wildlife Physical Works – Revelstoke Reach**

***ARROW LAKE RESERVOIR, SITE 6A ENGINEERING SERVICES
West Arm Headcut Mitigation – Conceptual Design Options***

Technical Memorandum

RE: **ARROW LAKE RESERVOIR, SITE 6A ENGINEERING SERVICES**
West Arm Headcut Mitigation – Conceptual Design Options
Our File 478.240-300

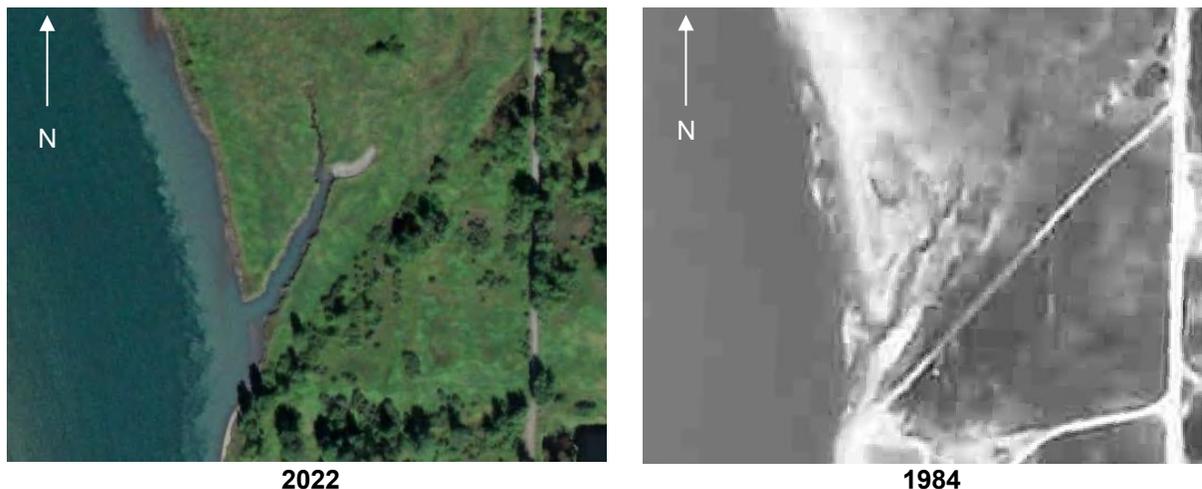
Figure 4: The head cut erosion feature shown in the 2022 image (left) is visible in the 1984 aerial image (right).

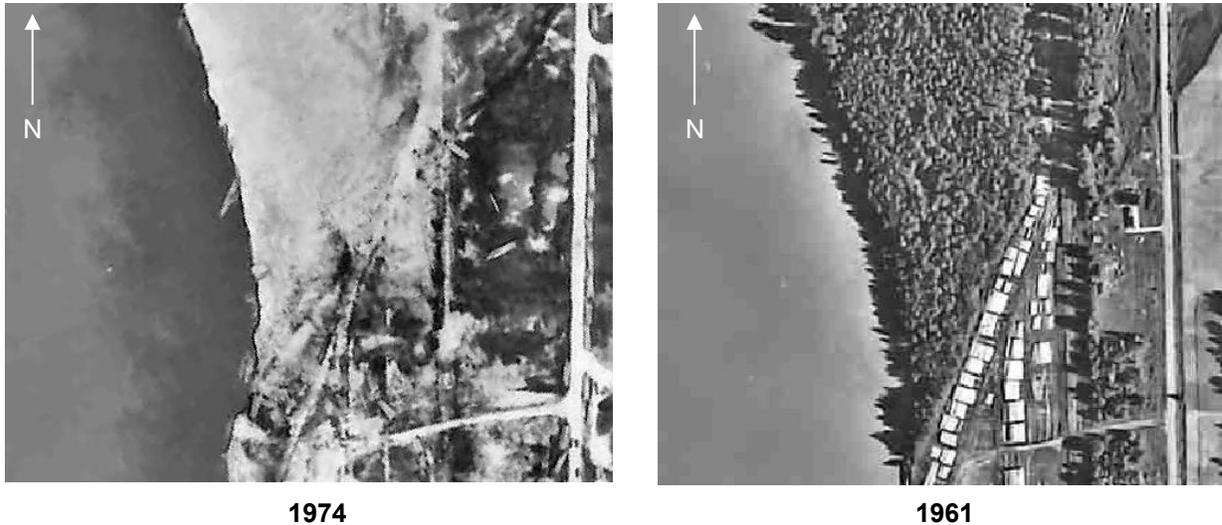
Figure 5: The headcut erosion feature does not appear in the 1974 aerial photo (left) and the 1961 aerial photo (right).

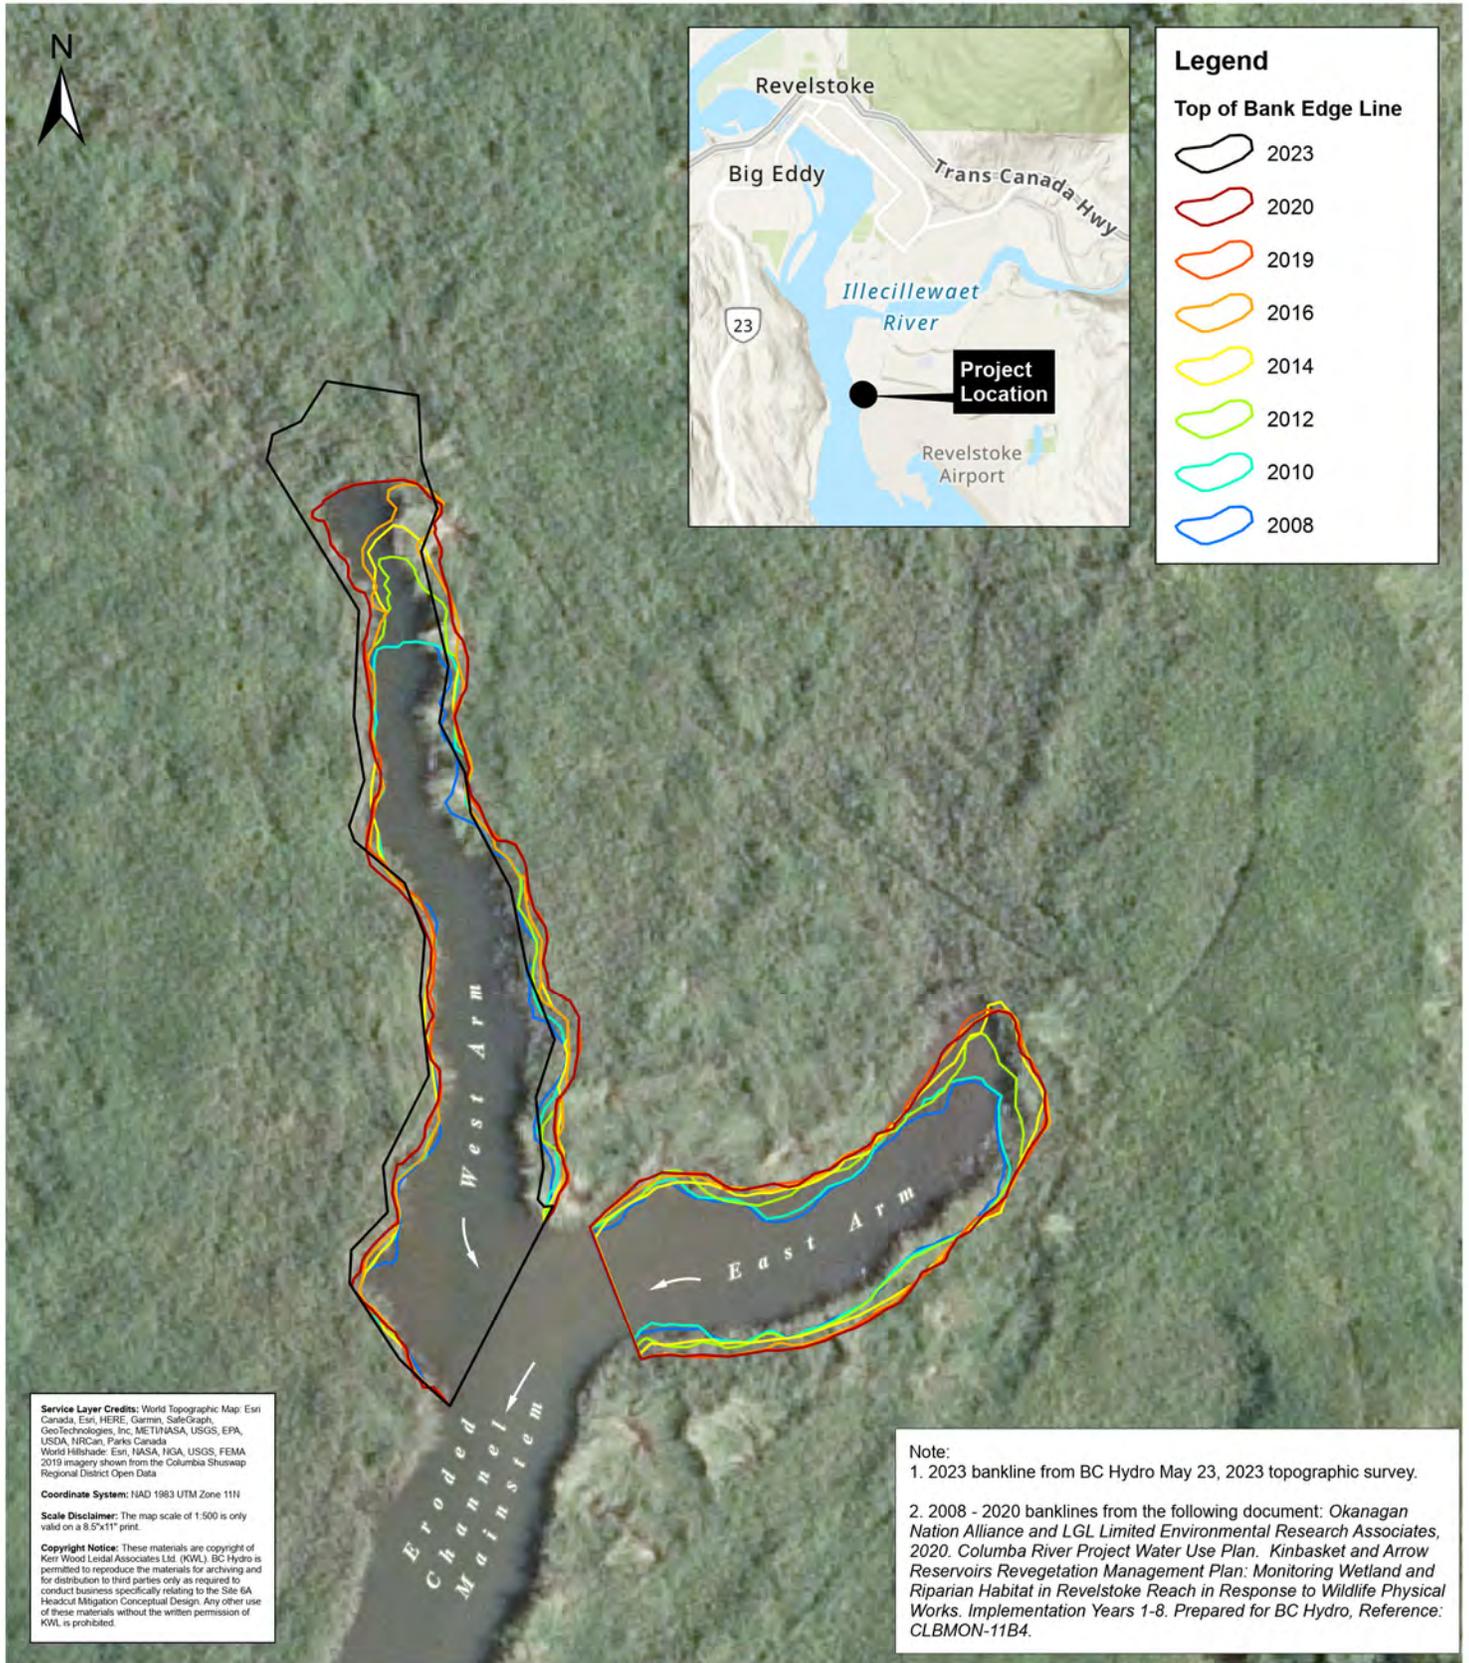
Figure 7

Table 4 summarises the erosion observed in the west channel over total site monitoring/date period (2008 to 2023). Erosion rates are approximate, and length of erosion varies across the channel width. Prior to 2020, erosion rates were estimated by LGL and ONA, and erosion rates after 2020 are based on KWL comparison of the digitized top (edge) of bank line from LGL and ONA in 2020 and the survey in 2023. The highest erosion rates observed occurred are approximately 2-3 m/year and occurred 2020-2023 and 2010-2012. Notably, based on information from BC Hydro and site observations, the recent erosion occurred primarily in 2022, indicating the erosion has been more episodic, resulting in certain years with higher rates of erosion than the annual average indicates.

Survey of East and West Channels of Headcut Erosion Features Delineated by Year

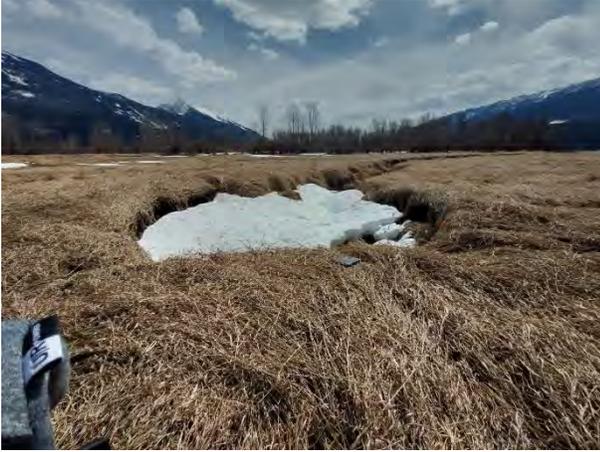
- The upstream end of the West Arm channel headcut has large blocks of soil and sod that have calved from the surrounding area and fallen into the headcut channel. In May 2023, the West Arm channel was predominantly dry with no surface flow into the channel from upstream, no flow at the base of the channel, nor any observed seepage from the channel walls. In April 2022, the West Arm was largely filled with snow, and the channel was partially backwatered by high water levels on the Columbia River. In April 2022, surface water was flowing into the West Arm at the headcut at two locations from Pond D.

Photo 1: Location of head cut at the end of the West Arm of the eroded channel, looking down the channel. April 12, 2022.

At this stage, BC Hydro's preferred approach is to focus on diverting water away from the West Arm and redirecting it towards the East Arm, where a riprap buttress is already installed. In the long-term armoring or other more intensive options may be considered if water diversion does not sufficiently reduce headcut progression. There is a risk that directing additional flow towards the East Arm (and drainage features that feed it) could cause erosion in new locations, which should be considered in any mitigation design and is discussed further in Section 5.

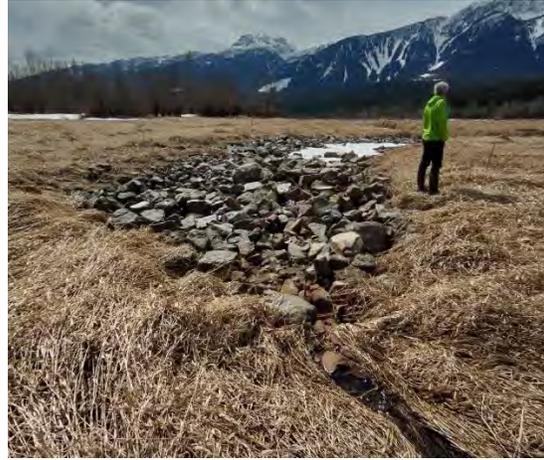
- The East Arm had no observed erosion around the riprap and little to no flow during the May 2023 site visit. In April 2022, surface waters were flowing into the East Arm from upstream and flowing water could be heard percolating through the riprap.

Photo 2: Existing riprap in the East Arm of the eroded channel, looking down the channel. April 12, 2022.

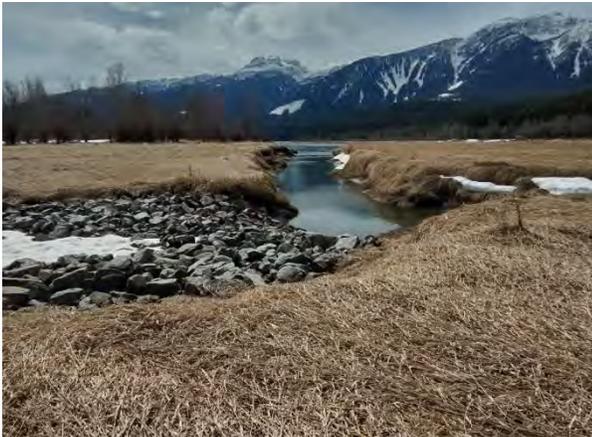
Photo 3: Confluence of the East and West Arms into the eroded channel mainstem, backwatered by Arrow Reservoir. Looking toward the reservoir. April 12, 2022.

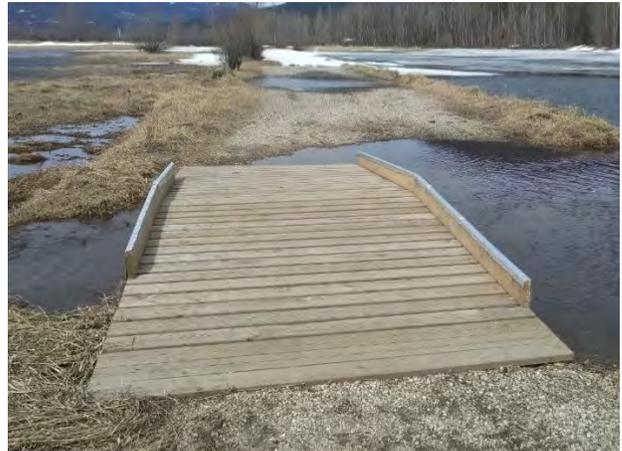
Photo 4: Water flowing over the old road (outflow A:B) into Pond B. Looking North. April 12, 2022.

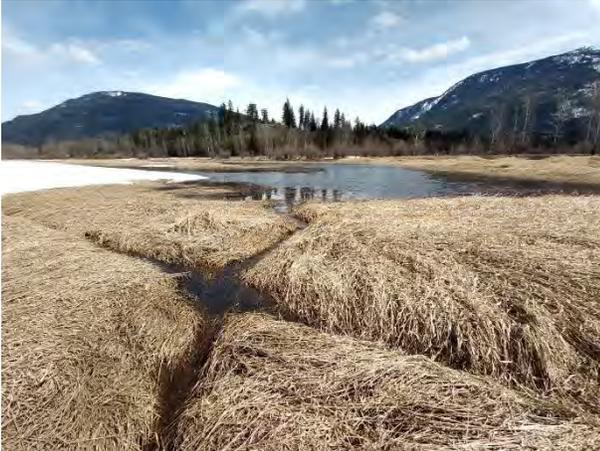
Notably, B:C-2 has a relatively steep grade, which is expected to have contributed to headcut progression at this location. Based on April 2022 conditions, the old road overflow (A:B) and B:C-1 channels are estimated to experience flow velocities at between 0.8 m/s and 1.5 m/s; however, they have more shallow grades and appear to be generally stable based on current site conditions.

Photo 5: Water flowing from Pond B into B-C:2 channel. Looking northeast toward Pond B. April 12, 2022.

The proposed work at the B:C-2 outlet re-directs flow towards the East Arm and mitigates the risk of the headcut at B:C-2 by regrading the site, infilling the headcut, and providing vegetation for erosion protection and temporary biodegradable erosion protection while vegetation establishes. However, it does have risks associated with significantly increasing flow to an area that presently receives limited flow. The concepts have been developed with shallow grades that mirror stable conditions elsewhere on site (notably at the B:C-1 outlet), but differences in conditions or vegetation establishment periods may result in some uncertainty in the outcome. This may necessitate ongoing monitoring and potential remedial actions if issues arise.

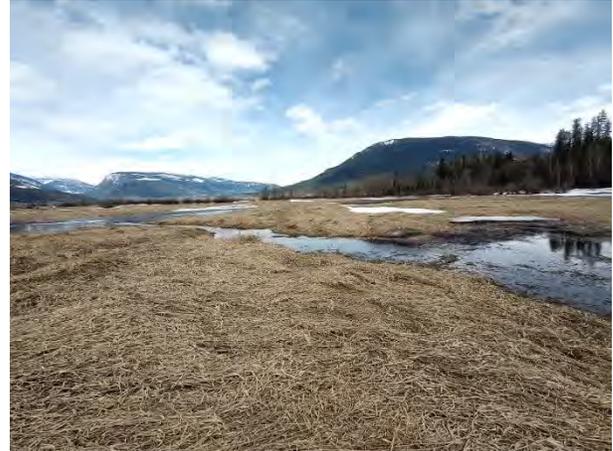
- B:C-1 has a wider, shallower grade, and had a much higher volume of flow (during the April 2022 site visit), than B:C-2. This indicates it is the primary outflow from Pond B, which was confirmed based on survey of the outlets. No erosion was observed at B:C-1 and the channel and slopes are completely vegetated.

Photo 6: Water flowing through the old rail road from Pond B into B-C:1 channel. Looking northwest toward Pond C. April 12, 2022.

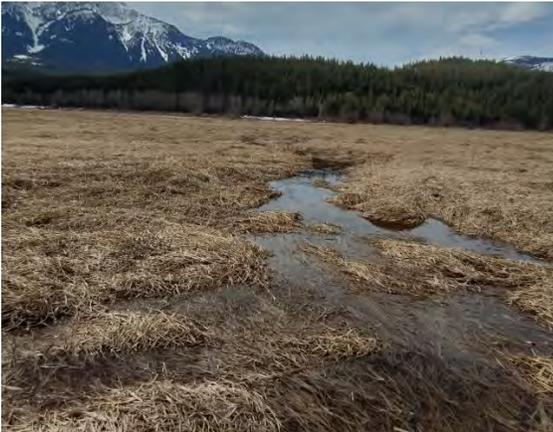
Photo 7: Water flowing from Pond C to Pond D through C:D channel. Looking west toward Pond D. April 12, 2022.

- Plugging the C:D outlet with a low channel plug constructed with locally salvaged borrow and sod for revegetation and erosion protection, along with biodegradable erosion control matting. The low plug would focus on filling the small outlet and has the potential to be overtopped or outflanked by overtopping elsewhere along Pond C.

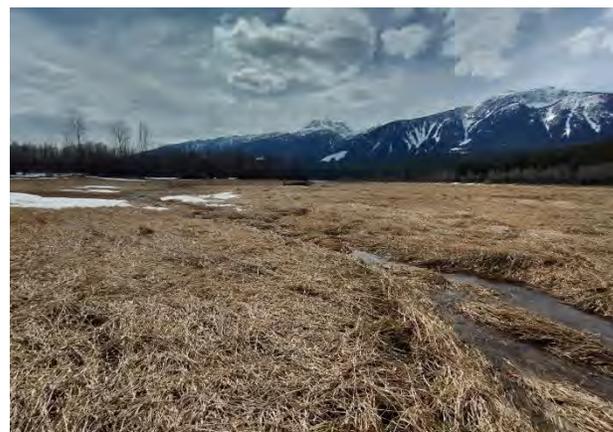
Photo 8: Water flowing from C pond to East Arm, looking southwest towards East Arm. April 12, 2022.

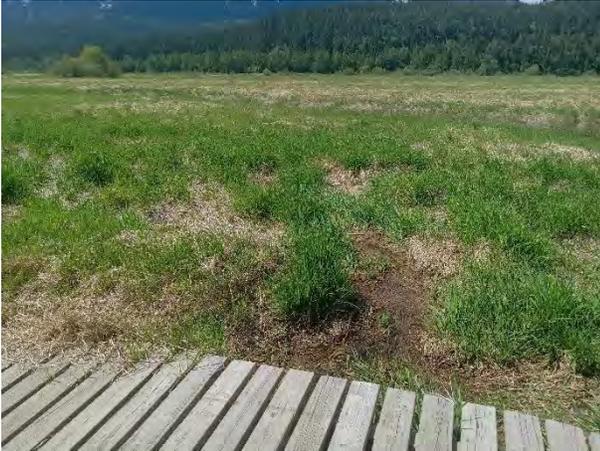
Photo 9: Water flowing over the old road (A:B) towards Pond B at 7 cm deep. Looking west, May 11, 2023.

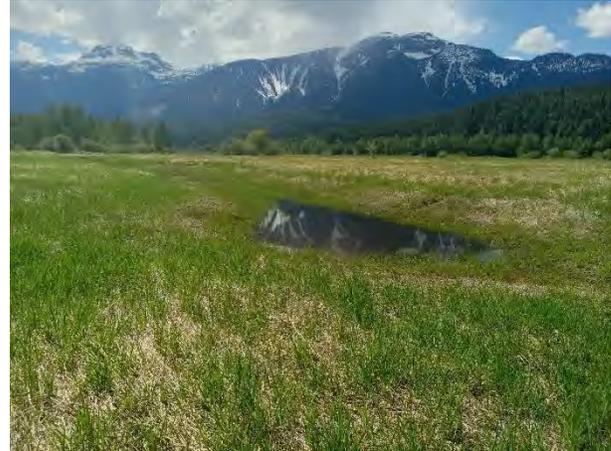
Photo 10: Water starting to pool in Pond B, but not yet spilling at B-C:1 or B-C:2. Looking southwest, May 11, 2023.

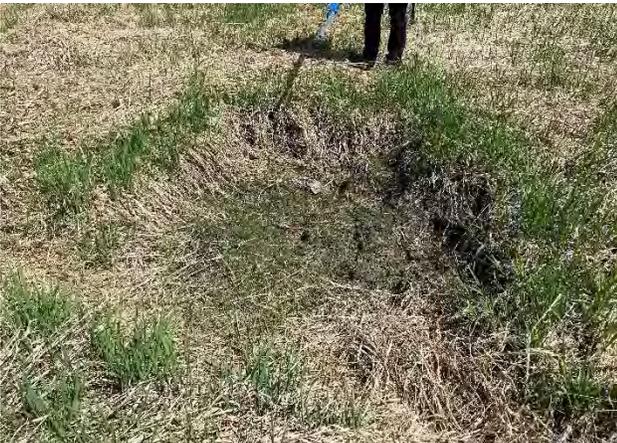
Photo 11: Previous attempt by BC Hydro to stop erosion at B-C:2 by digging out adjacent soil and placing it in the channel at the spill point. May 11, 2023.

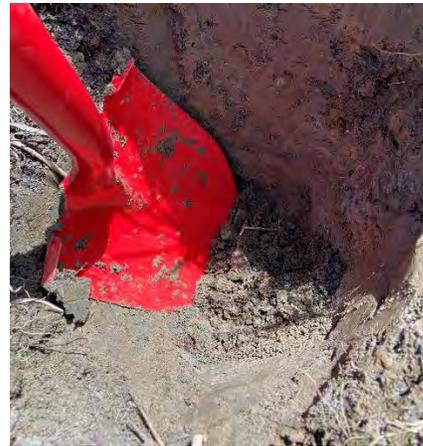
Photo 12: Typical silty clay test pit soils below the organic layer. May 11, 2023.

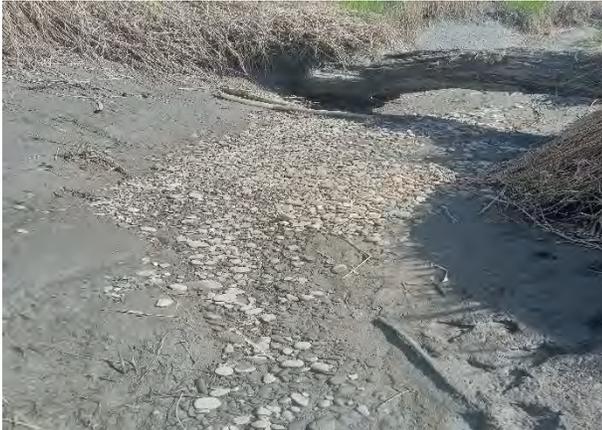
Photo 13: Gravel on channel bed in eroded channel mainstem, with erodible silt on side slopes and undercut banks. May 11, 2023.

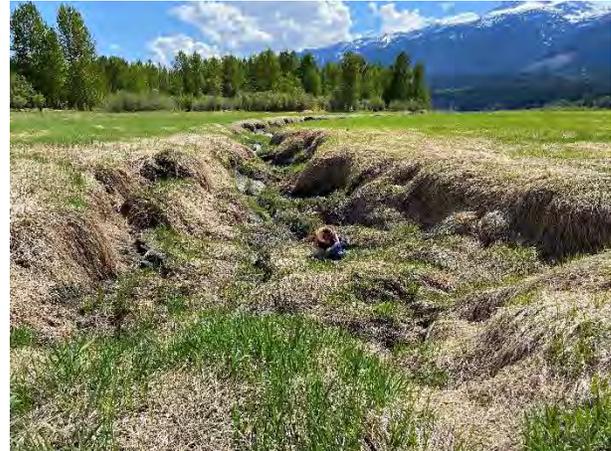
Photo 14: Looking down West Arm from the channel head cut. May 11, 2023.

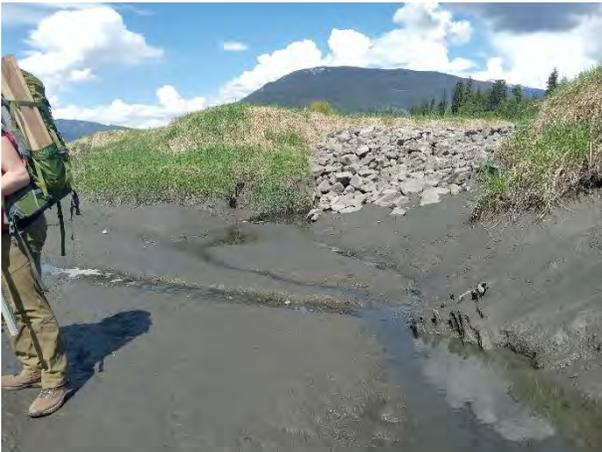
Photo 15: Confluence of East and West Arms to main eroded channel. Looking northeast, May 11, 2023.

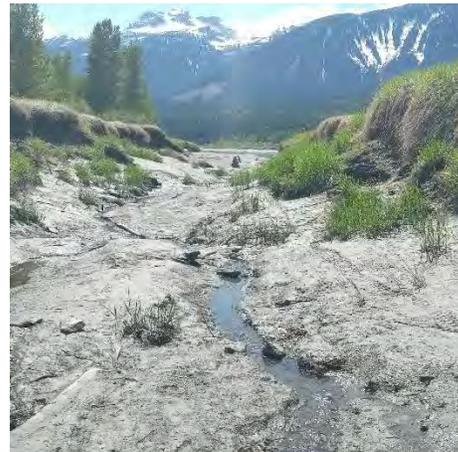
Photo 16: Looking southwest down the main eroded channel from the confluence of the East and West Arms. May 11, 2023.
