Columbia River Project Water Use Plan

Kinbasket and Arrow Reservoirs Revegetation Management Plan

Kinbasket Reservoir Monitoring of Revegetation Efforts and Vegetation Composition Analysis

Implementation Year 6

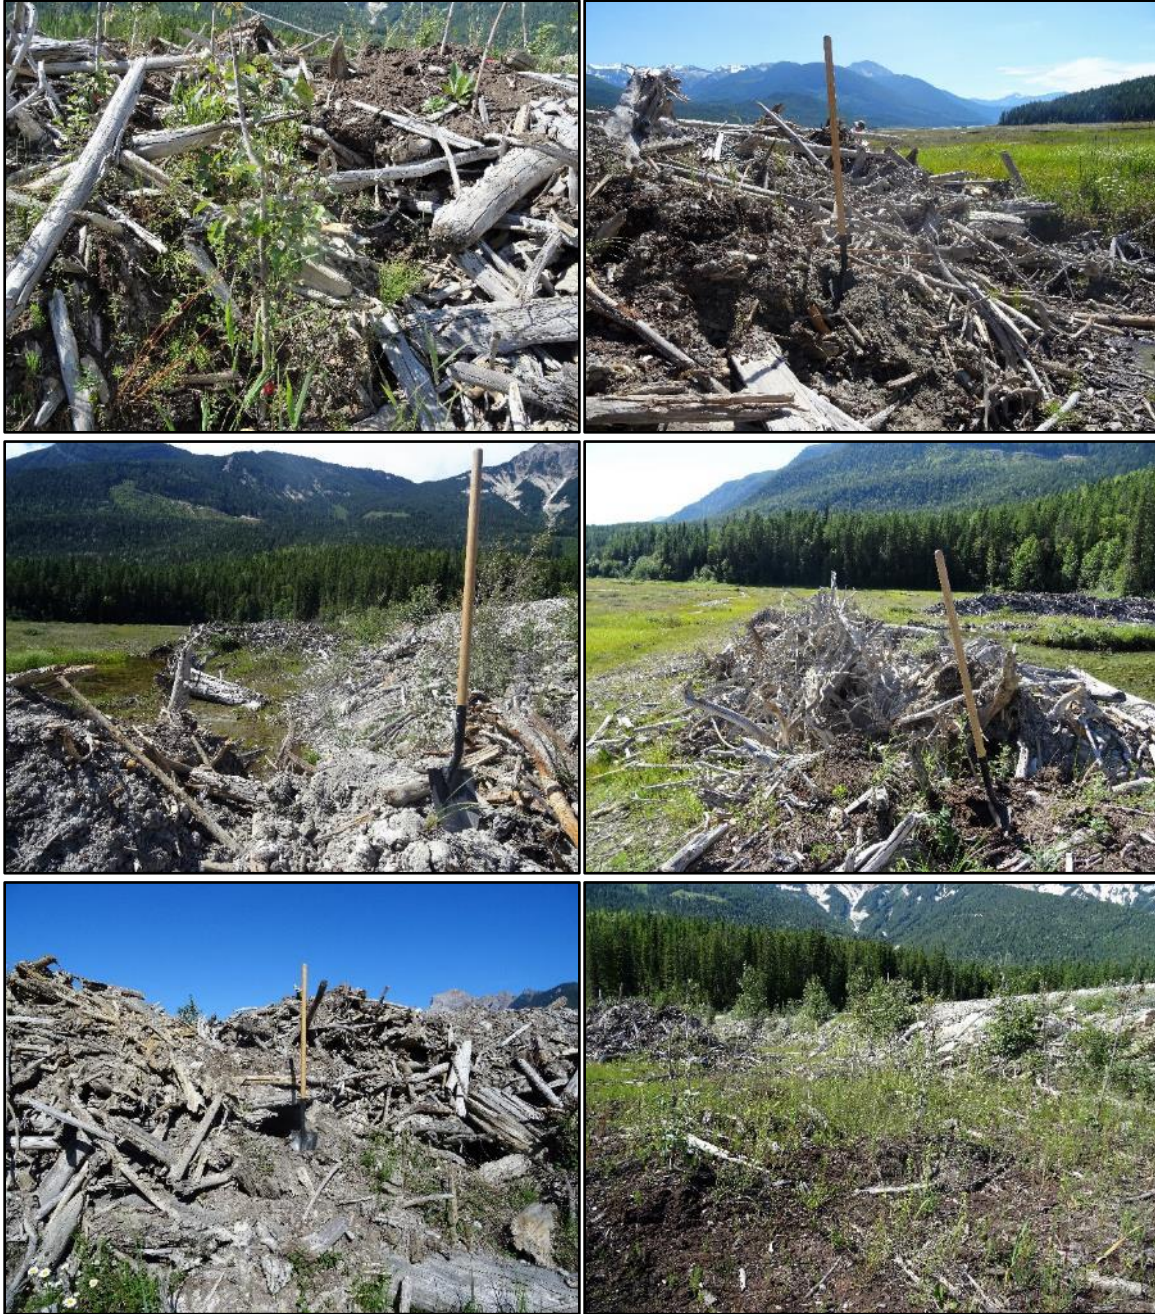
As of July 2018, a variety of plant species had colonized the constructed mounds at Bush Causeway (Figure 3-1). The lower fringes of the mounds (including the recovering mound construction footprints) supported the greatest array of establishing plants, with about 70 taxa recorded. Of these, 17 (~25%) were naturalized exotic species. The middle portions of mounds supported about 50 species, while the tops of mounds supported about 40 species (Table 3-1). Anecdotal observation indicated that individual mounds varied with respect to plant cover, with narrower mounds (windrows) tending to show sparser establishment than the more rounded mounds.

A total of 36 surviving, and 42 non-surviving, cottonwood stakes were counted within sample polygons on three constructed mounds (Figure 3-1), for an estimated stake survival rate (to date) of 46%.

Figure 3-1. Constructed mounds, Bush Causeway (north site), illustrating current state of establishing planted and natural vegetation. Leaf-bearing live stakes are visible in the top left and bottom right panels. Photographed July 2018.

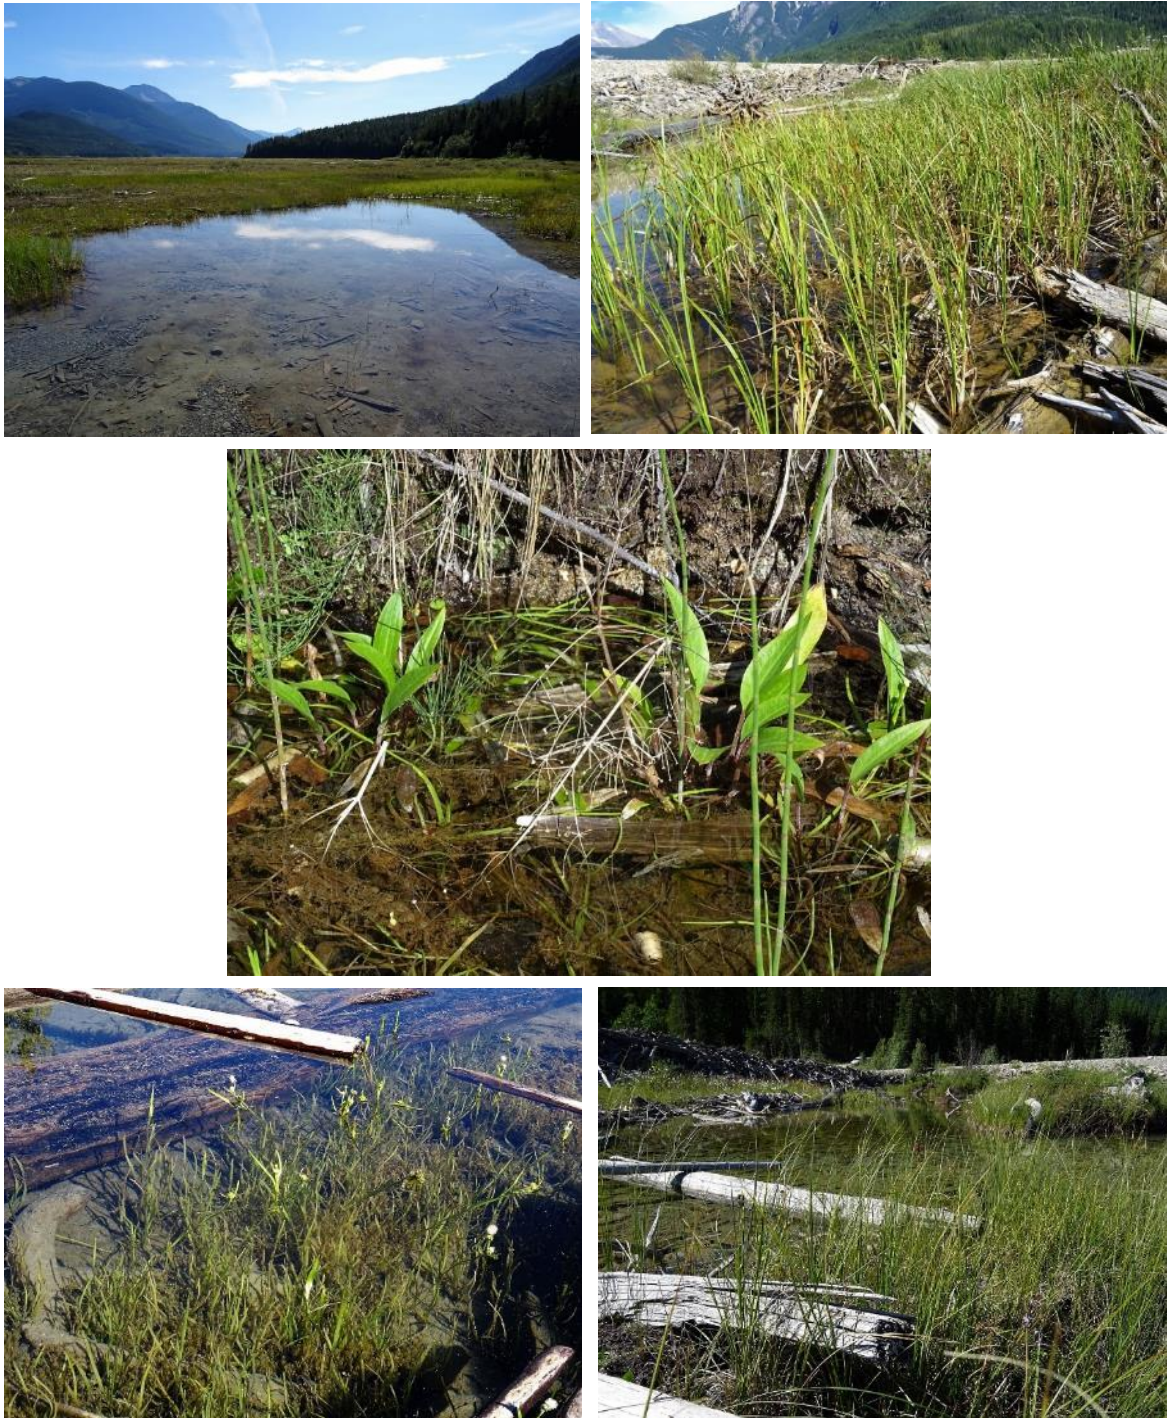
The three Bush Causeway ponds that were cleaned of wood debris and subsequently protected behind a log-boom placement are exhibiting signs of vigorous regrowth with respect to both riparian and aquatic macrophyte vegetation. Wetland-associated genera observed in or along the edges of ponds in 2018 included *Carex*, *Potamogeton*, *Hippuris*, *Sparganium*, *Myriophyllum*, *Alisma*, *Equisetum*, and *Persicaria* (Figure 3-2). As in the case of the mounds, the log-boom has not yet been exposed to a full-scale inundation event; therefore, there has been no opportunity yet to assess its long-term effectiveness at excluding wood debris from reaccumulating in the upstream ponds. Similarly, the biophysical responses of the ponds to seasonal inundation remain untested and unknown.

Figure 3-2. Regenerating wetland vegetation in ponds cleaned of wood debris in 2015 at Bush Causeway. Clockwise from top left: overview of cleaned pond with log-boom (in background), *Carex utriculata*, *Alisma gramineum*, *Carex aquatilis*, *Sparganium* sp. Photographed July 2018.

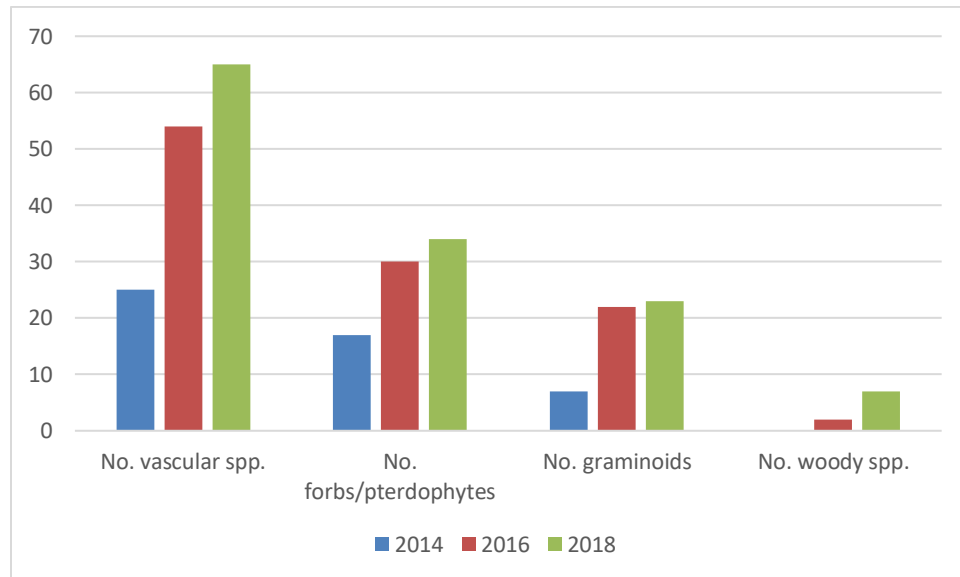
A total of 18 vegetation cover transects (nine treatment and nine control) were sampled at the Valemount Peatland woody debris removal and log-boom enclosure site in 2018. Sixty-five vascular plant species were recorded in the log-boom protection area, including 34 forb and pteridophyte species, 23 graminoid species, and seven woody species. These numbers represent a substantial increase (>100%) in species richness compared to the richness recorded just after the physical works were implemented in 2014 (Figure 3-3). Species richness also increased since 2016 for all species groups, though at a slower pace than in the years immediately following installation of the log-boom. In contrast to the trial at Bush Causeway, the reservoir maximum was high enough in 2016 to briefly inundate the Valemount Peatland log-boom. However, the log boom has not yet been tested by high reservoir levels and it is currently unknown how effective the enclosure will be at protecting the regenerating vegetation at this site from heavy wood deposition during full pool events. Future analyses will compare trends in richness, diversity, cover, and composition over time between the treated (log-boom) site and an adjacent, unprotected control site.

Figure 3-3. Changes in vascular plant species richness at Valemount Peatland woody debris removal and log-boom enclosure site between 2014 (two months post-treatment) and 2018.

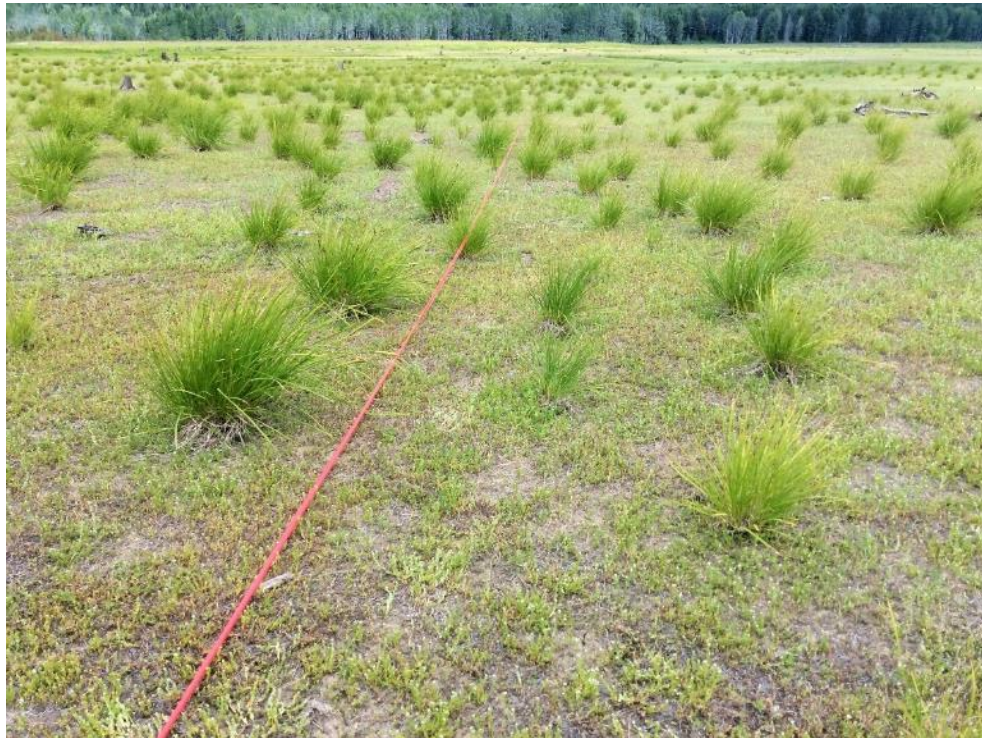
Five years following planting, the sedge seedling plugs at Km 88 (Figure 3-4) continue to perform well both in terms of survivorship and reproductive development. In sample polygons at each of the three treatment units (TU-1, TU-3, and TU-5), estimated surviving plug densities (per ha) were approximately 7,190, 9,310, and 8,440 respectively. These establishment rates are slightly below the targeted densities of 10,000-15,000 plugs per ha for TU-1 and TU-3, and in line with the target density of 5,000-10,000 per ha for TU-5 (Adama 2015). Based on the reported initial stocking densities, this places the estimated survival rate for all TUs at ~35% after five years. By comparison, survivorship at several other Kinbasket sites was nil or minimal after a similar period (Hawkes et al. 2018), making

this one of the more successful revegetation initiatives under CLBWORKS-01. Sedge vigour was rated “good” overall for TU-1 and TU-3, and “moderate to good” for TU-5.

Figure 3-4: Sedge planting treatment at Km 88, Bush Arm. Planted plugs of Kellogg’s sedge are visible mixed with an existing ground cover of annual forbs, primarily Scouler’s popcorn flower (*Plagiobothrys scouleri*). Photographed 28 June 2018.

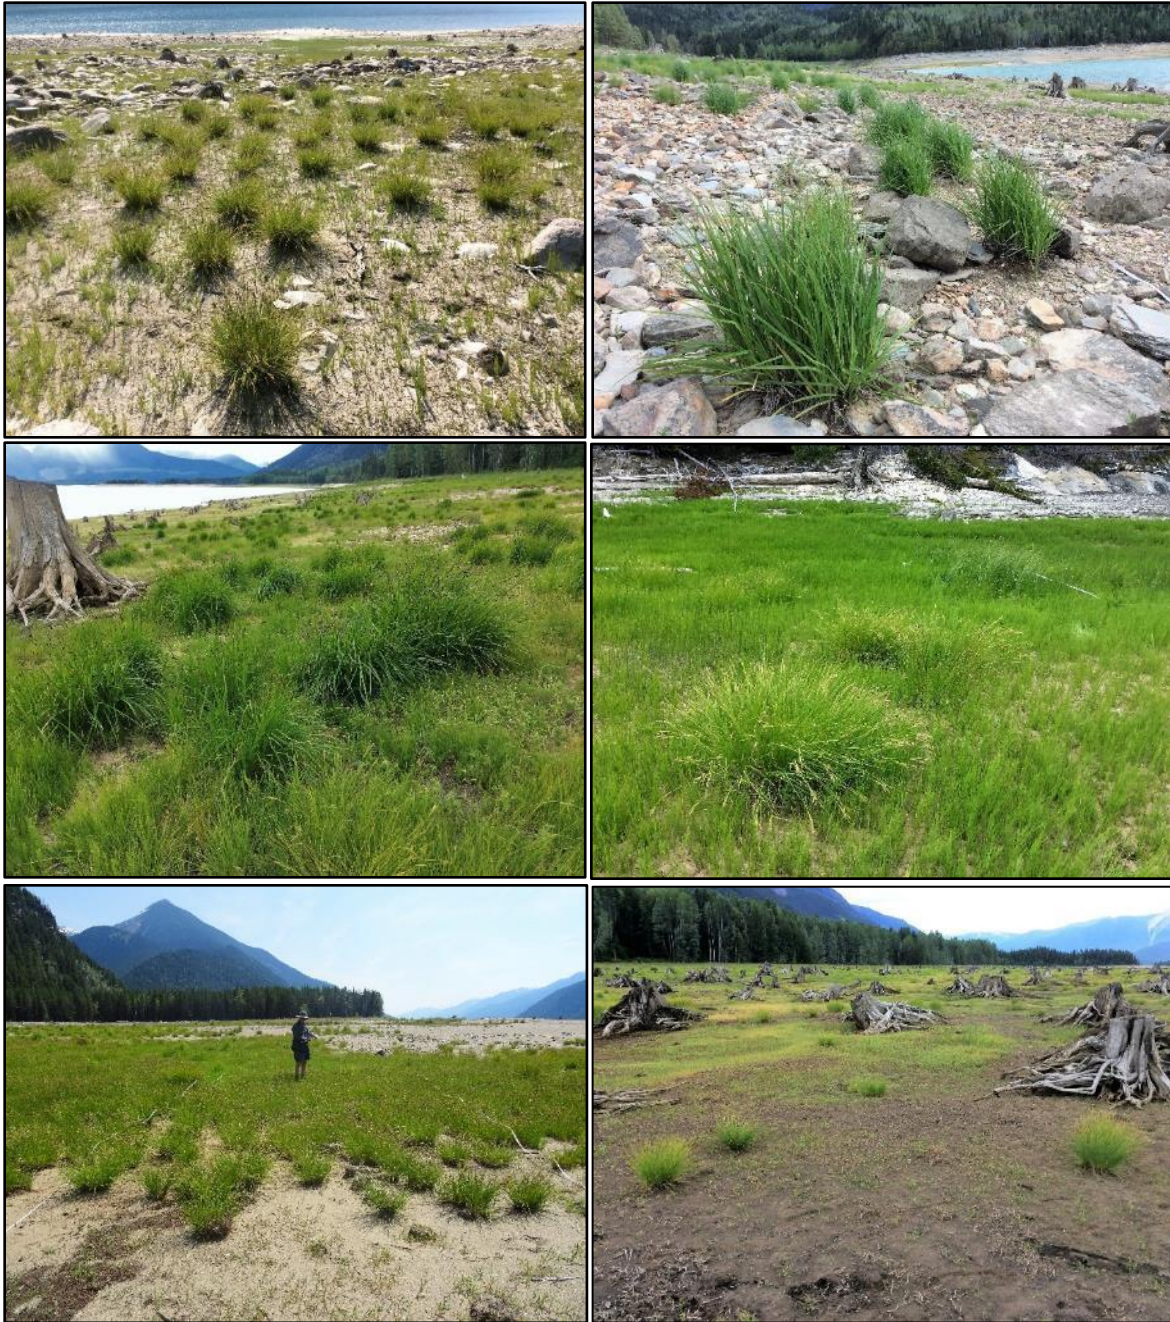
Figure 3-5. Examples of sedge establishment associated with the CLBWORKS-01 (2008-2011) revegetation treatments. Clockwise from top left: Kellogg's sedge, Yellow Jacket Creek; Columbia sedge, Km 77; Kellogg's sedge, Chatter Creek; Kellogg's sedge, Km 88 peatland; Kellogg's sedge, Ptarmigan Creek; Kellogg's sedge, Km 77. Photographed June 2018.

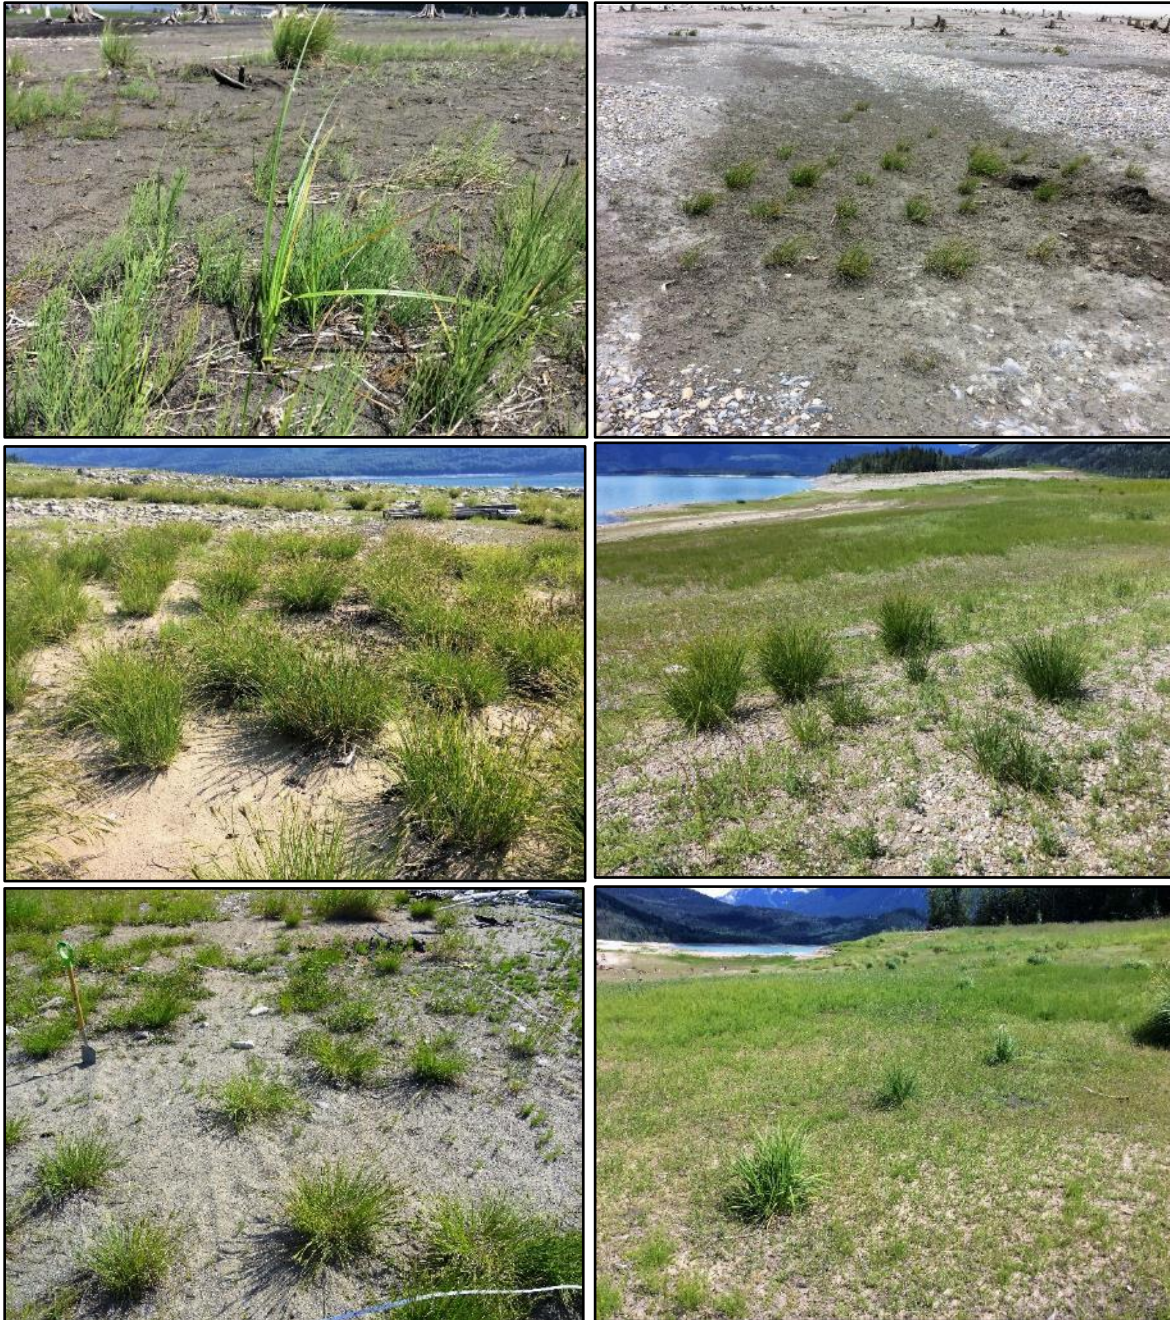
Figure 3-6. Examples of sedge establishment associated with the CLBWORKS-01 (2008-2011) revegetation treatments. Clockwise from top left: water sedge, Hope Creek; Kellogg's sedge, Hope Creek; Kellogg's sedge, Km 79; Columbia sedge, Km 79; Kellogg's sedge, Ptarmigan Creek; Kellogg's sedge, Yellow Jacket Creek. Photographed June 2018.

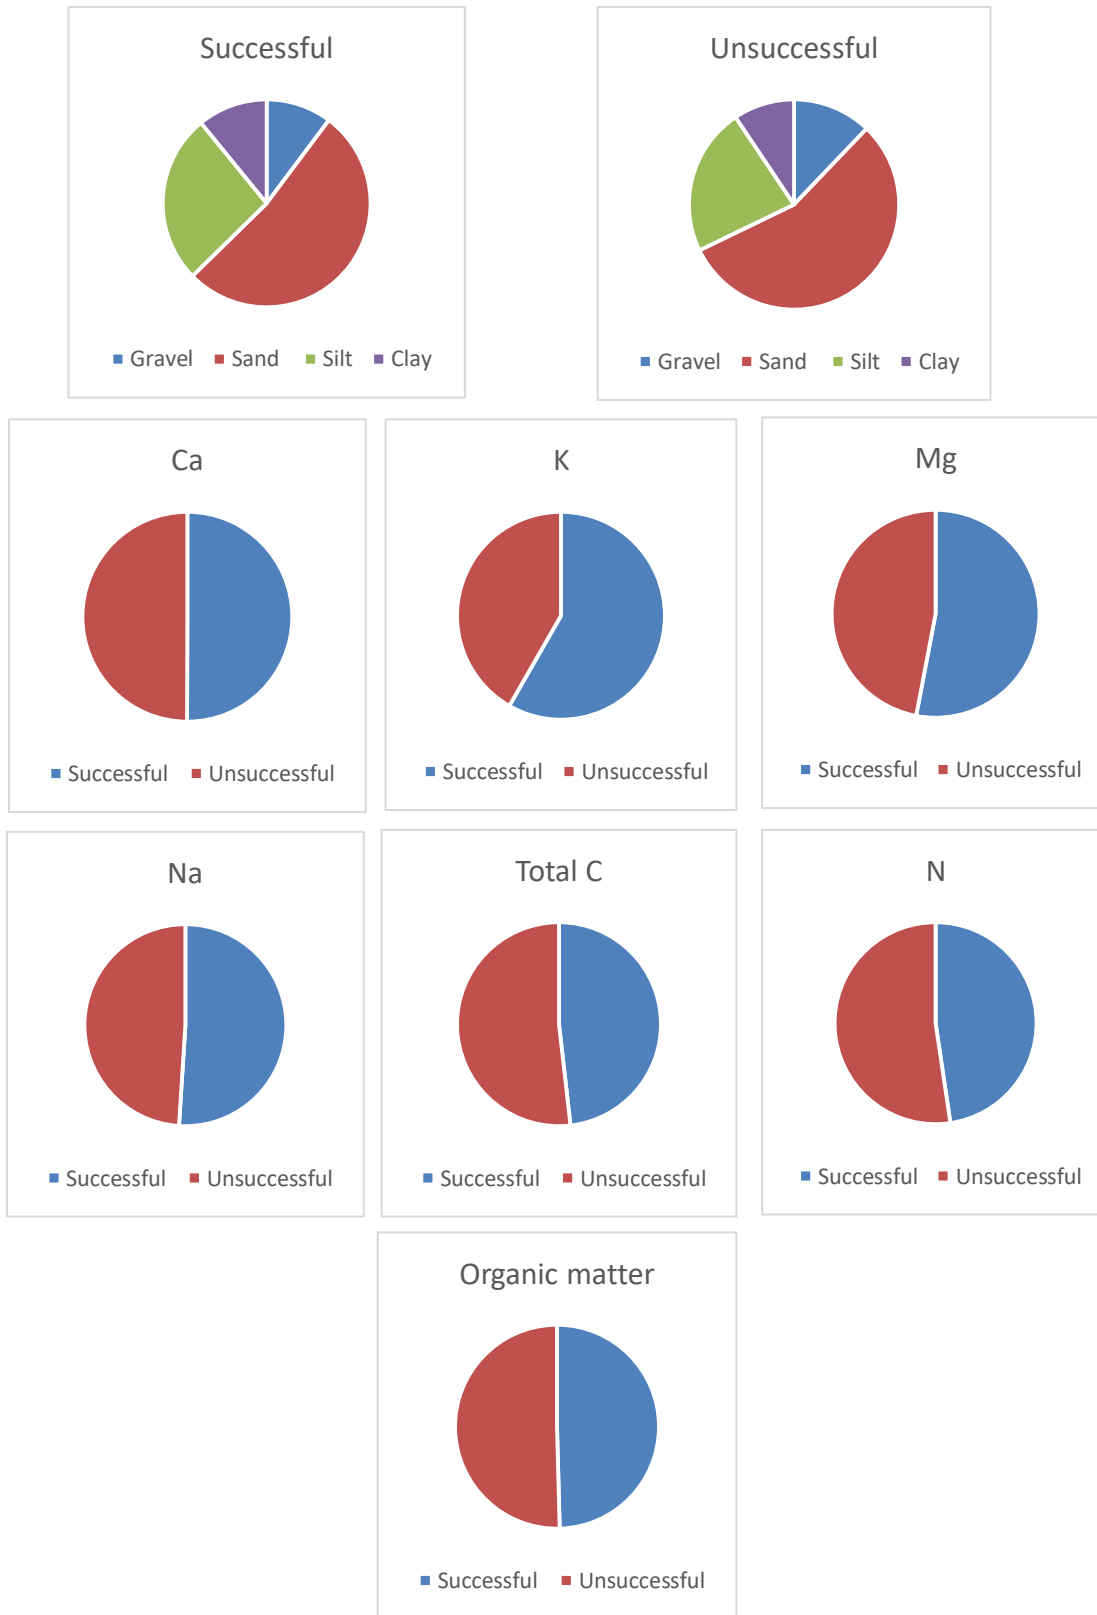
Figure 3-7 shows a comparison of soil parameters (average texture and nutrient content values) between sample plots with at least some successful revegetation establishment and those where revegetation treatments failed to take hold. Successful microsites tended to have slightly higher silt and clay content, and slightly lower sand and gravel content, than unsuccessful microsite, implying that soil water holding capacity may be a limiting factor influencing plug establishment. Successful microsites also had higher average volumes of Potassium (K), Magnesium (Mg), and Sodium (Na), suggesting that these elements may be nutritionally limiting. In contrast, unsuccessful microsites tended to have higher average total Carbon (C) and higher Nitrogen (N) content, implying that these elements are not limiting. Note that this very preliminary comparison does not distinguish among different revegetation species nor account for sample variation or differing establishment densities. It also does not consider other potentially influential topo-edaphic factors such as slope, aspect, water source, and soil moisture regime. A more comprehensive analysis of soil nutrient and other site limiting factors will be undertaken as part of the comprehensive report.

Figure 3-7. Preliminary comparison of soil parameters (average texture and nutrient content) between microsites supporting some successful revegetation establishment in 2018, and microsites with no apparent surviving revegetation.
