Columbia River Projects Water Use Plan

Kinbasket Reservoir and Mid-Columbia River Boat Launch Ramps Feasibility Study

Reference: CLBWORKS-18

October 5, 2007

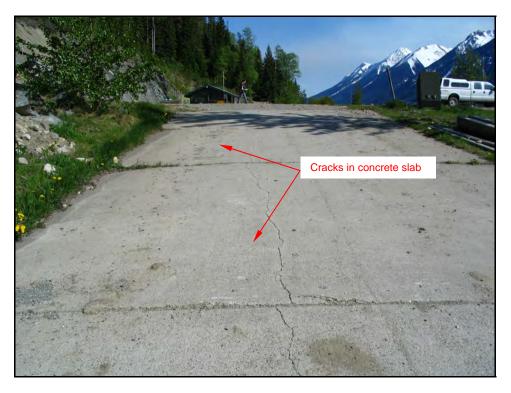
In general, the concrete surface of the existing ramp is in fair condition, with the exception of cracks in the concrete slab that run along the length of the ramps as shown in photographs 8 and 9 in Appendix B. The width of the cracks ranges from 5 mm to 20 mm. A close-up view of a typical crack is shown in photograph 11 in Appendix B. While these cracks do not currently interfere with the functionality of the ramp, annual freeze-thaw conditions will likely lead to further deterioration of the condition of the concrete slab if maintenance repairs to seal the cracks are not carried out in the near future.

Photo No. 8: Taken on 2007-05-25 at Valemount Marina View of the boat launch ramp showing cracks along length of the concrete slabs.

| Item No. | Item Description | Unit | Quantity | Rate | Total |
|---|---|---|---|---|---|
| 3 | Repair cracks in existing concrete slab | Sum | - | - | \$ 3,000 |

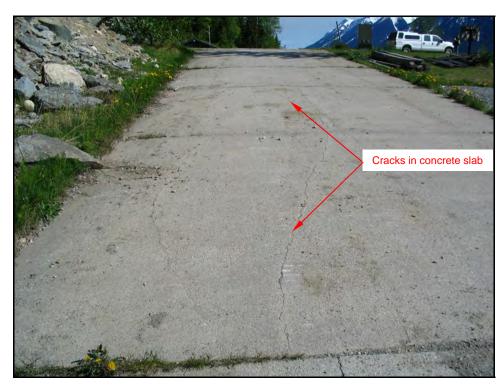
Photo No. 9: Taken on 2007-05-25 at Valemount Marina More cracks further along the ramp.

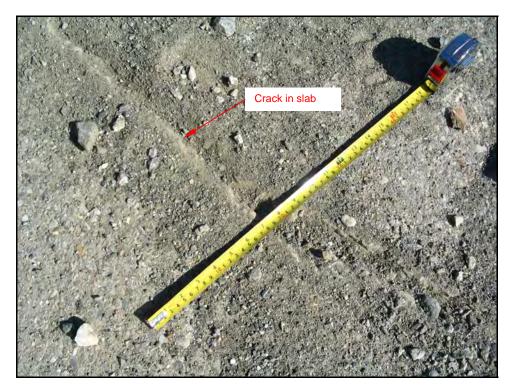
Photo No. 11: Taken on 2007-05-25 at Valemount Marina Close-up view of crack in slab covered up by debris on the boat launch ramp.

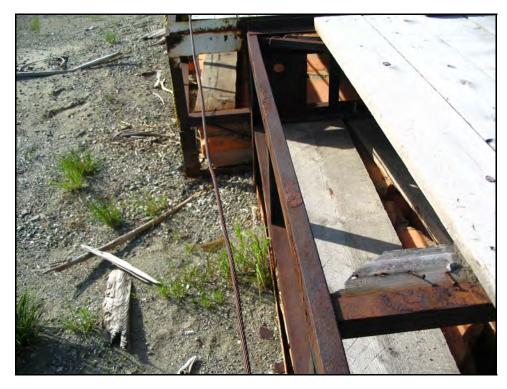
A cursory examination of the existing walkway and boat slip floats revealed that there is some minor corrosion of uncoated sections of the structural steel frame members of the walkway and marina floats as shown on photographs 16 and 18 in Appendix B.

Photo No. 16: Taken on 2007-05-25 at Valemount Marina Close-up view of steel frame members for floats. Note rust build-up on uncoated steel frame members.

| Item No. | Item Description | Unit | Quantity | Rate | Total |
|---|---|---|---|---|---|
| 2 | Repair floats | Sum | - | - | \$ 3,000 |

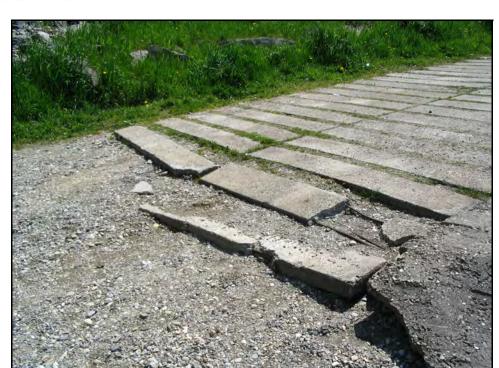
The end elevation of the ramp is at El. 437.2 m. The last two rows of precast concrete slabs were broken as shown in photograph 62 in Appendix B. Although the precast concrete planks were broken, the end of the ramp did not show any signs of erosion as the natural slope of the ramp continued into deeper water. The surface of the concrete planks appears to be in fair condition.

Photo No. 61: Taken on 2007-05-24 at Centennial Park Broken Concrete planks at the end of the boat launch ramp.

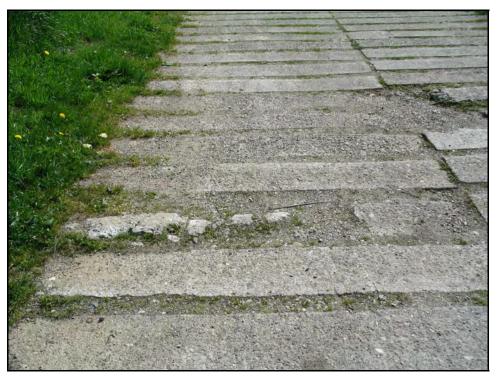
Photo No. 64: Taken on 2007-05-24 at Centennial Park View of the damaged concrete planks at section on the ramp.

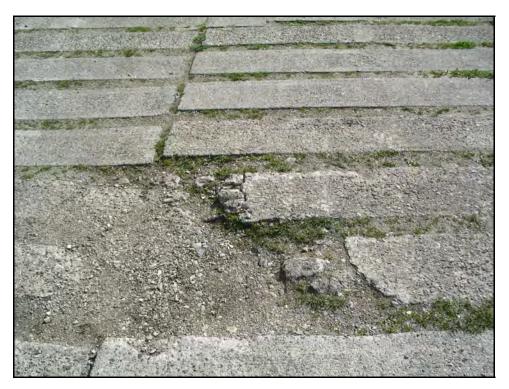
Photo No. 65: Taken on 2007-05-24 at Centennial Park Close-up view of damaged concrete planks in the boat launch ramp.

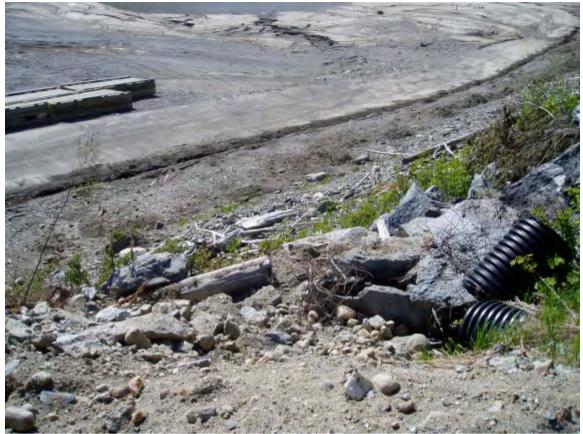
Plate 7. View of current ramp, ditchline and culvert conveying surface flow during spring freshet. Will need to incorporate these features into EMP.

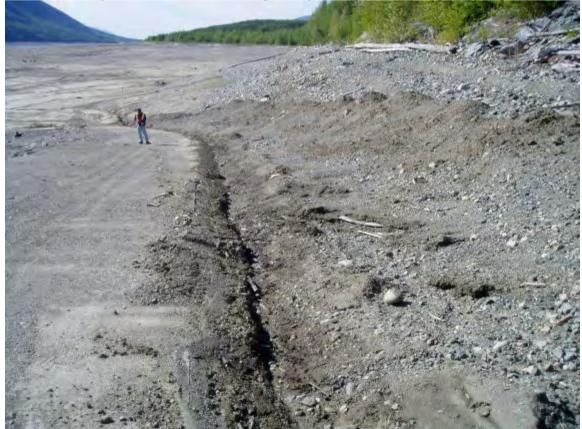
Plate 10. Looking north along ditchline and boat ramp. Ditchline conveys flows during spring freshet and jumps the ramp and moves downslope.

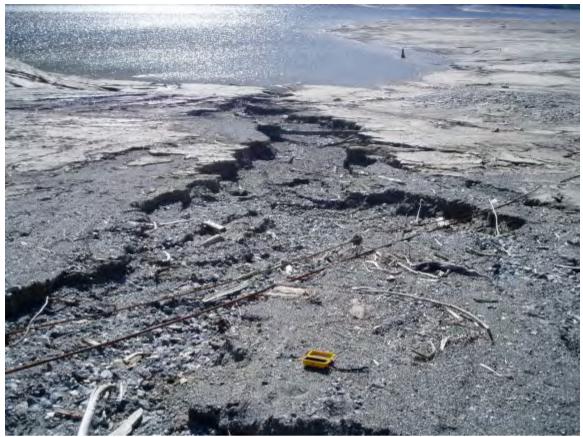
Plate 11. Looking east at extensive erosion caused by ditchline flows jumping the ramp.
