## **Columbia River Project Water Use Plan**

**Arrow Lakes Reservoir: Implementation of Wildlife Physical Works –  
Revelstoke Reach**

*Cartier Bay Site 15A Erosion Repair – Detailed Design Report*

# CLBWORKS 30A Cartier Bay Site 15a Engineering Services **Detailed Design Report**

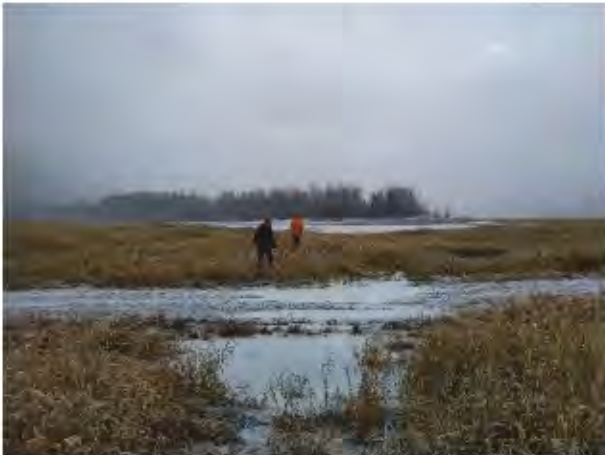
**Photo 3:** Looking south along vegetated swale at Area A. A low spot in the road was visible.

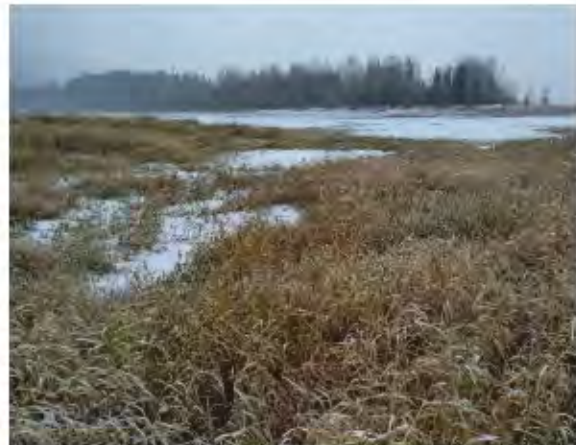
**Photo 4:** Looking south along partly vegetated swale at Area A. Subdued swale and frozen/ponded water were observed.

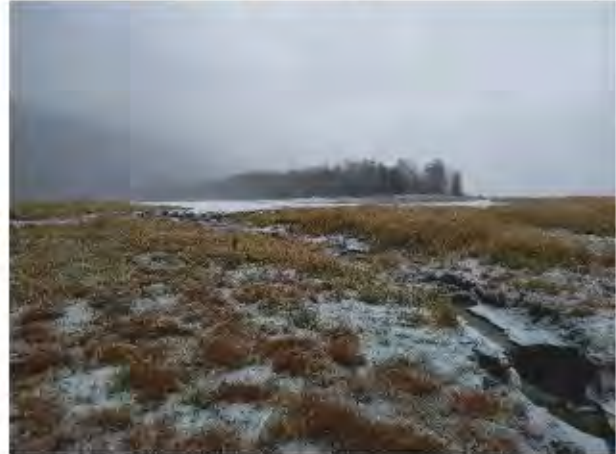
Photo 6: Looking south along eroded channel at Area B. Headcut was receding towards the temporary bulk bag saddle dam.

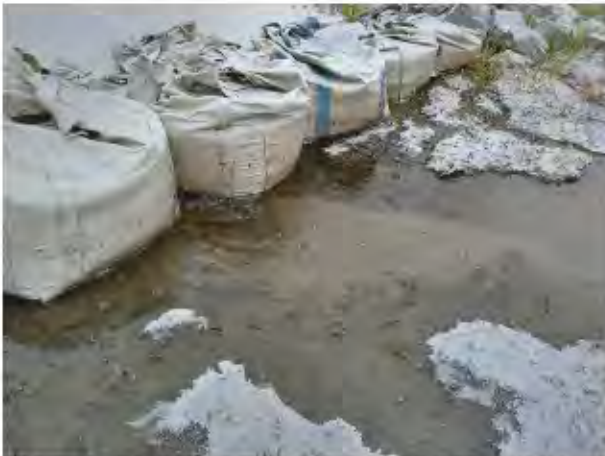
2. The temporary bulk bag berm placed in the spring of 2020 had begun to fail. There was water flowing between bags near the center of the barrier, and one of the bags had ripped open resulting in the loss of some sand and gravel on the downstream side and an approx. 100 mm deep scour hole had formed (Photo 7).

Photo 7: Downstream side of temporary bulk bag saddle dam above eroded channel at Area B. Sand and gravel spilled out of a torn bag and water was flowing between bags.

Following the site visit, a repair was conducted to the Area B temporary berm to reinstate the integrity of the bulk bags on November 26, 2021. A new bulk bag was added to block the flow and a second bulk bag was placed where the damaged bag had been removed. Sand from the damaged bulk bag was salvaged and transferred to the upstream bags to increase their size and height, and reduce voids between bags.

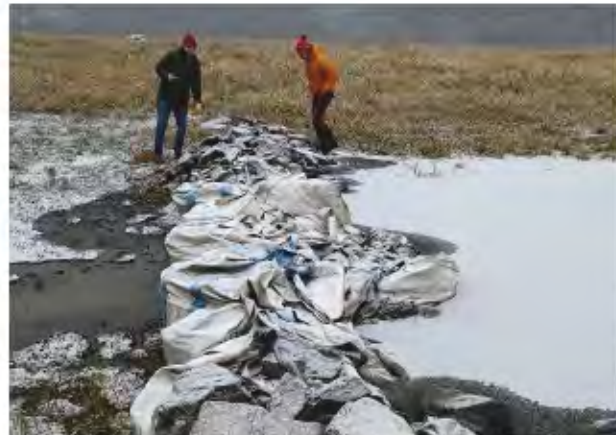
Photo 8: Looking west. Approximately 25 cm difference in hydraulic head between upstream and downstream of the bulk bag saddle dam.

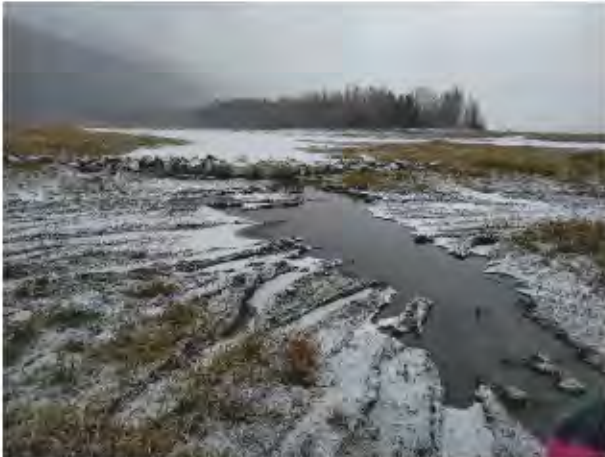
**Photo 9:** Looking south along swale in Area B. Vehicles have contributed to the depression where the swale has formed connecting the lower compartment to the oxbow channel to the north.

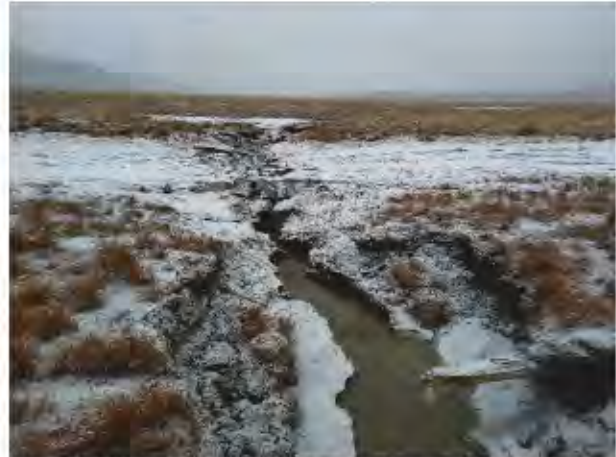
**Photo 10:** Looking north along area B. Riprap was placed in the eroded channel to partly re-establish the road.

The existing rock used as a temporary repair at the eroded section of the access road will be removed and reused as riprap on at the saddle dam (Section 2.3.1). The eroded section of road will be backfilled with an imported 75 mm minus pit run fill, suitably compacted, and finished to include a gentle swale to maintain the drainage from the eroded channel area. This road section will not be surfaced with the surfacing aggregate specified for the raising of the road at Area A.

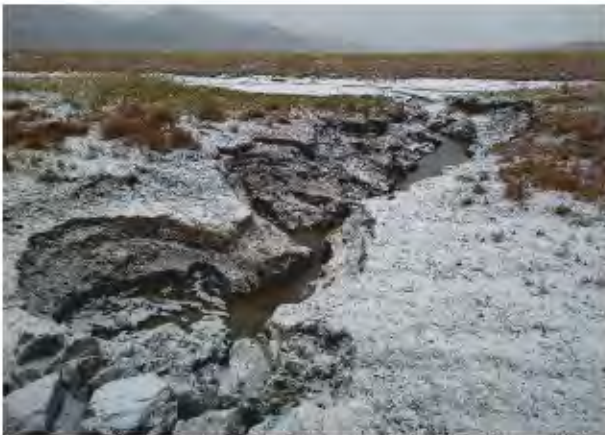
**Photo 11:** Looking north along eroded channel at Area B. Evidence of previous head-cutting in erodible floodplain silts.

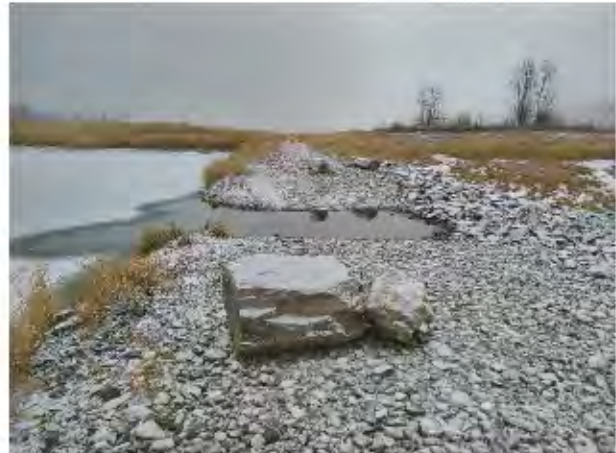
The elevated riprap crest may also be contributing to unwanted wetland discharge at Areas A and B, and erosion at Area B prior to inundation, as the riprap is above the elevations of the swales at Areas A and B and perhaps C.

**Photo 12:** Looking south along former railway embankment at location of Site 15a outlet. Depth of water in outlet was 13 cm above invert. Note riprap proud of invert on left side of outlet.

The existing Site 15a outlet will be excavated and armoured with an articulated concrete block mattress (ACBM) to the geometry and elevation noted in the previous section. Excavated fill material and riprap will be salvaged for reuse at the Area B saddle dam.

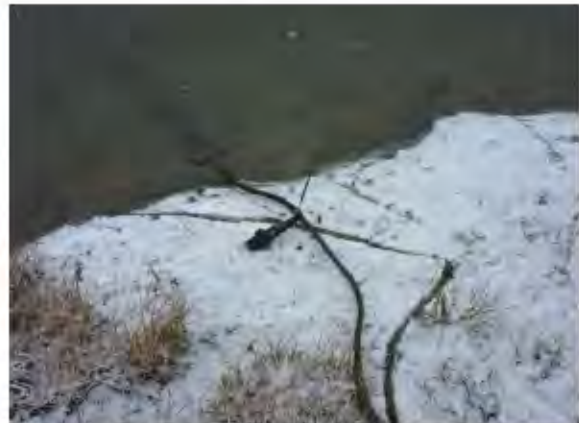
4. An anchored water level logger was found in the channel downstream of the Site 15a outlet (Photo 16).
5. The soil in the channel downstream of Site 15a is a similar erodible silty floodplain soil to what was observed at Area B. The channel had near vertical eroded side slopes and was flowing slowly towards the main reservoir.

Photo 16: Anchored water level logger found downstream of Site 15a outlet.
