**Kinbasket and Arrow Lakes Reservoir Recreation
Management Plan**

Mid Columbia River Long Term Erosion Monitoring Program

2014 Progress Report

**Kerr Wood Leidal Associates Ltd.
200 – 4185A Still Creek Drive
Burnaby, BC
V5C 6G9
(604) 294-2088**

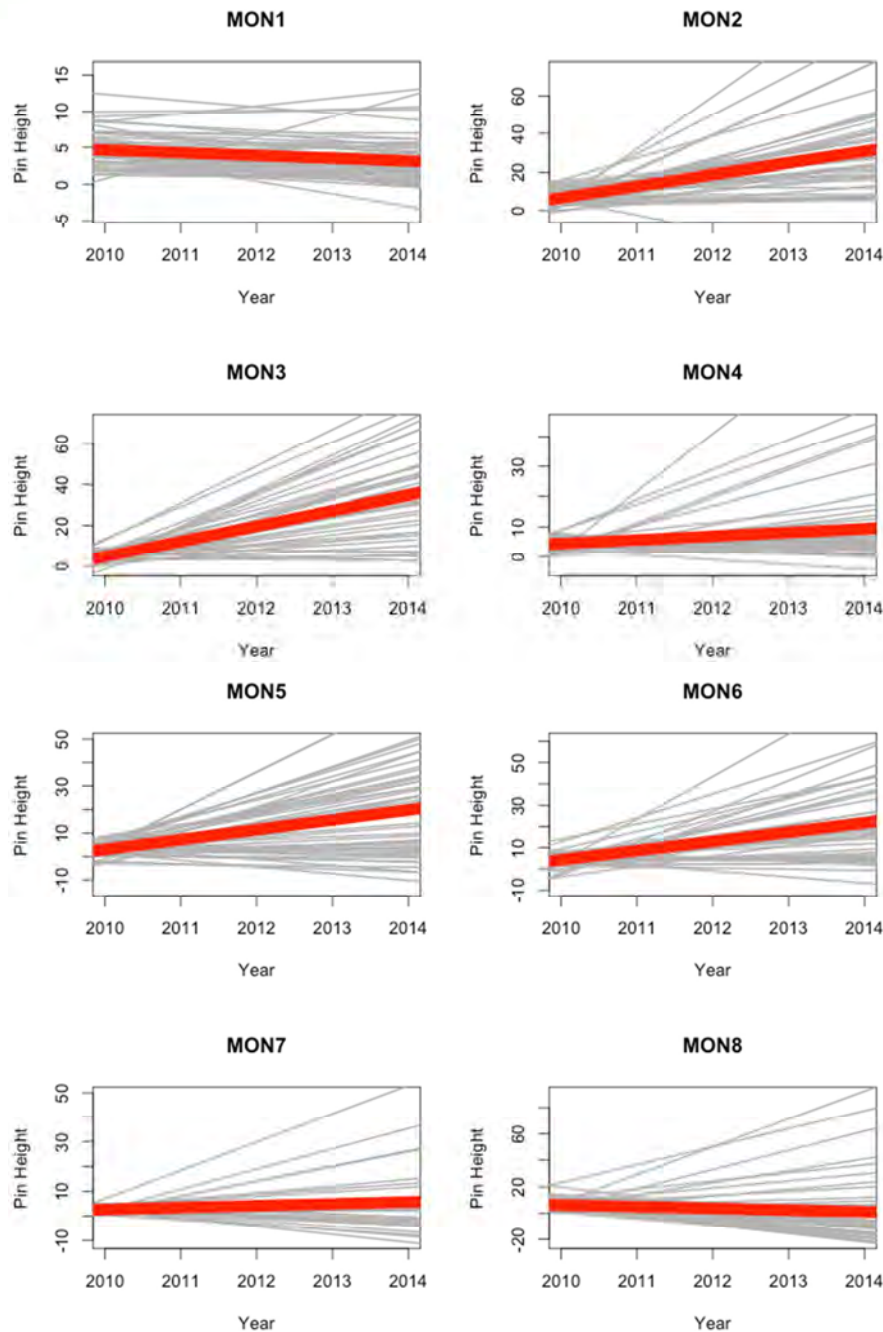
Figure 3-1: Erosion Pin Lengths (cm) Over Time Sites MON 1 Through MON 8 For Individual Pins (Grey Lines) And Site Average (Red Line). Erosion Indicated By Increasing Pin Length, Deposition Indicated By Decreasing Pin Length.

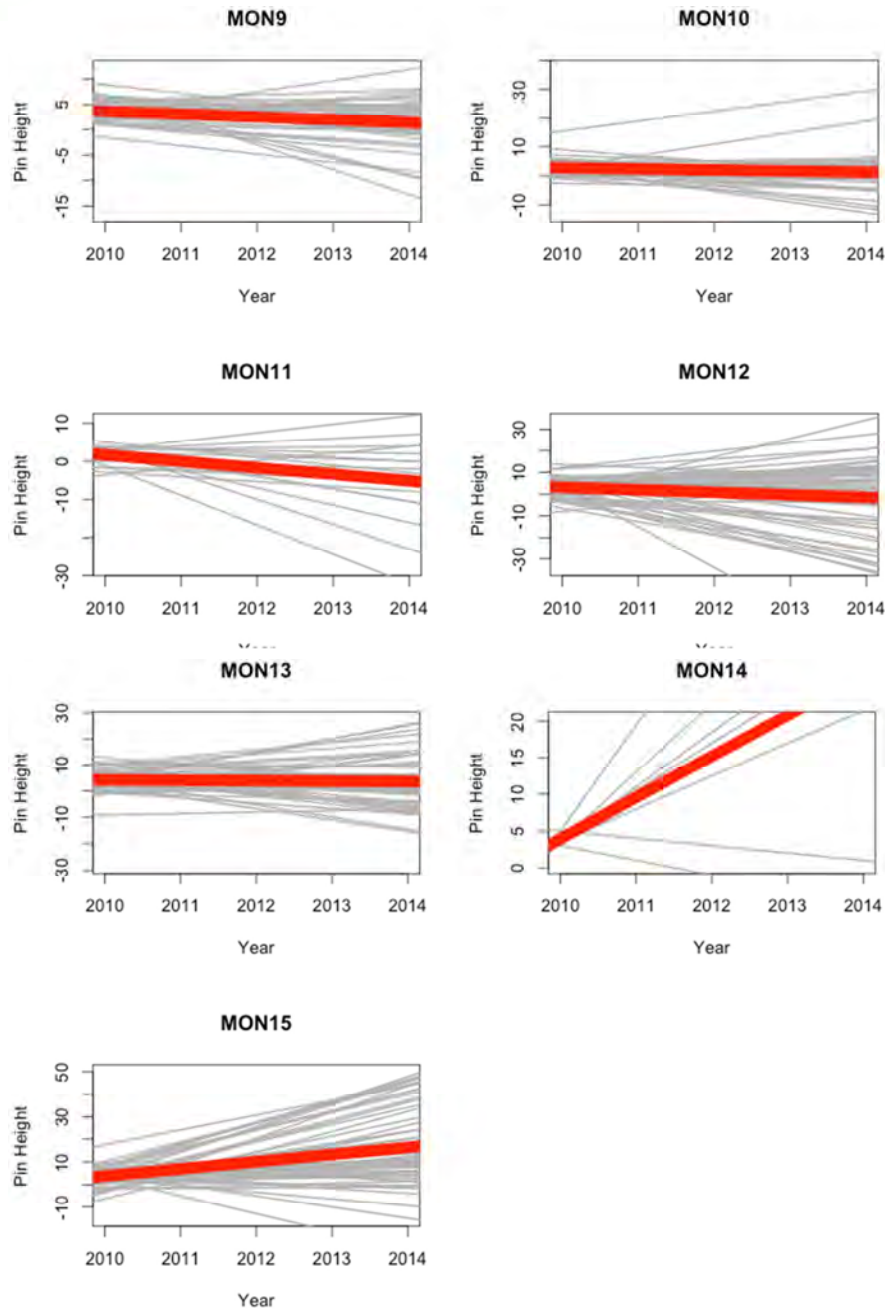
Figure 3-2: Erosion Pin Lengths (cm) Over Time Sites MON 9 through MON15 for Individual Pins (Grey lines) And Site Average (Red line). Erosion Indicated By Increasing Pin Length, Deposition Indicated By Decreasing Pin Length.

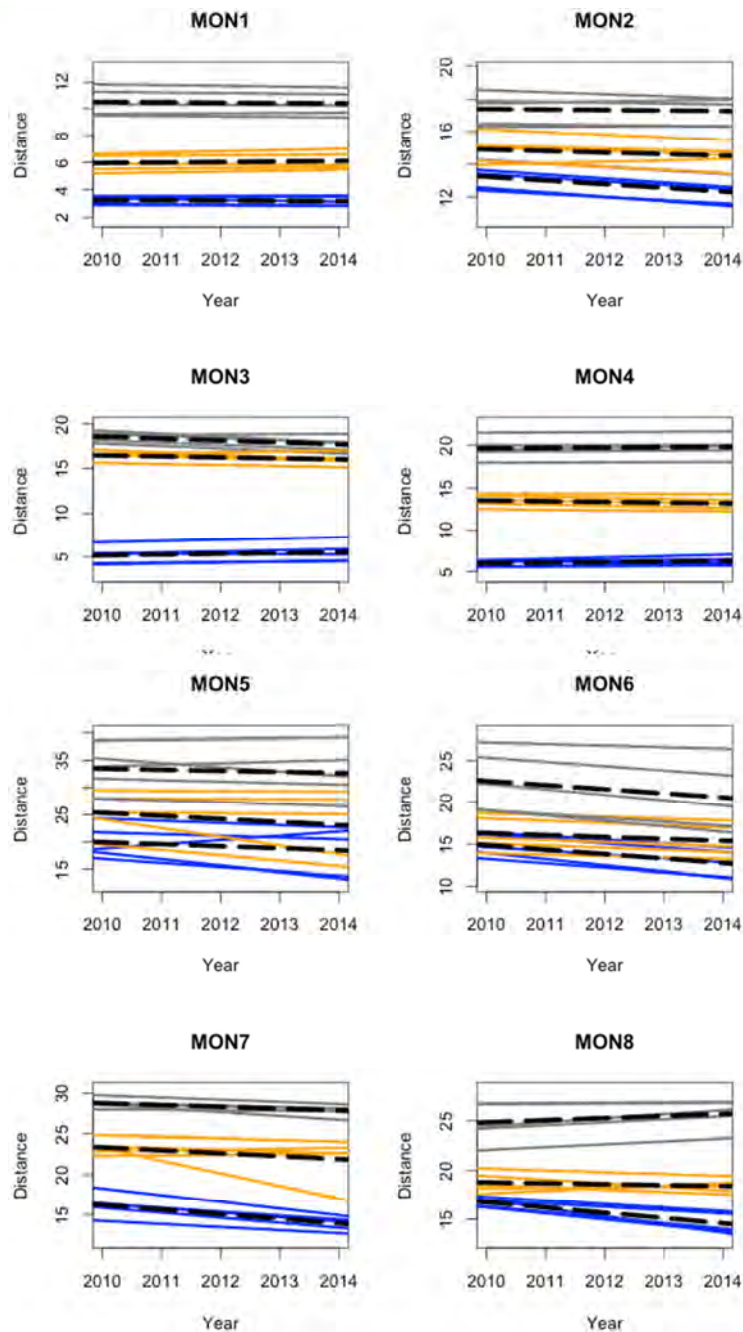
Figure 3-3: Distance To Cross-section (XS) Line (m) For Individual XS in Elevation Band (Upper: Blue, Middle: Orange and Lower: Grey), and Average (Black Dash), Sites MON 1 Through MON 8. Erosion Indicated By Decreasing Distance, Deposition Indicated By Increasing Distance.

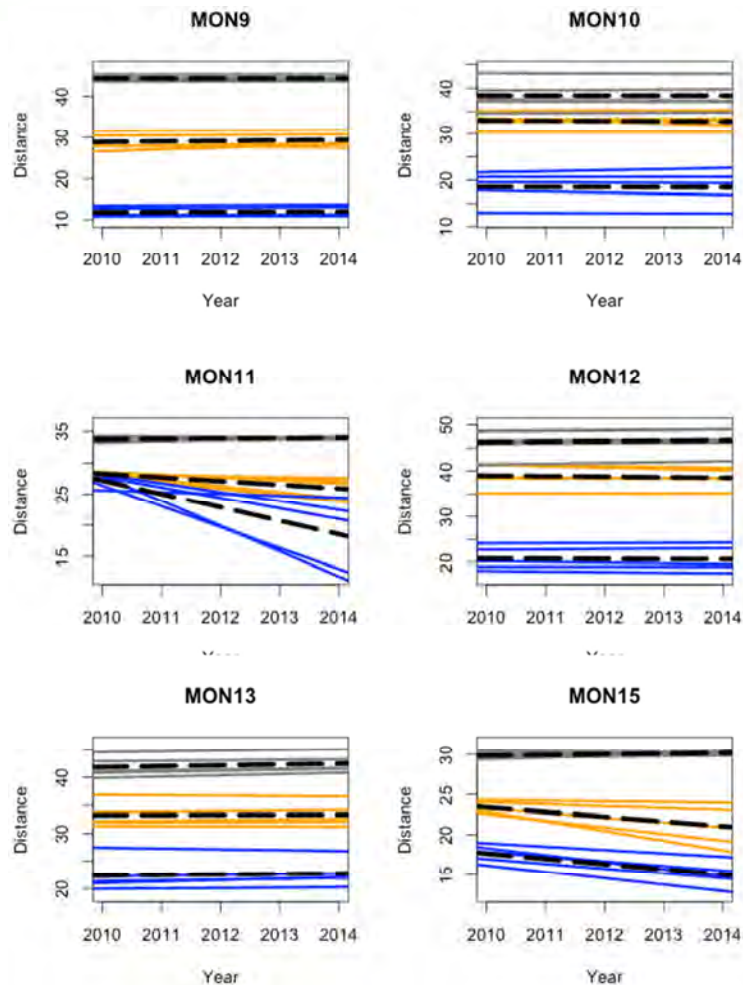
Figure 3-4: Distance To Cross-section (XS) Line For Individual XS In Elevation Band (Upper: Blue, Middle: Orange, Lower: Grey), And Average (Black Dash), Sites MON 9 Through MON 15. Erosion Indicated By Decreasing Distance, Deposition Indicated By Increasing Distance.
