Columbia River Project Water Use Plan

Mid Columbia River Long Term Erosion Monitoring Program

Final Report

Study Period: 2009 to 2016

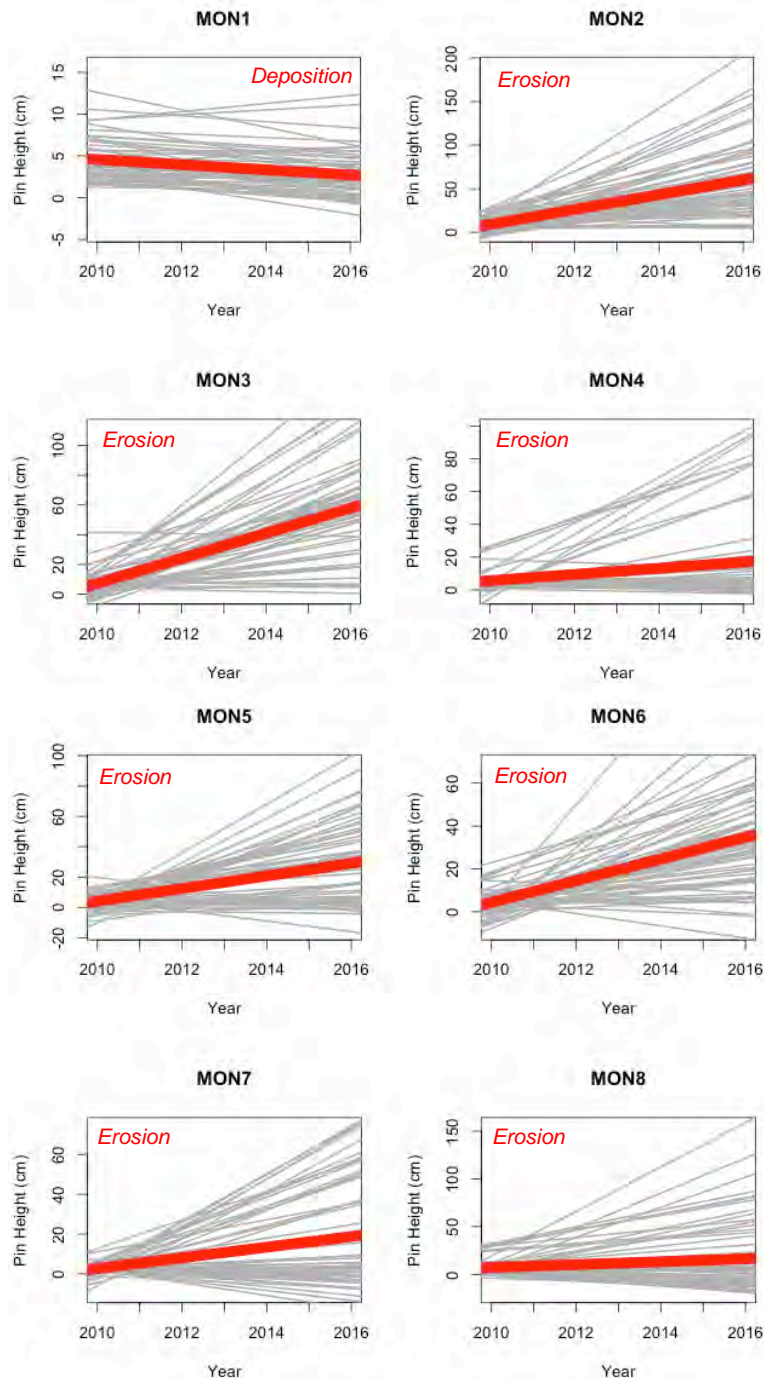
- An upward-sloping line (pin length *increasing* over time) indicates **erosion**.
- A downward-sloping line (pin length *decreasing* over time) indicates **deposition**.
- A line with little or no slope (pin length remains more or less constant over time) indicates little or no change.

Figure 3-1: Erosion Pin Lengths (cm) Over Time Sites MON 1 through MON 8 for Individual Pins (Grey lines) And Site Average (Red line). Erosion Indicated By Increasing Pin Length, Deposition Indicated By Decreasing Pin Length.

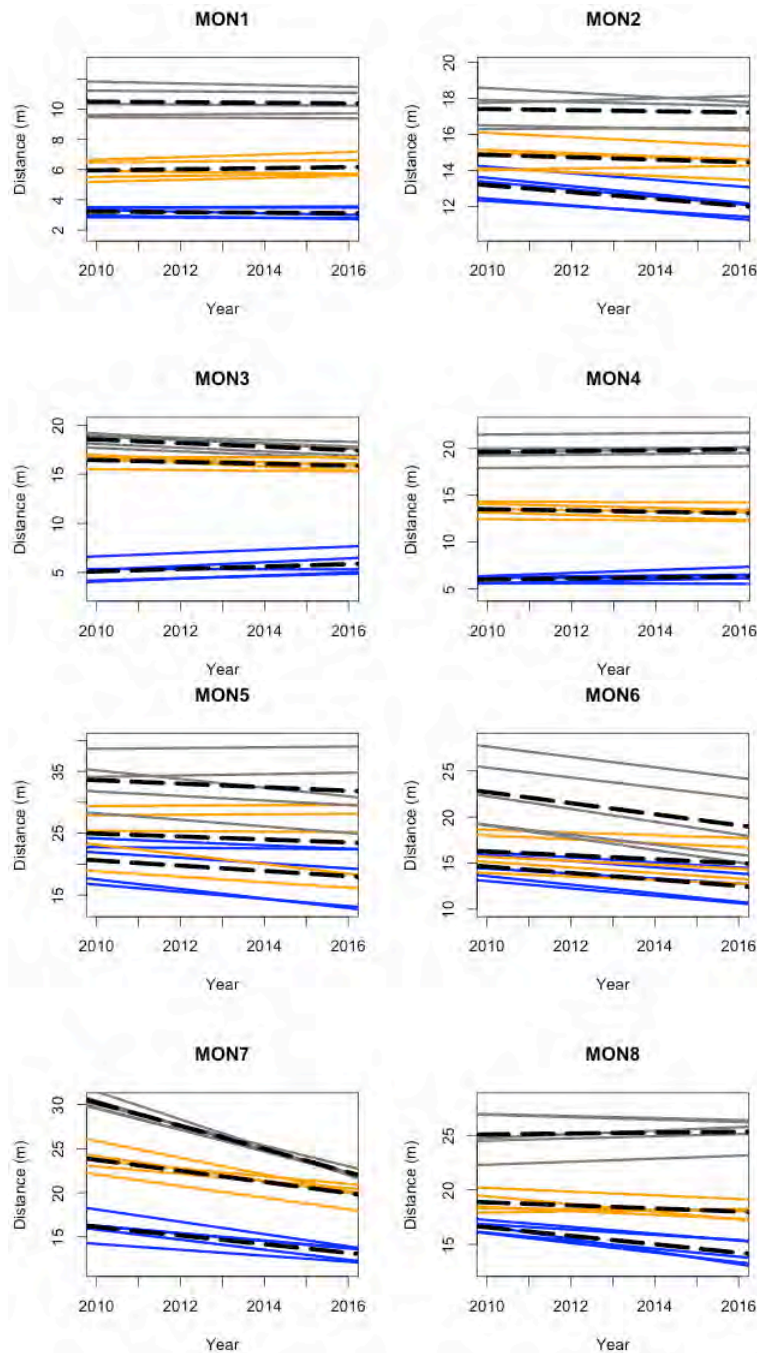
The resulting regression lines are plotted for each site in Figure 3-4 and Figure 3-5. Note that in these figures a consistently decreasing distance (negative slope) would imply consistent erosion over time, while a consistently increasing distance (positive slope) would imply consistent deposition over time (i.e. *opposite* to how the erosion pin data are interpreted).

Figure 3-4: Distance To Cross-section (XS) Line (m) For Individual XS in Elevation Band (Upper: Blue, Middle: Orange and Lower: Grey), and Average (Black Dash), Sites MON 1 Through MON 8. Erosion Indicated By Negative Slope, Deposition Indicated By Positive Slope.

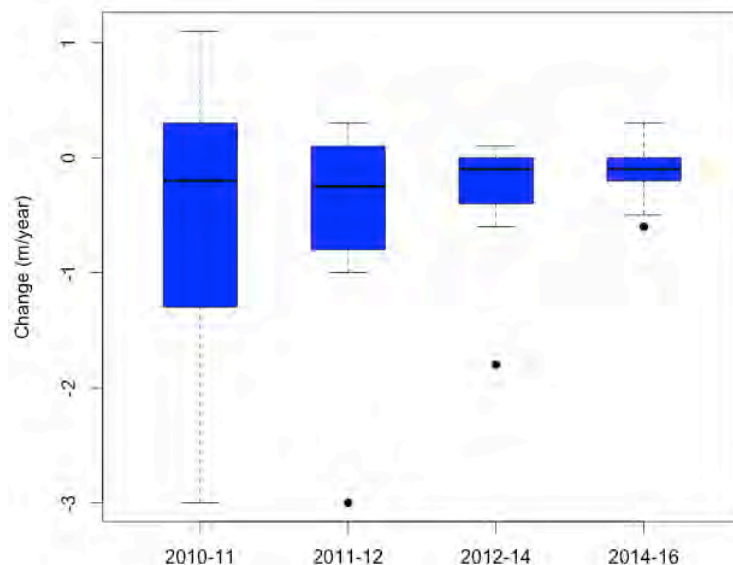
No consistent differences were observed for the change in distance to cross-section: the rate of erosion did not increase or decrease during the 4 time periods observed (one-way ANOVA, $p > 0.05$).

The lack of a consistent trend over time is also evident in Figure 3-6, Figure 3-7, and Figure 3-8, which present the changes over time graphically. As indicated in these figures, the average erosion rate is fairly constant between the different time periods, and erosion occurs in all elevation bands (although it appears to be somewhat less in the lower elevation bands).

Figure 3-6: Change in Distance to Cross-section for Upper Elevation Band For Each Time Period. Negative values indicate erosion, positive values indicate deposition. Shown in box plots are the median (solid line), 25th and 75th percentiles (edges of box), range of values (whiskers) and outlier (dot).
