**RE: British Columbia Utilities Commission (BCUC or Commission)
British Columbia Hydro and Power Authority (BC Hydro)
Vancouver Power Outage – November 4, 2020
BCUC Staff Questions**

BC Hydro writes to provide its responses to BCUC staff questions regarding a recent power outage on the west side of Vancouver that occurred on November 4, 2020 (**Outage**).

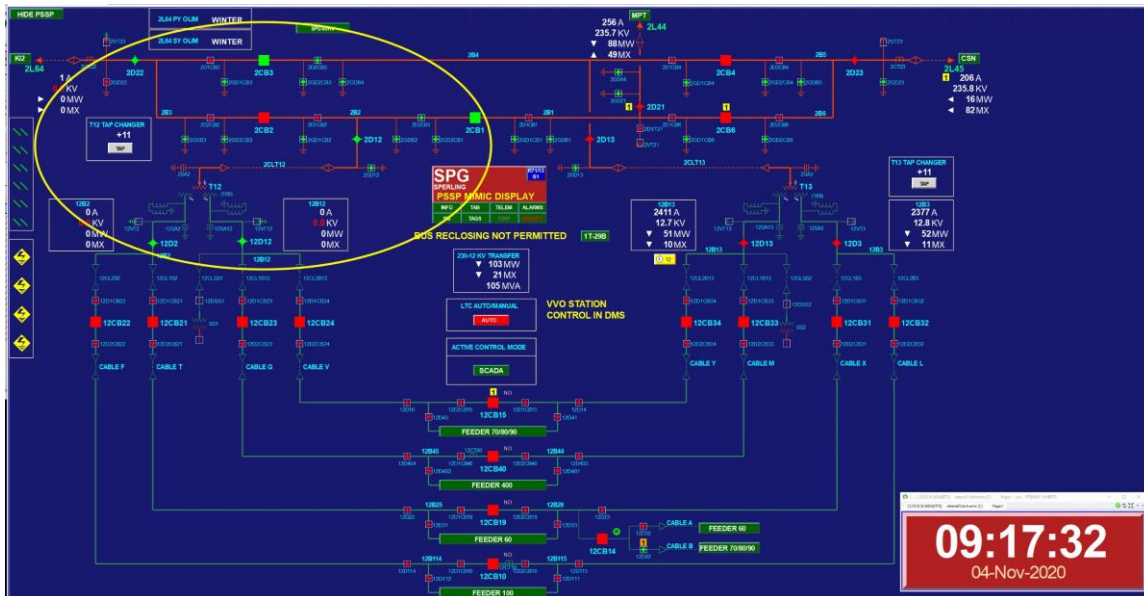
Figure 3b SPG substation Electrical Configuration Prior to Outage

[Figure 3a](#) shows in part, the substation Operating One Line Diagram of the SPG substation. [Figure 3b](#) shows the Energy Management System operating display just prior to the Outage. The yellow circled area in [Figure 3b](#) represents part of the substation that was out of service for the planned maintenance work.

The system operator at FVO mistakenly thought that transformer T13 at SPG substation would remain connected during the brief outage of circuit 2L45. However, due to the configuration of SPG substation, the action of opening circuit breaker 2CB4 at SPG substation caused transformer T13 at SPG substation to become disconnected from the grid, resulting in the Outage.

As shown in [Figure 3b](#), transformer T13 at SPG substation is connected between circuit breakers 2CB3 and 2CB4. Circuit breaker 2CB3 was already out of service for planned maintenance work of circuit 2L46. The system operator at FVO did not realize that opening circuit breaker 2CB4 at SPG substation would also have the unintended consequence of de-energizing transformer T13 and interrupting supply to all customers fed from SPG substation.

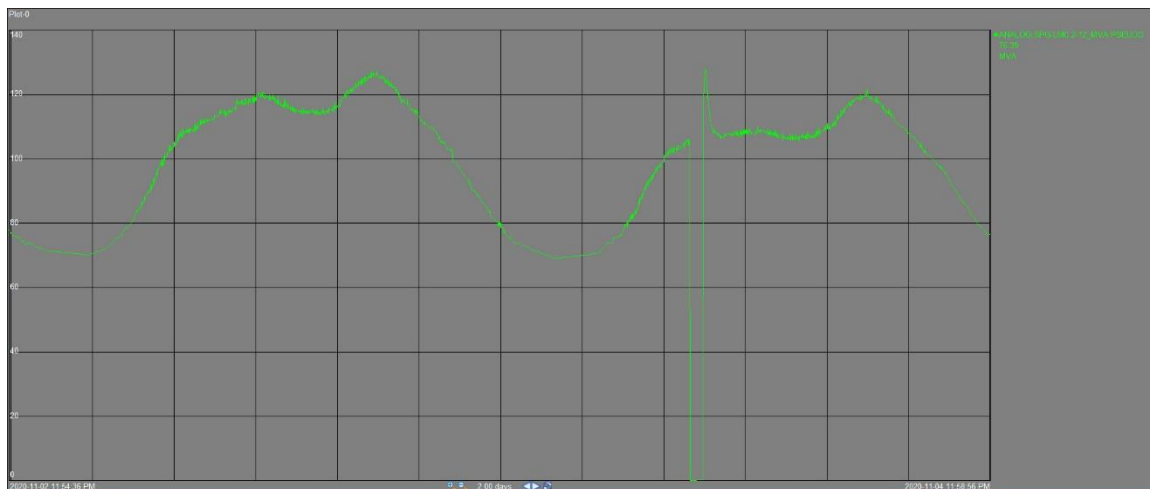
Figure 4 Total MVA Demand at SPG Substation
(November 3, 2020 to November 4, 2020)

Figure 4 is a plot of the total electricity demand in MVA supplied by SPG substation between November 3, 2020 and November 4, 2020. The interruption in supply to customers can be seen in **Figure 4** starting at 9:17 A.M. and ending at 10:00 A.M. on November 4, 2020. The reason for the increased demand of approximately 20 per cent for 20 minutes after 10:00 A.M. is due to the phenomenon of “cold load pickup” as normally diverse and cyclic loads, such as space heating, all came on together at the same time.

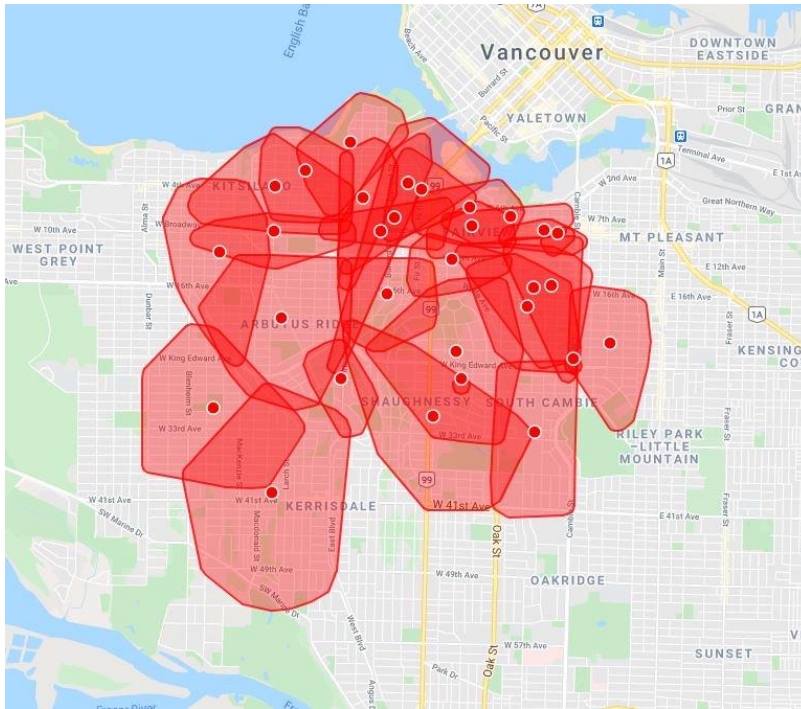
Figure 5 Geographic Extent of November 4, 2020 Outage

Power was interrupted to 62,000 customer accounts in the Kerrisdale, Arbutus, Kitsilano, Shaughnessy, Cambie, and Fairview neighborhoods. **Figure 5** is a geographical representation of the extent of the Outage that was posted to BC Hydro’s website and social media accounts shortly after the Outage started. BC Hydro’s outage information webpage listed the cause of the Outage as a transmission circuit failure as initial attempts to restore the supply to SPG substation transformer T13 by closing circuit breaker 2CB4 were not successful.
