**Board briefing – DAM SAFETY QUARTERLY REPORT**
**Executive Summary**

**Risk Profile of BC Hydro's Dam**
**Dam Safety Contribution to Enterprise Risk**

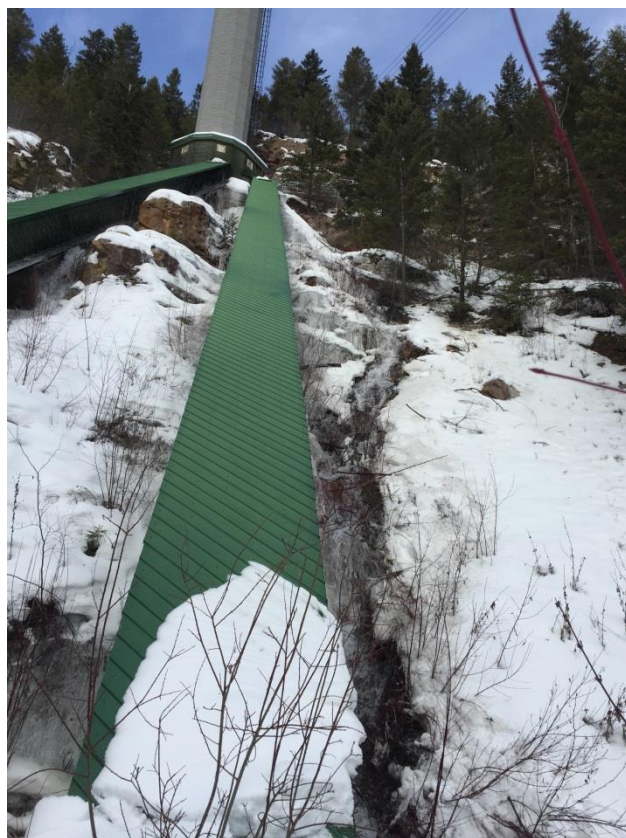
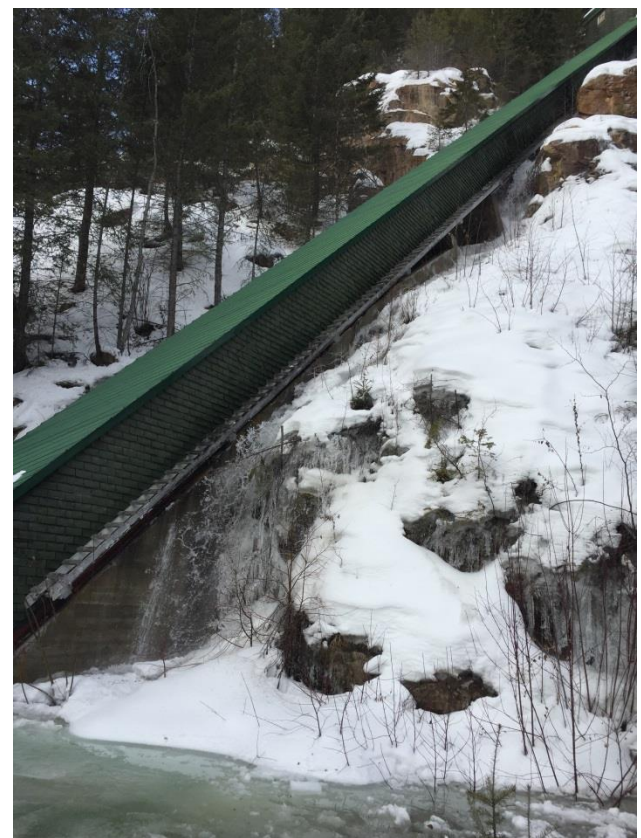
In the very early hours of March 15, 2019, while Spillimacheen was offline for maintenance, Stations Field Operations personnel from Invermere were dispatched to respond to an alarm signalling an overflow condition in the powerhouse sump. Upon arrival, the crew observed the powerhouse to be flooded and water cascading down the penstock slope. The crew determined the source of the leak was Penstock 01/02, near the Penstock Inlet Valve PIV01/02, located as shown in the right hand photo of Figure 5. Photos showing the water leakage later that morning (in daylight) are in Figure 6.

**Figure 6** Water cascading down the slope adjacent to Penstock 01/02 along a channel eroded through the soil overburden.

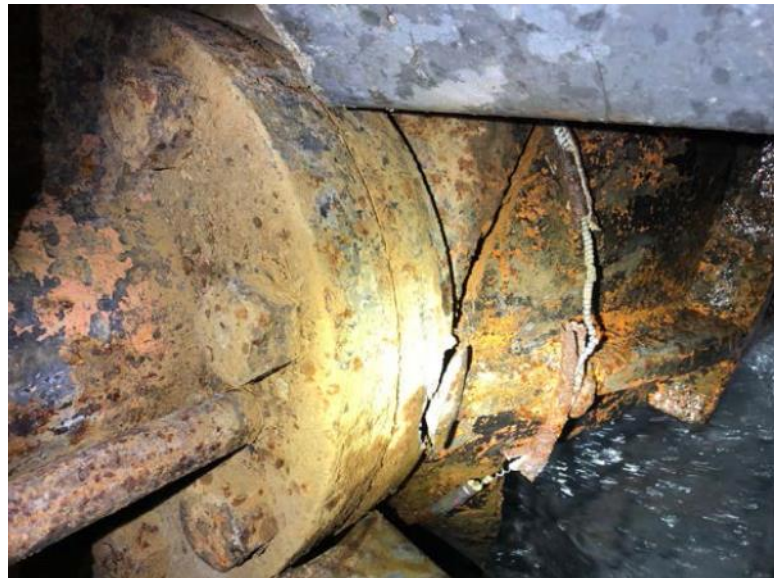
**Figure 7** A large fracture was discovered in the body of Penstock Inlet Valve PIV01/02. This was the source of the leak and the uncontrolled flows down the penstock slope that created the Dam Safety Incident.

After regaining control of the flows, the failure was inspected and found to be a large fracture located in the penstock inlet valve. This is shown in Figure 7. The potential for such a fracture does not appear to have been identified in any previous inspections or documented in Equipment Health Rating reports. The conclusions from a root cause analysis of the failure are not yet known to Dam Safety.

The Spillimacheen facility remains secured in this state, with the stoplogs isolating the tunnel from the forebay and the generating station out of service. A root cause analysis of the failure is being conducted and the results will be documented in a Forced Outage Report.
