Executive summary

The purpose of this report is to update the Operations, Planning, Information & Technology Committee of the Board of Directors on key dam risk management activities during the period from July 1 to September 30, 2021 and to provide reasonable assurance that the safety of dams operated by BC Hydro continues to be managed to the established guidelines and criteria of the Dam Safety Program. To keep the Committee as fully abreast of the Dam Safety Program as possible, some notable developments that took place after September 30 but before the completion of this report have also been included.

Dam Safety Quarterly Report

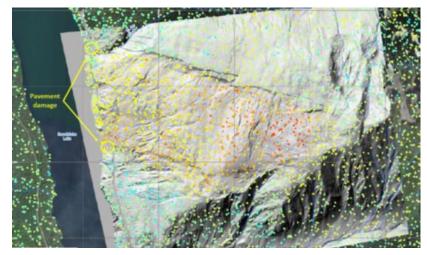
Figure 4 at right shows the "bare earth" image overlain by the satellite remote sensing displacement data (the coloured dots). The imagery shows distinct scarps along the head and sides of the slide, and the red and yellow dots that indicate larger ground velocities are very clearly aligned with the imagery. Ground inspections have further verified these remote sensing data, pavement cracking displacement was observed on Highway 23 along the inferred edges of the slide. Through these various means, we are of the opinion that the St. Cyr Landslide Complex exists and is active.

Figure 4 Satellite and aerial imaging data are consistent and supported by ground observations, confirming the existence of the St. Cyr Landslide Complex.

The landslide is approximately five square kilometres in area, making it one of the larger known active landslides in the province; Downie and Branham Ridge slides are the only known active landslides larger in surface area. Preliminary estimates of the landslide volume are in the order of 900 million cubic metres. The slide may be moving a rate of up to 100 mm per year.

The discovery of this landslide is not a cause for alarm, as it has clearly been in existence for a long time. The size of the landslide and its proximity to Revelstoke Dam, however, do make it a feature of significant interest requiring further investigation and provision for ongoing monitoring. An issue has been entered into the Dam Safety Issues Database, and we are informing other potentially interested ministries, agencies, First Nations and stakeholders. Additional field investigation work scheduled this fall by the Dam Safety reservoir slopes team will investigate options for interim monitoring of the slide area, and a project is being initiated to drill and install instrumentation near the toe of the slide. To facilitate commencement of work at St. Cyr as early as 2022, consideration is being given to deferring the planned 2022 drilling project at Little Chief Landslide near Mica Dam that follows the project at Downie Slide (see "Capital Projects"). Updates will be provided to the Committee in future quarterly reports.

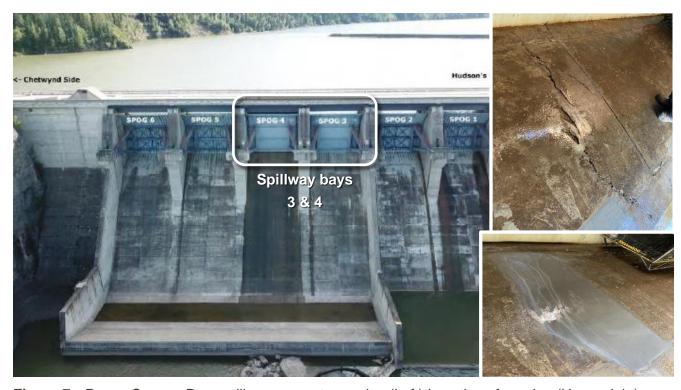
Peace Canyon spillway bay 3 and 4 concrete repairs were also completed in Q2. This included the repair of a crack in bay 3 (Figure 7) and two spall repairs in bay 4 near the Spillway Operating Gate sills. This location is difficult to access and required several measures to ensure the safety of the construction personnel while performing the work as well as our ability to recall the spillway if needed, including: an Interim Dam Safety Risk Management Plan, engineered mechanical blocking and basket lifts of personnel to and from the work location from the spillway bridge, and confined space and fall protection procedures. Work was performed by Construction Services with engineering design and support by the Stations Maintenance Civil Engineering team. Project expenditures were approximately \$135,000.

Figure 7 Peace Canyon Dam spillway concrete repairs: (Left) Location of repairs; (Upper right) crack in bay 3 between stoplog and spillway gate sills; (Lower right) repaired crack.

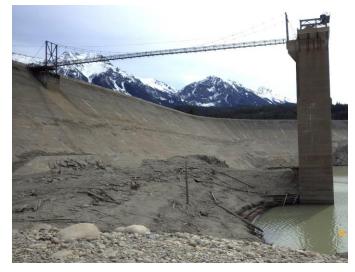
The key dam safety issue at La Joie Dam centres around the ongoing deterioration of the dam's shotcrete facing. The shotcrete is prone to cracking and buckling over time as the dam undergoes dimensional changes in response to ongoing settlement and temperature changes, requiring extensive annual maintenance to control through-dam seepage. Please see "Corrective and Condition-based Maintenance" in last quarter's report for a report on the completion of this year's maintenance. Refer also to Figure 15, below right.

Figure 14 La Joie Dam and intake tower at low reservoir.
