DAM SAFETY QUARTERLY REPORT

QUARTERLY FEATURED DAMSITES – KOOTENAY CANAL

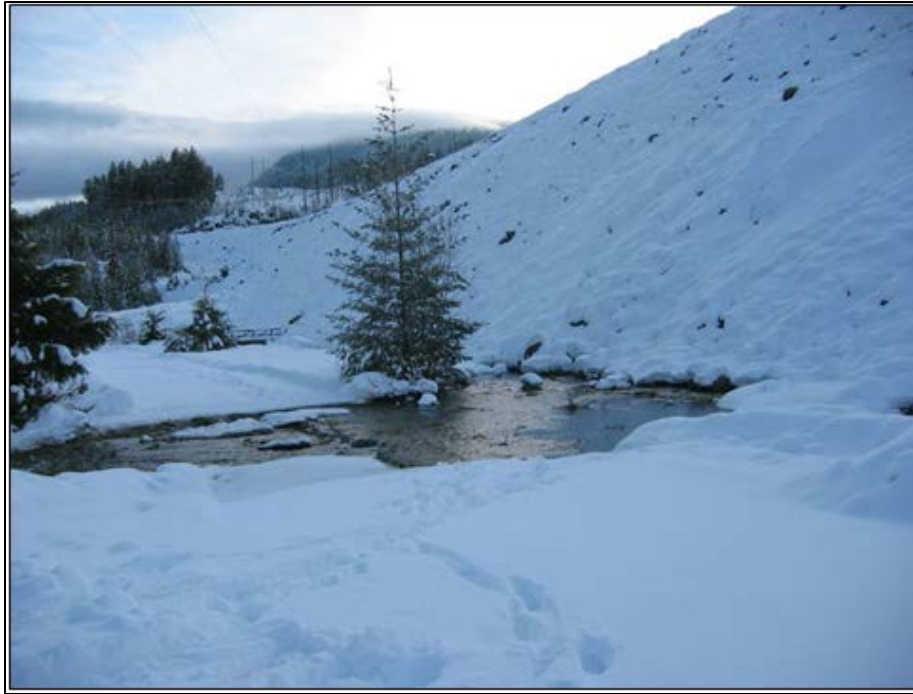
On December 17, 2003, leakage through the toe of the North forebay embankment section, about 75 metres upstream of the Power Intake, inundated the switchyard and powerhouse access roads. The leak resulted from a displaced concrete slab (Slab 579) in the canal lining immediately adjacent to the concrete gravity dam. The displaced concrete slab had settled over 150 millimeters, exposing the underside of the adjacent slab. The leak was stopped by dumping sand, gravel and pumice on top of the displaced slab from the top of the north gravity dam. A temporary weir setup on that day recorded flows on the order of 250 liters/second. No further work was required at that time to reduce the leakage to tolerable levels. It is surmised that ongoing historical leakage in this area caused washing out of fines from underneath the slab. This caused the slab to settle and created a larger opening for water to enter, causing more fines to be washed away. Annual inspections showed no signs of further deterioration until 2006.

2003 Leakage from the toe of the north embankment

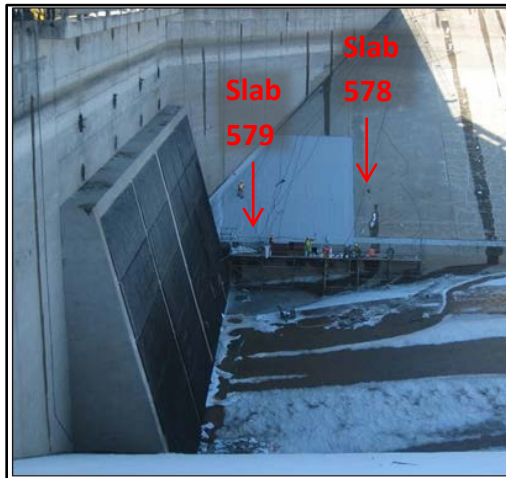
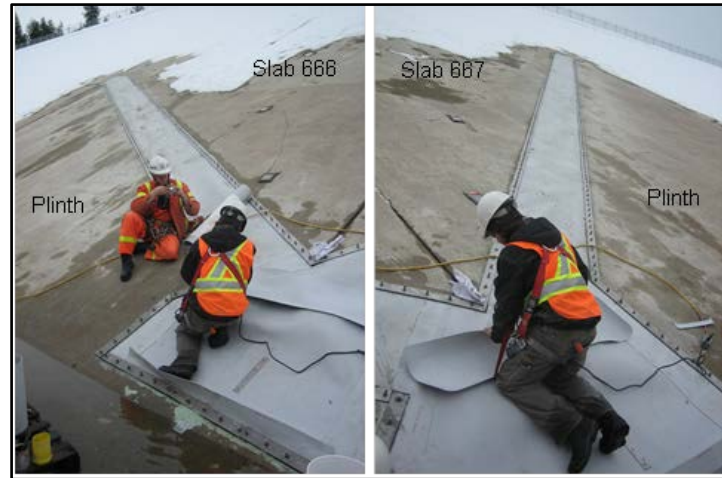
The annual underwater inspection in 2006 noted cracking near the upper end of Slab 579 and two nearby cracks in the adjacent Slab 578. In 2007, the divers found that these latter cracks had greatly increased in length and new cracks had developed in Slab 578. Remediation was completed 3 months later that included installation of a reinforced concrete patch placed underwater, slightly larger than Slab 579 and overlapping Slab 578 by about 1 metre. The overlapping patch was intended to prevent a larger leak resulting from another sudden drop of Slab 579 which could expose the fill underlying the canal liner slabs and cause another leakage event. Dive inspections in early 2008 found no new cracking in Slab 578 and the concrete patch was reported to be in good condition. A late 2008 dive inspection showed signs of vertical offsetting in the cracks in Slab 578 with leaves and twigs protruding from the cracks, indicating major leakage inflows. The slab degradation was assessed to require further remediation as soon as practicable.

The canal was dewatered in March 2009 and CARPI geomembrane was installed over both the 2007 concrete patch as well as most of Slab 578. During the planning for the CARPI work, a 2001 photograph of the dewatered canal was found that showed an area on the opposite side of the forebay with water flowing out of the lower joints of two slabs (Slabs 666 and 667). The scope of work was increased to cover the lower diagonal joints in this area (known as the Chevron area).

(Left) 2009 CARPI geomembrane on Slabs 579 and 578; (Right) 2009 CARPI repair on Slabs 666 and 667 on south forebay (left, upstream; right, downstream sides of Chevron)

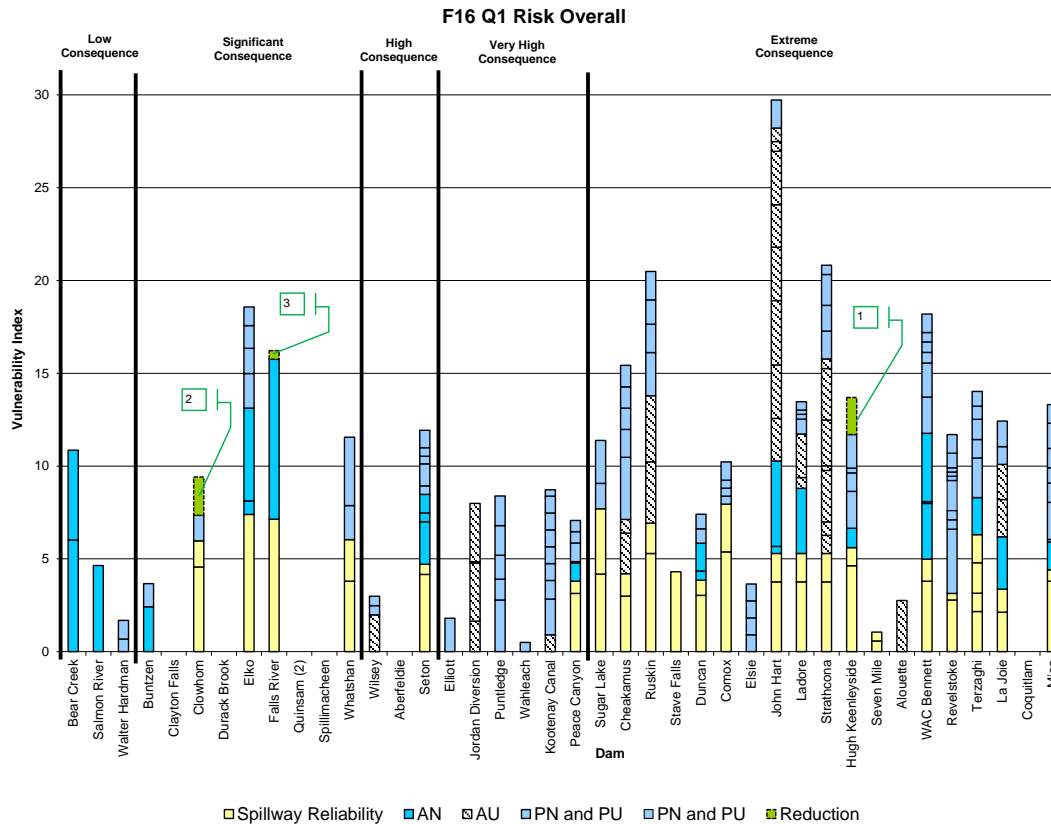
FIGURE 1 - DAM SAFETY: OVERALL RISK PROFILE

The Dam Safety Program has been carried out consistent with its stated objectives throughout the reporting period. The overall Dam Safety risk profile is shown in Figure 1. There is an overall decrease in the risk profile this Quarter due to the completion of a downstream berm at Hugh Keenleyside dam as well as the re-rating of issues at Clowhom Dam and Falls River Dam.

- 1. Hugh Keenleyside Dam** – the vulnerability associated with leakage through the right abutment at high water levels has been mitigated by construction of a downstream filter berm
- 2. Clowhom Dam** – derated consequence category due to removal of forestry worker accommodation barge
- 3. Falls River Dam** – issue re-rated on basis of external report regarding acceptability of penstock for operation.
