EXECUTIVE SUMMARY

QUARTERLY FEATURED DAMSITES – ELSIE LAKE DAMS

BOARD BRIEFING – DAM SAFETY QUARTERLY REPORT

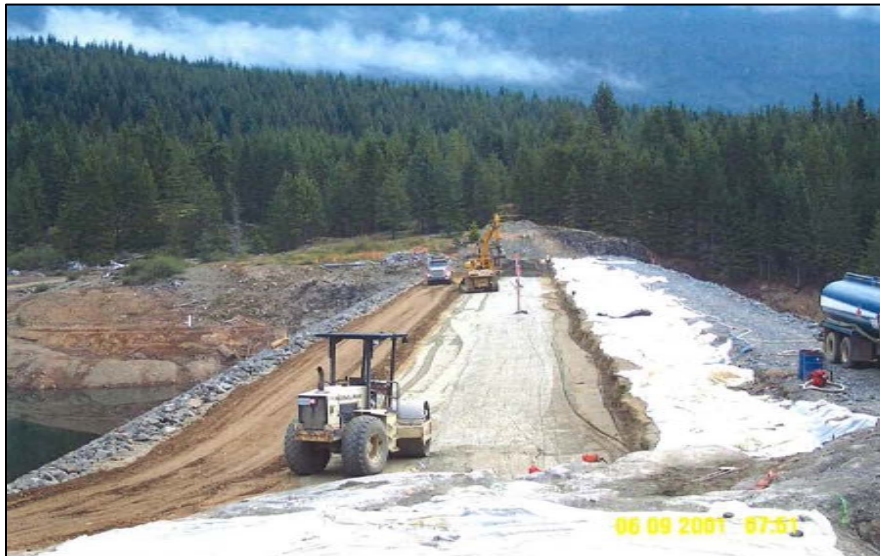
During 2001, the Main Dam was excavated down approximately 13 metres from the crest to remove loose, potentially liquefiable layers in the dam. Saddle Dam 1 was also partially excavated to remove potentially liquefiable layers in its upstream shells. Both dams were reconstructed slightly higher than original to provide freeboard for an updated flood estimate. Instrumentation was upgraded and a downstream rockfill berm was later built on the downstream slopes of the two dams to increase their seismic resistance.

Main Dam: Compacting new fill placement (Crest View)

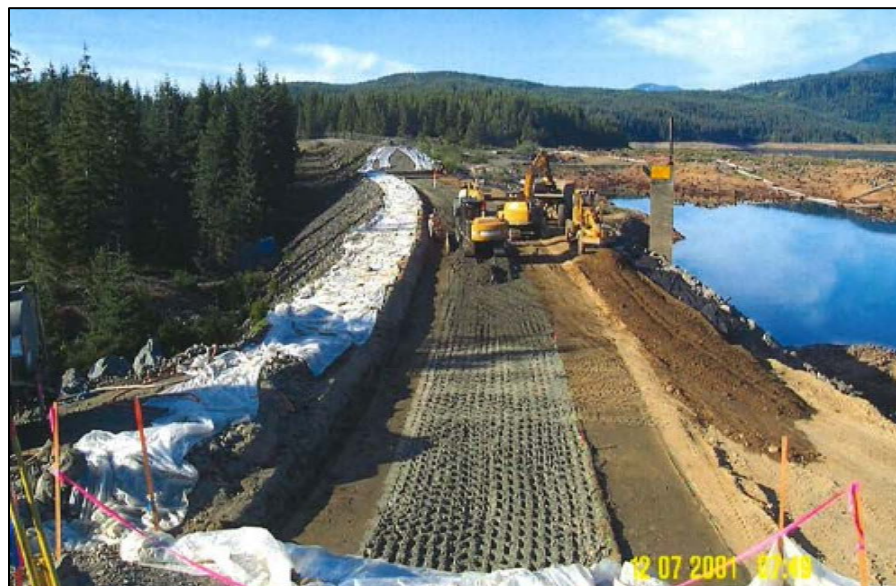
Saddle Dam 1: Reconstruction of dam in 2001

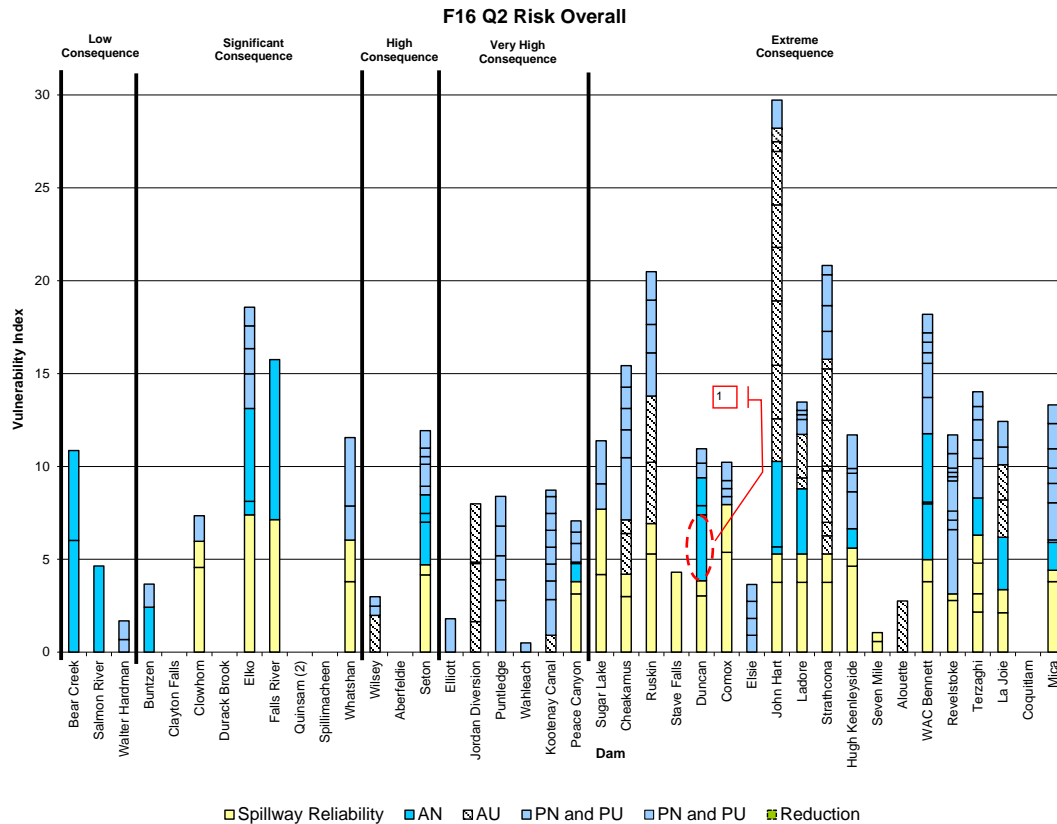
FIGURE 1 - DAM SAFETY: OVERALL RISK PROFILE

The Dam Safety Program has been carried out consistent with its stated objectives throughout the reporting period. The overall Dam Safety risk profile is shown in Figure 1. There is an overall increase in the risk profile this Quarter due to the discovery that the top elevation of the effective impervious core in Duncan Dam is lower than designed.

1. Duncan Dam – the core of the dam is lower than designed
