Board briefing – DAM SAFETY QUARTERLY REPORT

Quarterly Featured Damsite – Wahleach Dam

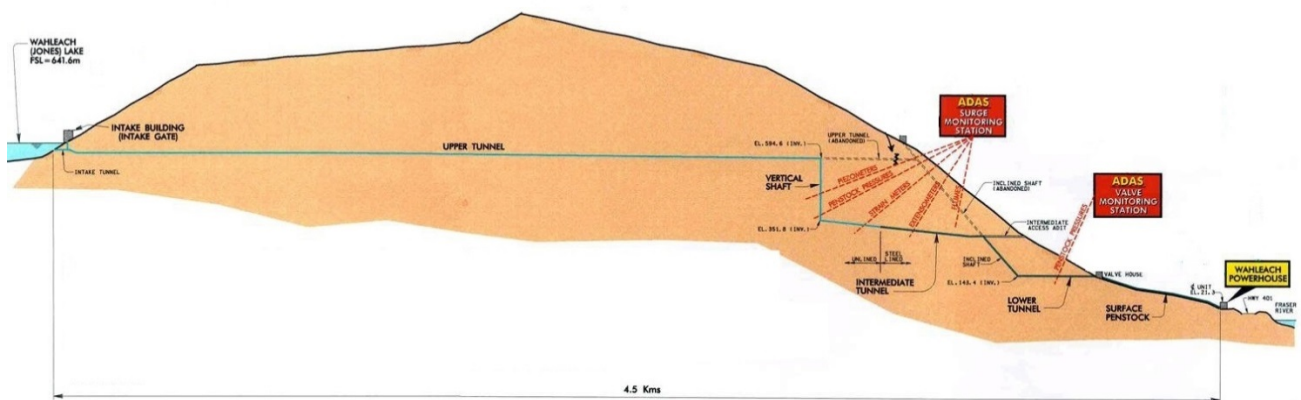
Wahleach Tunnel Cross Section

In January 1989, abnormally high leakage was discovered in the Wahleach Tunnel. The leakage was caused by slow movement in Four Brothers Mountain deforming and rupturing the steel lining on the horizontal portion of the upper tunnel. In addition to the rupture of the upper tunnel steel lining, the initial inspection found seven buckled zones in the inclined part of the power tunnel and one in the 3.2 metre diameter surge shaft. This incident initiated a major slope investigation and instrumentation program, which led to the portion of the Wahleach Tunnel located within the slow moving rock mass to be replaced by a 243 metre unlined vertical rock shaft constructed in sound rock below the zone of distressed slow moving rock. The replacement power conduit was filled and operated for the first time in June 1992.

tunnel has decreased approximately logarithmically from an initial rate in the order of 250 mm / year, immediately following the lining break, to the current 1-2 mm / year. Short-term accelerated movements of about 2-3 mm occur when the tunnel is unwatered, due to changes in hydrostatic pressures within the rock mass.

On February 24, 2011, the Wahleach Intake Operating Gate closed unintentionally, causing the 243 metre high vertical unlined rock shaft to dewater in less than ten minutes and the generating unit power to drop. The rapid de-watering resulted in a quick depressurization of the rock shaft, dislodging significant rock fall in the process, filling the rock-trap, as well as causing an increase in movement in the slow moving rock mass above the tunnel. The rock trap has been subsequently cleaned out, but the shaft has not yet been inspected following this event due to challenging safety issues associated with the inspection. A future project is being planned to carry out the inspection.

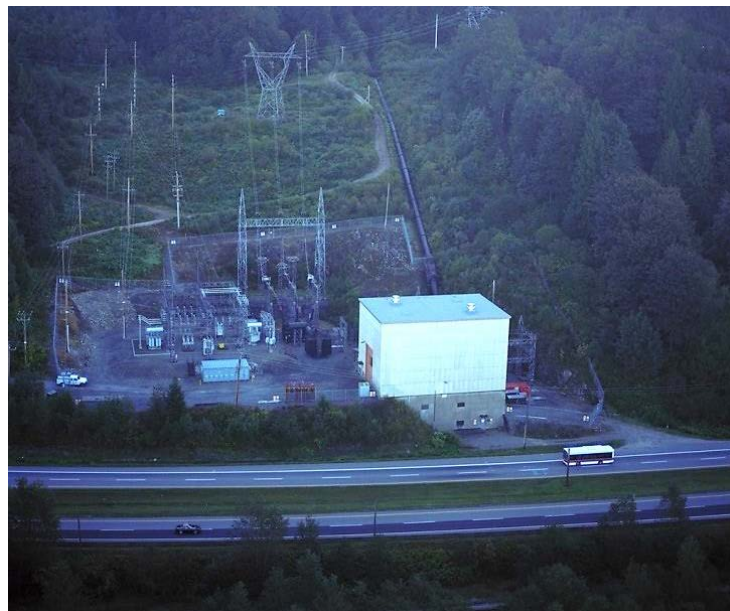
Wahleach Powerhouse and the Trans-Canada Highway

On March 11, 2007, the Wahleach powerhouse was flooded by a debris torrent originating from nearby Ted Creek, which normally passes under the Trans-Canada highway to the east of the powerhouse through a large culvert. The trashrack on the culvert plugged with debris, diverting the flow along the ditch on the south side of the highway. The water and debris forced open the door on the north side of the second floor of the powerhouse. The first floor was completely submerged and the second floor was submerged to within four feet of the ceiling. Significant efforts were needed to clean the powerhouse, inspect the turbine bearings, inspect the governor system and restore station service.

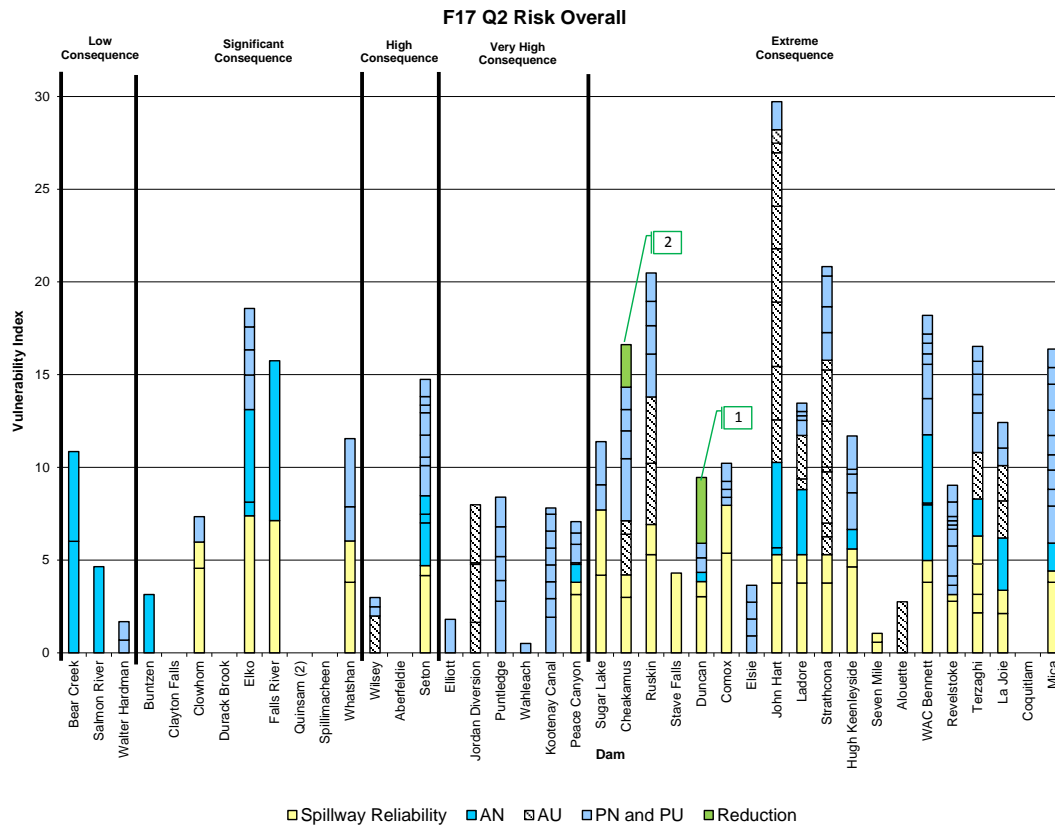
Figure 1 - Dam Safety: Overall Risk Profile

- Duncan Dam** – The construction of a cut-off wall was completed.
- Cheakamus Dam** – The seismic withstand of two components of the Cheakamus facility are better than previously reported.
