Executive summary

The purpose of this report is to update the Operations, Planning, Information & Technology Committee of the Board of Directors on key dam risk management activities during the period from April 1 to June 30, 2023 (F2024 Q1) and to provide reasonable assurance that the safety of dams operated by BC Hydro continues to be managed to the established guidelines and criteria of the Dam Safety Program. To keep the Committee as fully abreast of the Dam Safety Program as possible, some notable developments that took place after June 30, 2023, but before the completion of this report have also been included.

Dam Safety Program Dashboard

Risk Profile of BC Hydro's Dams

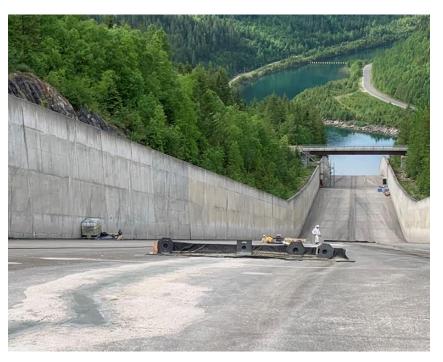
A significant project completed in Q1 was the repair of a crack running all the way down the centerline of the concrete spillway at Mica Dam, part of a multi-year program of repairs to the spillway. This crack was observed to extend through the slab to the drainage gallery below. With this configuration, the crack could lead to excessive uplift forces in the chute slab panels during a spill event.

Figure 5 The Mica Dam spillway with repairs to the centerline crack underway.

Construction Services Vernon performed concrete repairs along the crack following procedures provided by BC Hydro Engineering and the repair material vendor, incorporating lessons learned from previous repairs in the same area. The repair procedures were designed to minimize the risk of future cracking in the repaired area.

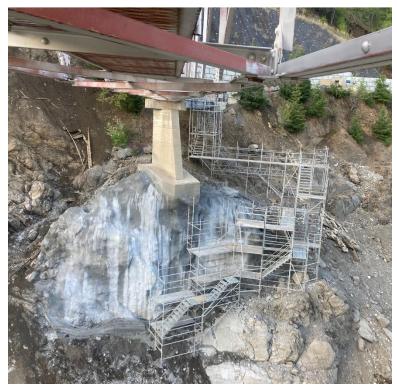
Undermining of the Bridge River 2 intake structure's access bridge pier foundation was observed during preventative maintenance inspections in May 2021. A subsequent investigation in June 2021 carried out by members of Generation Stations Civil Engineering determined that the structural integrity of the bridge was satisfactory, but that further destabilization of the rock slope could lead to a loss of support of the pier foundation. An ex-plan project was initiated to address this issue and an adjacent slope stability issue on the intake tower access road. The bridge pier stabilization work, which included anchoring of rock blocks and shotcreting to prevent further erosion, was completed in May 2023.

Figure 7Stabilization of a bridge pier at the Bridge River 2
Generating Station intake tower.

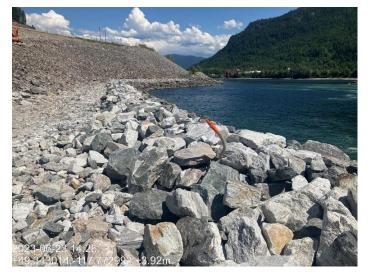
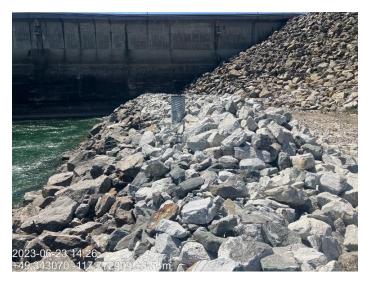
In 2020 and 2021, several sturgeon fatalities were discovered along the north bank of the Hugh Keenleyside tailrace. The sturgeon that had injuries consistent with being stranded amongst the north bank riprap material. Subsequently, a flat section of the north bank – a "bench" – was identified as being a potential contributor to the sturgeon strandings.

Figure 8 Hugh Keenleyside completed tailrace north bank modification. A berm has been constructed in front of the flat bench to prevent fish stranding.

This project was initiated to modify the geometry of the north bank to eliminate it as a potential cause of fish strandings and fatalities. In F2024 Q1, the Project constructed an elevated berm along the north bank to act as a barrier preventing fish from being pushed onto the existing bench through wave action and fluctuating water levels. The effectiveness of the berm will be monitored over the summer of 2023 to determine if any further modifications are required to minimize impact to sturgeon and other aquatic species.

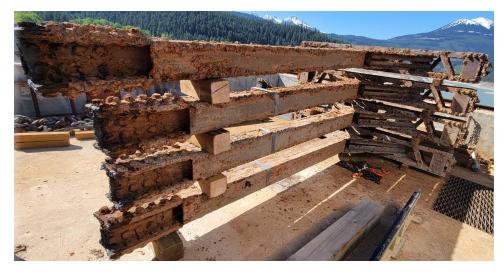
While raising Intake Operating Gate 4 on March 23, 2021, the uppermost cruciform follower (part of the Intake Operating Gate lifting mechanism) failed and dropped the intake operating gate approximately five feet to the sill. See the Quarterly Dam Safety Reports from F2021 Q4 and F2022 Q1 for additional information regarding this incident.

Figure 9 Replacement of Intake Operating Gate 3 cruciform followers at La Joie Dam. Heavily corroded followers that were removed are shown above; newly fabricated and installed followers at right.

Replacement of the Intake Operating Gate 3 followers was completed in May and June of 2023. (The followers on Intake Operating Gate 4 were replaced in 2022. See the F2022 Q4 report.) Construction activities included helicopter work to bring equipment on and off the intake tower, removal of the old followers, installation of the new followers and refurbishment of the intake gate guides. The followers for Intake Gates 1 and 2 will be replaced in spring of 2024.

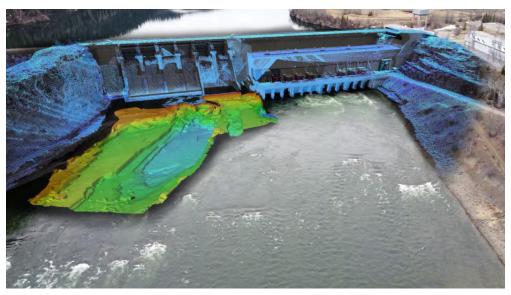
A plunge pool bathymetric survey was conducted in April 2023, using vessel-mounted multibeam sonar augmented by sonar conducted from a remotely operated vehicle to survey areas not reached by the surface bathymetry (either through geometry or turbulence). Located through the global navigation satellite system, the survey produced a high-resolution point cloud that describes the underwater surface of the plunge pool, as illustrated in Figure 10. This was the most recent in a series of surveys through which the progression of scouring is being measured.

Figure 10 Point cloud survey data overlayed on drone imagery of Peace Canyon Dam.
