Executive summary

The purpose of this report is to update the Operations, Planning, Information & Technology Committee of the Board of Directors on key dam risk management activities during the period from October 1 to December 31, 2022 (F2023 Q3) and to provide reasonable assurance that the safety of dams operated by BC Hydro continues to be managed to the established guidelines and criteria of the Dam Safety Program. To keep the Committee as fully abreast of the Dam Safety Program as possible, some notable developments that took place after December 31, 2022, but before the completion of this report have also been included.

Quarterly Meeting of the Operations, Planning, Information & Technology Committee March-01-2023

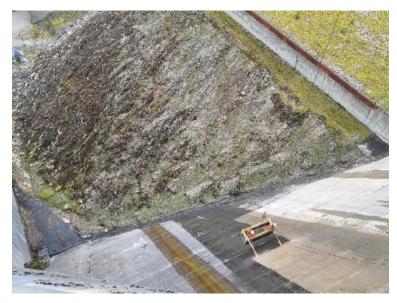
Figure 5 Workers pressure washing the Revelstoke Dam Transition Blocks.

One of the projects completed in Q3 was the pressure washing of the Transition Blocks at Revelstoke Dam to remove moss and emergent vegetation that was obscuring the condition of the dam's downstream exterior face. The pressure washing was completed by workers suspended in a work platform by a mobile crane on the dam deck. The project involved detailed planning, ensuring a safe rescue plan was in place, and that wash water did not enter the river. The cleaned surface was mapped and photographed to enable Dam Safety to compare past and future surveillance observations on this portion of the dam.
