## 13: Quarterly Dam Safety Report

### Executive summary

The purpose of this report is to update the Operations, Planning, Safety and Information Technology Committee of the Board of Directors on key dam risk management activities during the period from July 1 to September 30, 2024 (F2025 Q2) and to provide reasonable assurance that the safety of dams operated by BC Hydro continues to be managed to the established guidelines and criteria of the Dam Safety Program. To keep the Committee as fully abreast of the Dam Safety Program as possible, some notable developments that took place after September 30, 2024, but before the completion of this report have also been included.

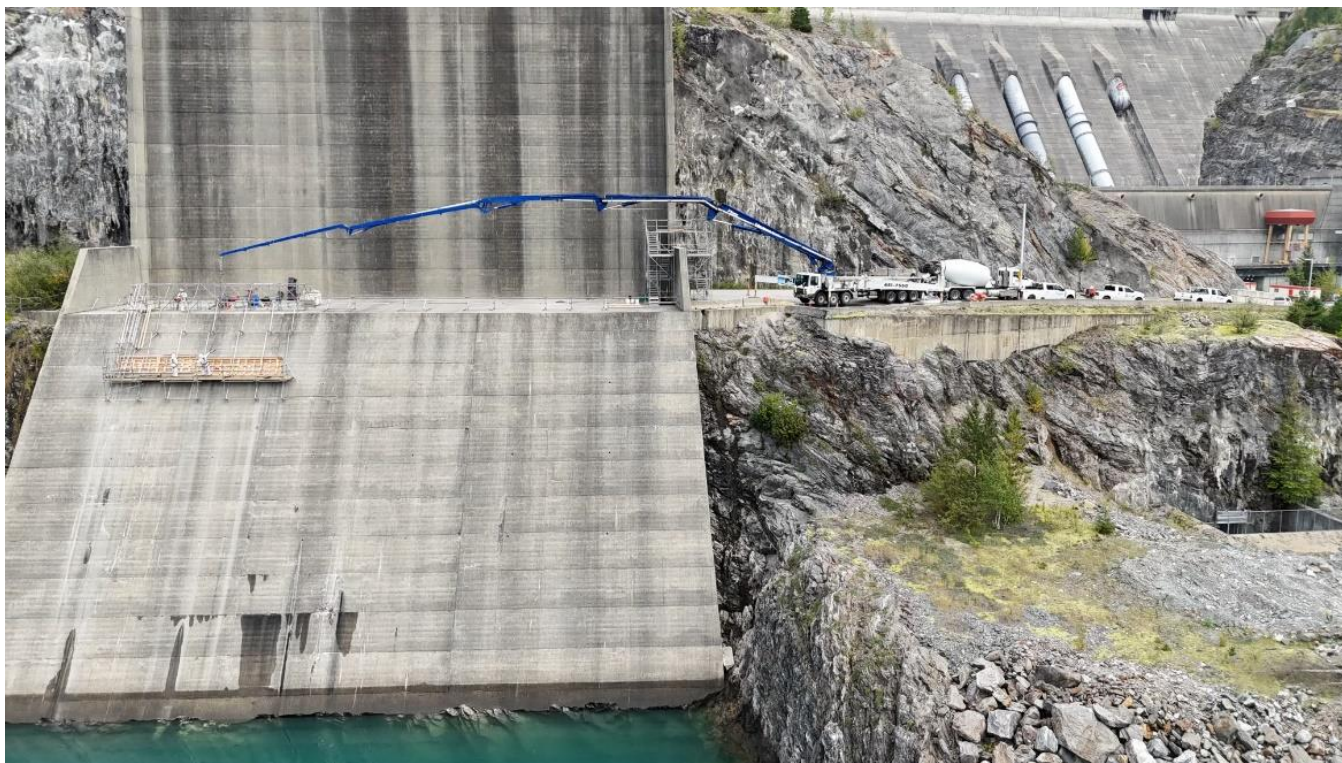
The two projects completed in Q2 were spillway repairs at Alouette Dam and at Revelstoke Dam. The work at Revelstoke, which included repairs on steeply sloping chute sections and on the sloped face below the flip bucket and above the plunge pool, was performed by the Construction Services Vernon team and a rope access contractor. See figure 4, below.

**Figure 4** Concrete repairs underway on the downstream slope section of the spillway at Revelstoke Dam, directly above the plunge pool.

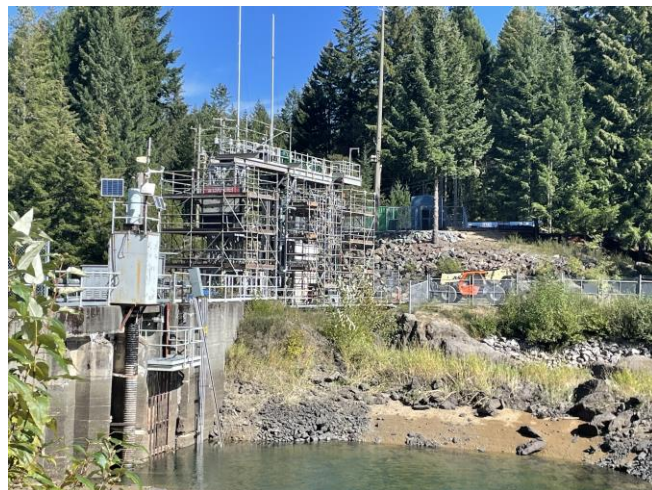
The first construction outage has now concluded. Upgrades to the first of two spillway gates and the hoist structure commenced, and new hoist machinery, power, communications and controls were installed. The new gate body was assembled at site, but deformations arising from welding will have to be repaired prior to it being installed in F2026. In the interim, the old gate has been modified to function with the new hoist.

**Figure 6** Construction scaffolding surrounds the spillway gate hoist structure at the Comox Dam in September.

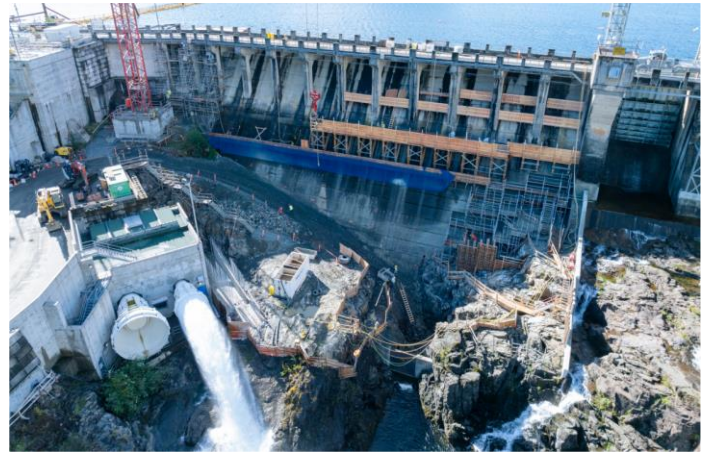
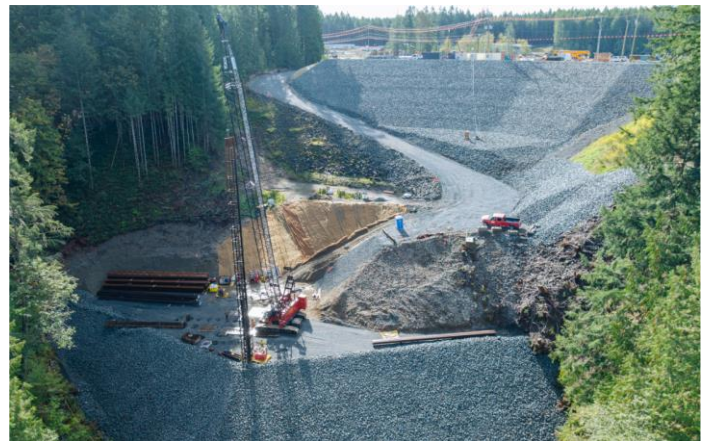
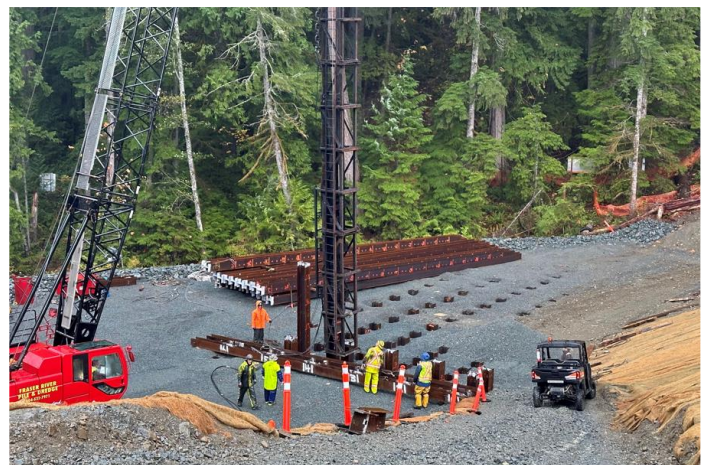
On the Middle Earthfill Dam, excavation of material from the downstream face to improve stability was completed. The installation of more than 300 H-piles is underway on the downstream toe to further improve stability, as shown in the bottom two photos in Figure 7.

**Figure 7** Construction on the John Hart Dam Seismic Upgrade Project. Top: Main Concrete Main Dam. Middle: H-Pile installation on the toe of the Middle Earthfill Dam. Bottom: Close-up of H-pile installation.

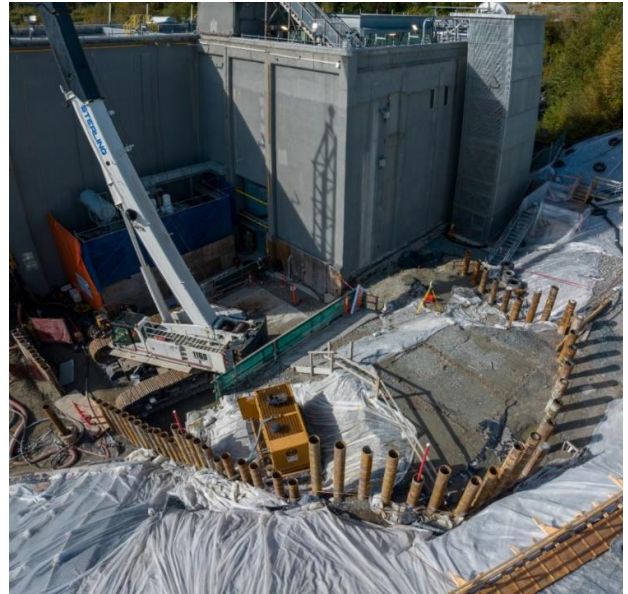
This project was released to develop and implement remedial solutions to the causes and impacts of the sinkholes. The F2025 Q1 Quarterly Dam Safety Report described the discovery of a void within the bedrock above the penstock and fractured bedrock underlying the soil overburden, necessitating design modification. The project team has completed the design modifications, and are proceeding with penstock grouting works, as well as the installation of piles and shoring that are required to support the excavation of the erodible sub-surface clays that led to the sinkholes. The grouting is proceeding well, and the installation of the piles and shoring is nearing completion. See Figure 8. Excavation of the erodible clays is expected to commence in Q3.

**Figure 8** Pile shoring nearing completion on the left abutment of Ruskin Dam.
