Executive summary

The purpose of this report is to update the Operations, Planning, Safety and Information Technology Committee of the Board of Directors on key dam risk management activities during the period from July 1 to Sept 30, 2025 (F2026 Q2) and to provide reasonable assurance that the safety of dams operated by BC Hydro continues to be managed to the established guidelines and criteria of the Dam Safety Program. To keep the Committee as fully abreast of the Dam Safety Program as possible, some notable developments that took place after Sept 30, 2025, but before the completion of this report have also been included.

10 Quarterly Dam Safety Report

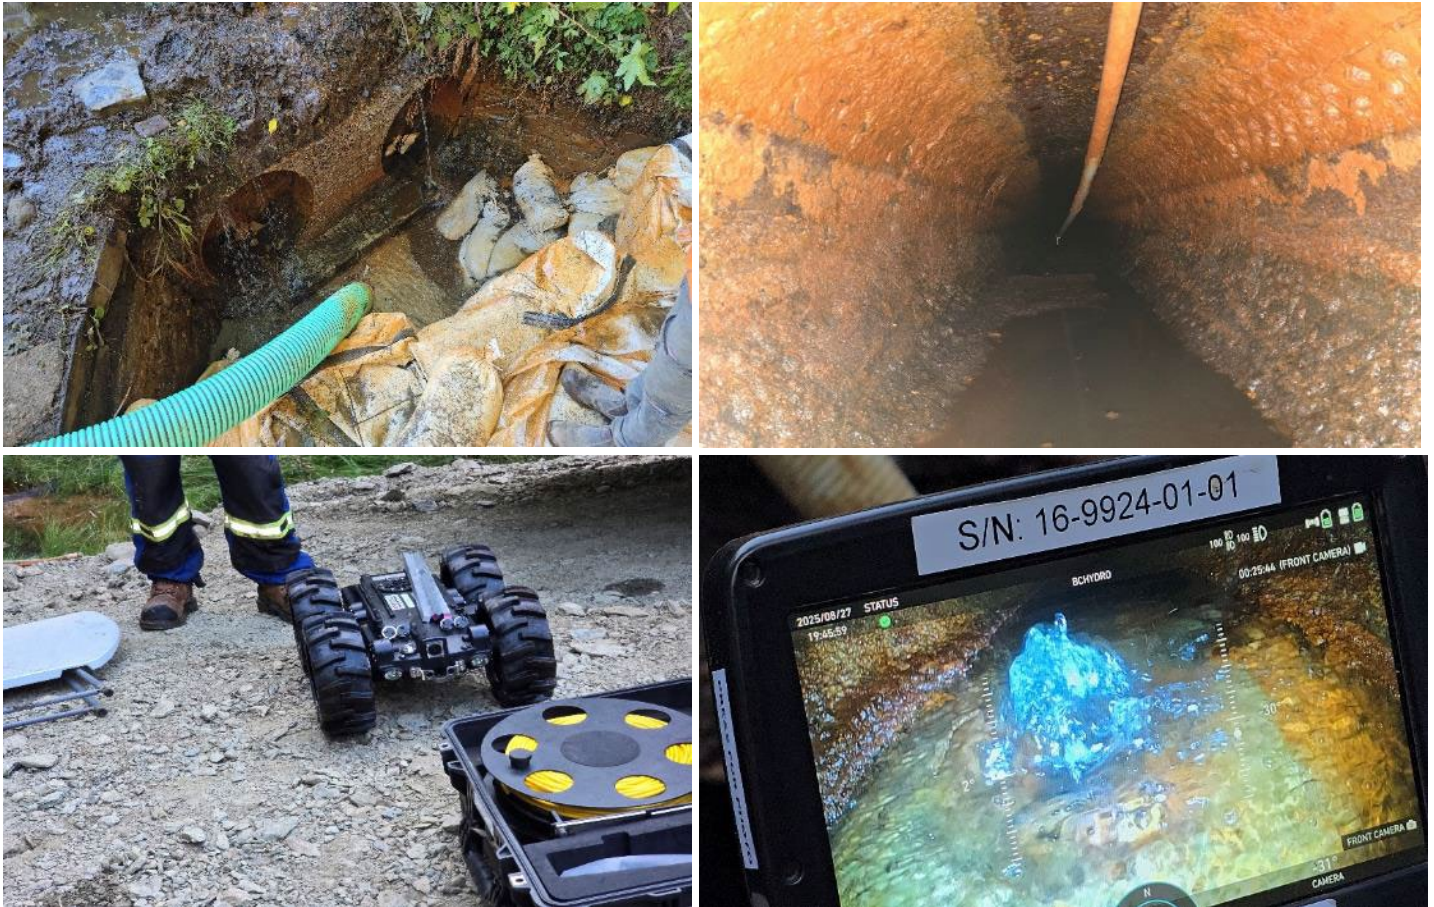
- 2** An **addition** of 7.7 (Actual Normal deficiency) at **Bear Creek Dam**.
Leakage flows into the deteriorated low level outlet pipes were observed during an interior inspection of the pipes. Further details on the remediation plan are provided under New Issues below.

A planned inspection of the low level outlet was conducted during the week of August 25. A pipe crawler equipped with camera and survey scanning technology was used to inspect the two pipes. The inspection revealed heavy corrosion and significant material loss. Leakage was observed near the invert level of both pipes, located below the upstream slope of the dam near the decommissioned intake. Measured seepage rates were 10 L/min for the left pipe and 50 L/min for the right pipe. Advanced corrosion and leakage in the unpressurized low level outlet pipes pose a risk of uncontrolled reservoir release. This could occur if leakage water erodes dam fill material and creates a pathway through the pipes. Although there is currently no direct evidence of dam fill loss, an enhanced surveillance program was initiated following

Figure 4 Seepage into the left Low Level Outlet pipe through holes in the rivetted steel pipe.

At Bear Creek Dam, an inspection was completed to assess the internal condition of the low level outlet pipes decommissioned in 2019. The work required extensive coordination with external contractors, BC Hydro's Environmental and Stations Maintenance teams. Key activities included installation of a temporary cofferdam to isolate the outlets from tailwater, dewatering and pressure washing the pipes, and the use of remotely operated vehicles (ROVs) to perform visual inspections and internal survey scans. As noted in the *New Issues* section of this report, the inspection revealed deterioration of the pipes and leakage near the invert of both pipes, prompting an enhanced Dam Safety surveillance program.

the inspection. Daily visual inspections of the dam and monitoring of leakage flow rates from both conduits are being conducted to detect any signs of deterioration and enable timely implementation of further risk reduction measures.

The remediation approach is currently being evaluated by Engineering. The most likely solution involves fully grouting the two low-level outlet pipes, with work planned for completion in late fall or early next spring. This is being executed as a priority project, with contractors and environmental plans being developed in parallel with specifications for remediation.

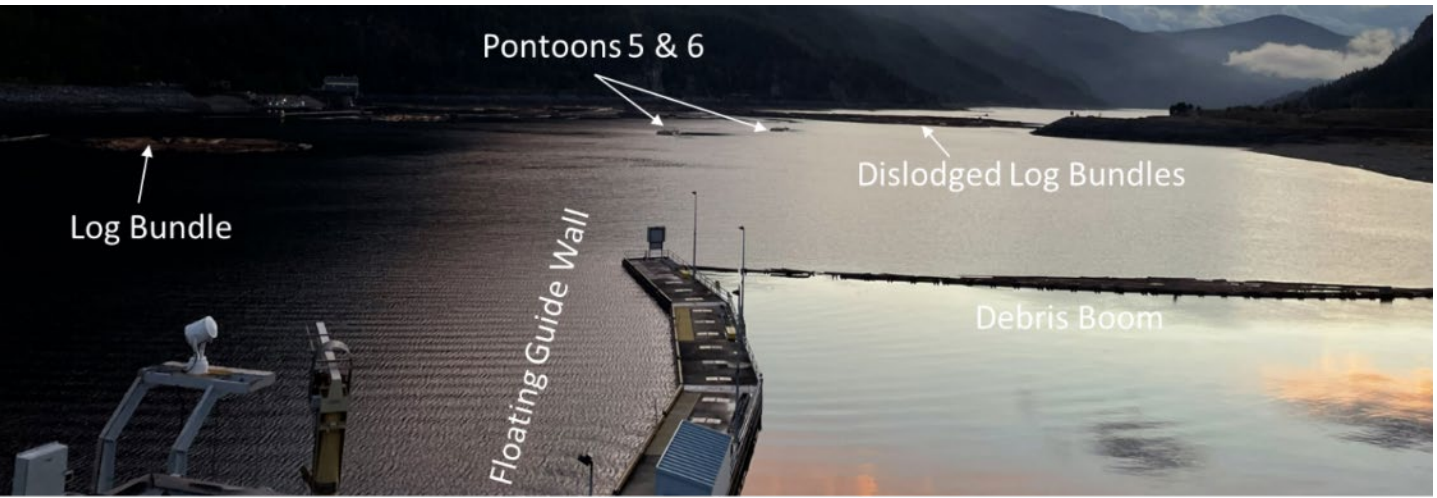
Following the failure, the uncontrolled log bundles drifted downstream toward Hugh Keenleyside Dam and the Arrow Lakes Hydro power canal. The main mass of logs became lodged at a narrow section of Arrow Lake, fully bridging the reservoir at the intake to the power canal. Some log bundles breached the debris barrier and entered the power canal, while others continued downstream toward the Hugh Keenleyside debris boom.

The large volume of woody debris posed a significant hazard to critical infrastructure at the dam, including the debris boom, floating guidewall pontoons 5 and 6 (moored upstream of the dam), and the intact floating guidewall sections. A failure of the debris boom or mobilization of the guidewalls could obstruct the dam's discharge facilities, potentially reducing conveyance capacity or causing damage to infrastructure.

Figure 5 Photo of the log bundles that were dislodged from their moorings at Hugh Keenleyside Dam

Interfor successfully re-established control of the log bundles using a temporary corral, effectively mitigating the immediate risk to the dam. BC Hydro maintained 24-hour site supervision throughout the event until September 26, when a permanent corral was re-established.

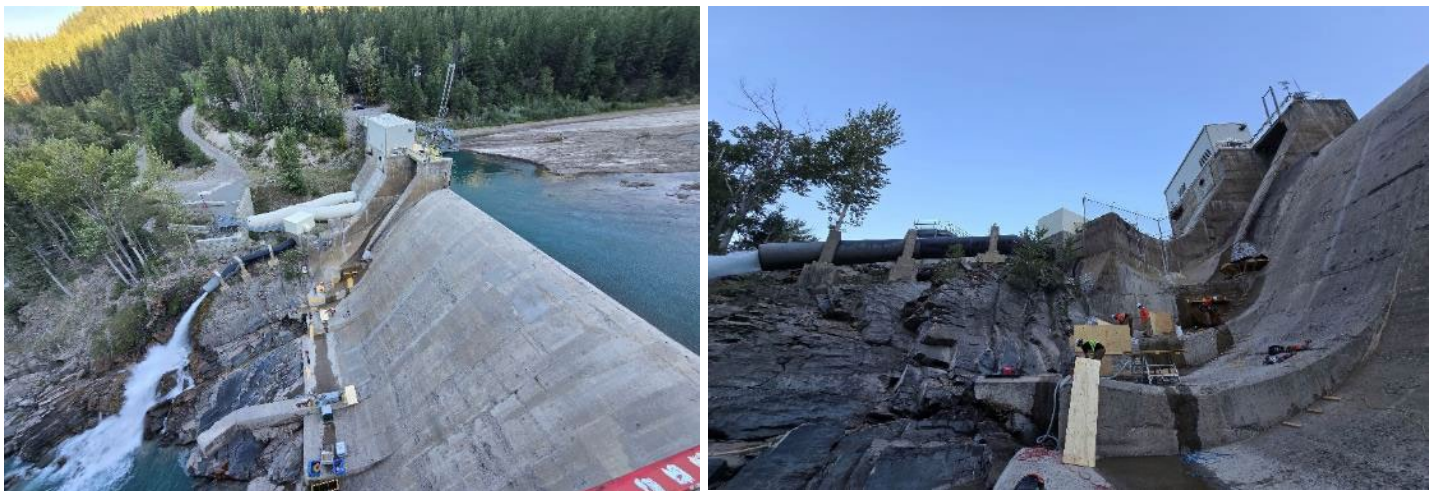
Figure 6 Aberfeldie spillway repairs. Bottom left: Overview of the spillway overflow channel and work area. Bottom right: Construction Services team preparing for formwork installation at a repair location.

At Aberfeldie Dam, localized repairs were completed by the Vernon Construction Services team on spillway areas exhibiting concrete deterioration. To support safe planning and execution of the work, several mitigation measures were implemented as the reservoir is hydrologically sensitive and can fill rapidly, resulting in a spill across the un-gated overflow spillway with limited notice. The mitigation measures included updated hydrotechnical modelling for the site, inflow forecasting, and the assignment of a designated spillway monitor responsible for tracking reservoir levels and issuing any necessary spillway evacuation alerts to the project team.

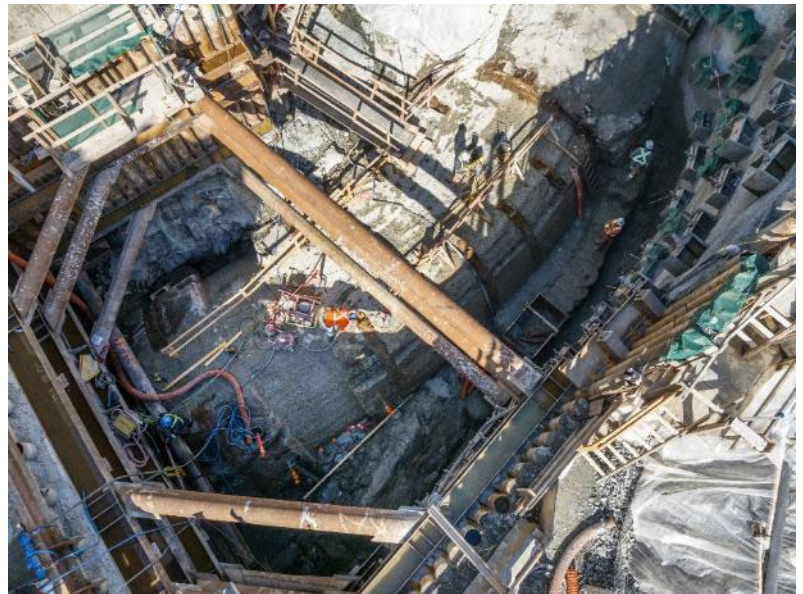
As described in previous Quarterly Dam Safety reporting three sinkholes have been identified to date. Ground Improvements to complete an engineered drainage filter area are underway. All excavation and concrete placement have been completed in the area where the engineered drainage filter is to be placed. Backfilling with gravel and sand is ongoing. Completion of construction is expected by the end of January 2026.

Figure 10 Exposed Penstock 3 in excavation.

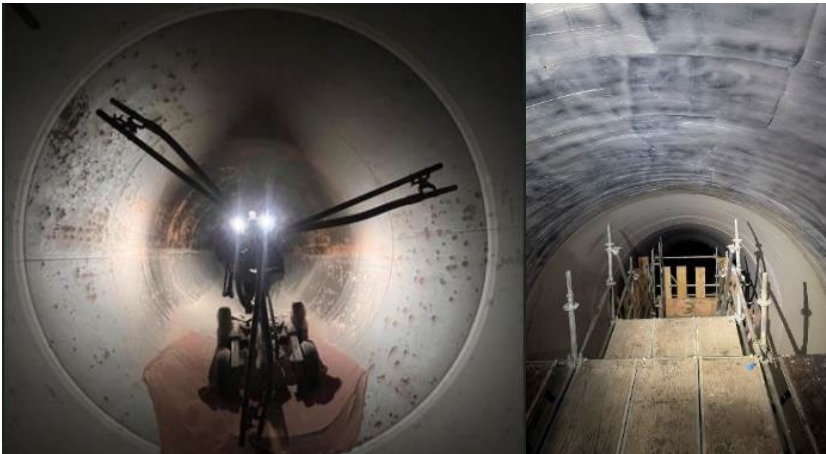
Figure 11 Left: Penstock recoating robot. Right: Carbon fiber reinforced polymer sleeve.

Construction for stripping and recoating began in June 2025. The interior penstock and scroll case recoating using robotic technologies was completed in Q2. The submersible pumps used to mitigate impacts to the Buntzen Lake Public Use Area have since been removed. The work to install a carbon fiber reinforced polymer sleeve in a select length of the penstock was completed on October 9th, during the existing outage.
