### Executive summary

The purpose of this report is to update the Operations, Planning, Safety and Information Technology Committee of the Board of Directors on key dam risk management activities during the period from Oct 1 to Dec 31, 2025 (F2026 Q3) and to provide reasonable assurance that the safety of dams operated by BC Hydro continues to be managed to the established guidelines and criteria of the Dam Safety Program. To keep the Committee as fully abreast of the Dam Safety Program as possible, some notable developments that took place after Dec 31, 2025, but before the completion of this report have also been included.

## 6 Quarterly Dam Safety Report

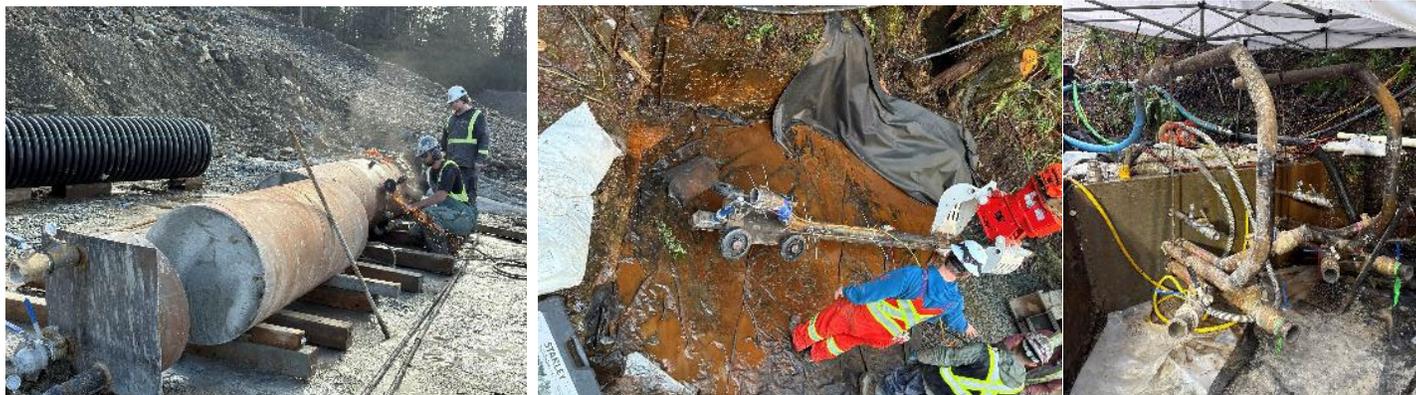
The F2026 Q3 report described the poor condition and presence of leaks in both decommissioned Low Level Outlet conduits at the Bear Creek Dam that were discovered during a planned inspection during the week of August 25, 2025. The issue was reported to the Provincial Dam Safety Officer and enhanced surveillance was initiated following the inspection. A capital project was also initiated to address the dam safety risks.

**Figure 4** Bear Creek Low Level Outlet sealing. Left: Successful grouting trial; Middle: Custom-made grout delivery trolley; Right: Grout delivery equipment installed in downstream end of conduit;

The capital project was tasked with fully decommissioning the low level outlet conduits by filling them with grout. The project team responded quickly to complete the work within a short time frame. Through several rounds of on-site investigation and testing trials, BC Hydro Engineering and the grouting contractor developed a suitable grout mix and an effective delivery method for ensuring complete sealing of the low level outlet conduits with grout (Figure 4). Both conduits were successfully sealed with grout on December 14th, effectively removing any further dam safety risk related to this issue

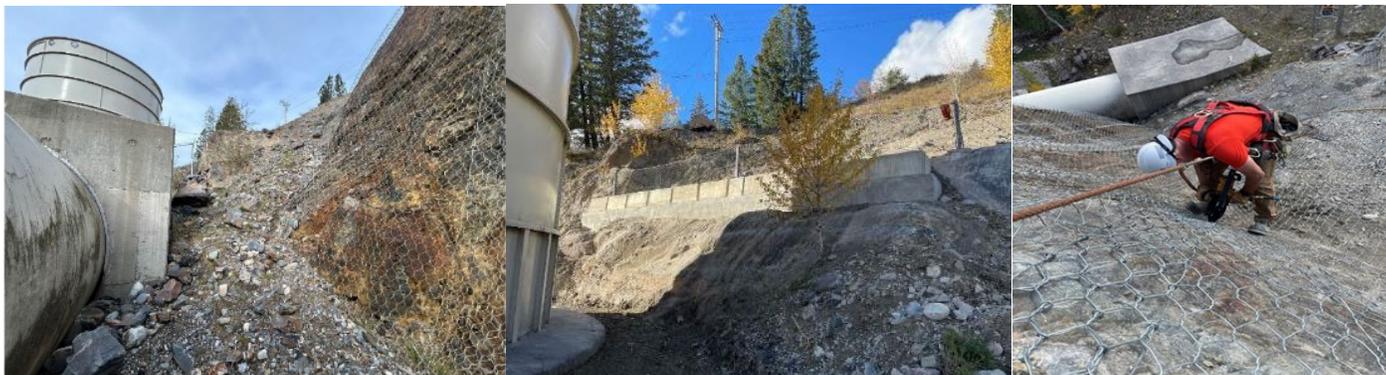
At Aberfeldie, routine inspections by the regional Dam Safety Engineer had previously identified debris accumulation against a section of exposed steel penstock from an adjacent slope where no rockfall barrier had been installed. Additionally, it was noted that the lock blocks installed as a debris barrier to protect the surge tank showed signs of

settlement, raising concerns about their stability and long-term effectiveness. Both scopes of work were successfully completed by the Vernon Construction Services team. For the slope adjacent to the penstock, the team performed scaling to remove loose debris, followed by installation of rock anchors and an extension of steel mesh to cover previously exposed areas. The existing lock blocks and debris fence were removed, and the slope above the surge tank was excavated and regraded to a more gradual slope. A pedestal foundation with integrated drainage was then constructed to support the new lock blocks and debris fence.

**Figure 5** Left: Previously accumulated rockfall debris against the downstream section of the penstock from the exposed slope. Middle: Excavated and regraded slope above the surge tank, with upgraded lock block barrier and debris fence. Right: Geo-mesh installation on the slope following scaling and debris removal.

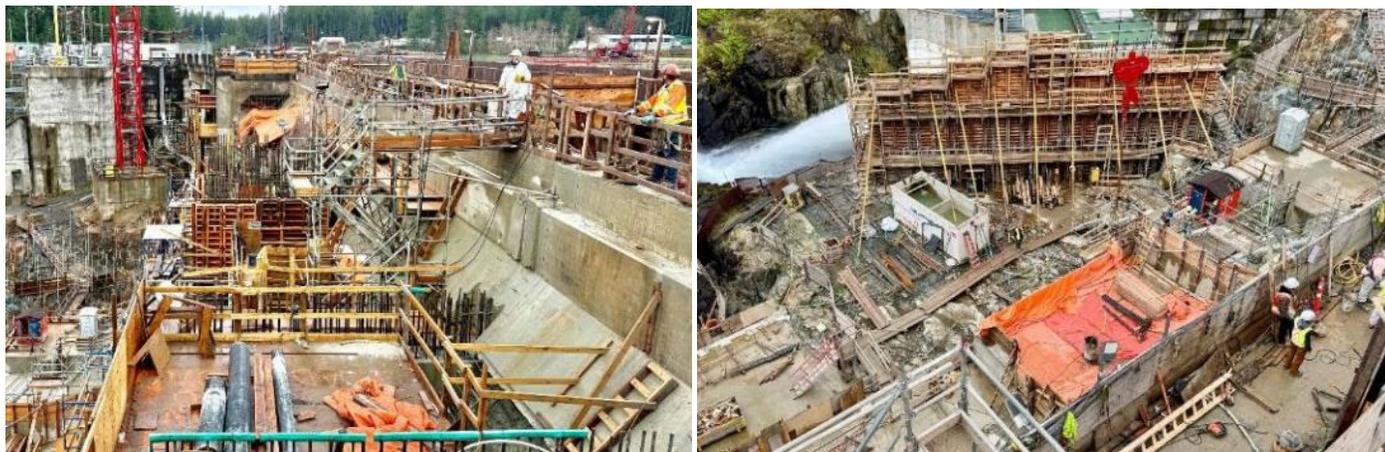
**Figure 7** John Hart Dam Seismic Upgrade Project. Left: Construction of ogee spillway crest; Right: Left training wall and formwork

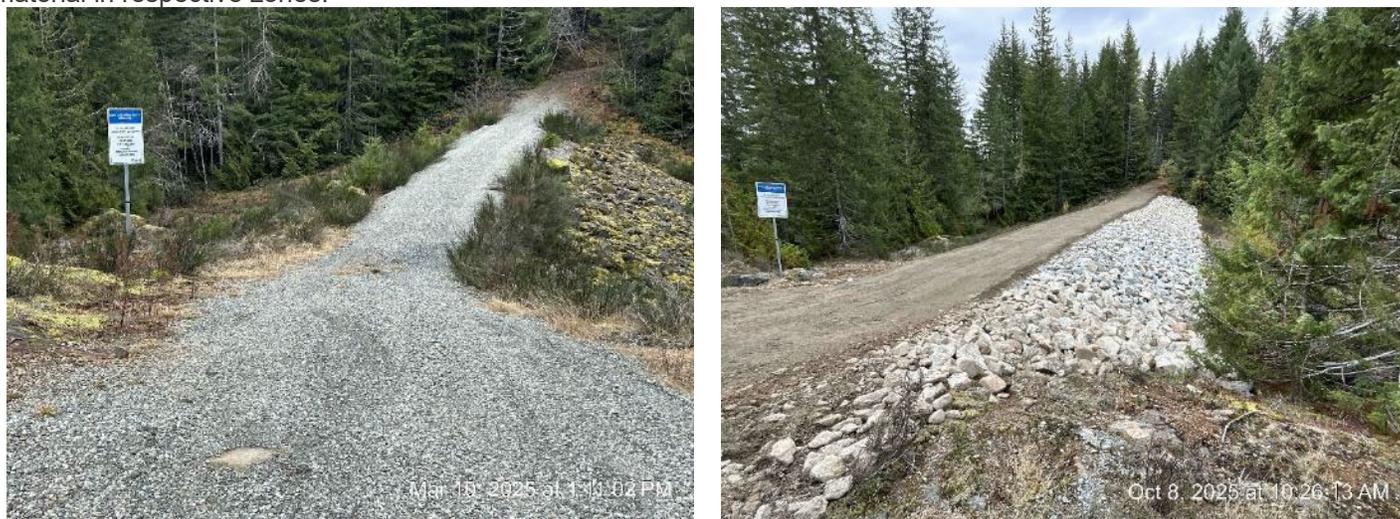
A 2021 survey identified that the crest levels of both Saddle Dams 3 and 4 at the Elsie Dam site were lower than design elevations by up to 0.5 m. A small capital project was raised in 2023 to restore crest elevations at Saddle Dams 3 and 4 to address the potential dam safety risks. The construction work was completed between Sept. 22<sup>nd</sup> and Oct 2<sup>nd</sup>, 2025. The dam core level and crest level at both saddle dams were restored to design elevations by placement of suitable earthfill material in respective zones.

**Figure 8** Elsie Saddle Dam 4 before (left) and after (right) dam crest raise

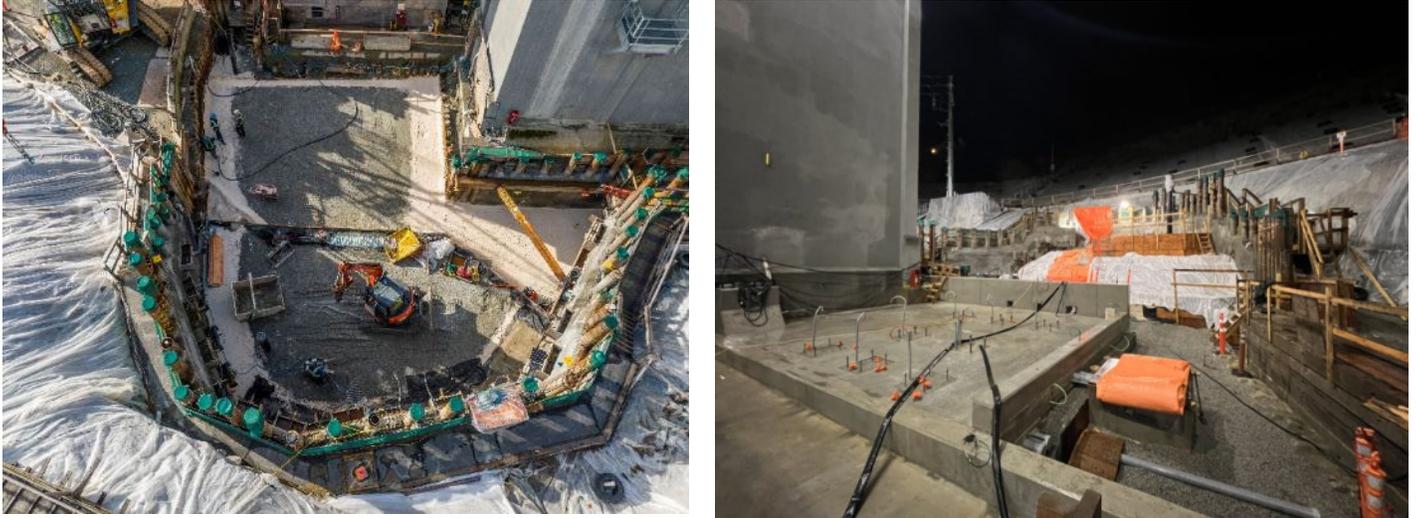
This project was released to develop and implement remedial solutions to the causes and impacts of the sinkholes that developed on the left abutment of Ruskin Dam in 2020.

At the end of F2026 Q3, concreting and backfilling of the engineered drainage filter with special filter sand and gravel were nearly complete. Concrete placement for the Transformer 3 slab and curb walls is complete, and laying of the duct bank is ongoing. The main scope of construction is expected to be completed in Q4, with some electrical work planned towards the end of Q4 and early in F2027 in parallel with the re-commissioning of Generating Unit G3.

**Figure 9** Ruskin Dam Left Abutment Sinkhole Remediation. Left: backfilled excavation of engineered drainage filter. Right: Transformer 3 concrete slab.

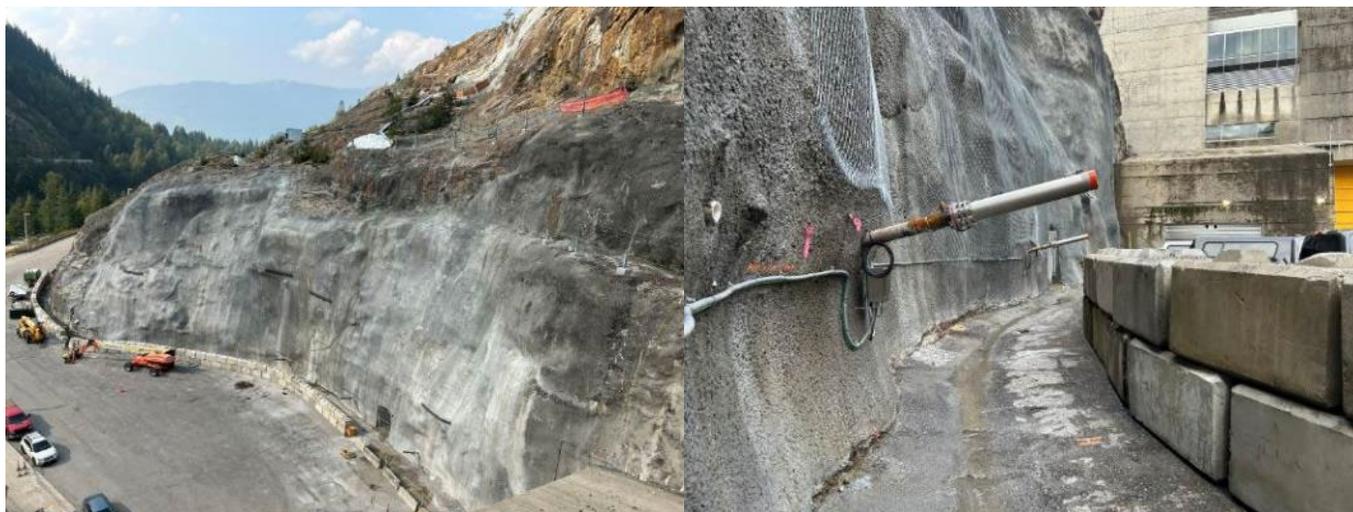
The Marble Shear Block is a massive rock block located on the right bank which abuts the concrete dam and powerhouse. It underlies the spillway, and contains the compressed gas insulated bus tunnel. The most critical volume of the Marble Shear Block is instrumented and its stability is monitored using a combined displacement and piezometric pressure-based threshold. On October 5, 2022, a slope failure occurred on a steep but near-surface discontinuity of the Marble Shear Block which was not instrumented, and the failed material's run-out covered the parking lot. The subsequent inspection identified the cracks and rock mass features which can contribute to additional potential instabilities.

Earlier phases of construction, including stabilization of the rock slope and application of shotcrete on the stabilized faces, were completed in 2024. The final phase of work was completed in Q2 and Q3 of F2026 and included the laying of rockfall drape mesh on the rock slope surface, repairing the damaged parking lot, and installing instrumentation to monitor the slope.

**Figure 10** Revelstoke - Marble Shear Block Rockfall Mitigation. Left: Shotcrete applied to stabilized faces  
Right: Instrumentation and draped mesh
