### Executive summary

The purpose of this report is to update the Operations, Planning, Safety and Information Technology Committee of the Board of Directors on key dam risk management activities during the period from Jan 1 to March 31 2026 (F2026 Q4) and to provide reasonable assurance that the safety of dams operated by BC Hydro continues to be managed to the established guidelines and criteria of the Dam Safety Program. To keep the Committee as fully abreast of the Dam Safety Program as possible, some notable developments that took place after March 31, 2026, but before the completion of this report have also been included.

## 8 Quarterly Dam Safety Report

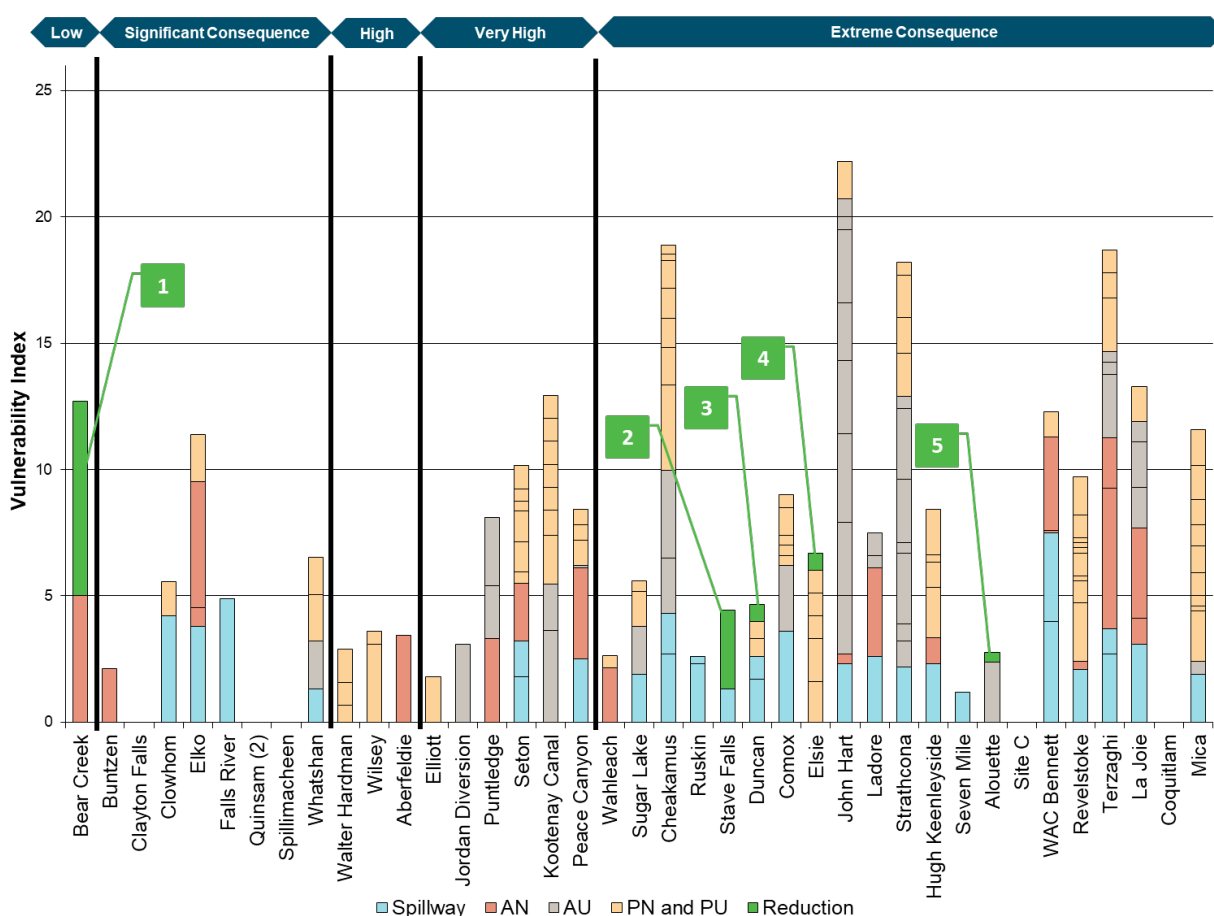
**1** An **reduction** of 7.7 (Actual Normal deficiency) at **Bear Creek Dam**.

A project to fill the deteriorated Low-Level Outlet pipes with concrete at Bear Creek Dam was completed in F2026 Q4. The concern that leakage flows may carry dam shell and core material into the pipe, potentially leading to significant dam performance concerns, has been addressed.

**2** An **reduction** of 3.15 (Actual Normal deficiency) at **Stave Falls Dam**.

New debris booms were installed in June 2025, replacing the older booms which were not expected to fulfill their function in significant inflow events.

**3** An **reduction** of 0.5 (Actual Normal deficiency) at **Duncan Dam**.

The existence and condition of the rip rap on the upstream face of Duncan Dam is unknown, as it is covered by a layer of finer surficial material and is not visible. A review of historic photos shows that the upstream face condition has not substantially changed since construction and the issue has been recharacterized from an actual deficiency to a non-conformance of information.

**4** An **reduction** of 0.7 (Actual Normal deficiency) at **Elsie Dam**.

A survey of the crest elevations of Saddle Dams 3 and 4 at Elsie Dam determined that these were lower than design. A project to restore these dams to their design elevation was completed in 2025 and the issue has been resolved.

**5** An **reduction** of 0.36 (Actual Normal deficiency) at **Alouette Dam**.

The seismic withstand of the Spillway and Overflow Weir were reassessed in F2026 Q4 as part of the annual review of database issues. The rating was updated to take into account current operating protocols of the Alouette reservoir which reduce the likelihood of free spill post-earthquake.

**Figure 1** Dam Safety overall risk profile at the end of F2026 Q4, as represented by the Vulnerability Index. Changes this quarter are indicated by the numbered boxes.

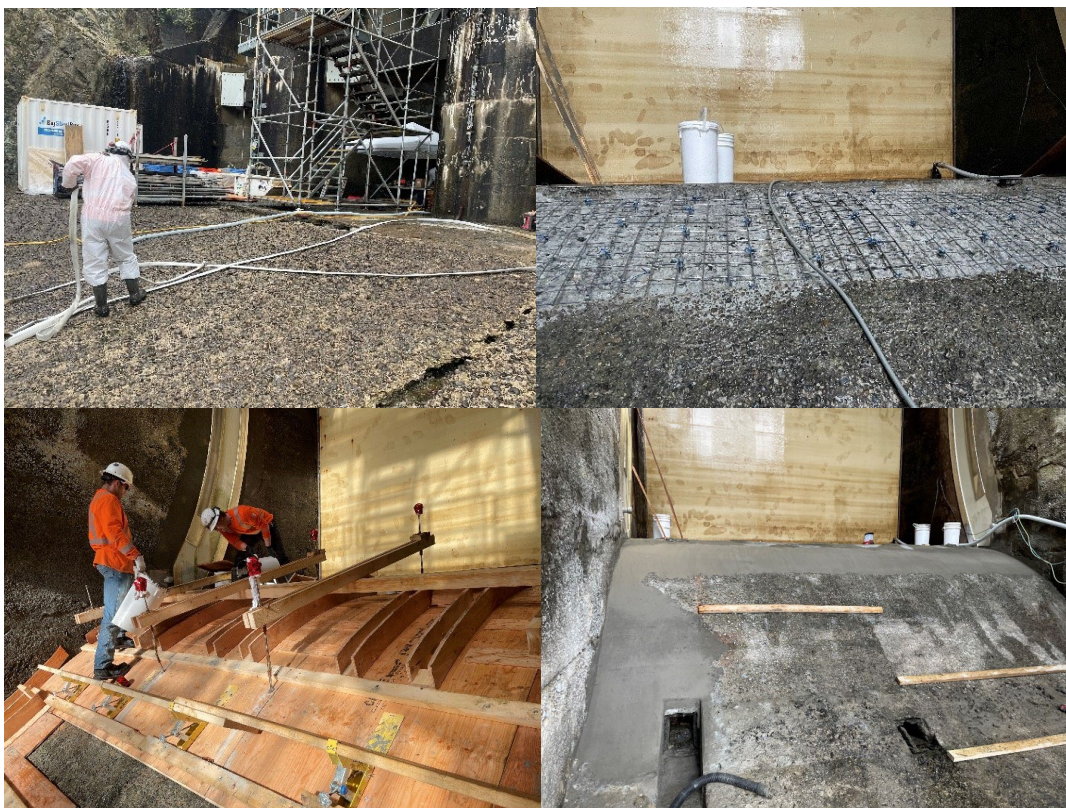
A notable project completed during the quarter was the rehabilitation of spillway concrete at Blind Slough Dam (Stave Falls). Previous inspection findings identified deterioration of repairs completed in the 1980s, with the most pronounced degradation occurring immediately downstream of the gate sill beams in spillway bays 1 and 2.

Progressive concrete erosion presented a risk of undermining the sill beams, with the potential for structural deformation if left unaddressed. As the spillway bay 1 repairs were completed in F2025, the efforts this quarter primarily prioritized the rehabilitation of the upper third of the spillway surface in bay 2. Construction Services Vernon executed the work in accordance with repair methodologies developed by BC Hydro Stations Maintenance Engineering, as shown in Figure 4.

**Figure 4** Stave Falls Spillway Bay 2 Concrete Repairs. Top Left: Scaffolding installation for access and egress into spillway bay 2. Top right: Installation of welded wire mesh following removal of deteriorated concrete. Bottom left: Curved form work in preparation of concrete placement. Bottom right: Concrete placement.

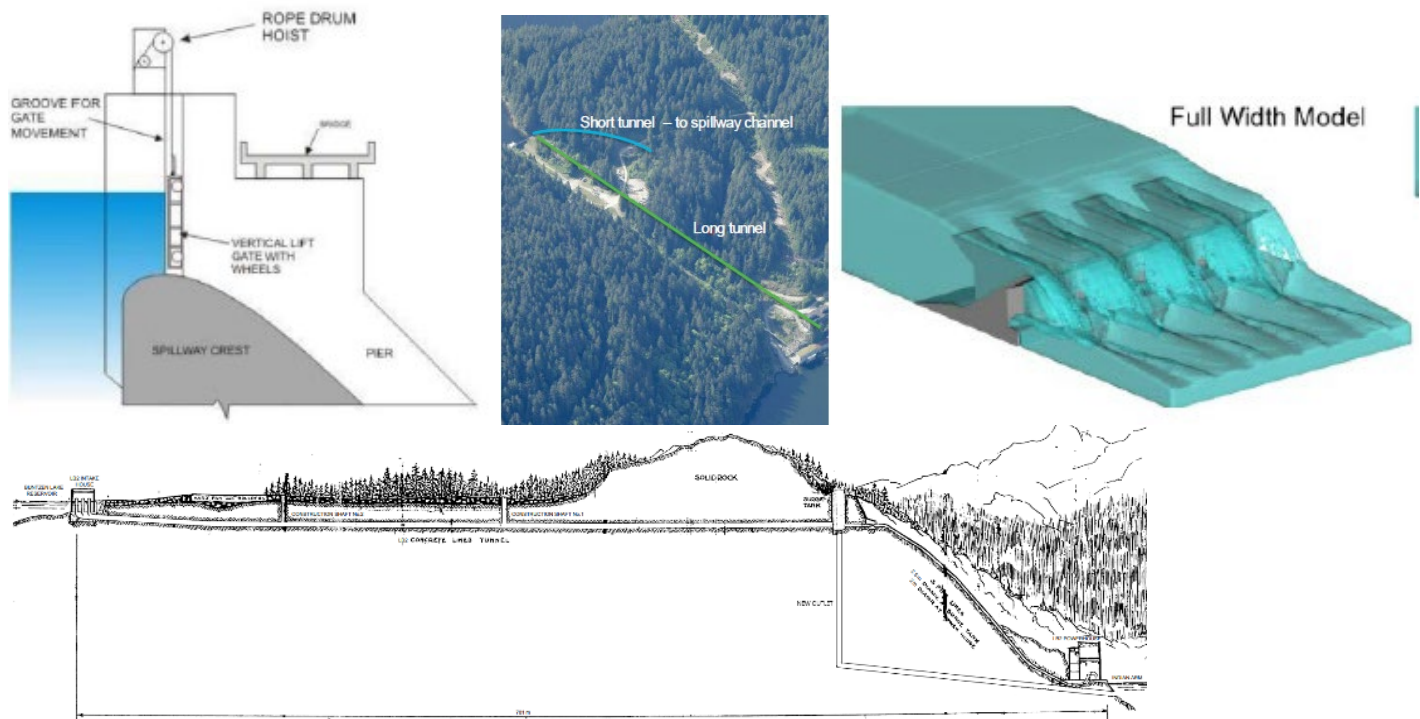
**Figure 6** Conceptual alternatives to increasing spillway discharge capacity at Lake Buntzen 1. Top Left: Lowered spillway crest with an operating gate. Top Right: Conceptual options for a short or long tunnel to bypass the upper flow constricted spillway. Middle: Piano-key weir that extends the effective spillway crest length. Bottom: Re-use of the Lake Buntzen 2 tunnel with a new outlet to Indian Arm.

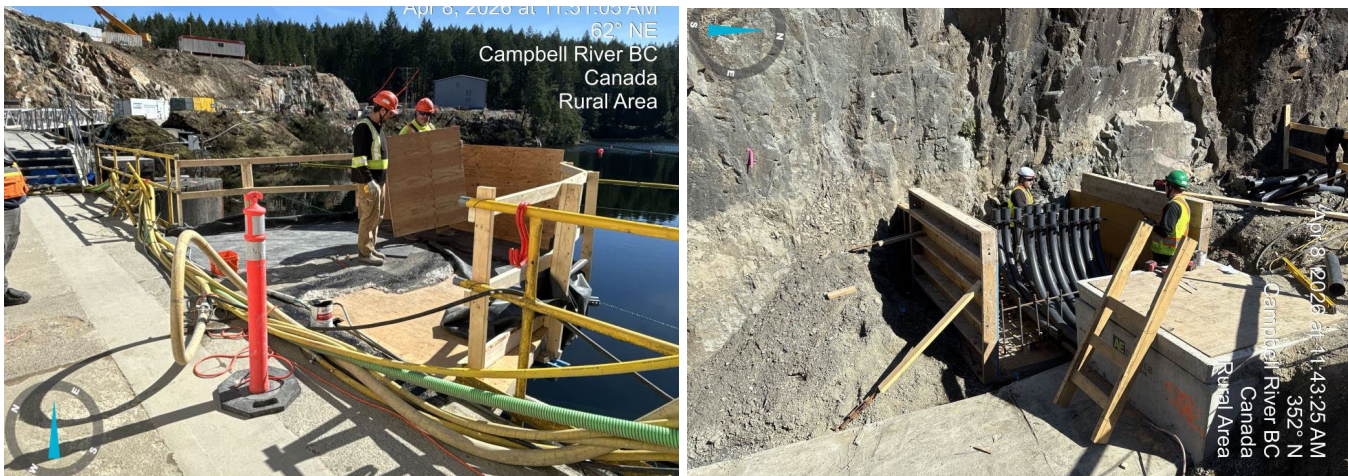
Site construction work continued in F2026 Q4 with substantial completion of the concrete pads and building construction for the main control building and the backup control building, and mitigation of rockfall hazards on the left abutment. Work continues on the excavation and installation of duct banks, the construction of the Battery Inverter System building and the Diesel Generator 2 building. Drilling and installation of the post-tensioned anchors remain in progress. Spillway Operating Gate 3 guide installation is in progress, along with concrete chipping for the spillway stoplogs.

**Figure 7** Ladore Spillway Seismic Upgrade Project. Left: Containment setup for post-tensioned anchor drilling; Right: Electrical ducting installation.

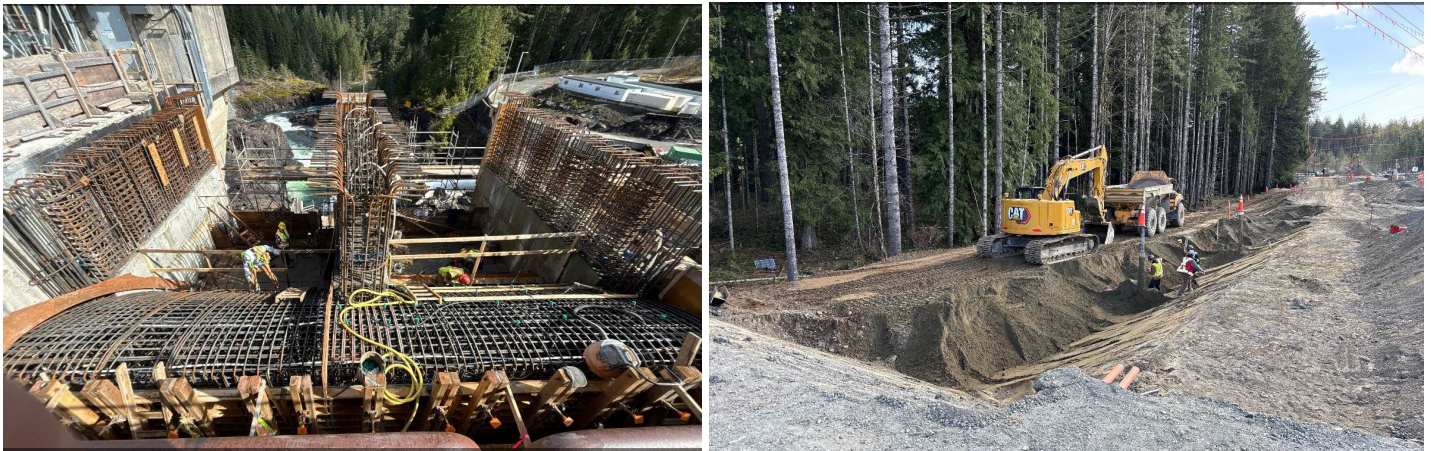
Construction activities at the John Hart Dam site continued as planned in F2026 Q4, with significant progress on the civil works. Earthworks at the North Earthfill Dam are now substantially complete. At the Concrete Main Dam, construction of the overflow spillway ogee crest and apron progressed, along with continued installation of post-tensioned anchors and construction of the road deck. At the Middle Earthfill Dam, in-reservoir rockfill placement was completed, concrete placement for the right training wall is ongoing, and installation of the south drain has commenced. At the Intake Dam, construction of the elongated downstream berm and in-reservoir rockfill placement were both completed.

**Figure 8** John Hart Dam Seismic Upgrade Project. Left: Construction of ogee spillway crest; Right: Excavation of south bank drain.
