## 11.2 Quarterly Dam Safety Report

The purpose of this report is to update the Operations, Planning, Safety and Information Technology Committee of the Board of Directors on key dam risk management activities during the period from April 1 to June 30 2026 (F2027 Q1) and to provide reasonable assurance that the safety of dams operated by BC Hydro continues to be managed to the established guidelines and criteria of the Dam Safety Program.

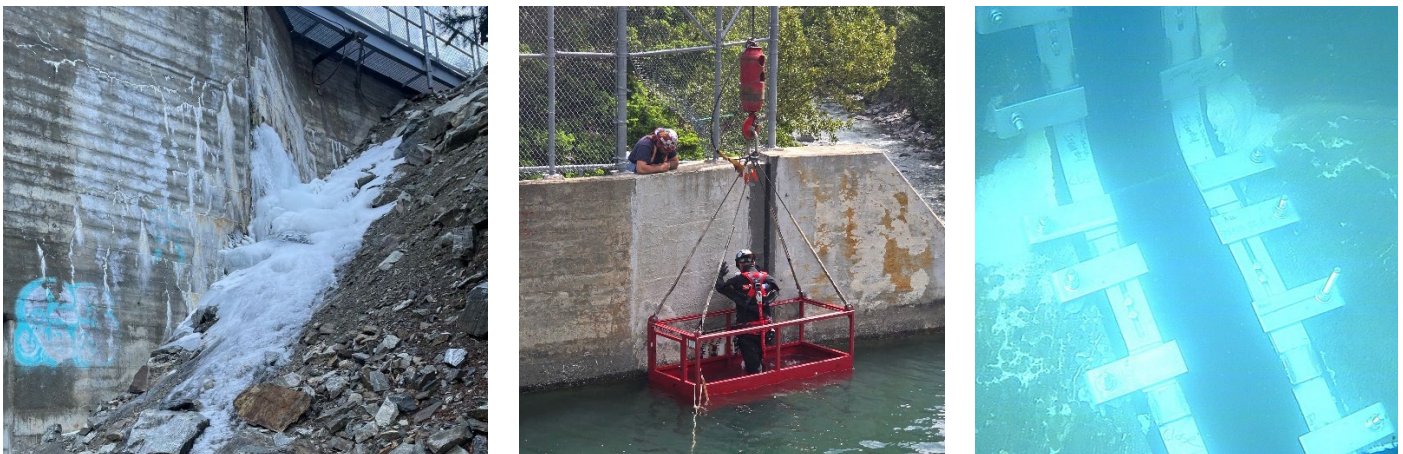
Dam Safety initiated a maintenance project to repair persistent leakage from a concrete joint in the Seton aqueduct that crosses Cayoose Creek. The repair began during a unit outage in May. During site preparation, a significant new leak appeared through the concrete panel when the diver moved a piece of loose concrete inside the aqueduct. If left untreated, there was concern that freezing temperatures over the winter would cause further concrete degradation and the leak to worsen, resulting in erosion along the creek bank and aqueduct footings. The civil maintenance team quickly developed and implemented a repair solution during the extended unit outage, addressing both the newly identified leak and the original leak from the joint.

**Figure 1:** Aqueduct leak in winter (left), diver on maintenance project (middle), completed joint repair (right).

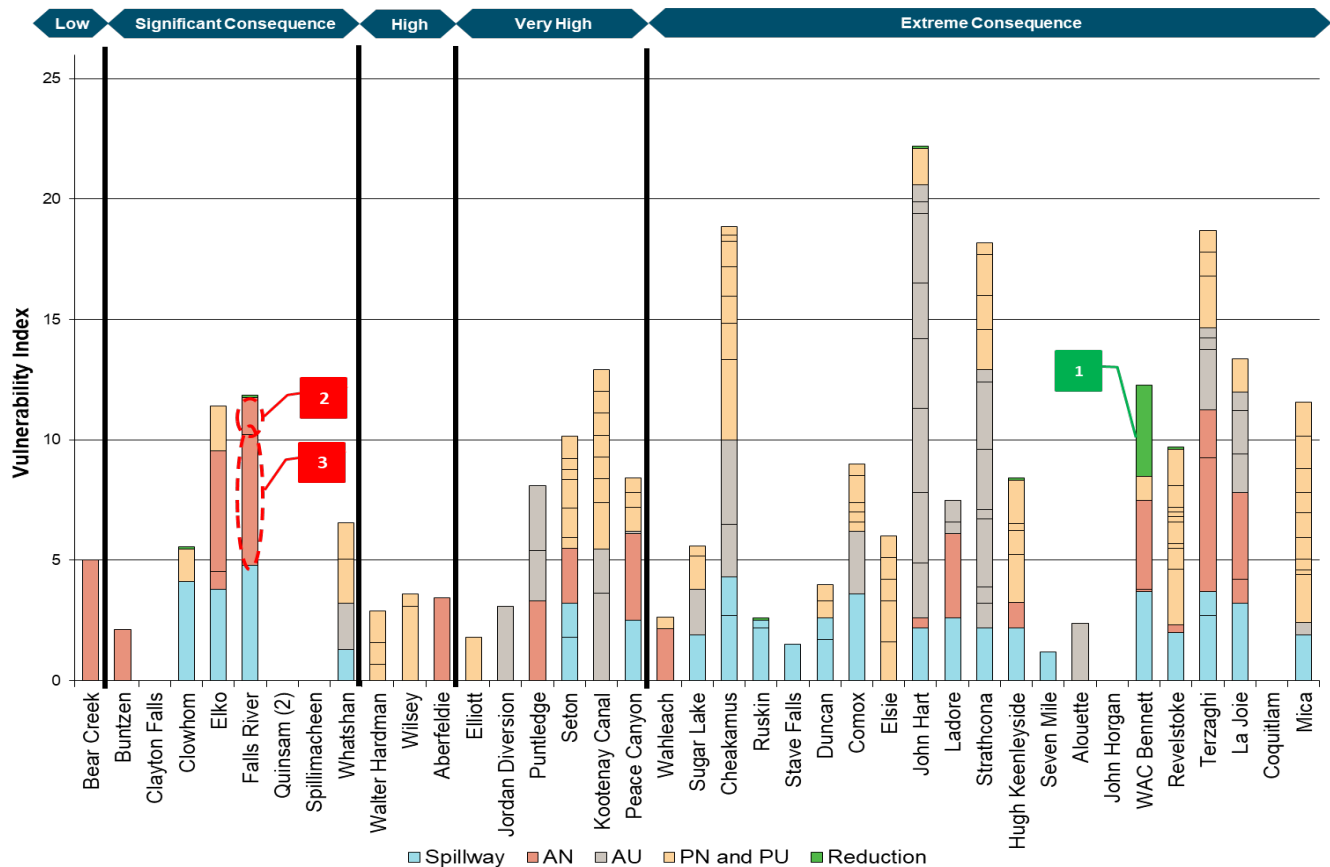
**1 WAC Bennett Dam: reduction of 3.5 Gate Serviceability Deficiency.**

Backup drives were out of service on all three spillway operating gates (SPOGs). The issue has been addressed, commissioning tests were completed and the backup drives returned to service.

**2 Falls River Dam: increase of 1.54 Actual Normal Deficiency.**

Automatic and remote operation of the spillway operating gates and remote gate position indication is unreliable. The ability to remotely operate the gates has been lost at least four times in the last two years.

**3 Falls River Dam: increase of 5.43 Actual Normal Deficiency.**

The two spillway operating gates at Falls River have experienced significant degradation, primarily due to corrosion. A recent assessment indicates that the gates do not meet current standards for normal loading conditions.

**Figure 3** Dam Safety overall risk profile at the end of F2027 Q1, as represented by the Vulnerability Index. Dams are ordered from left to right in order of increasing downstream consequences.

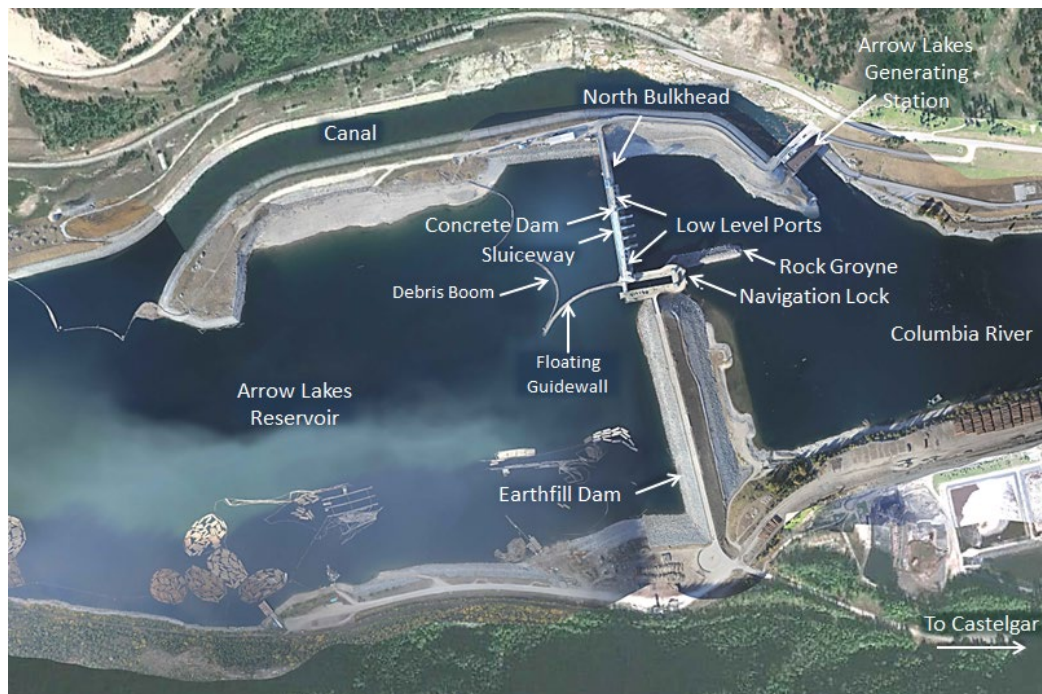
Figure 4: Hugh Keenleyside Dam Site Layout.

Both the earthfill embankment dam and the concrete dam are expected to survive a large earthquake but could sustain some damage. The earthfill embankment dam may also be vulnerable to internal erosion due to migration of fine particles from the core and the upstream clay blanket. Both of these issues require further investigation to confirm if they present a credible risk to the dam and are being prioritized in Dam Safety's investigation program.

Cavitation has caused severe concrete damage downstream of the spillway and low level outlet gates and on the energy dissipation structures. Modified gate operations are in place to minimize further damage until the structures are repaired.

**Spillway and Low-Level Outlets Concrete Upgrade:** Underwater placement of concrete to refurbish damaged areas at the spillway and low-level outlets caused by cavitation. The project is planned to commence construction in Fall of 2026 and will take 5 consecutive years to complete, using a 24/7 work schedule of divers during the annual planned fall outages.

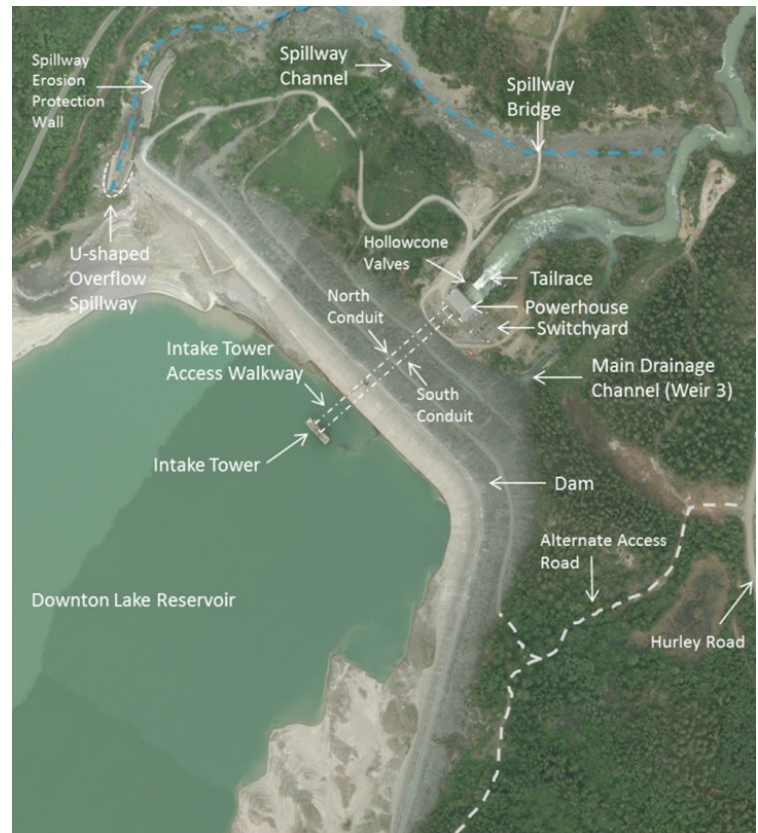
Figure 5: La Joie Dam Site Layout.

The dam's shotcrete facing suffers from ongoing cracking and bulging/buckling of local shotcrete panels, likely caused by stresses induced by temperature, the shape of the foundation and differential settlement, leading to significant leakage through the dam. This issue is currently managed through Dam Safety's civil maintenance program that completes annual repairs of the shotcrete face to manage the leakage rate. However, cracking is expected to be exacerbated following an

The south conduit and the intake tower are in poor condition. Further, the intake tower is not expected to survive a large earthquake. Its collapse would lead to the inoperability or blockage of the conduits and loss of control over the reservoir. The continued operability of these structures is critical to maintain minimum environmental flows, maintain the dam safety reservoir restriction, and to enable further reservoir drawdown for the planned facility upgrades.

**La Joie Dam Upgrade:** The project was originally released to address the condition of the dam's shotcrete face and to perform seismic upgrades to the intake tower. More recently, inspections and analyses identified that the south conduit is in poor condition and is no longer suitable to operate at the water licence normal maximum operating level. Additionally, the costs and complexity of stabilizing the existing intake tower were found to be prohibitive. As a result, the project has further investigated alternatives to reduce the scope of the dam face upgrades and to replace the conduits with new larger capacity ones and a new intake tower. This approach prioritizes the ability to drawdown the reservoir following an earthquake to manage downstream risks and to complete inspections and repairs. This change in approach has also created an additional opportunity to replace the existing generating station with a new higher capacity facility. A capacity increase from 25MW to about 70MW is being explored.
